ECO SUPPLY ACOUSTICAL PERFORMANCE TEST REPORT

ASTM E90 SOUND TRANSMISSION LOSS TESTING ON A
BILDAU IV79, TILT-TURN WINDOW

I1160.01-113-11-R0

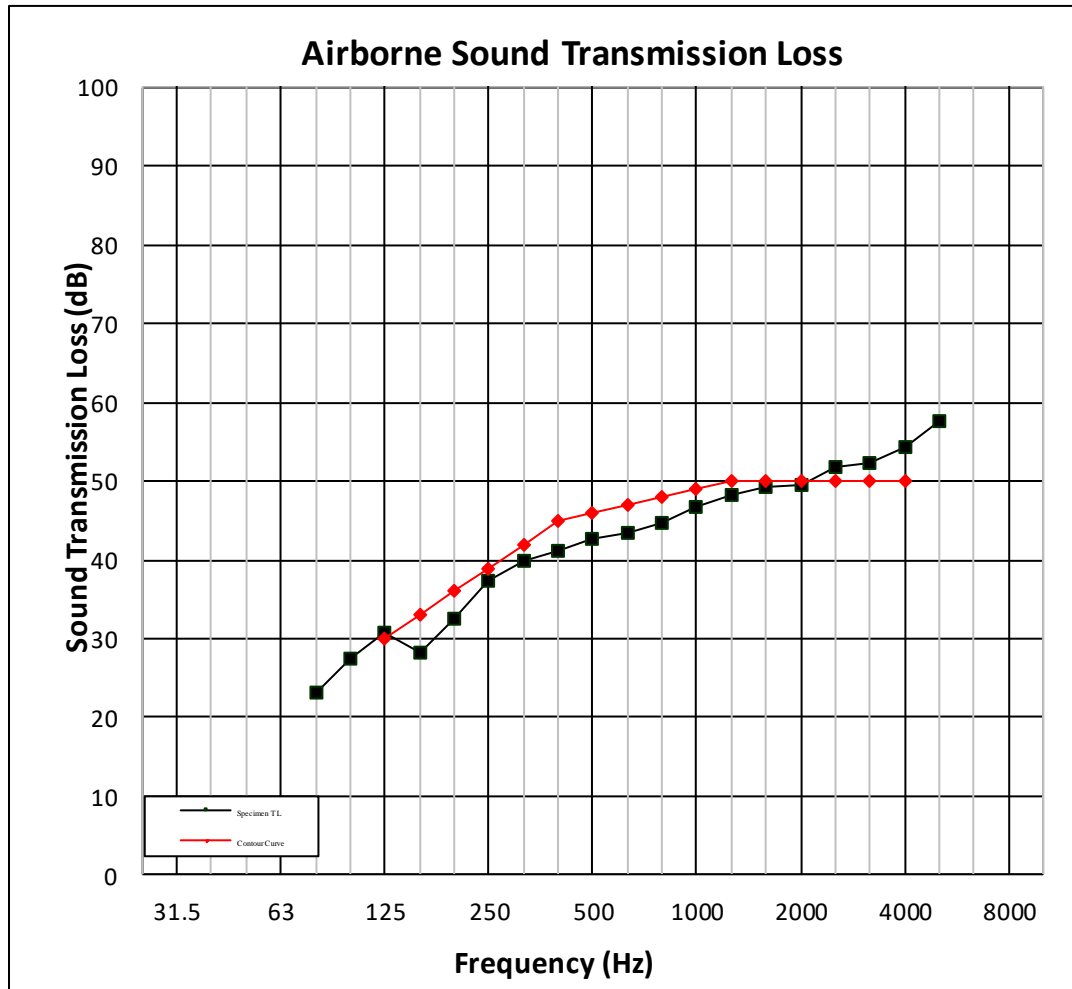
I1160.01 GRAPH

FREQ (Hz)	BACKGROUND SPL (dB)	ABSORPTION (m ²)	SOURCE SPL (dB)	RECEIVE SPL (dB)	SPECIMEN TL (dB)	95% CONFIDENCE LIMIT	NUMBER OF DEFICIENCIES
80	36.8	4.3	104	78	23	1.62	-
100	33.9	5.3	105	73	27	1.65	-
125	36.0	5.0	105	70	31	1.20	0
160	38.0	4.5	105	73	28	1.44	5
200	35.4	4.4	105	69	33	1.14	3
250	30.7	5.3	106	64	37	0.49	2
315	26.1	5.4	99	55	40	0.52	2
400	24.5	5.8	97	51	41	0.52	4
500	22.8	5.9	98	51	43	0.38	3
630	21.2	5.8	101	53	43	0.40	4
800	20.1	6.1	100	50	45	0.33	3
1000	17.5	6.3	97	45	47	0.18	2
1250	15.0	6.8	98	44	48	0.38	2
1600	12.3	7.1	102	47	49	0.36	1
2000	11.0	7.5	96	40	50	0.15	0
2500	10.6	8.4	95	36	52	0.27	0
3150	11.6	10.1	97	37	52	0.28	0
4000	12.9	12.2	96	34	54	0.23	0
5000	14.0	15.4	95	29	58	0.35	-
STC RATING	46 (Sound Transmission Class)						
DEFICIENCIES	31 (Sum of Deficiencies)						
OITC RATING	37 (Outdoor-Indoor Transmission Class)

To obtain the Sound Transmission Class (STC), read the TL of the contour curve at 500 Hz. The sum of the deficiencies below the contour curve must not exceed 32. The maximum deficiency at any one frequency must not exceed 8.

The Outdoor-Indoor Transmission Class (OITC) is calculated by subtracting the logarithmic summation of the TL values from the logarithmic summation of the A-weighted transportation noise spectrum stated in ASTM E1332.

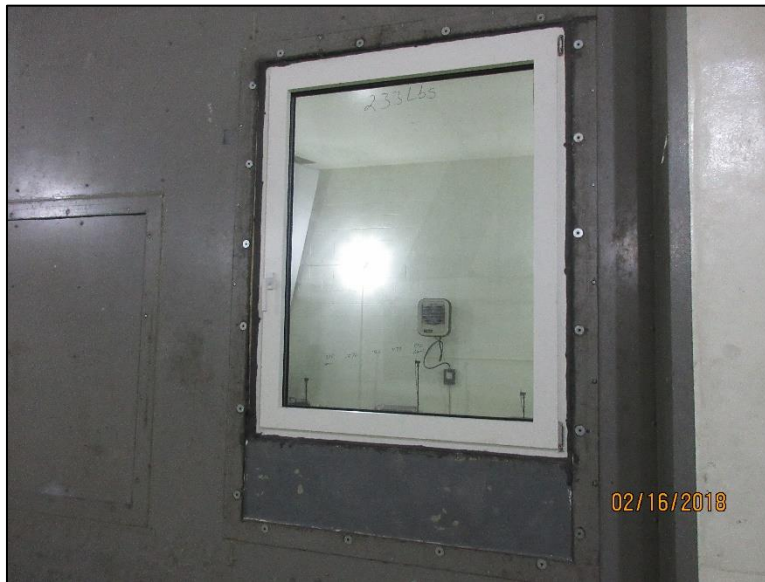
Photo No. 1
Receive Room View of Installed Specimen

The specimen plug was removed from the filler wall assembly. A filler wall-reducing element, consisting of two separate 2x6 wood frames filled with concrete, was used to adjust the test opening size to accommodate the test specimen. A dense neoprene gasket was placed between the two wood and concrete frames. The specimen was placed on an isolation pad in the custom test opening. Duct seal was used to seal the perimeter of the specimen to the test opening on both sides. The interior side of the specimen, when installed, was approximately 1/4" from being flush with the receive room side of the filler wall. A stethoscope was used to check for any abnormal air leaks around the test specimen prior to testing. Operable portions of the test specimen, if any, were cycled at least five times prior to testing.

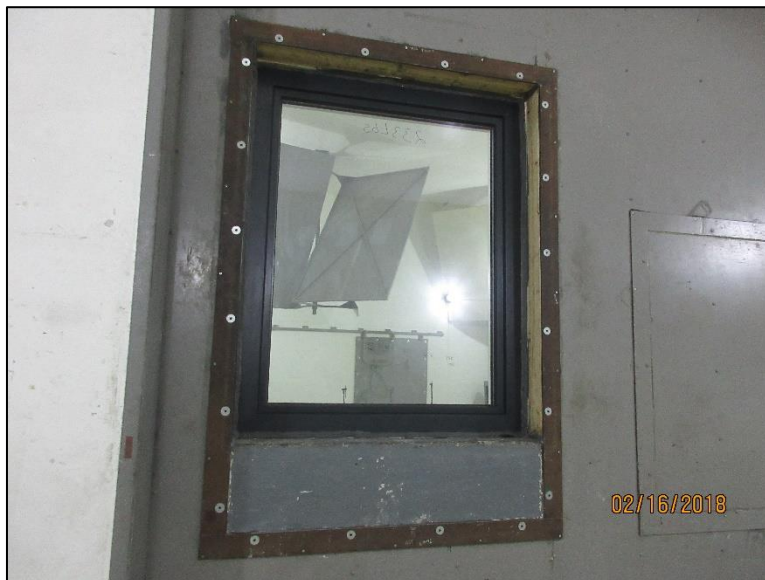
Photo No. 2
Source Room View of Installed Specimen
