30 September 2021

Re: CTA Development Project - Waters of the United States Delineation & Desktop Assessment
Approximately 69 acres across 13 different sites within the DFW International Airport CTA Terminals A and C Development Project located on the DFW International Airport complex, Dallas and Tarrant Counties, Texas

Integrated Environmental Solutions, LLC (IES) performed a site survey and desktop review to identify any aquatic features that meet a definition of a water of the United States on approximately 69 acres across 13 different sites within the DFW Airport CTA Terminals A and C Development Project located on the DFW International Airport complex, Dallas and Tarrant Counties, Texas. A desktop evaluation was conducted on Sites 1 through 7 as they were not able to be accessed due to airport regulations. A site survey was conducted on Sites 8 through 13 as they were able to be accessed via public roadways (**Attachment A, Figure 1**). This report will ultimately assess and delineate potentially jurisdictional aquatic features to ensure compliance with Sections 401 and 404 of the Clean Water Act (CWA).

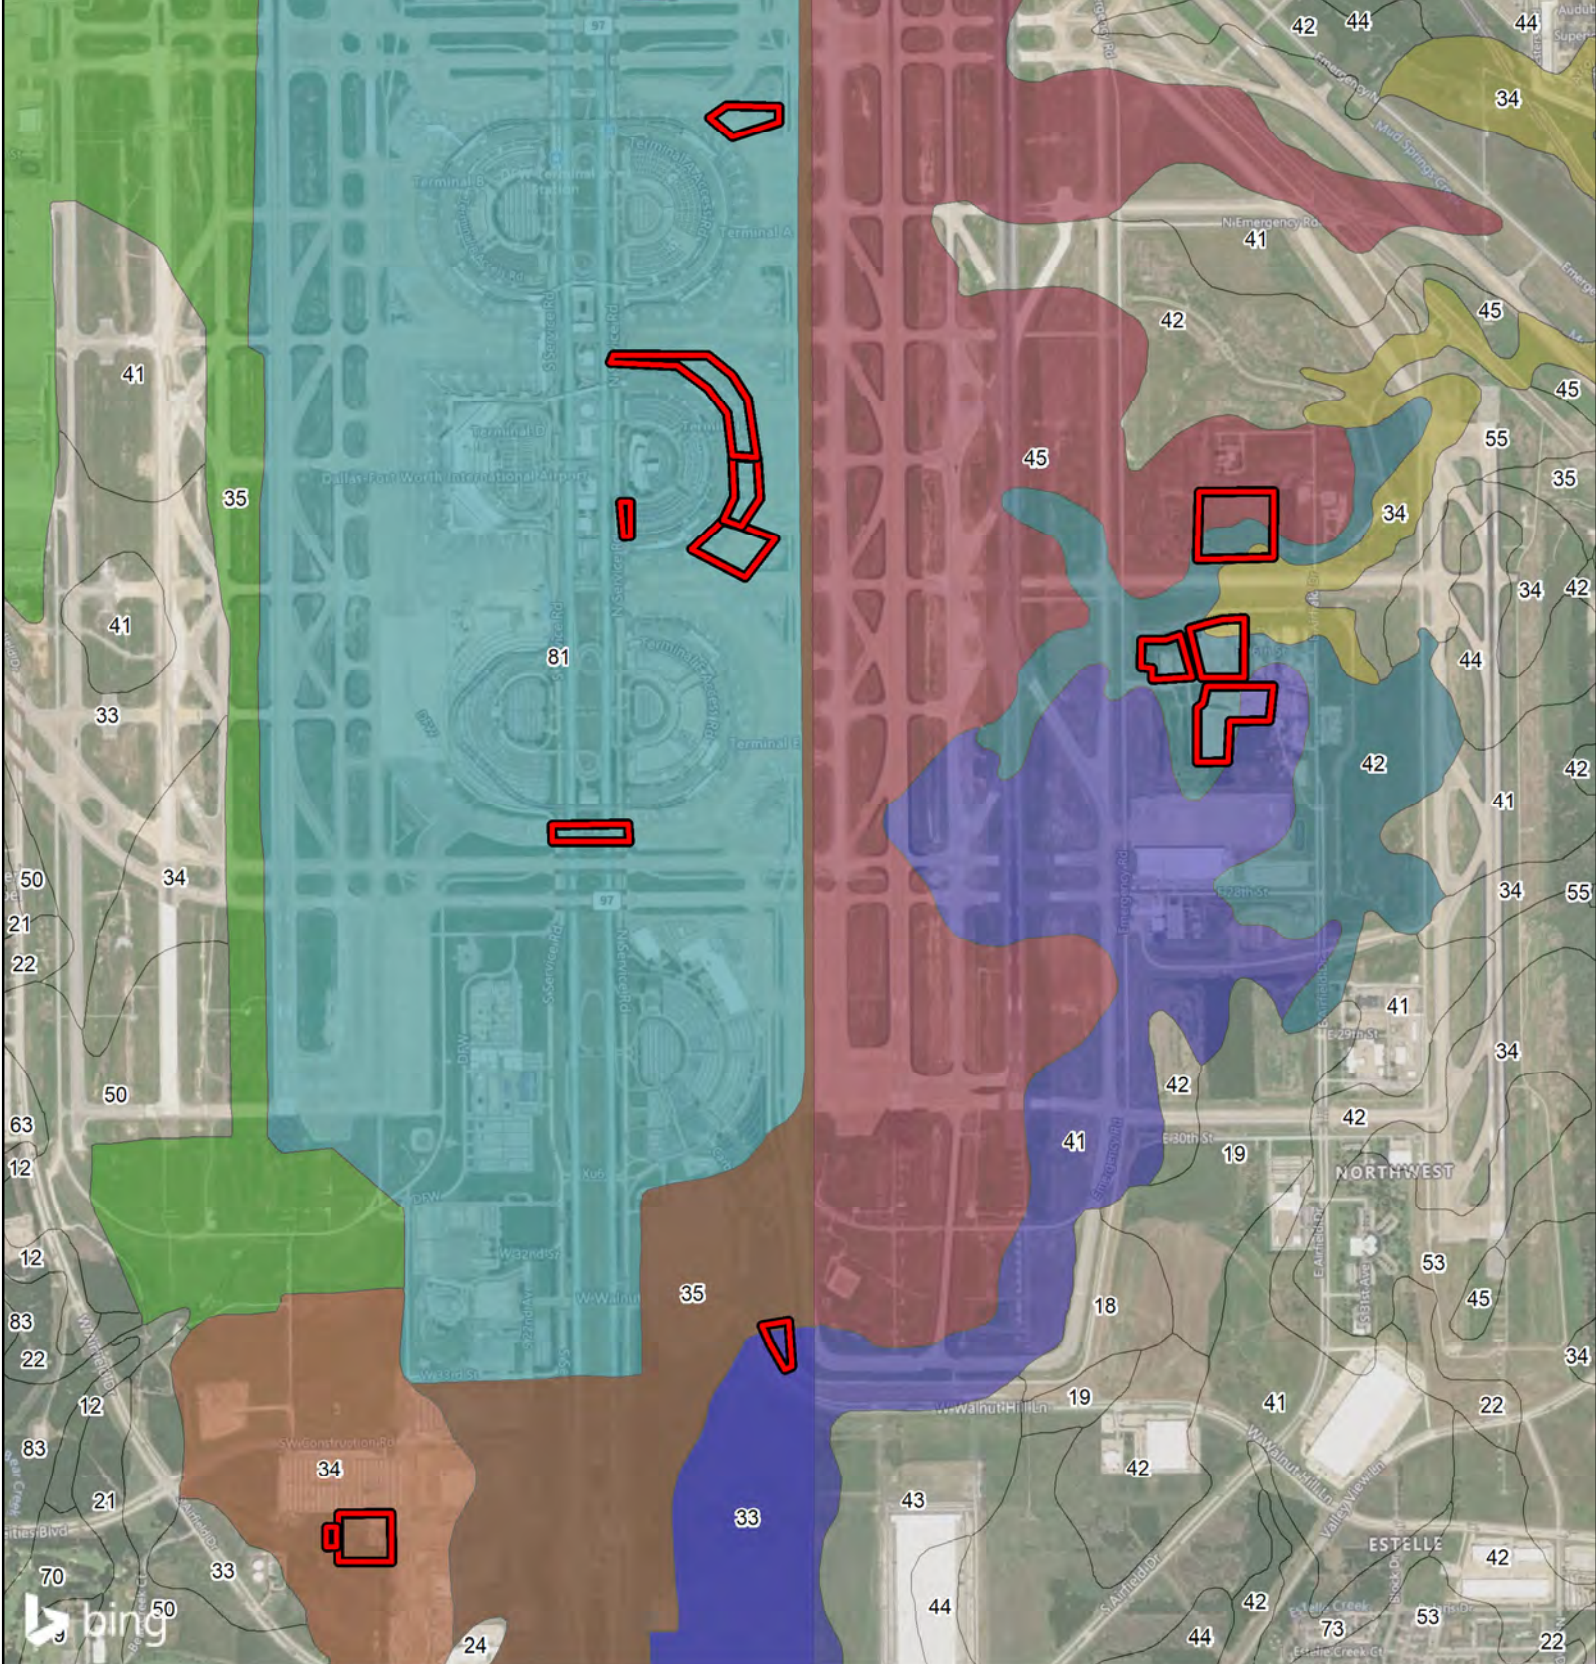
**Figure 3.
Soils Map**

The *Soil Survey of Dallas County, Texas* identified four soil map units within the survey area, Ferris-Heiden complex, 5 to 12 percent slopes; Heiden clay, 1 to 3 percent slopes; Heiden clay, 2 to 5 percent slopes, eroded; and Houston Black-Urban land complex, 0 to 4 percent slopes. The *Soil Survey of Tarrant County, Texas* identified four soil map units within the survey area, Heiden clay, 1 to 3 percent slopes; Houston Black clay, 1 to 3 percent slopes; Houston Black-Urban land complex, 1 to 4 percent slopes; and Urban land. None of these soil map units were listed as a hydric soil on the Hydric Soils of Texas list prepared by the National Technical Committee for Hydric Soils (accessed 29 September 2021, Dallas and Tarrant Counties, Texas) (see **Attachment A, Figure 3**). Hydric soils are described as those soils that are sufficiently wet in the upper part to develop anaerobic conditions during the growing season.

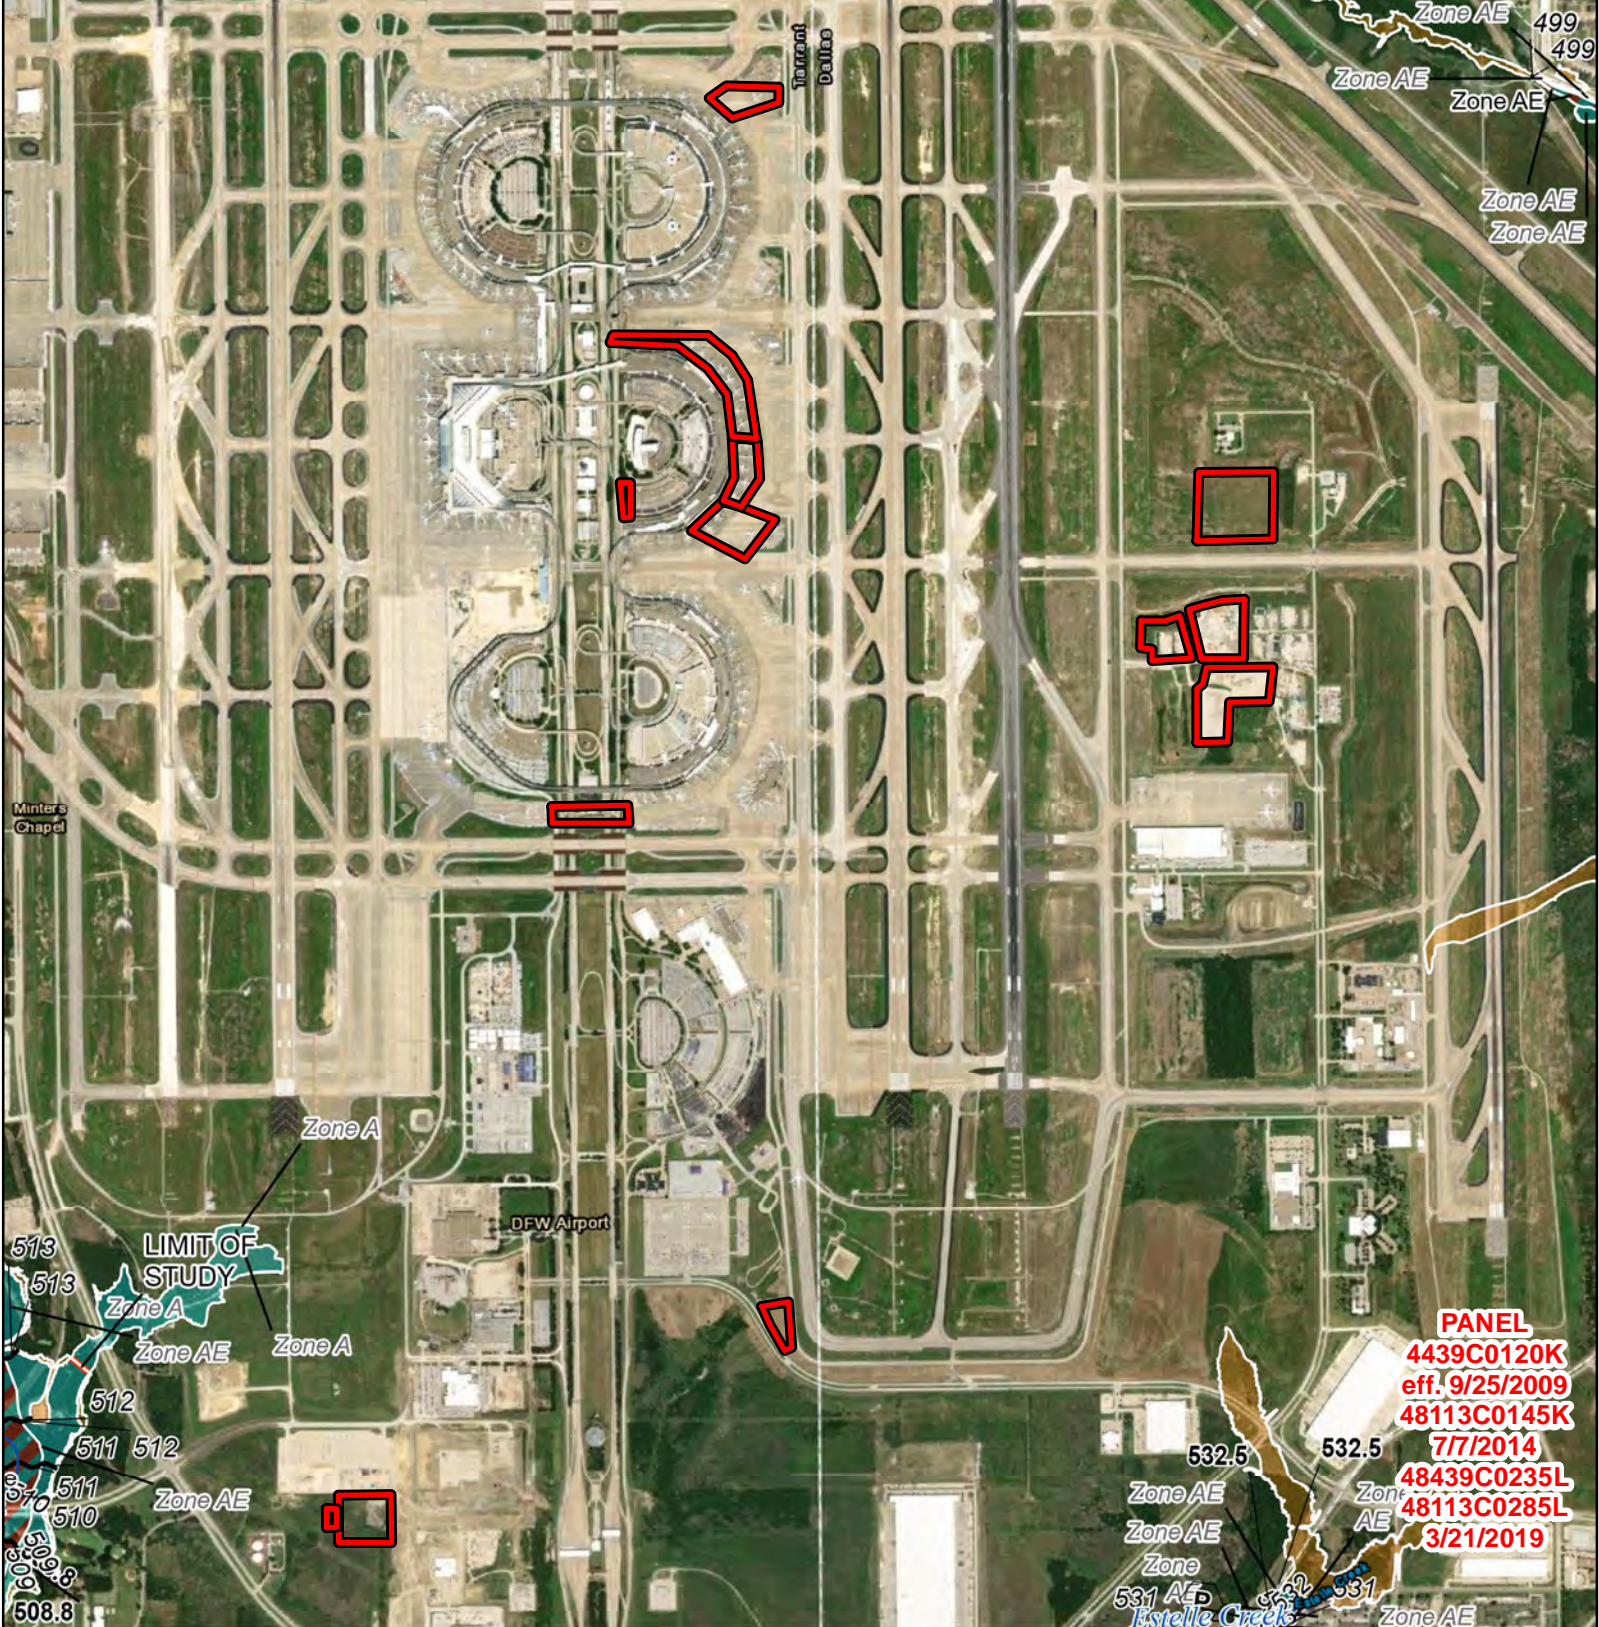
Figure 4.
Federal Emergency
Management Agency
Flood Insurance Rate Map

The FEMA FIRM (Dallas and Tarrant Counties; Map Panel 4439C0120K; effective 25 September 2009; 48113C0145K; effective 07 July 2014 and Map Panels 48439C0235L, and 48113C0285L; effective 03 March 2019) shows the entire survey area to be within Zone X (Areas determined to be outside the 0.2 percent annual chance floodplain) (see **Attachment A, Figure 4**).

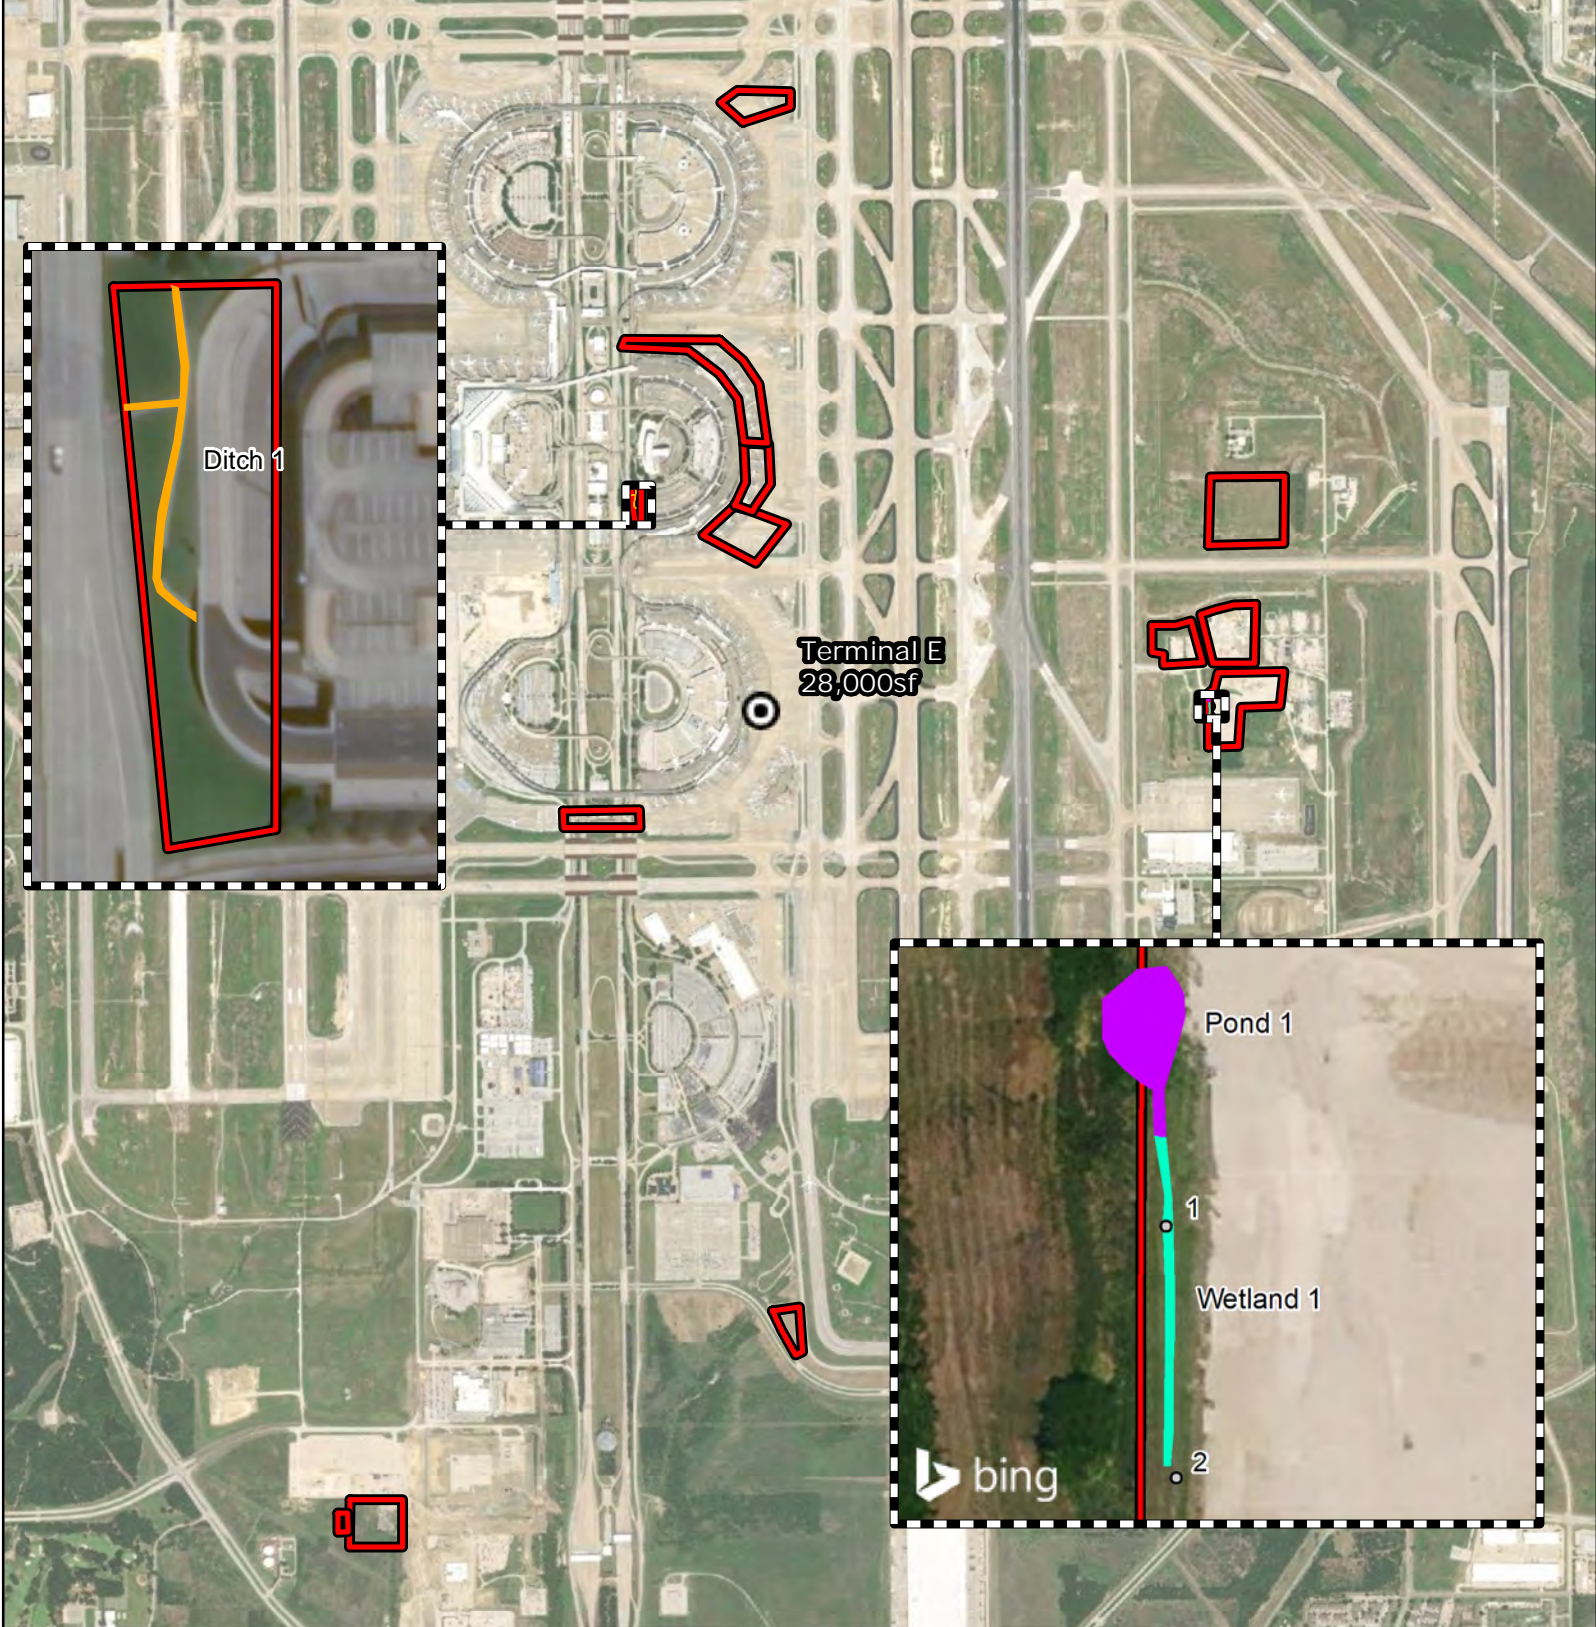
Figure 5.
NWPR Aquatic Features Identified
within the Survey Area

Aquatic features within Sites 1 through 7 were identified and delineated using both the National Hydrography Dataset (NHD) and historic and recent aerial photography. Sites 8 through 13 were field verified after a review of the available secondary data. **Table 1** and the following paragraphs detail the aquatic features identified within the survey sites at the time of evaluation (**Attachment A, Figure 5 and 6**).

Table 2 provides an overview of the jurisdictional assessment of the aquatic features located within the survey area under the NWPR. Under this rule, none of the aquatic features located within the survey area would be considered a water of the United States (see **Attachment A, Figure 5**). **Wetland 1** was adjacent to an isolated pond and **Ditch 1** was a man-made ephemeral ditch; therefore, these features do not meet the definition of an adjacent wetland, or a replacement of a jurisdictional water and would not be subject to regulation. **Pond 1** does not contribute water flow through a surface connection to any intermittent or perennial water; therefore, it would not meet a definition of a jurisdictional pond or impoundment under the NWPR.

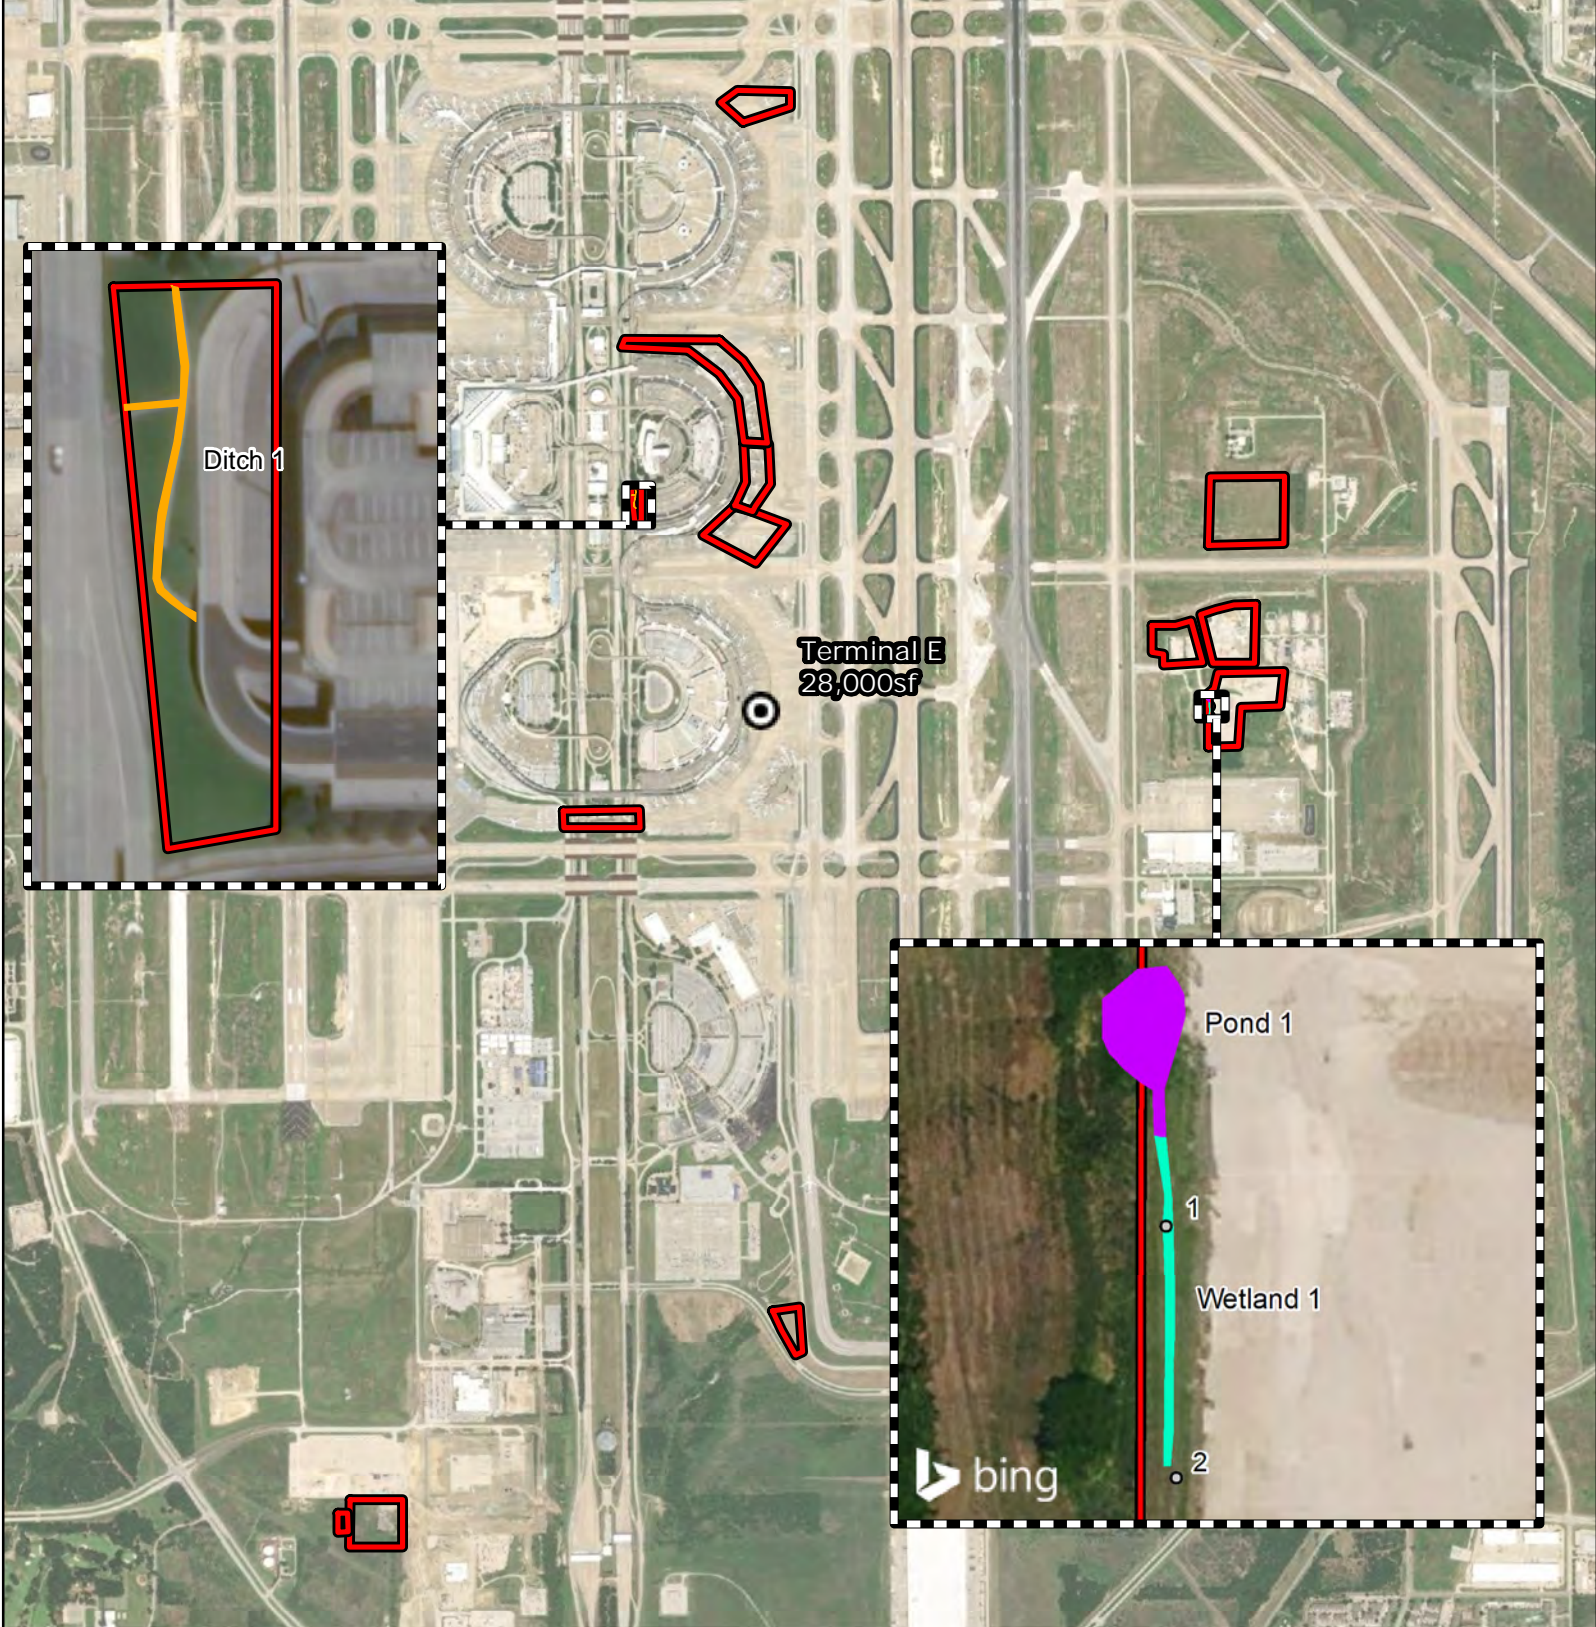
Figure 6.
Pre-2015 Aquatic Features
Identified within the Survey Area

The 05 June 2007 USACE and USEPA jointly published instructional guidebook is intended to provide the USACE field staff a national standard operating procedure for conducting jurisdictional determinations. The guidebook was prepared by combining all prior applicable provisions, regulations, statutes, and case laws pertaining to the CWA. All terms, definitions, and conclusions regarding the jurisdictional nature of the aquatic features used within this report are derived directly, as they are practiced, from the guidance. The following outlines the applicable interpretations of the guidance appropriate for this situation. **Table 3** provides an overview of the jurisdictional assessment of the aquatic features under the 1986 Waters of the United States definitions and the *Rapanos* decision (**Attachment A, Figure 6**).

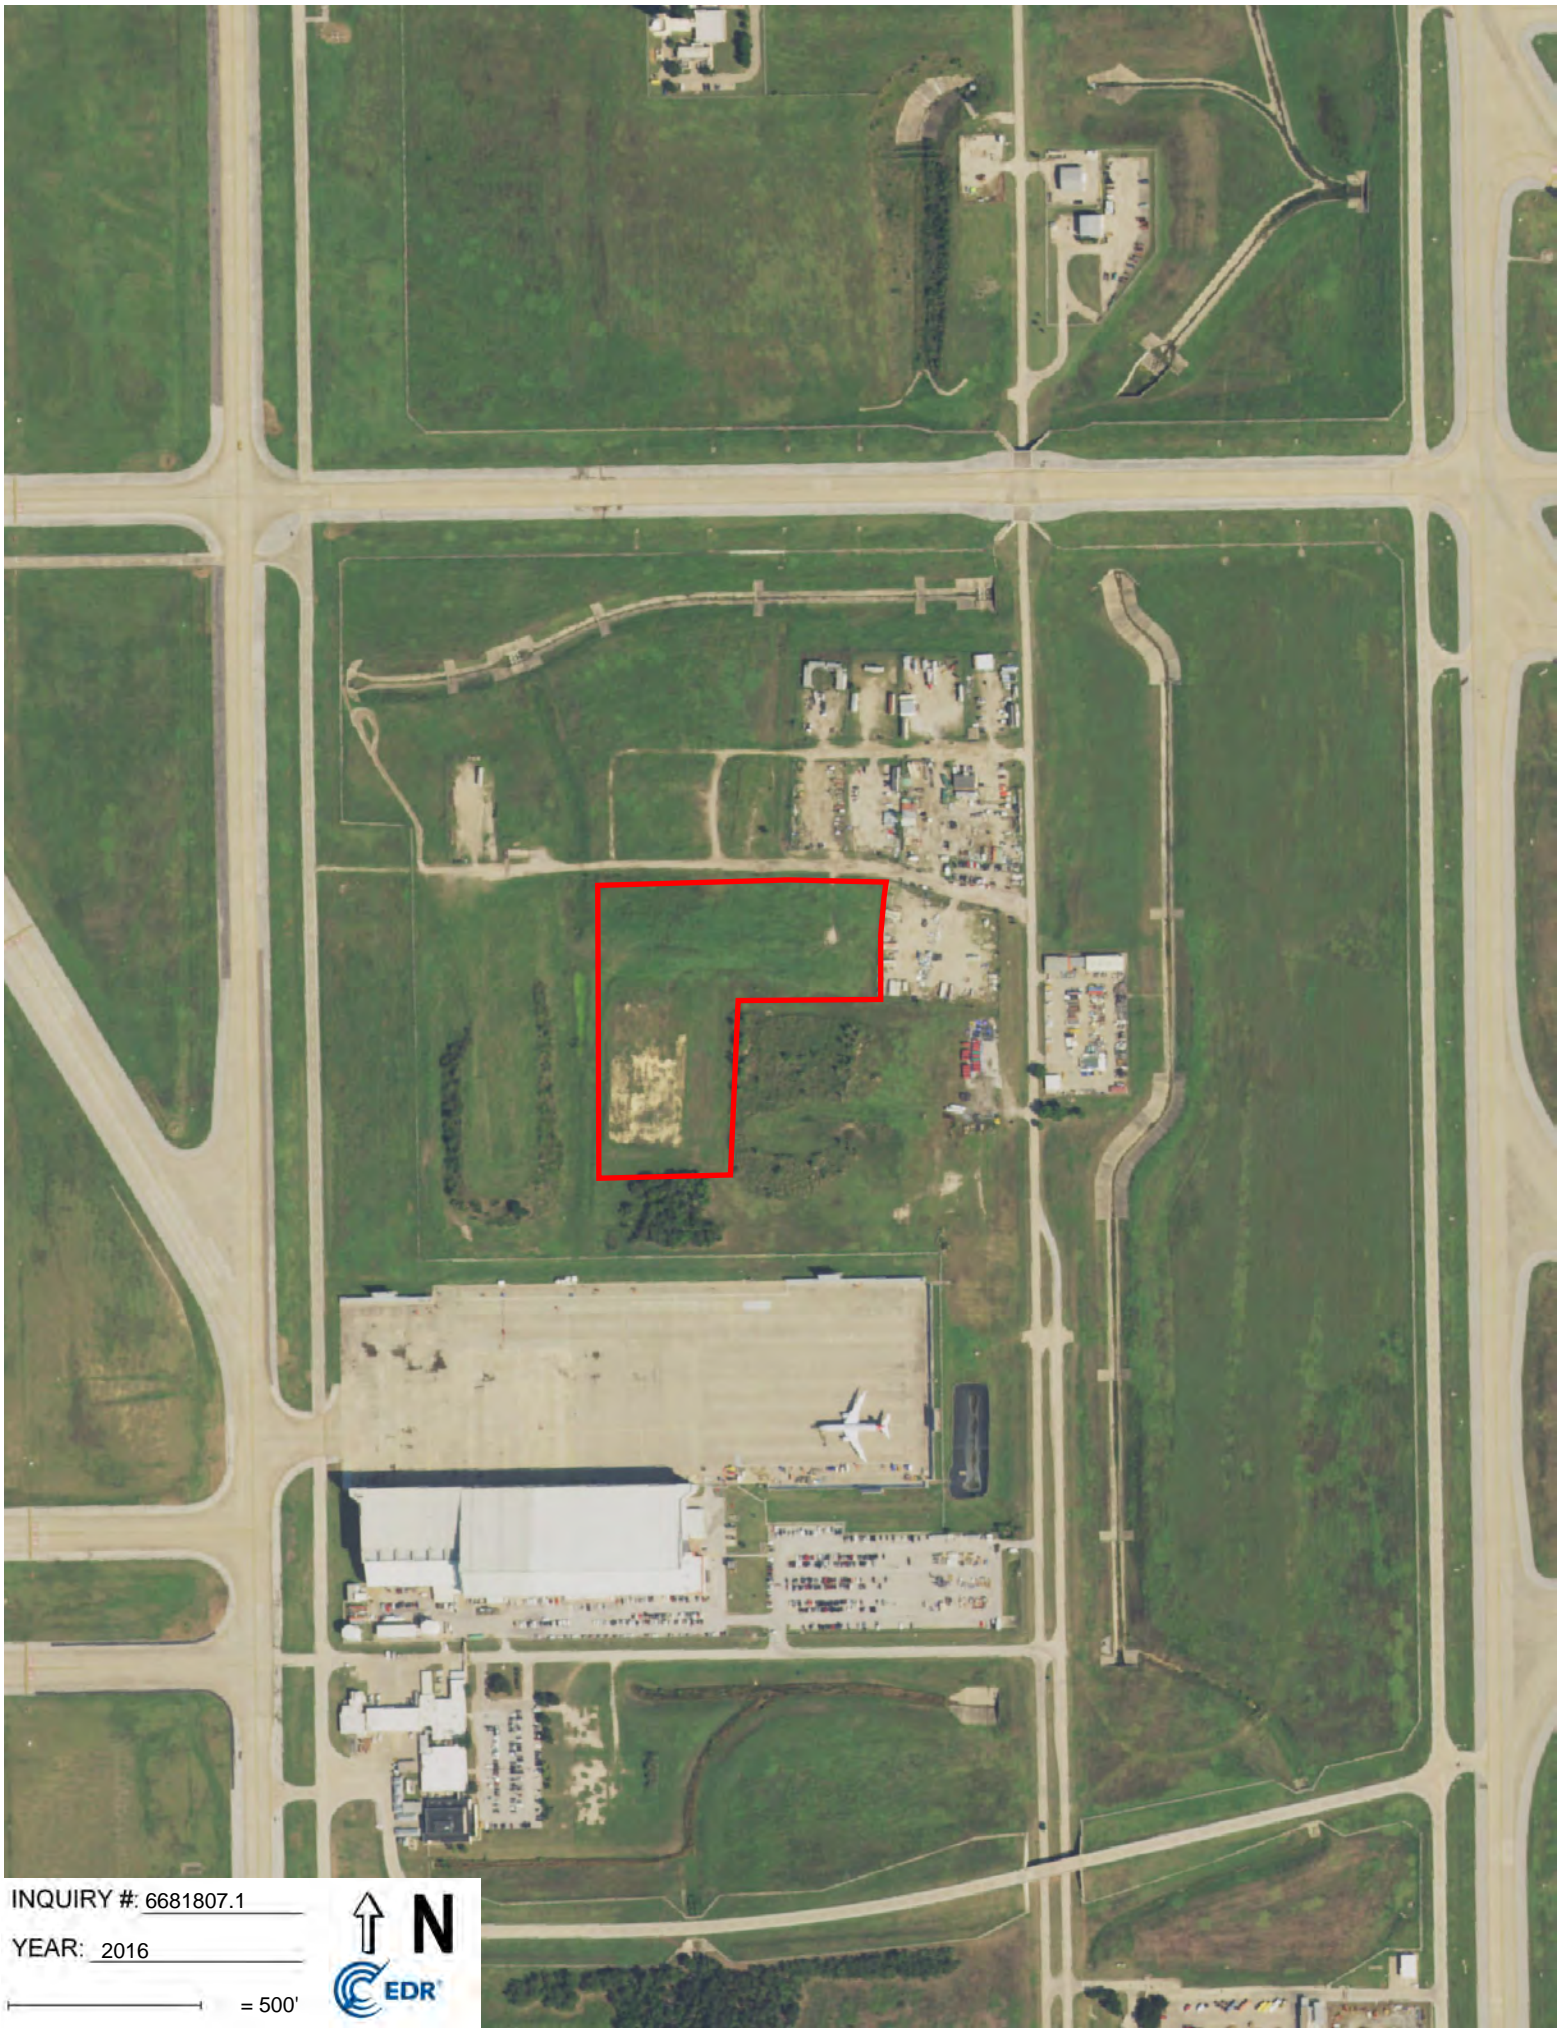
YEAR: 2016

2016 – A lot has been partially cleared in the southern region.

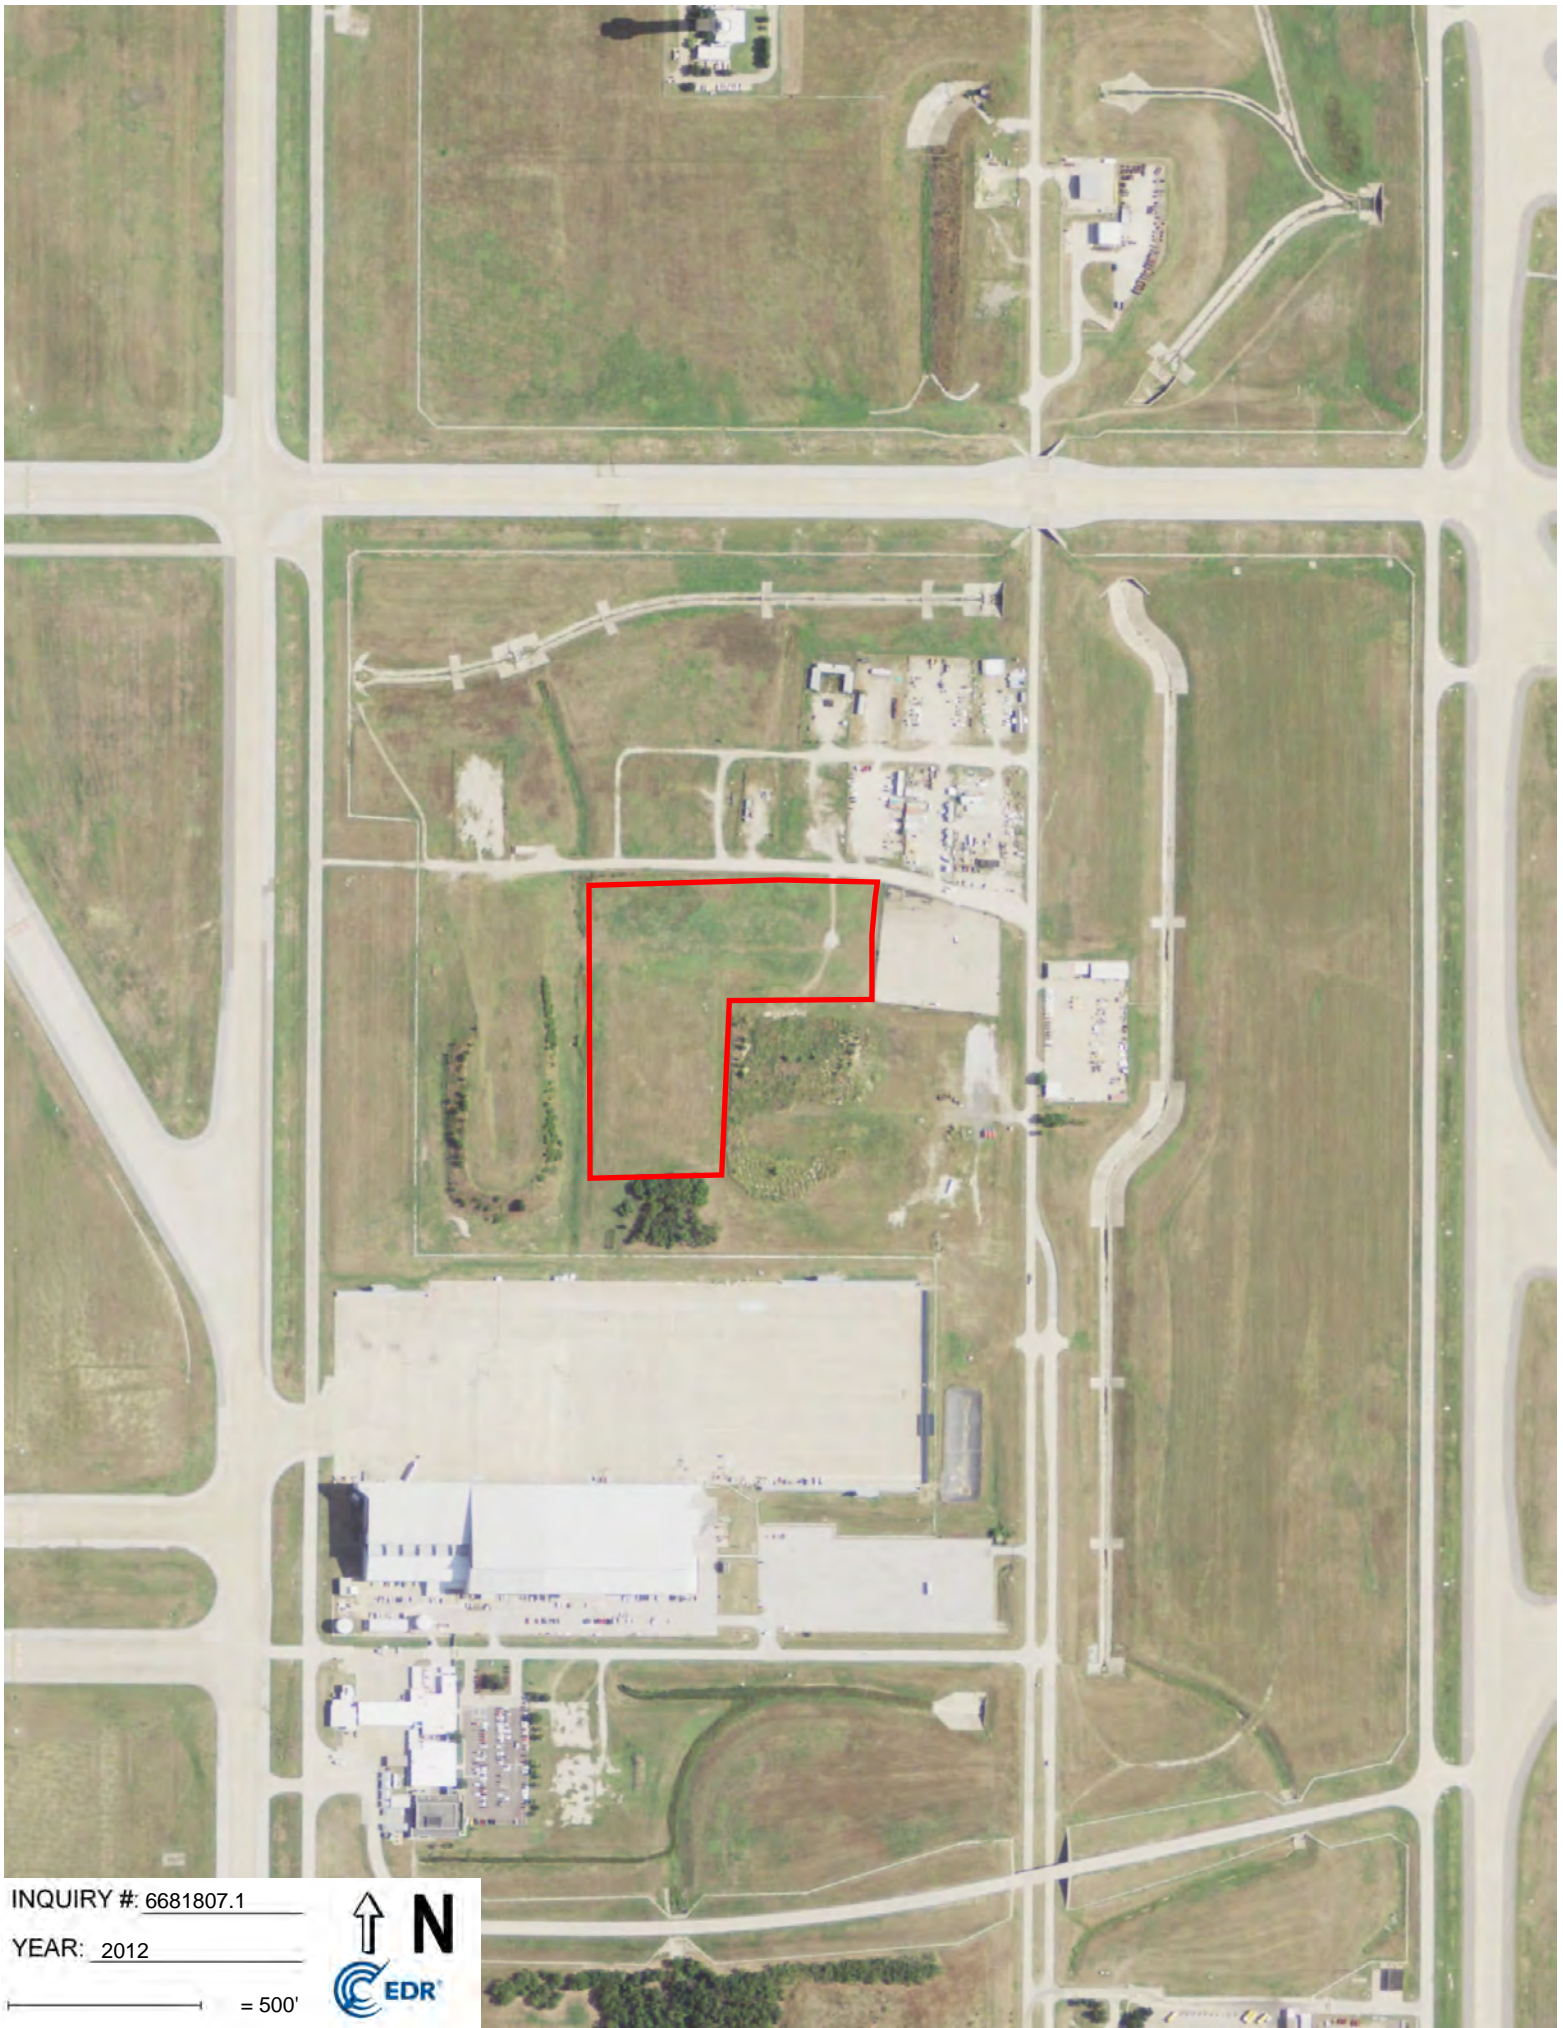
YEAR: 2012

2005-2012 – The eastern region of Site 10 has been cleared. Canopy cover has increased along the drainage to the west, and the area to the south.

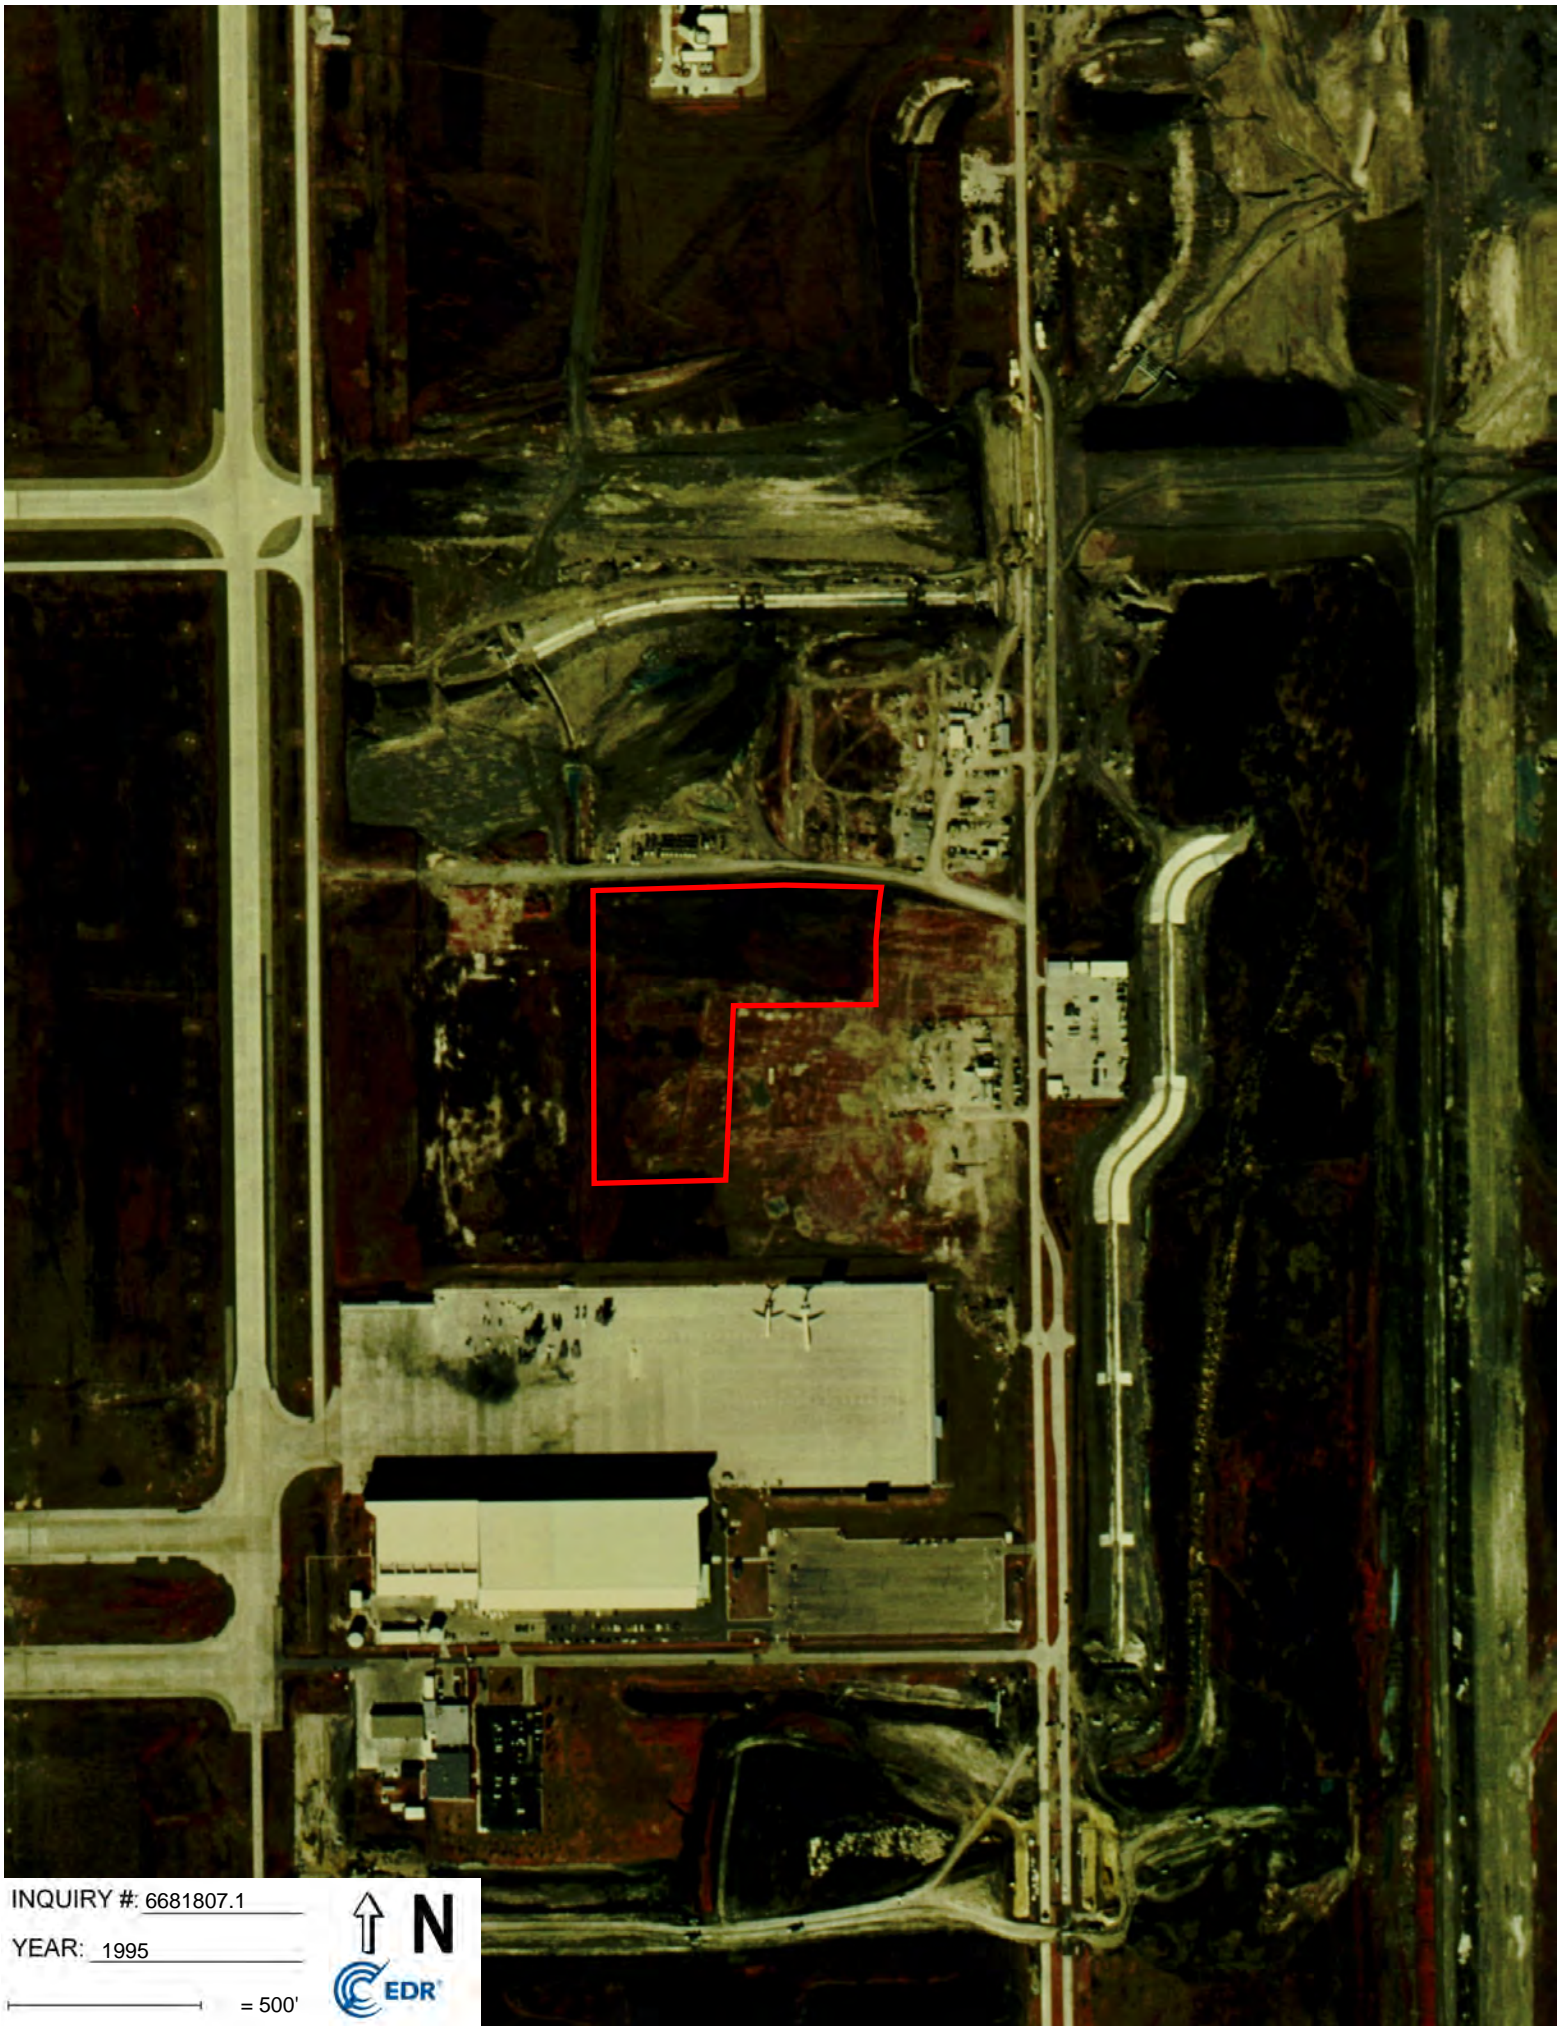
YEAR: 1995

1995 – Airport runways and buildings have been constructed surrounding Site 10 and a road has been cleared along the northern boundary. The drainage to the north that was previously impounded has been channelized and routed through a concrete channel.
