30 September 2021

Re: CTA Development Project - Waters of the United States Delineation & Desktop Assessment
Approximately 69 acres across 13 different sites within the DFW International Airport CTA Terminals A and C Development Project located on the DFW International Airport complex, Dallas and Tarrant Counties, Texas

Integrated Environmental Solutions, LLC (IES) performed a site survey and desktop review to identify any aquatic features that meet a definition of a water of the United States on approximately 69 acres across 13 different sites within the DFW Airport CTA Terminals A and C Development Project located on the DFW International Airport complex, Dallas and Tarrant Counties, Texas. A desktop evaluation was conducted on Sites 1 through 7 as they were not able to be accessed due to airport regulations. A site survey was conducted on Sites 8 through 13 as they were able to be accessed via public roadways (**Attachment A, Figure 1**). This report will ultimately assess and delineate potentially jurisdictional aquatic features to ensure compliance with Sections 401 and 404 of the Clean Water Act (CWA).

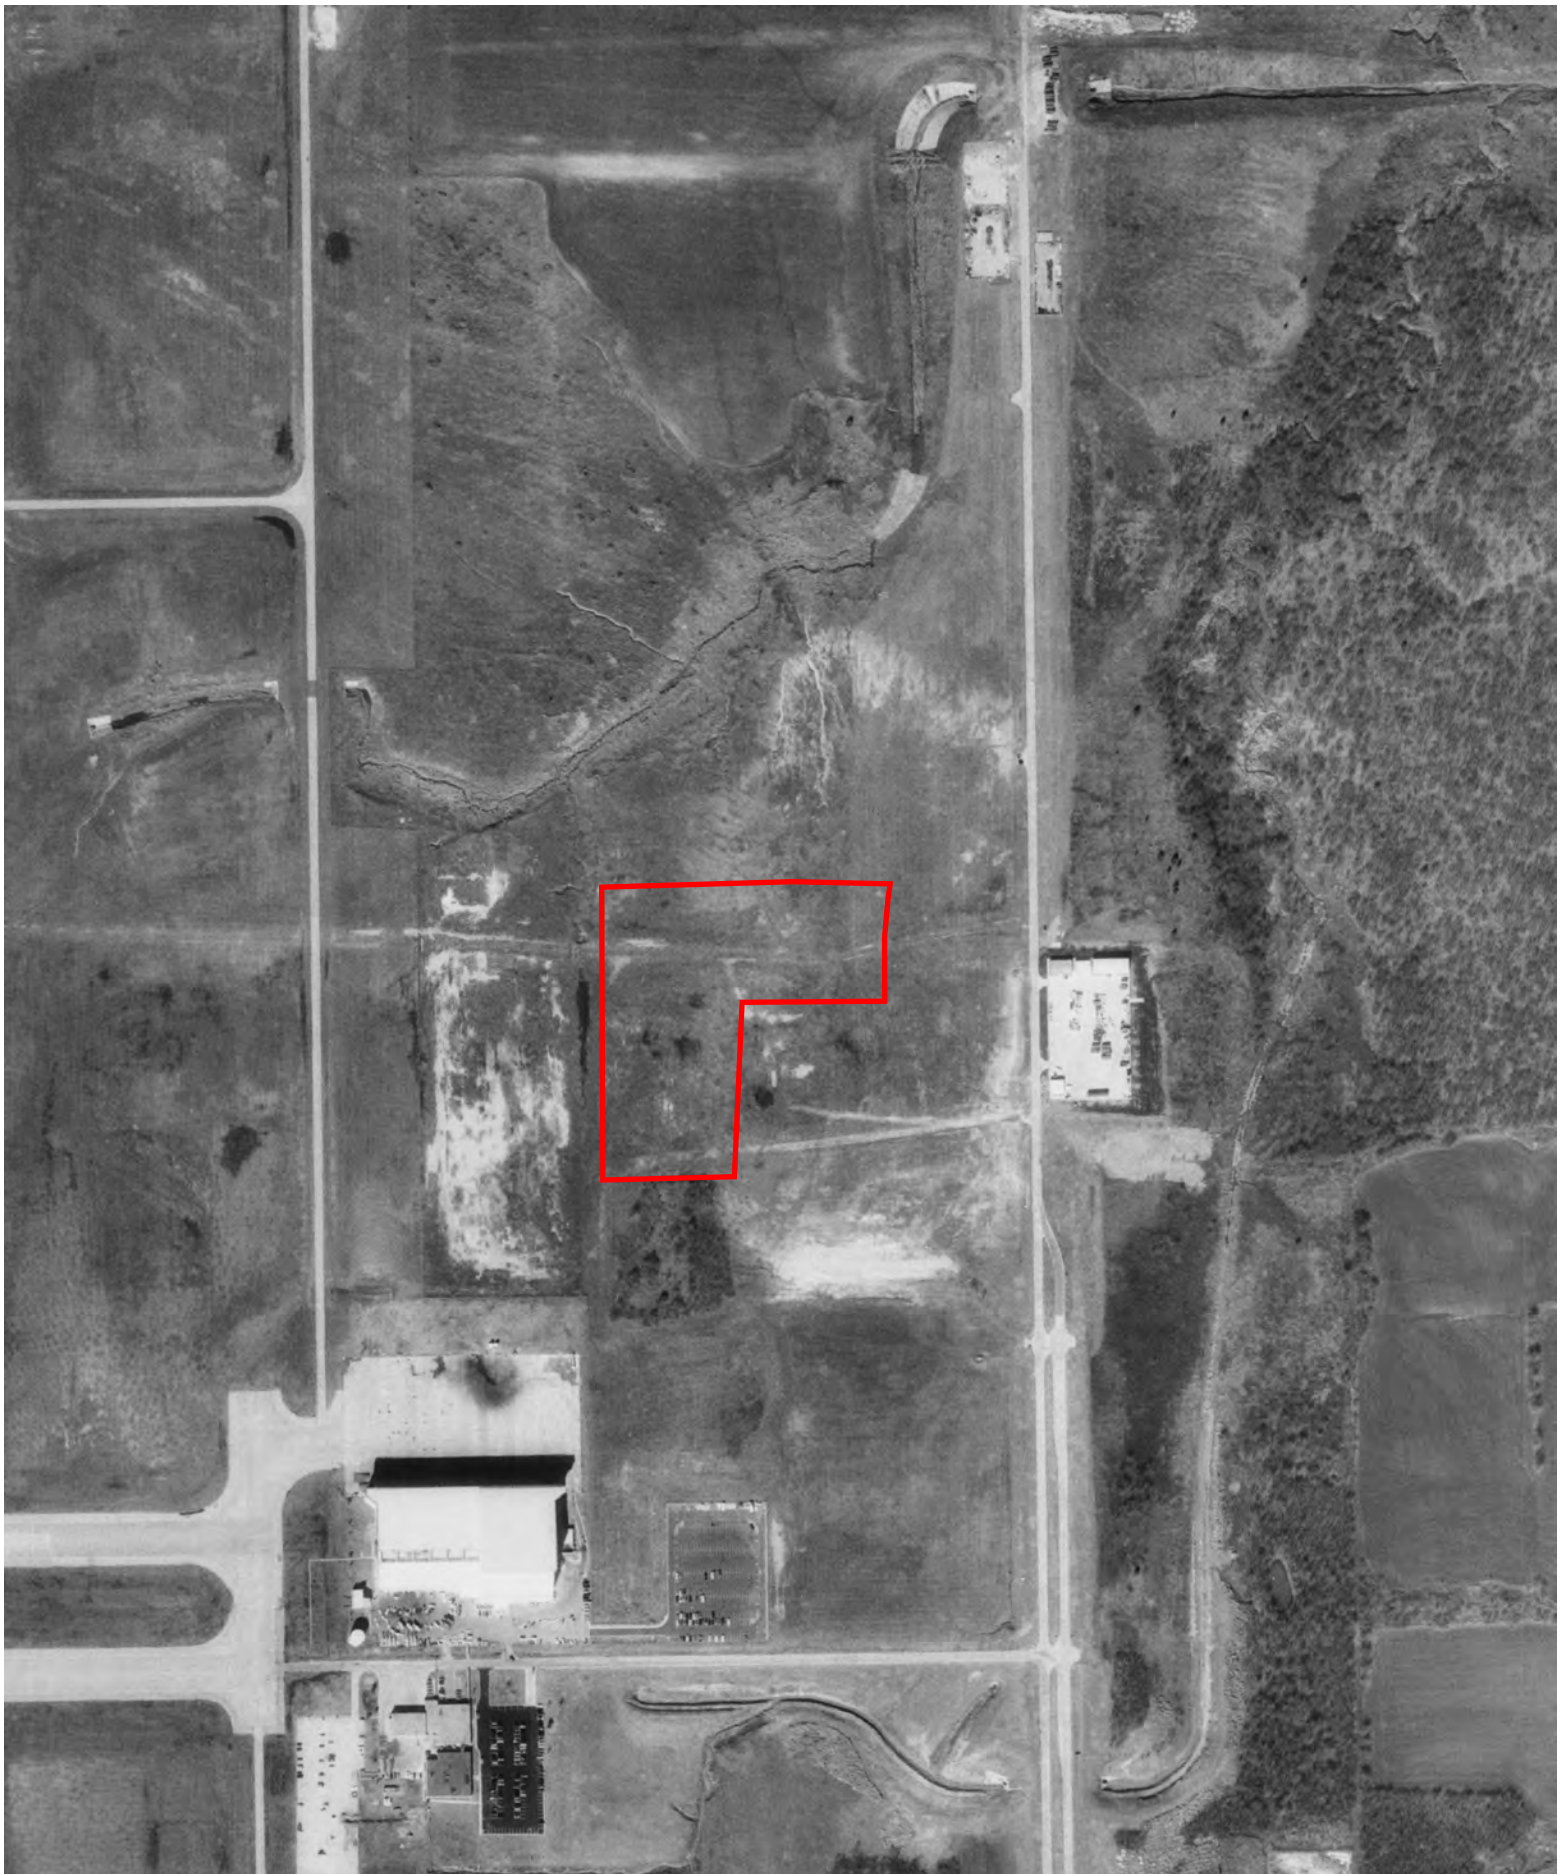
YEAR: 1990

1990 – Dark color signatures are visible in the channel to the west, indicating potential inundation.

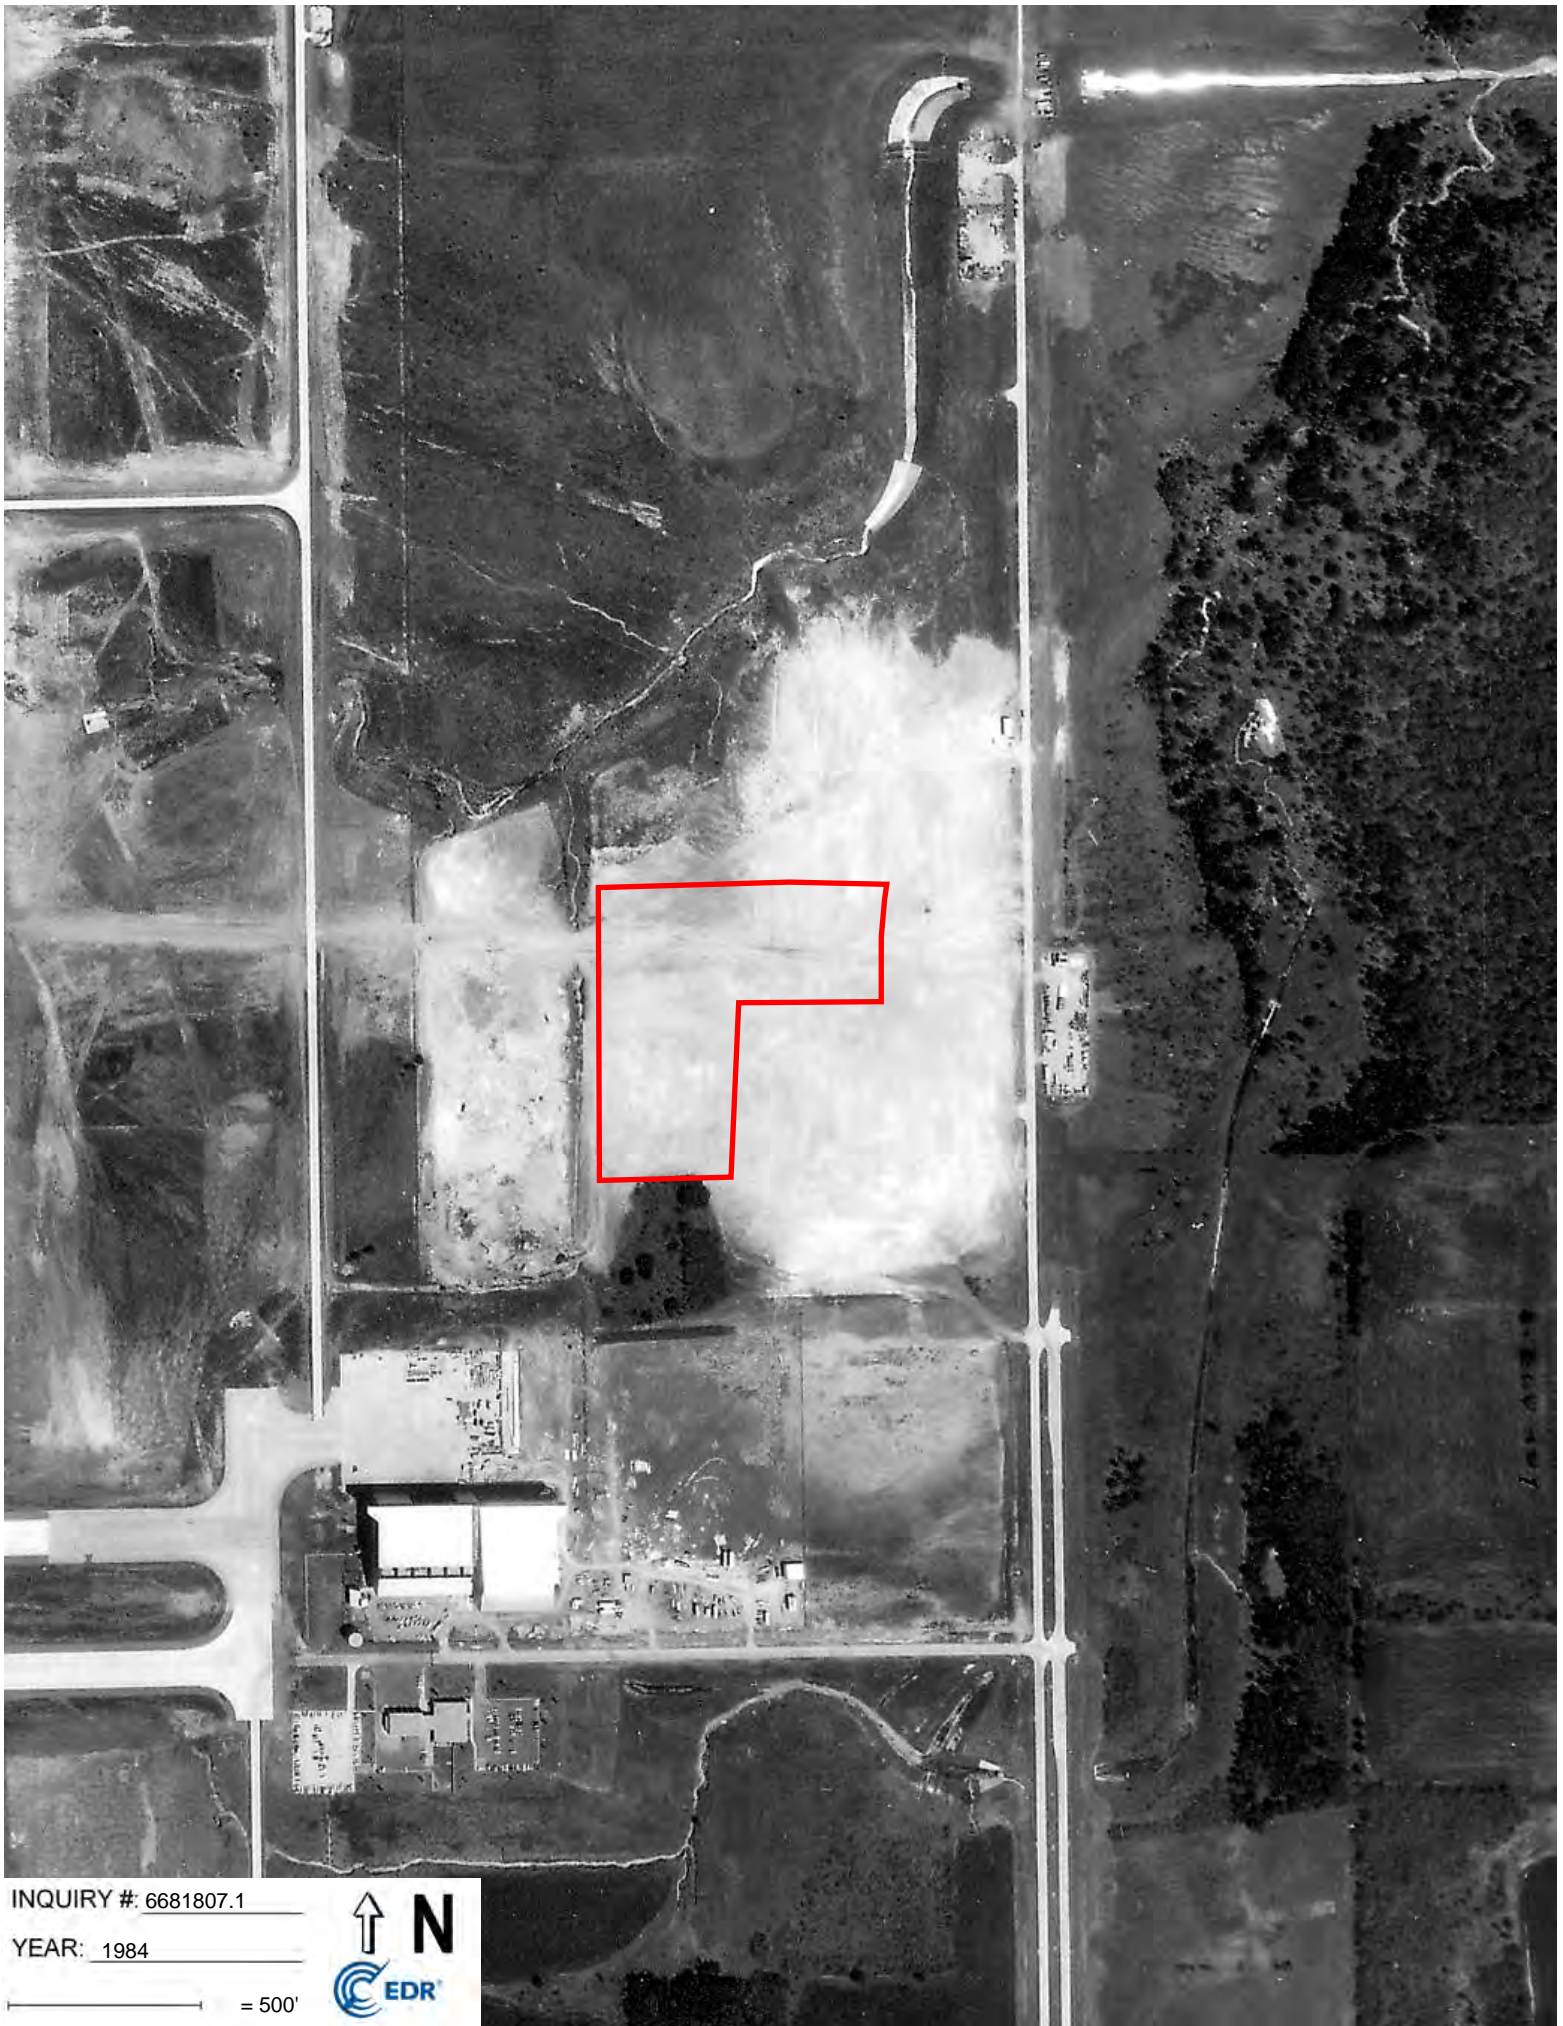
YEAR: 1984

1984 – Site 10 has been entirely cleared.

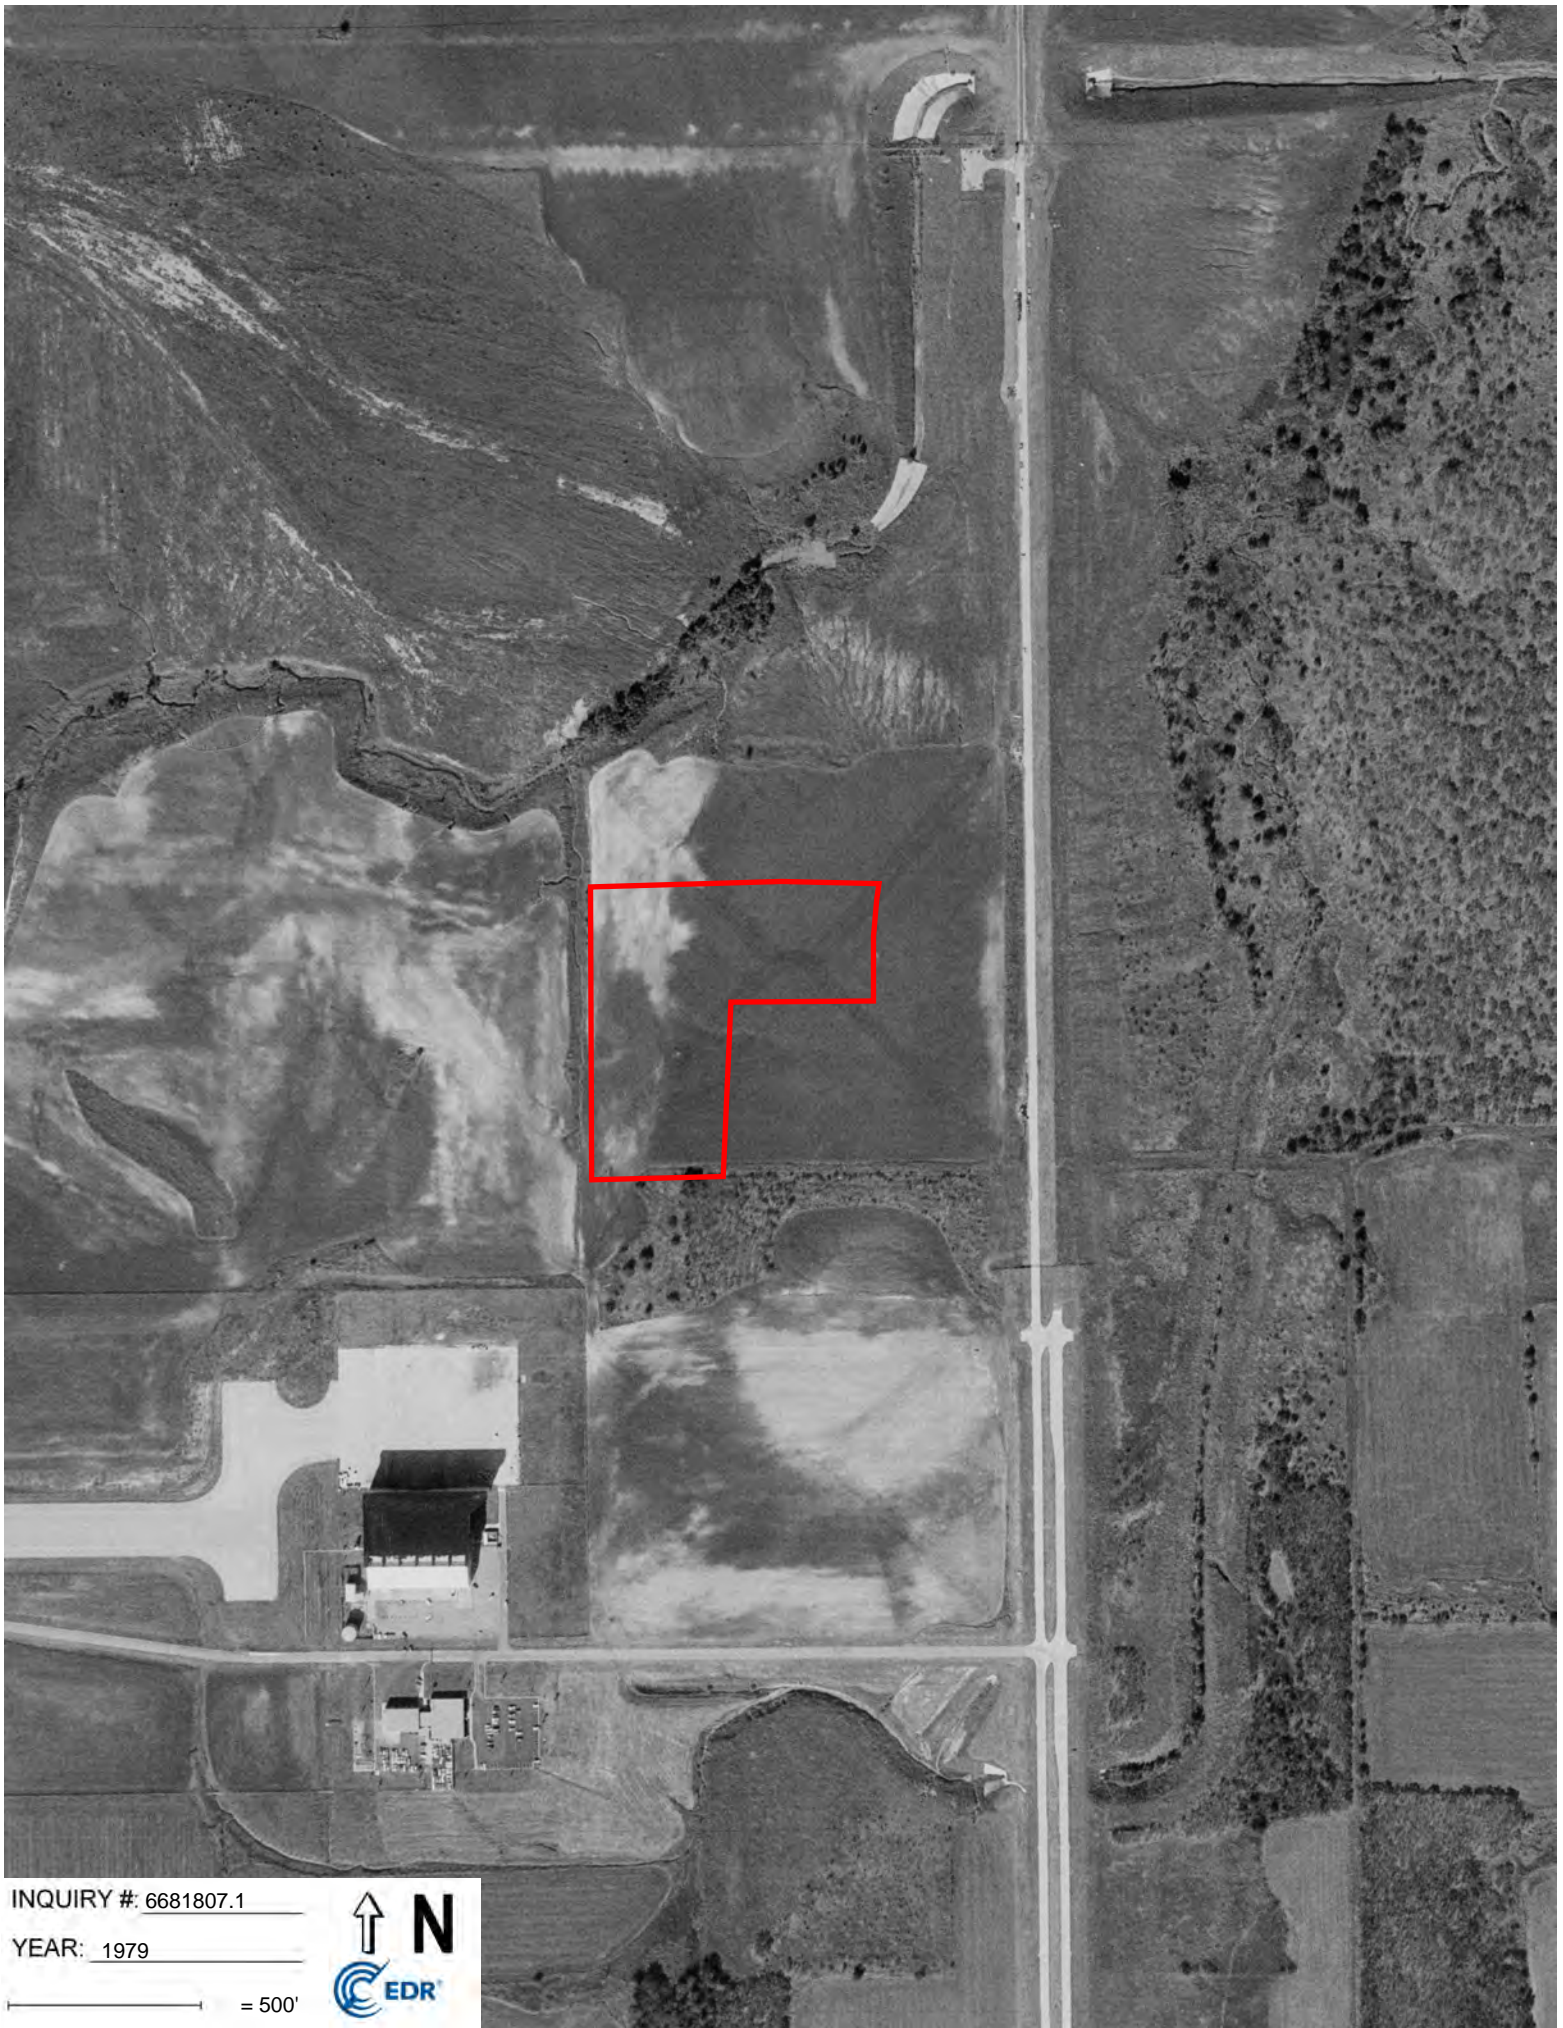
YEAR: 1979

1979 – The roads are no longer visible and the impoundment to the north has been filled. A commercial complex has been constructed south of Site 10.

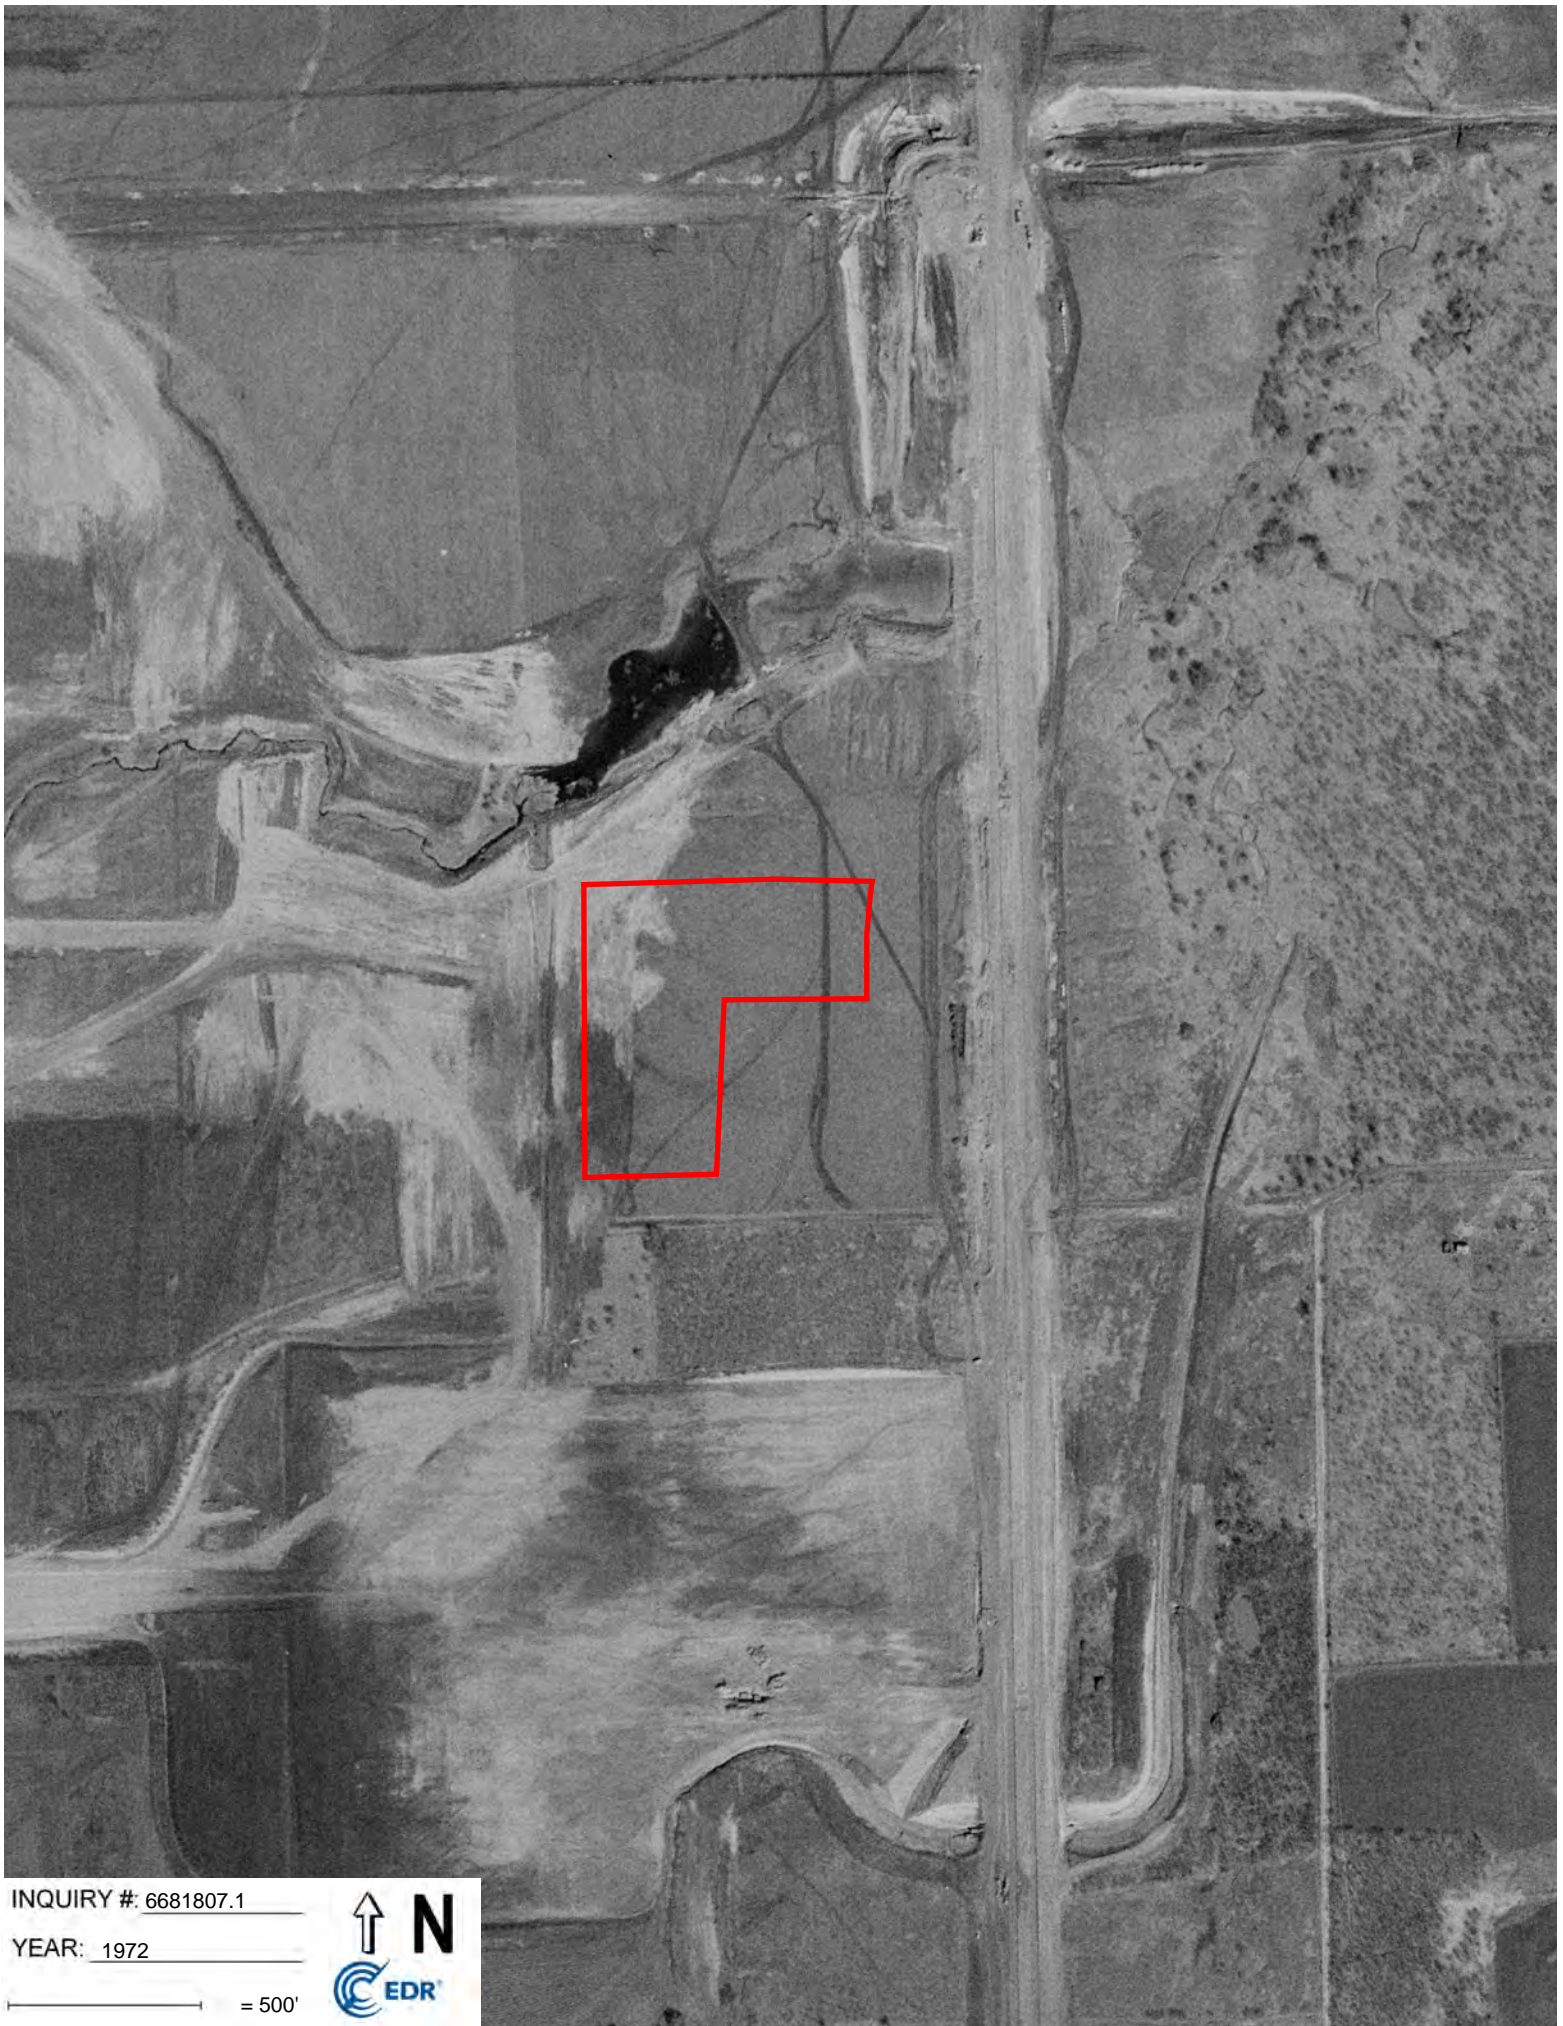
YEAR: 1972

1972 – Dirt roads are visible across Site 10. The drainage to the west has been channelized and an impoundment has been excavated to the north.

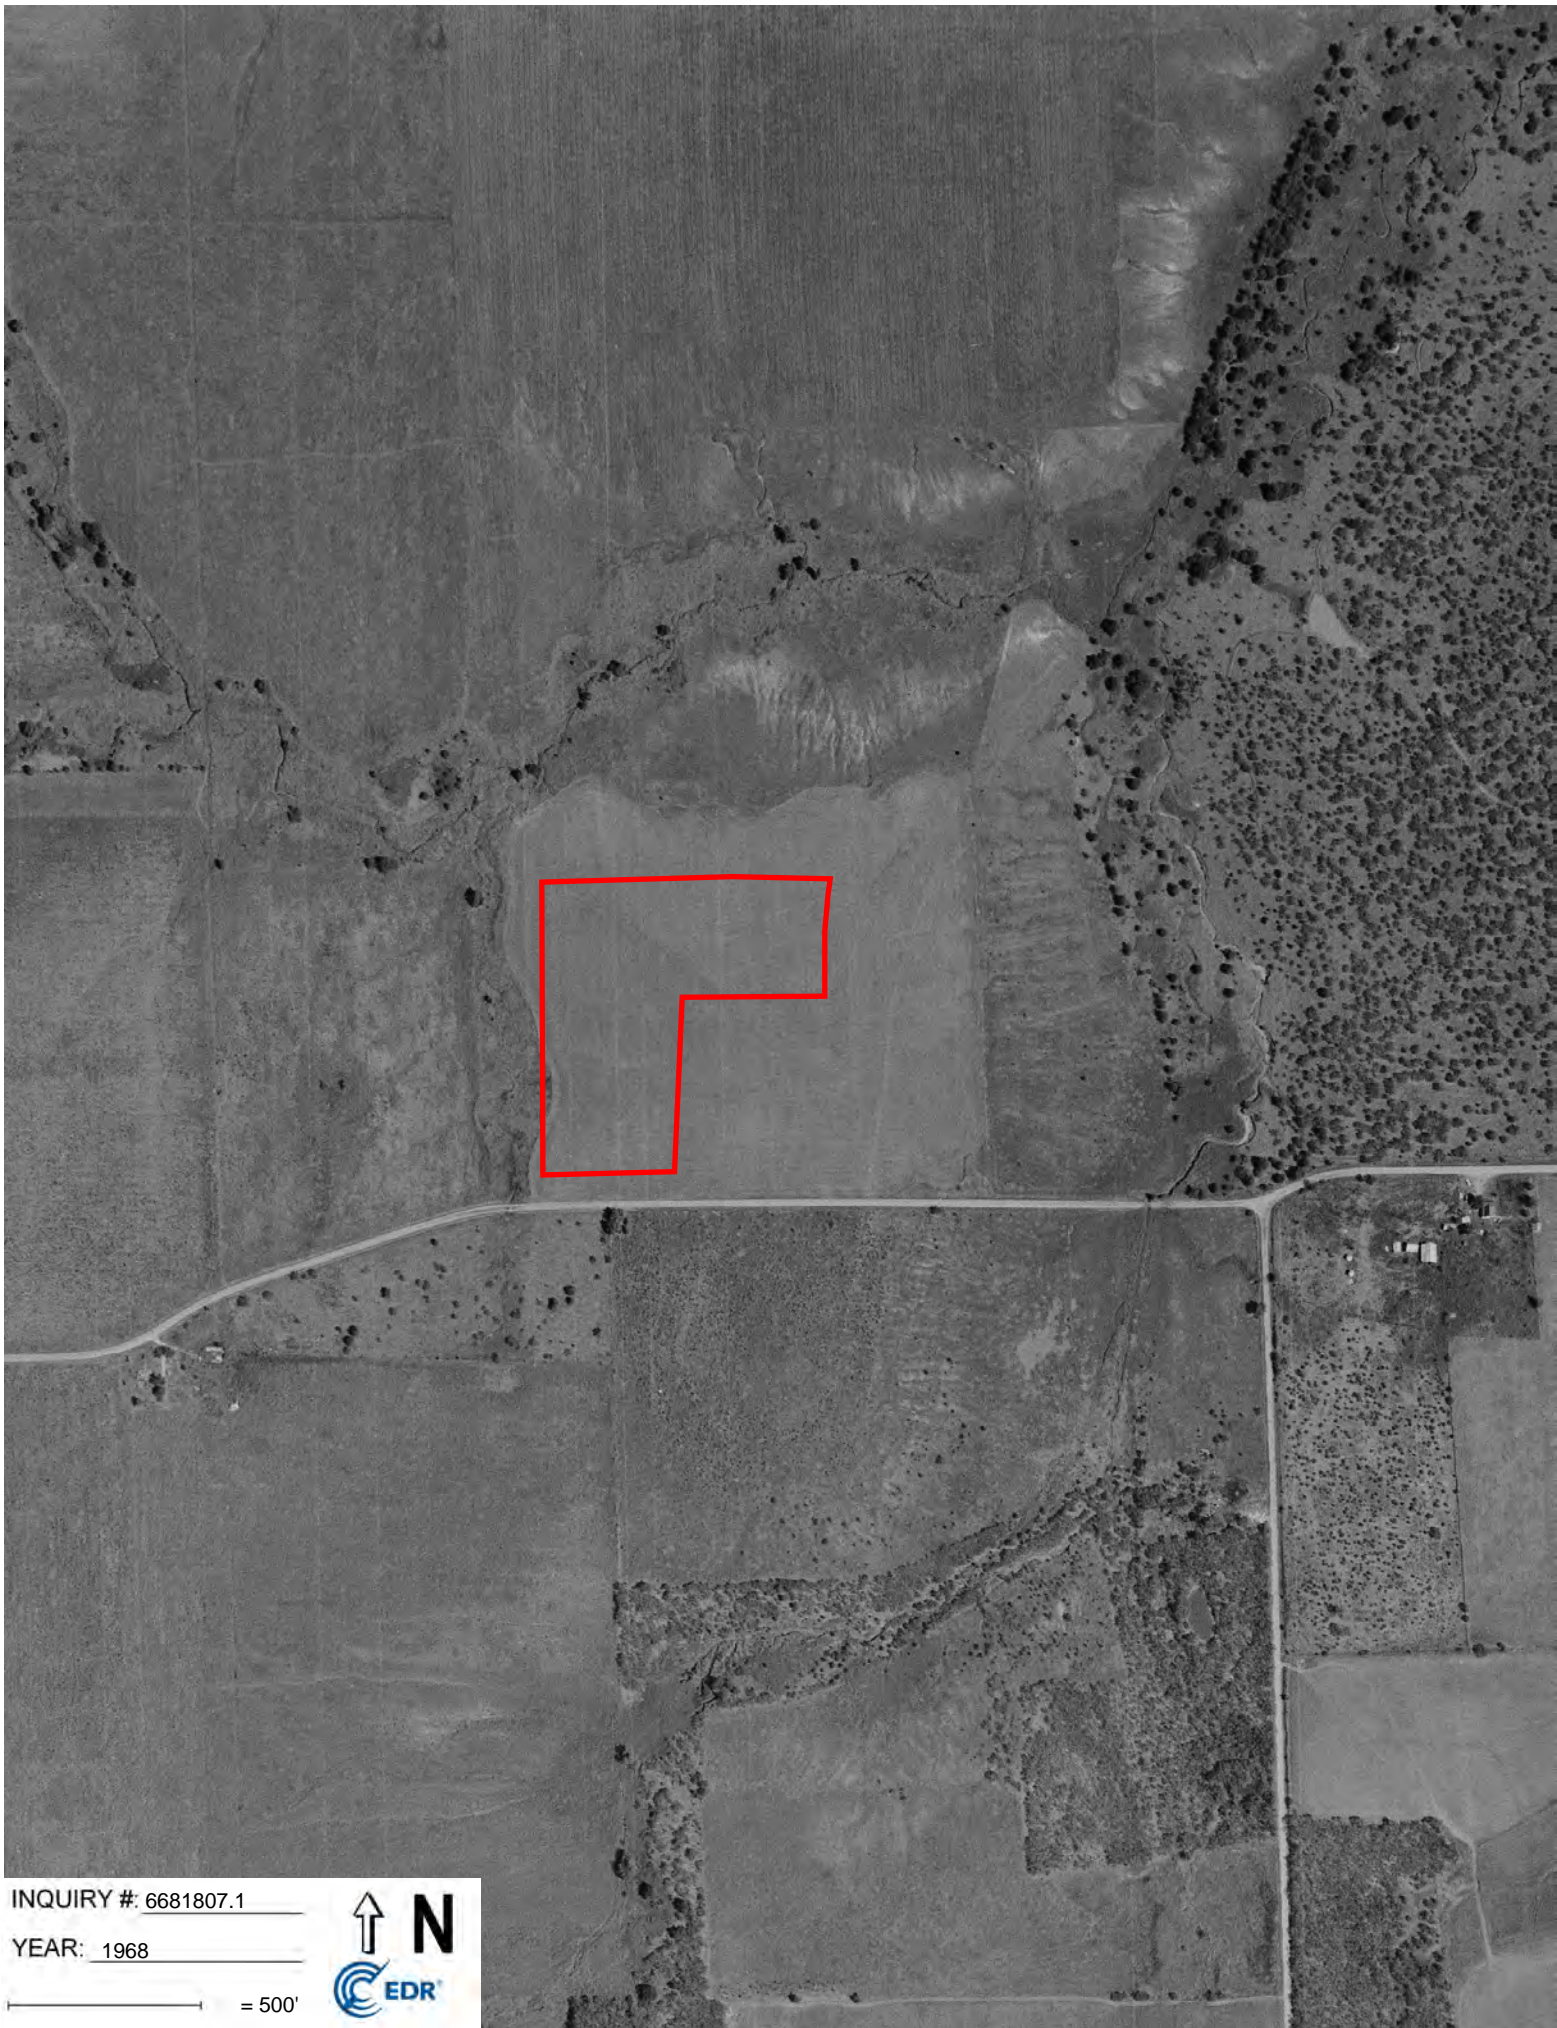
YEAR: 1968

1942-1968 – Site 10 is characterized as an active agricultural property comprised of pastureland. A drainage is depicted outside of the western boundary. The surrounding area is comprised of pastureland, drainages, and scattered homesteads.
