Automated Monitoring Determines Bridge Health and Longevity

After cracks were detected on the pilaster of the West Water Bridge in West Linton Village, DYWIDAG was contracted to provide and install an automated solution to monitor changes and movement in the bridge in real time.

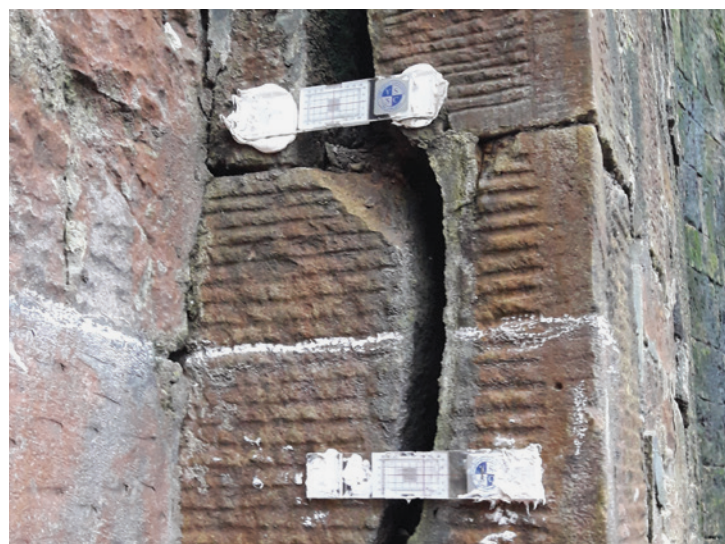
Constructed in 1831, the single span masonry bridge located in West Linton Village, Scotland, carries the busy A702.

A manual monitoring system, which could only be checked monthly, showed the formation of cracks. DYWIDAG was then contracted to install an automated monitoring system which collects data about bridge health and alerts owners to changes as they happen. Over the course of the next three months, bridge data will be collected, and next steps determined.

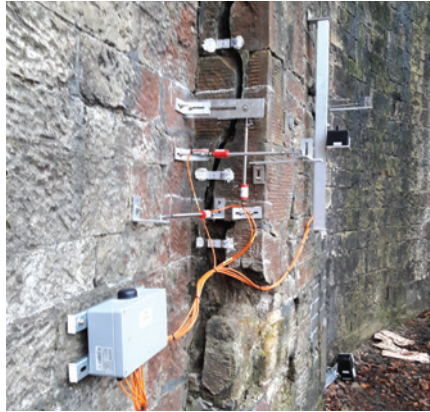
We installed six of our LVDT systems to provide 3D crack monitoring on either side of the pilaster. The system incorporates a specially designed mounting beam and anchor system, creating solid and permanent contact, measuring the X-, Y-, and Z-axes. The data feeds into DYWIDAG's cloud-based database, Infrastructure Intelligence, allowing bridge owners to better understand what is happening with the bridge.

In addition, two TiltMates were installed, one over the pilaster to determine if the pilaster was rotating or moving outward from the structure. This automated system minimizes the client's environmental impact and keeps people safer, this avoids visits to the structure to manually read tell-tale crack sensors.

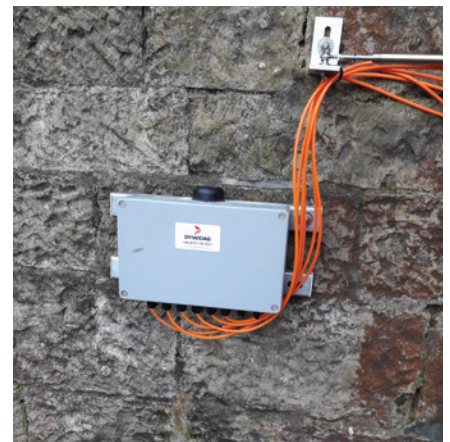
The solution provided was a wireless type, transceivers have been installed in close proximity to the monitoring area meaning this is a cable free solution. This type of system can be expanded to allow for further monitoring by adding extra vibrating wire products or wireless products to measure a different area within the structure. After three months (potentially longer, depending on results), next steps for the bridge – repair and maintenance – will be determined.
