Test Report No: TUL0673

SAMPLE ID: The test sample was identified as “**Ash Siding Panels**”.

TEST PROCEDURE: Materials and Construction Methods for Exterior Wildfire Exposure, EXTERIOR WALL SIDING AND SHEATHING, SFM Standard 12-7A-1.

TEST RESULTS: The sample **DOES COMPLY** with the Conditions of Acceptance of SFM Standard 12-7A-1.11. Detailed test results are presented in the subsequent pages of this report.

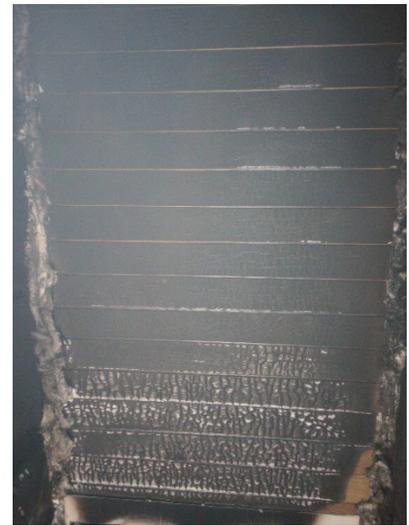
Test One Before	Test One After
------------------------	-----------------------

- 0:00 – Burner assembly ignited, 150 kW achieved and maintained.
- 00:50 – Charring
- 02:00 – Ignition of sample. Bottom right side above the thermal barrier.
- 05:00 – Flame going up both the right and left sides of the sample. Lite smoke.
- 10:00 – Burner assembly turned off. Small flame on the center, and right and left sides.
- 12:00 – Self extinguished. No active combustion.
- 30:00 - End of the test. No open combustion.

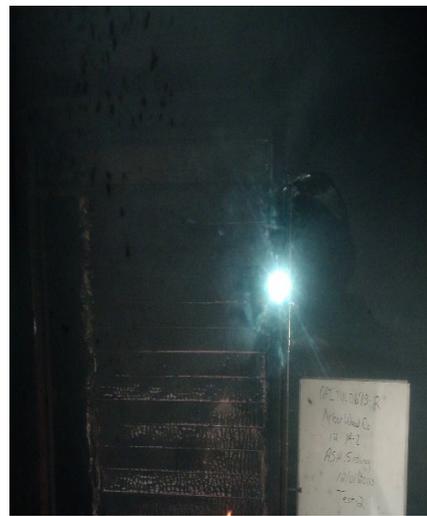
Test Two Before	Test Two After
-----------------	----------------

0:00 – Burner assembly ignited, 150 kW achieved and maintained.
00:20 – Charring.
02:00 – Ignition of sample at the bottom right corner above the thermal barrier.
05:00 – Embers behind siding $\frac{3}{4}$ of the way up on the right side.
10:00 – Gas burner off. Flames up the entire wall and behind the siding on the right side.
30:00 – Small flame at the thermal barrier, and lite smoke.
53:00 – End of the test. Ceramic fiber fell and allowed full penetration through to the backside going around the edge of the right side. All other areas of the sample self-extinguished. No actual penetration through to the backside during the test, making this test a pass.
