Report of the MS *Estonia* shipwreck site survey with RV *Electra*

July 8th–15th, 2021

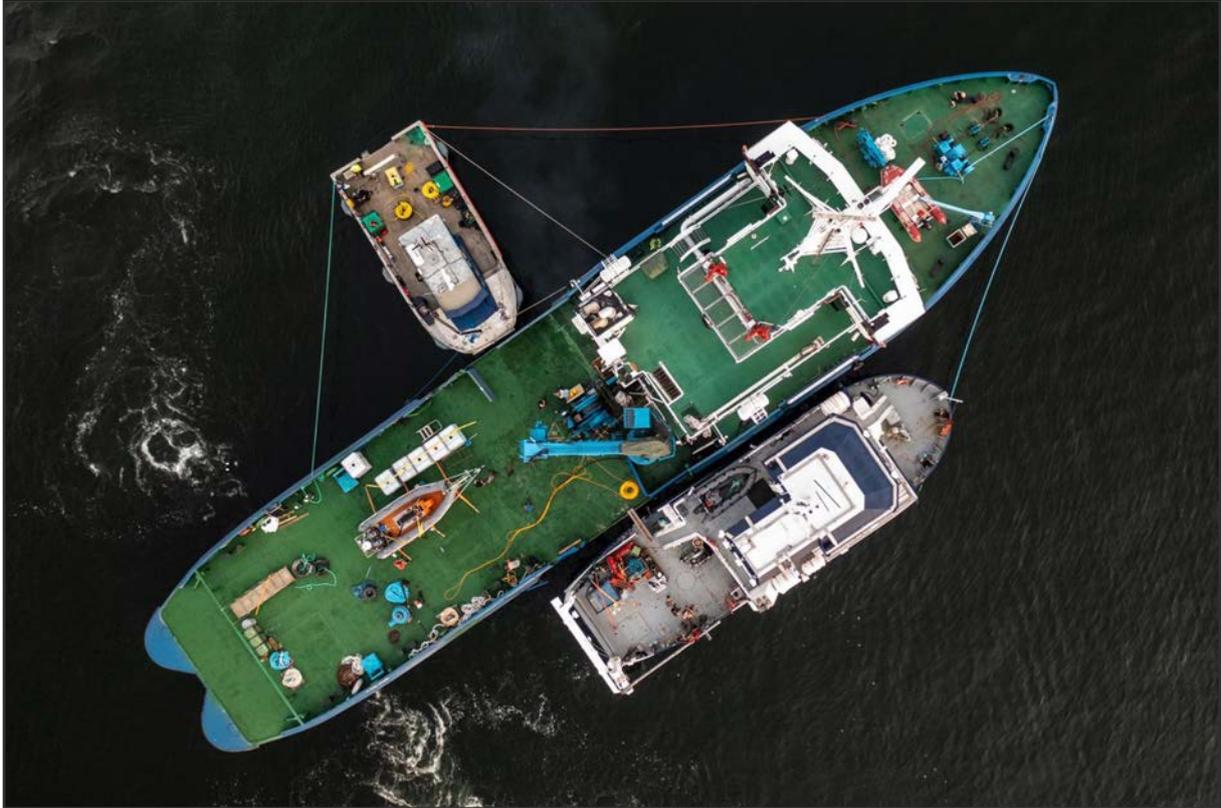
*Photo 11. Aerial photo of the three vessels involved in the survey of the MS Estonia shipwreck. Top: The Subsurveyor VLT-089 used for the ROV (Remote Operated Vehicle) operations; Center: The 58 m long Estonian icebreaker EVA-316 used as a supply vessel and as a platform for acoustic imaging of MS Estonia by Abbott Acoustics using a Mesotech scanning sonar; Bottom: Stockholm University's 24 m long Research Vessel (RV) Electra that carried out geophysical mapping, geological coring and oceanographic station work. Photo: Madis Veltman, Postimees*

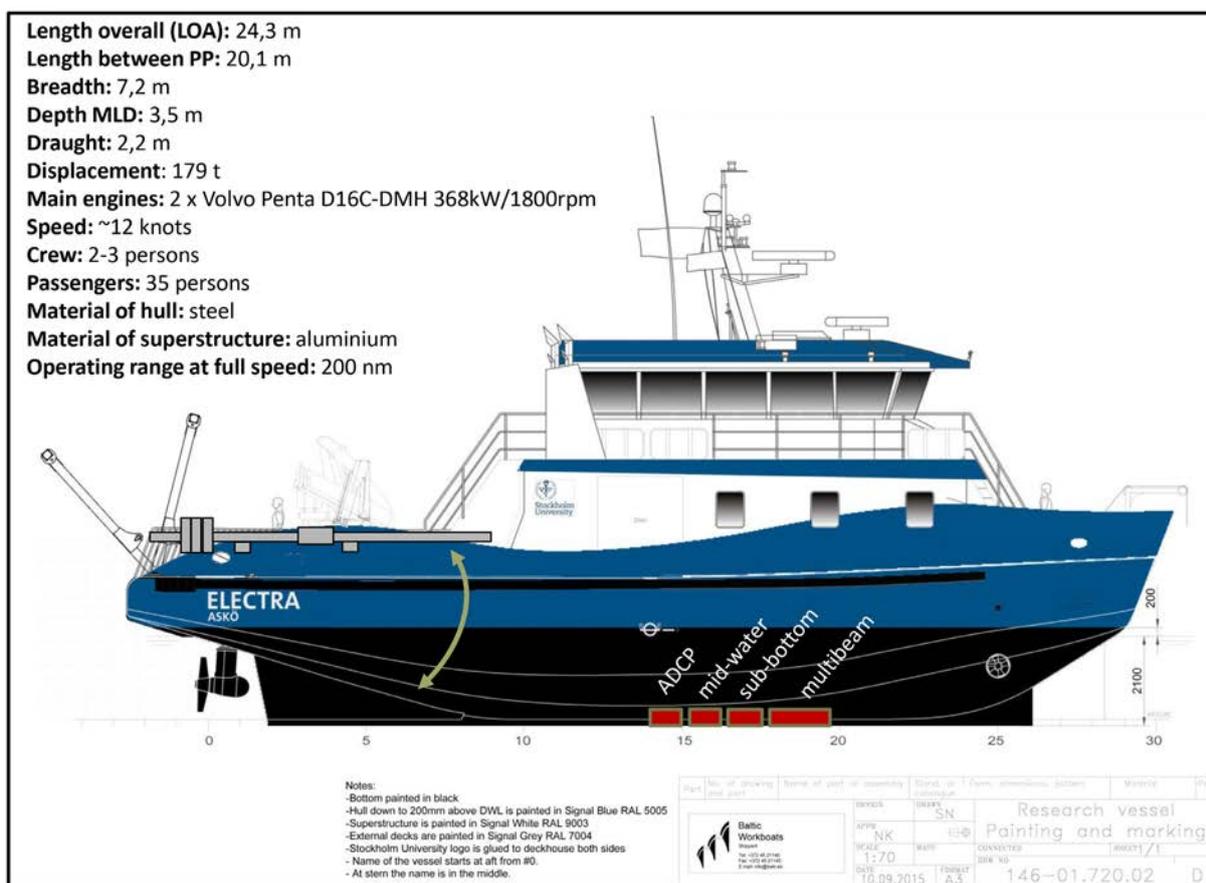
Figure M1. Specification of RV *Electra*. The transducers installed in the purpose-designed keel are shown as red boxes, not drawn to scale but they are installed in relationship to one another as shown in the drawing

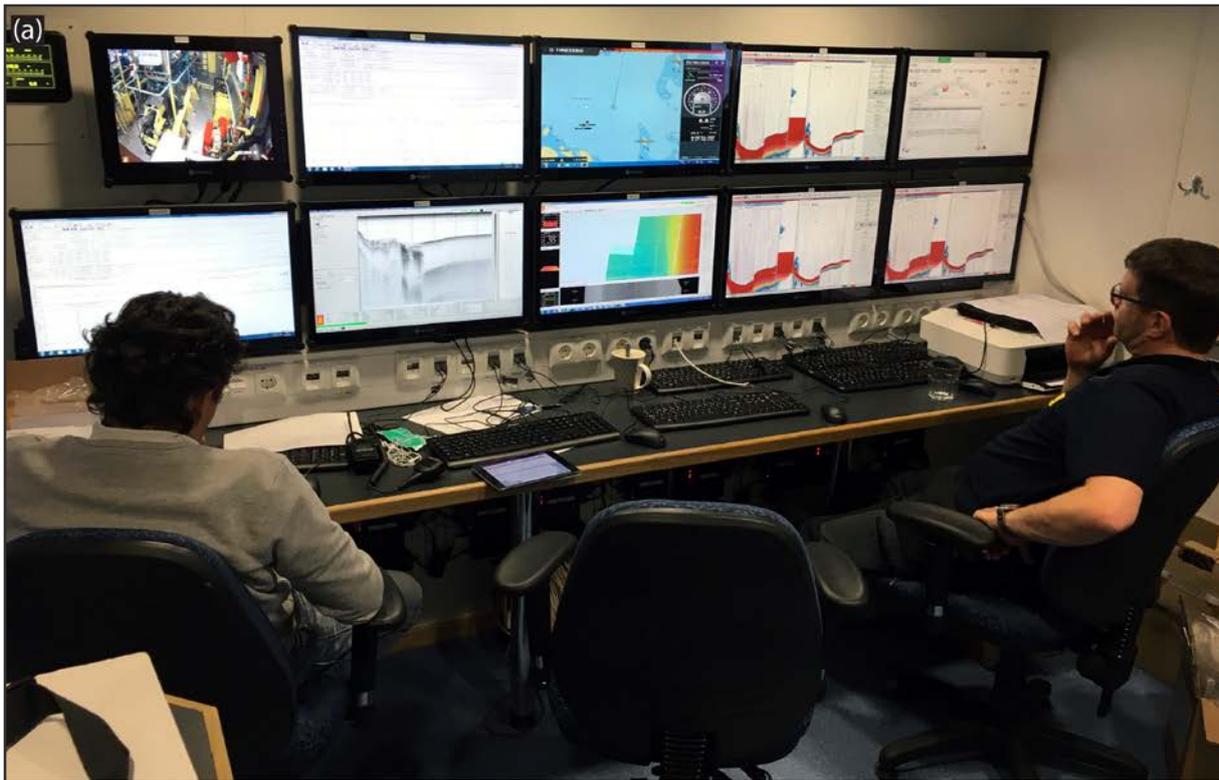
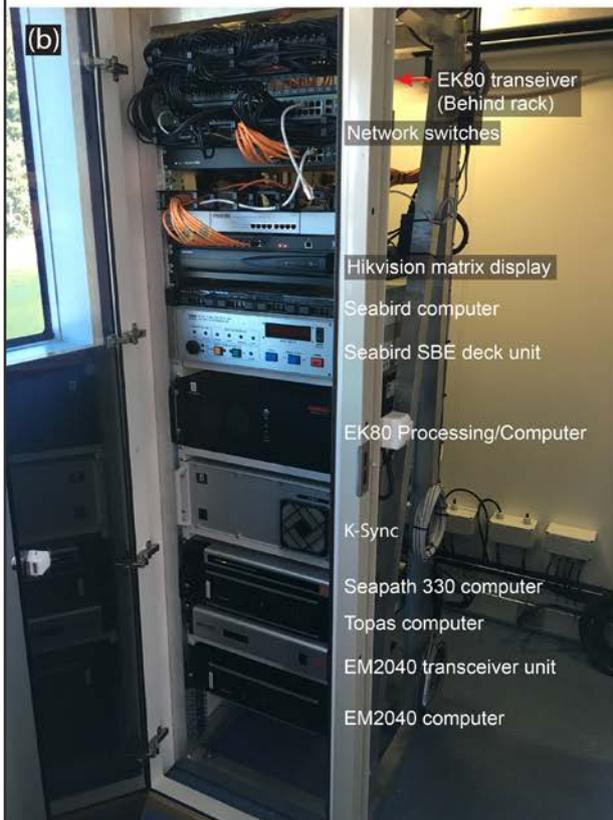
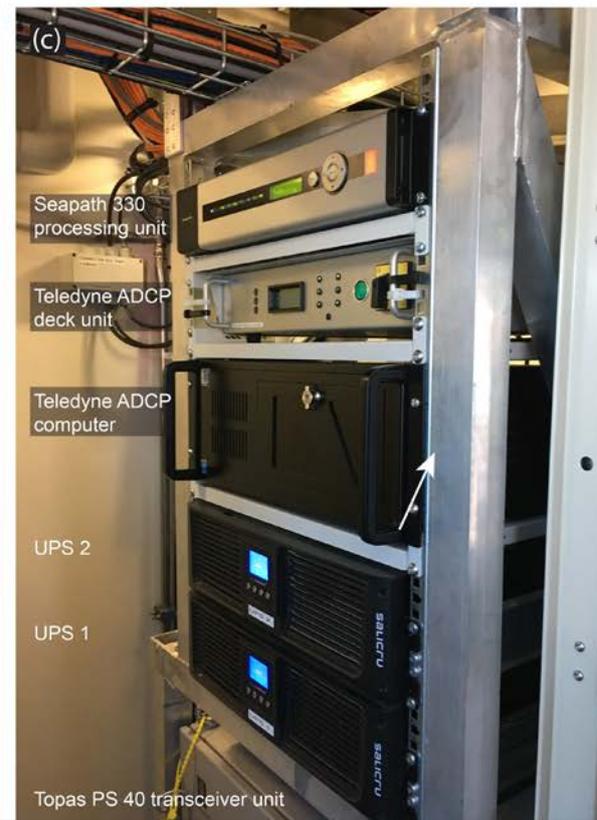
Photo M1. RV Electra's survey room from where all acoustic mapping systems are controlled. (a) Computer screens are mounted on the aft wall in the control room and connected to a display matrix system permitting switching between all computers controlling sonars, Seapath navigation/attitude system and CTD. The display matrix system is also extended to the bridge, permitting control and display of the sonars systems on the bridge. (b,c) All units belonging to the sonar systems, Seapath navigation, and CTD are mounted in specifically designed racks located in a cooled enclosed part of the survey room. (Photos: Martin Jakobsson, reused from previous RV Electra cruise reports).

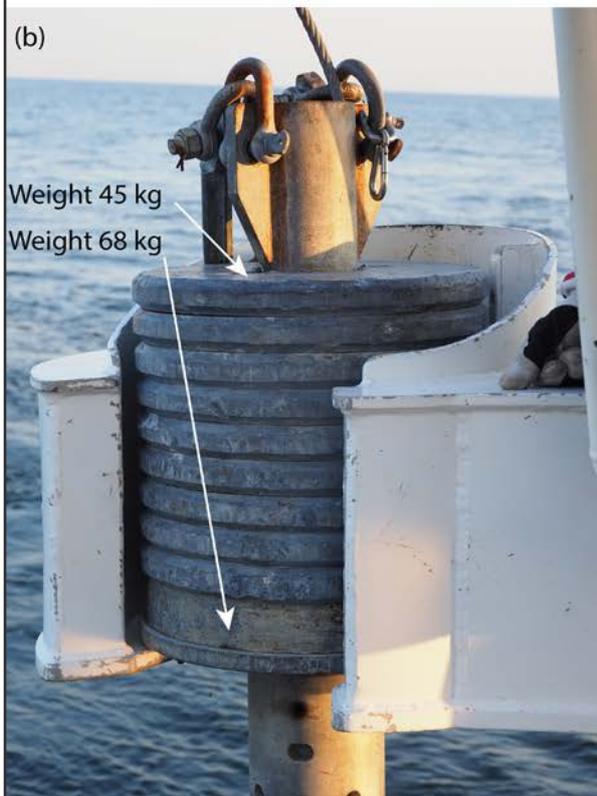
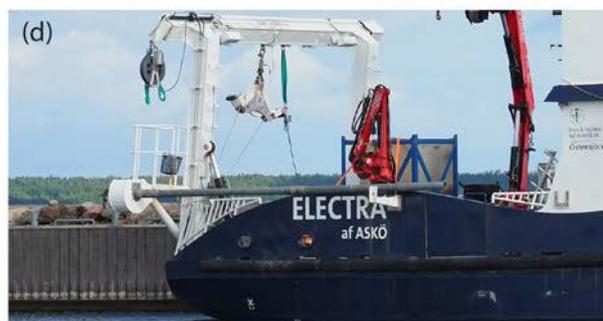
Photo M2. The coring system on RV Electra. (a) The corer has a launching system on the starboard side. A portable refrigerator for core storage is placed on the aft deck. (b) Core head loaded with 473 kg led weights. (c) Coring winch (InterOcean model 10031-20HLW hydraulic) equipped with 600 m of 11.43 mm diameter cable (Rochester A302799). (d) Corer in handling system. Photos: Martin Jakobsson (a and c are reused from previous cruise reports). Photos: Martin Jakobsson

An InterOcean hydraulic winch (model 10031-20HLW), equipped with 600m of 11.43mm diameter wire (Rochester A302799), is used to launch the corer through the A-frame (Photo M2c). Max working load of the wire is 1818kg and its breaking strength is 7273kg.

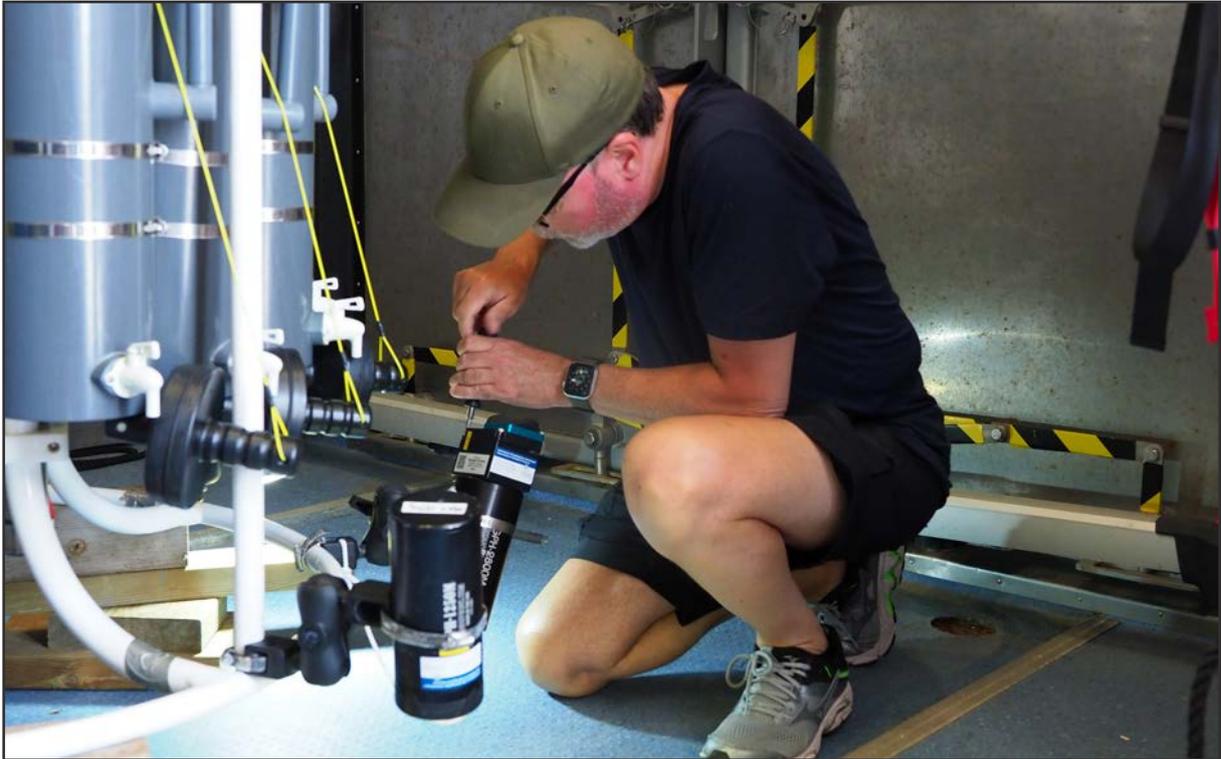
Photo M4. GoPro Hero 7+ camera and light placed in water proof housings and mounted on the frame of the CTD carousel. Bottom inspections were carried out either along with CTD-casts or separately by lowering the carousel to the seafloor. Photo: Martin Jakobsson

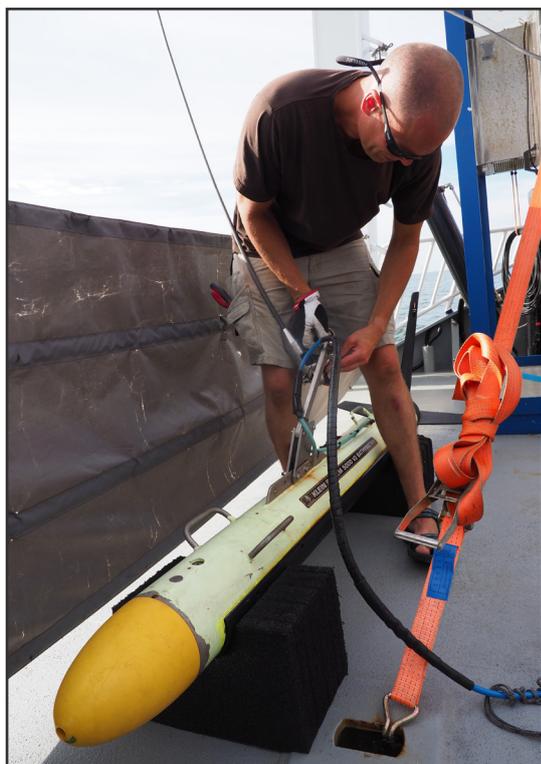
Photo M6. Side-scan sonar towed in the main coring winch wire and with separate signal cable. Photo: Martin Jakobsson

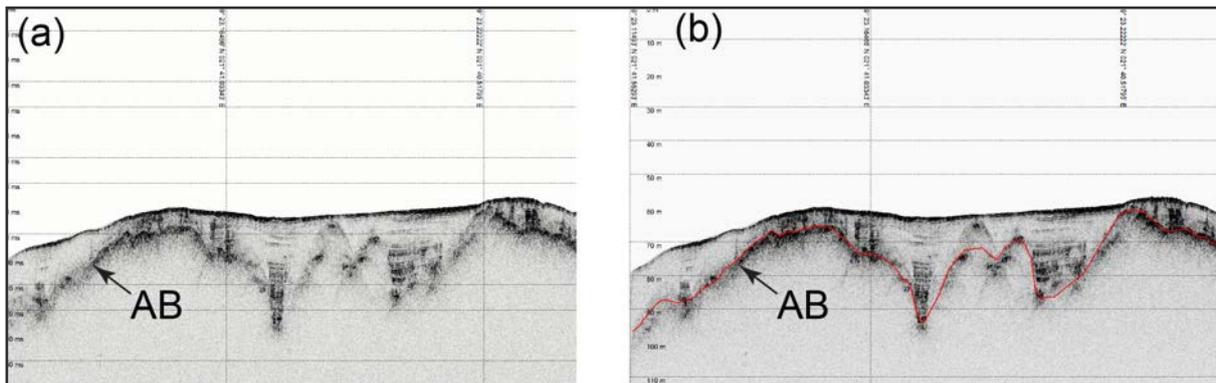
Figure M4. Sub-bottom profile illustrating the concept of identifying the Acoustic Basement (AB), here defined as the deepest coherent observed reflector. (a) Profile without interpretation. (b) Profile with interpretation of the AB inferred with a red line. Softer sediments, which are penetrable with the used 4–10 kHz 1 ms long chirp pulse, are assumed to generally make up the stratigraphy above AB. The typical signature of stratified (likely varved glacial clay) is seen in this profile above the AB.

The acoustic basement (AB) is here defined as the deepest coherent reflection observed in the sub-bottom profiles (Fig. M4). The AB was digitized in all profiles and interpreted to generally correspond to a bedrock or till surface. This interpretation implies that the thickness of overlying softer sediments could be estimated (Fig. M4). The conversion from two-way-travel time recorded by the sub-bottom profiler to depth in meters was made in SonarWiz using a sound velocity of  $1600\text{ ms}^{-1}$ . Absolute depths of the interpreted AB reflector as well as calculated sediment thicknesses along all sub-bottom profiles were exported from SonarWiz as xyz points into ASCII flat files.

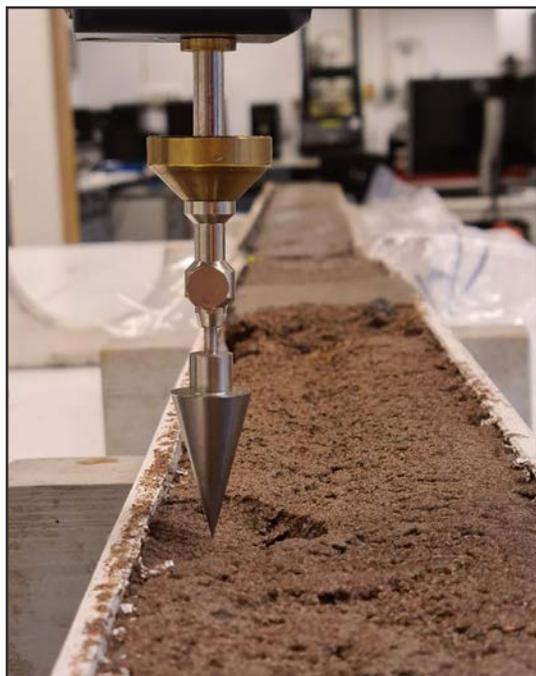
Figure M6. Fall Cone setup, shown before the cone is released into the sediment.

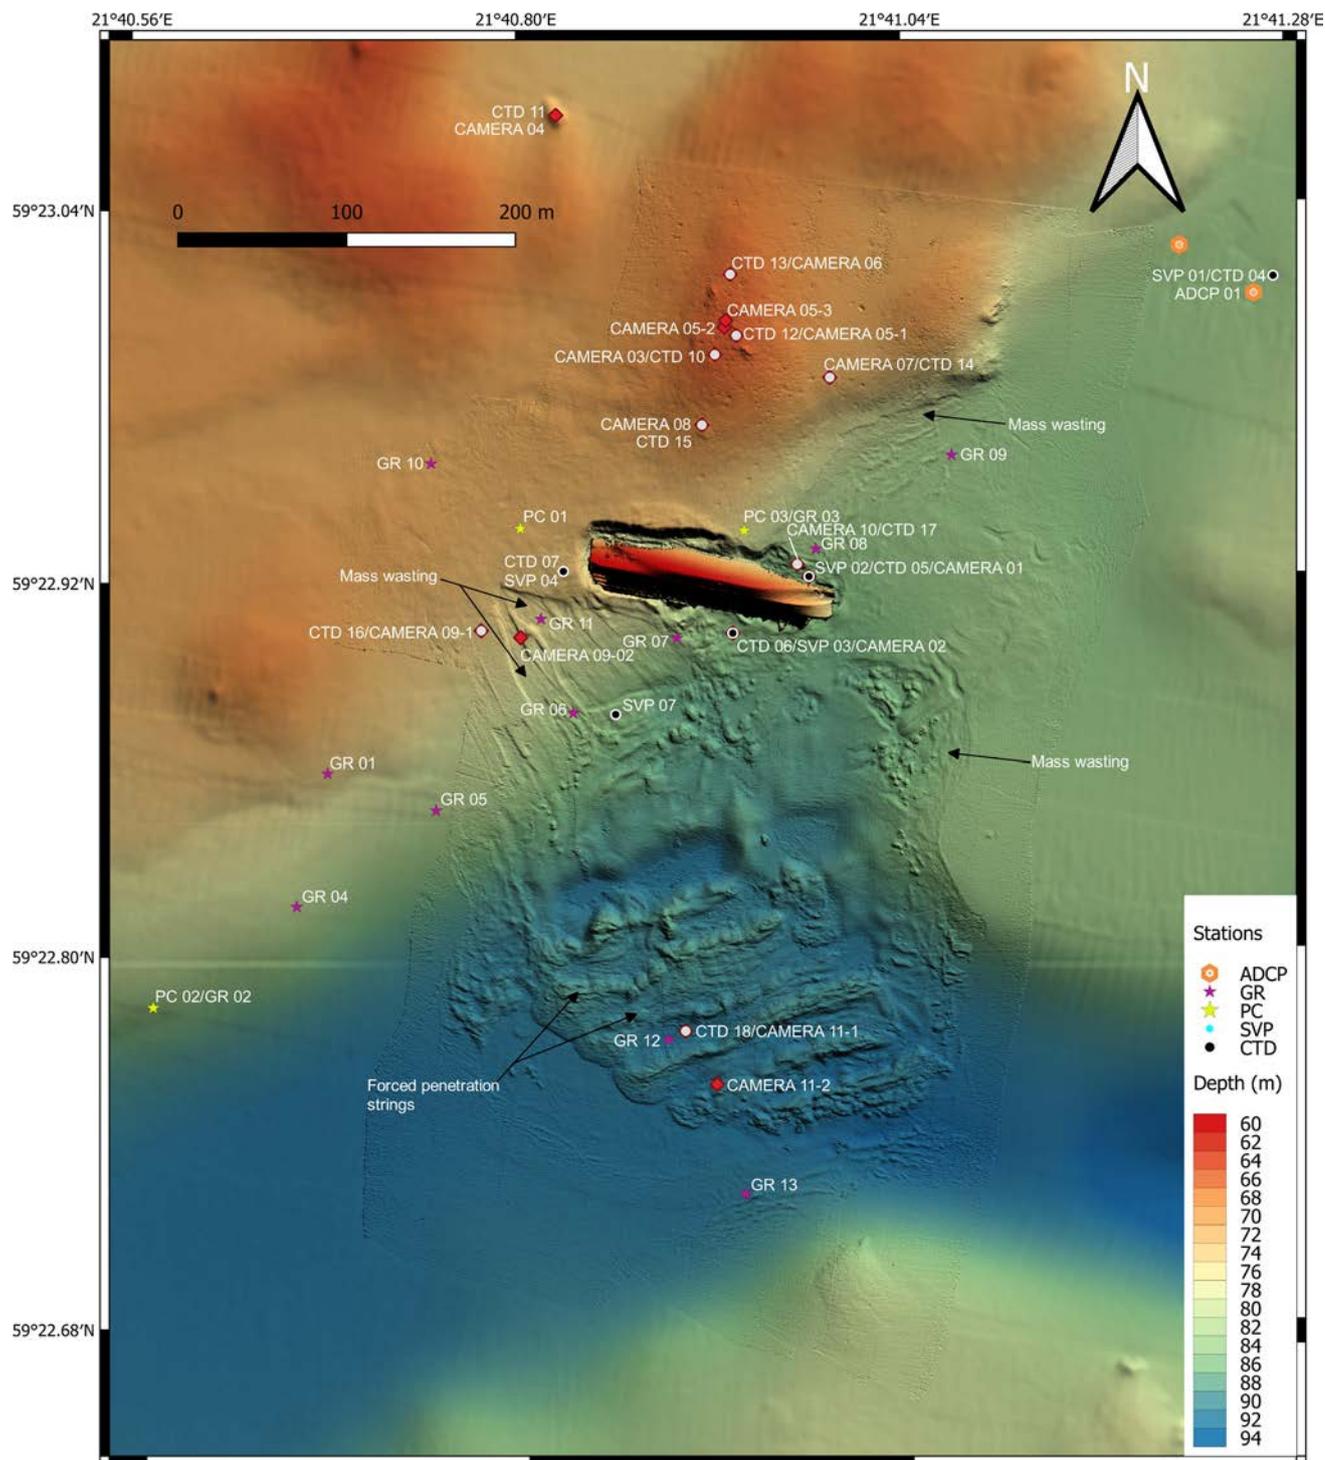
Figure MB3. Bathymetric map created using the high-resolution grid (cell-size: 0.25×0.25 m) based on the detailed multibeam survey completed on July 13. Acquired stations are shown on the map. Where more than one device was deployed at a station, the symbols cover each other. In these cases, the labels next to the visible symbols show the sampling accomplished. The forced penetration strings as well as signs of mass wasting are clearly visible in the bathymetry. The morphology is further shown along with interpretations in Figure MB7. A larger version of this map is found in Appendix 2.

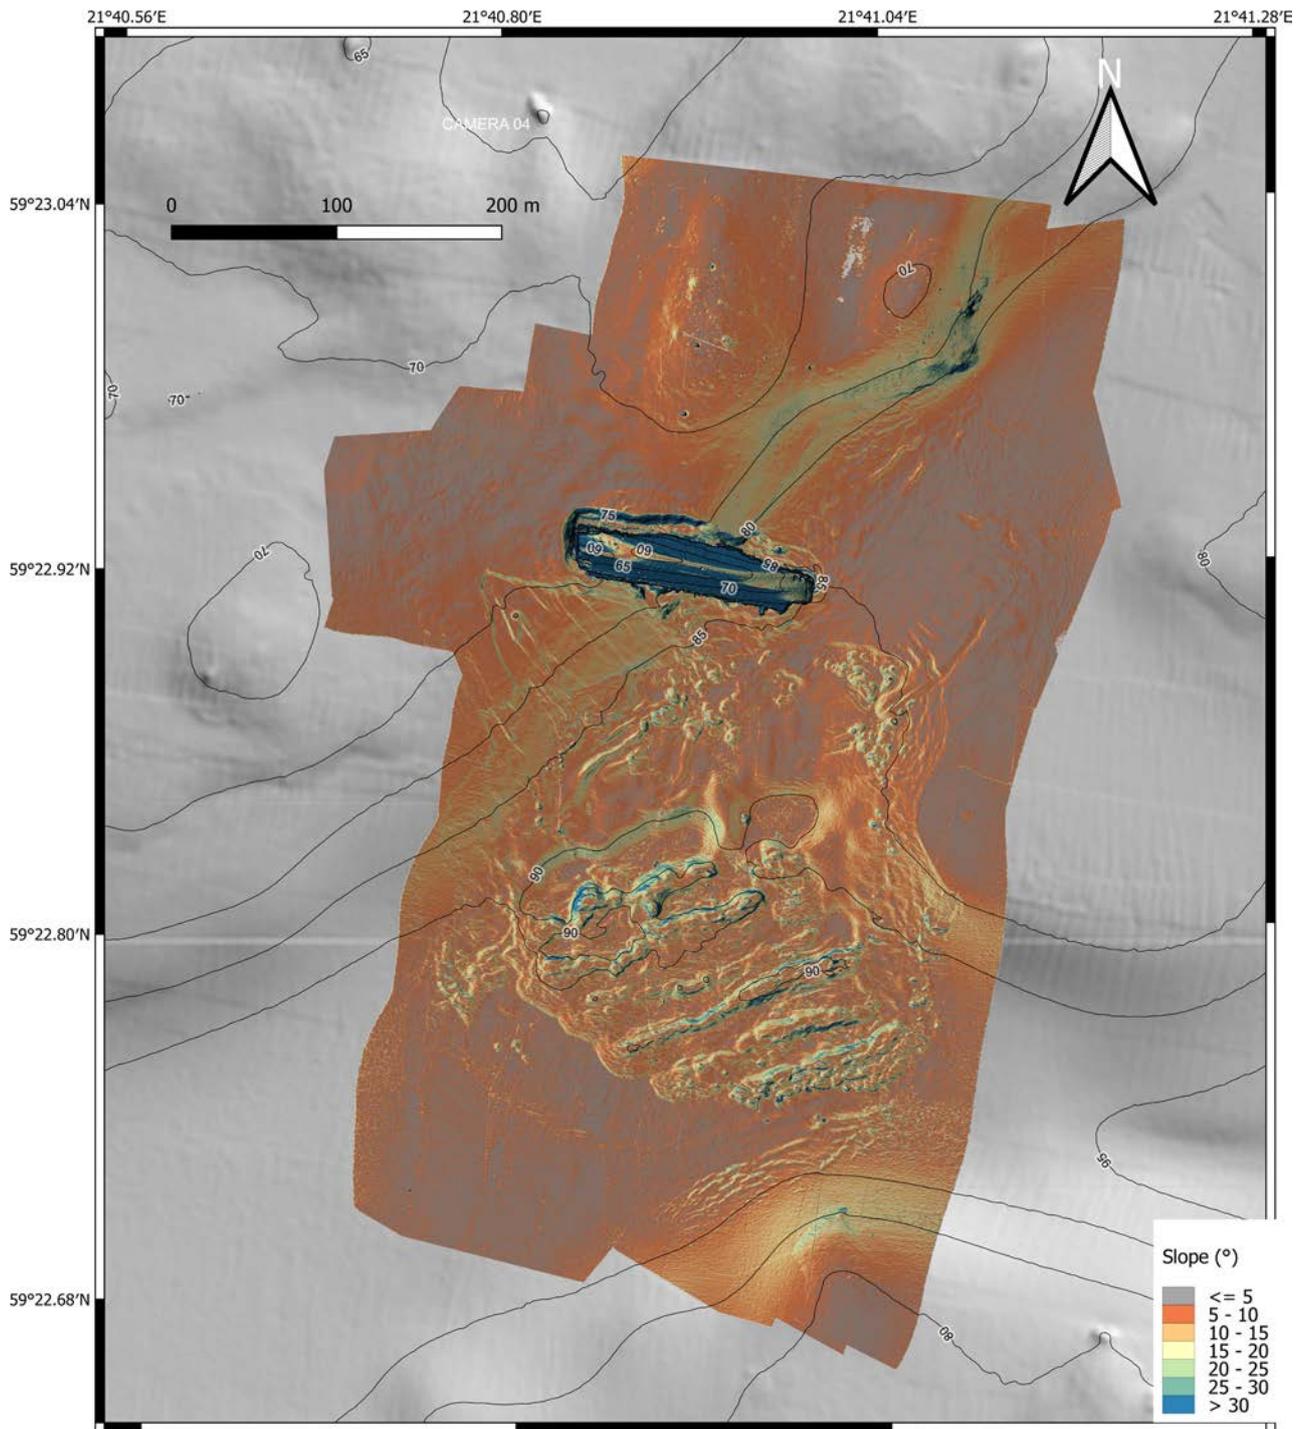
Figure MB4. Slope map created using the detailed multibeam high-resolution grid (cell-size: 0.25x0.25 m) based on the detailed multibeam survey. A larger version of this map is found in Appendix 2.

A slope map compiled using the detailed bathymetry shows that MS *Estonia* rests on a seafloor generally sloping between about 5 and 10° towards southeast (Fig. MB4). This conforms to previous coarser bathymetric surveys where the general slope where MS *Estonia* is situated was found to be between about 7 and 10°. The 75–80m depth interval is outlining the steepest seafloor. Beginning midship at the northern side of the shipwreck and continuing north-eastward, this depth interval becomes steeper than 10° (Fig. MB4).

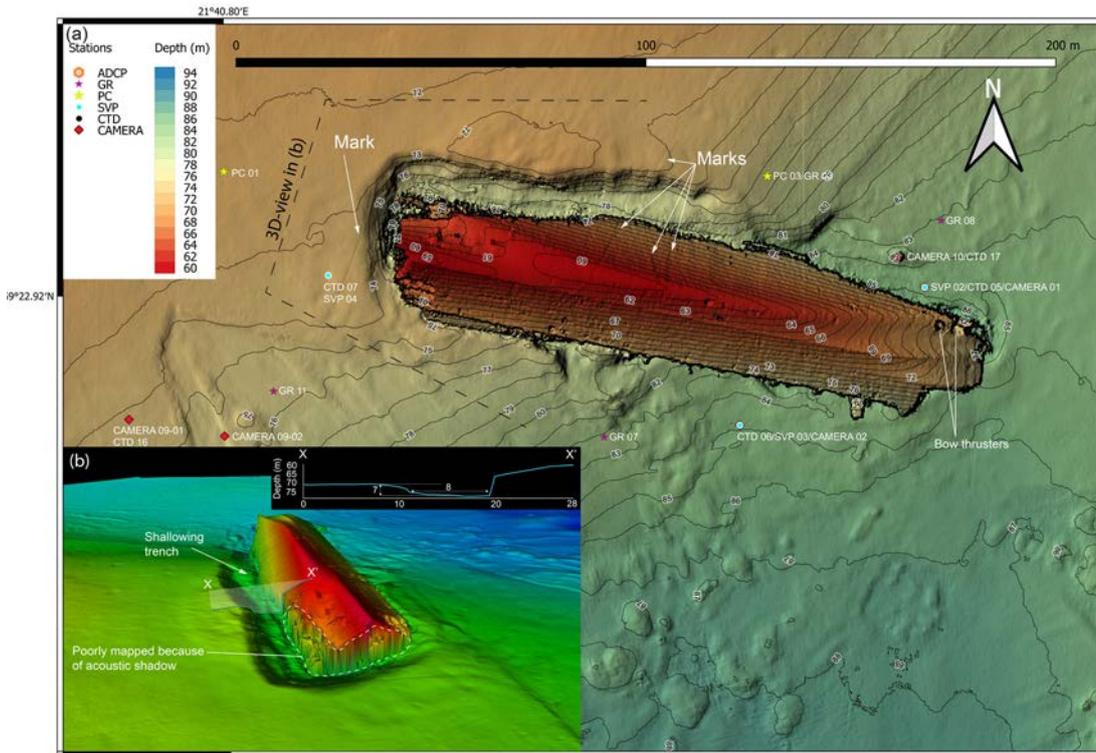
Figure MB5. The shipwreck of MS Estonia portrayed with the detailed multibeam high-resolution grid (cell-size: 0.25×0.25 m). A 3D-view looking towards the aft is shown in (b). This view clearly reveals the trench formed along the shipwreck. The most poorly mapped part of the shipwreck is indicated with a stippled line. A larger version of this map is found in Appendix 2.

The shipwreck itself is for the most part well imaged by the detailed multibeam survey (Fig. MB5). The exceptions are the aft part of the shipwreck and the contact between the hull and the seafloor along the northern side (Fig. MB5). This is due to a pronounced trench formed along the shipwreck in these areas, which caused an acoustic shadow, i.e. the beams of the multibeam are blocked from reaching the hull's contact with the seafloor. The trench is clearly visible in both the bathymetry and slope maps (Figs. MB5–MB6). It is roughly 6 m wide and 4 m deep along the aft of the shipwreck. The trench widens to >8m and deepens to about 7 m along the northern side (Fig. MB5). Following the trench for about 55 m from the aft, the bottom of the trench becomes shallower and the wall is less steep (Fig. MB5). The shallowest part of MS *Estonia* is the port bottom furthest aft, which rises to a depth of about 57 m (Fig. MB5). There are several elongated marks seen in the multibeam bathymetry, of which three are visible in the hull, two of them clearly and one a bit vaguer (Fig. MB6). These resemble scrape marks after a dragged object, similar to when an anchor is dragged across the seafloor. The holes for the bow thrusters are also possible to distinguish in the detailed multibeam bathymetry (Fig. MB6).

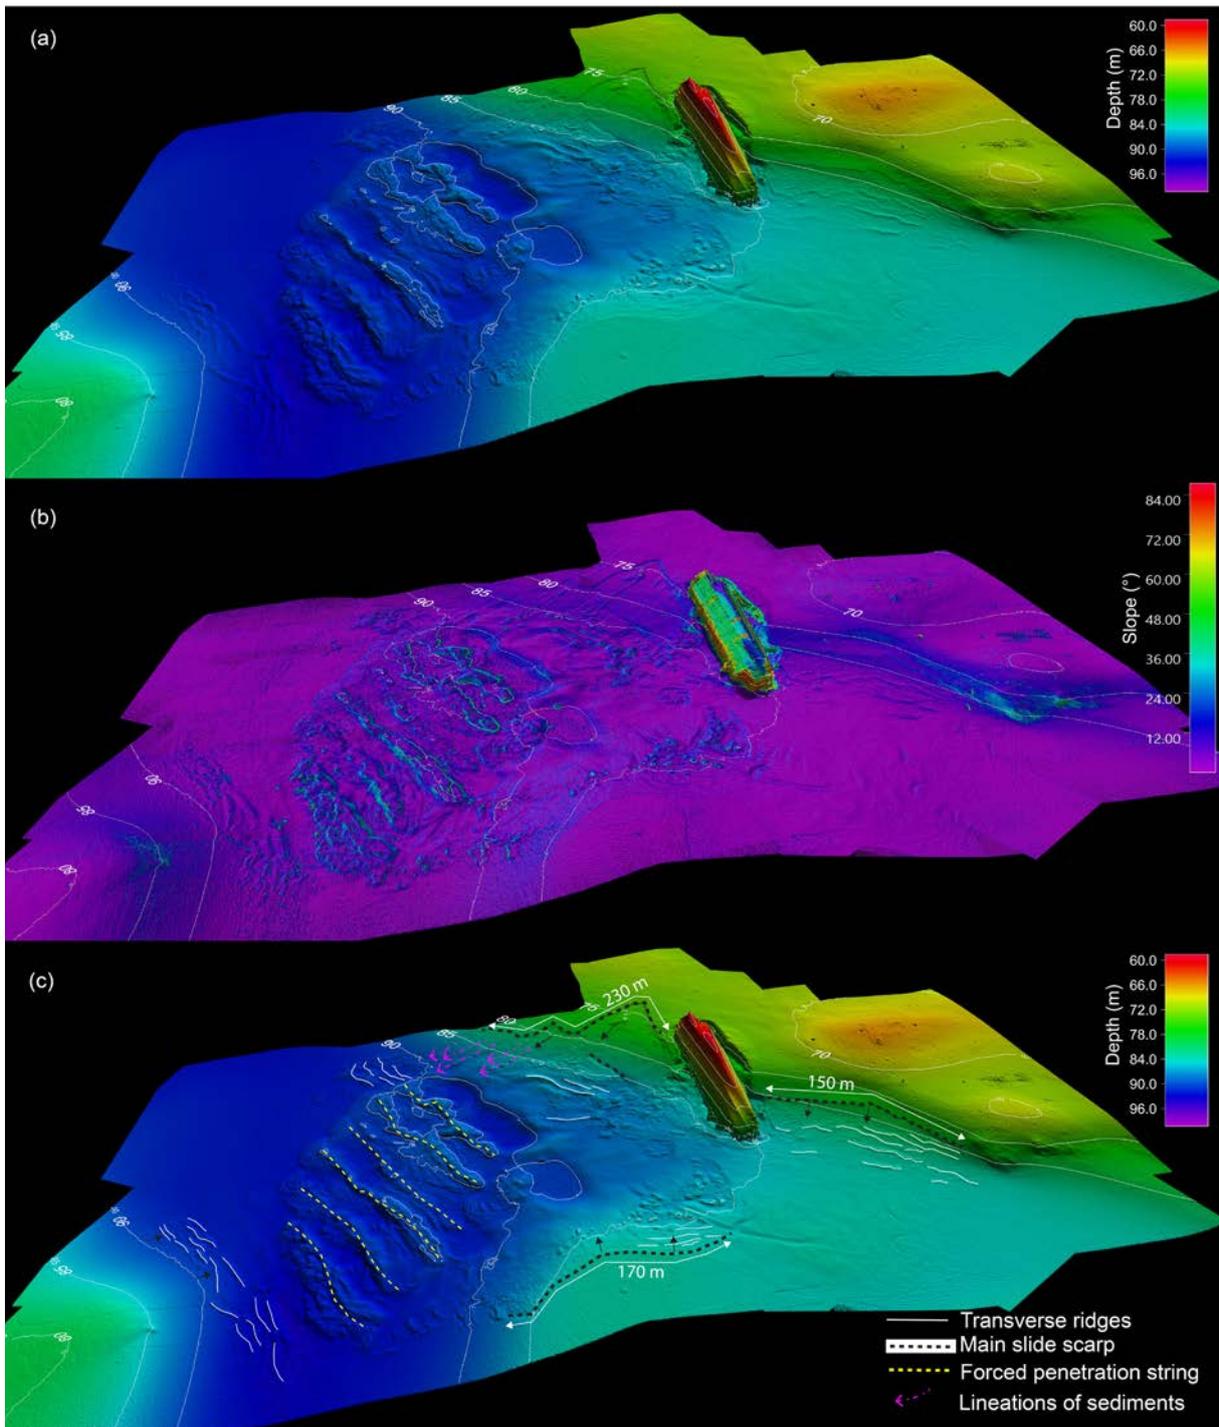
Figure MB7. 3D-views based on the detailed survey and the compiled grid with a cell-size of 0.25×0.25 m. (a) Bathymetry. (b) Slope derived from the bathymetry. (c) Interpretation of the seafloor morphology. A larger version of this illustration is found in Appendix 2.

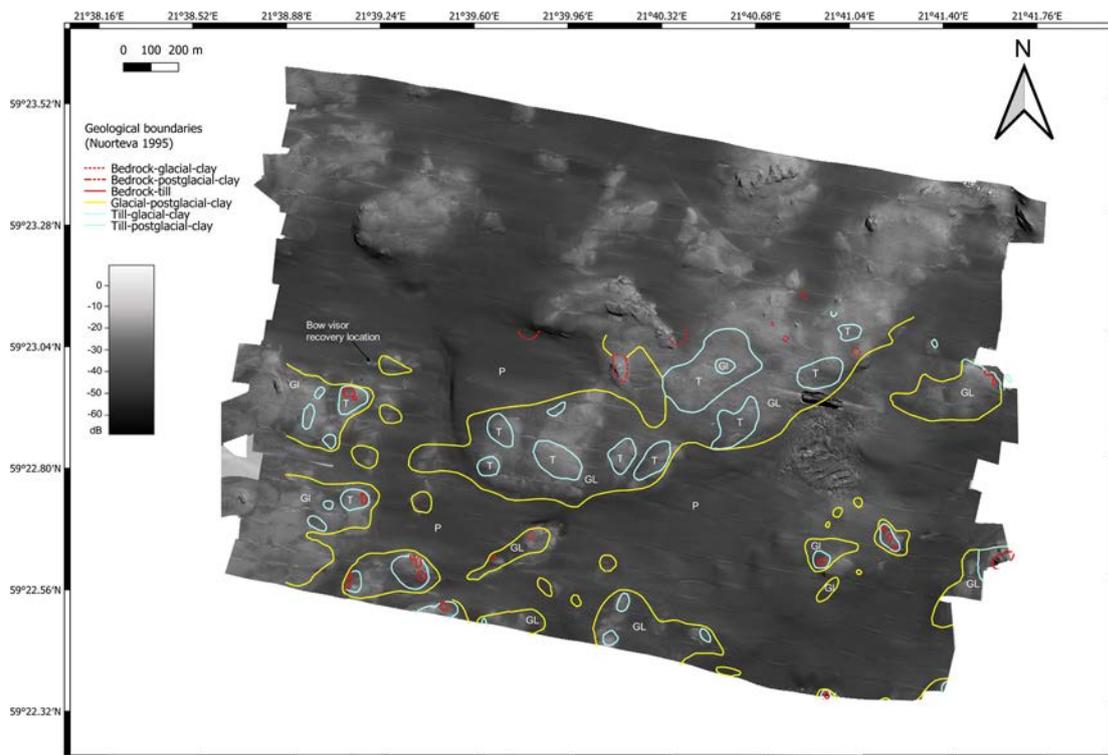
Figure MB9. Backscatter mosaic created at a grid cell-size of  $0.25 \times 0.25$  m using the multibeam data from the overview survey. The geological boundaries from the map compiled by Nuorteva (1995) are inferred. Letters indicate the seabed deposition shown on the geological map: P=Postglacial clay; GL=Glacial Clay; T=Till. The red enclosed areas are shown as bedrock on the map by Nuorteva (1995). The bathymetry is used to apply a shading from the northeast in order to give a better perception of the terrain. However, this has the downside of darkening the image behind high up sticking objects, such as along the southern side of MS *Estonia*. A larger version of this map is found in Appendix 2.

A backscatter mosaic with a resolution of  $0.25 \times 0.25$  m was created for the entire area (Fig. MB9). However, it should again be noted that the water depths in the survey area are deeper than 60 m yielding multibeam foot prints with diameters  $>0.4$  m, which implies that objects as small as  $0.25 \times 0.25$  m cannot be expected to be identified (see previous discussion). The bathymetric highs are generally associated with high backscatter values while the deeper areas show lower values (Fig. MB9). Overlying the boundaries from the geological map compiled by Nuorteva (1995) shows that the backscatter pattern broadly fits some of the inferred geological boundaries, although it is clear that a much more nuanced view is provided by the backscatter mosaic due to its full spatial coverage. A geological map based on sparse data will provide a much more generalized view and details will be left out. MS *Estonia* is resting across the boundary between postglacial clay and glacial clay, which generally follows a marked transition from lower to higher backscatter values (Fig. MB9). This is even better seen on a backscatter mosaic where mean values have been calculated for grid cells of  $4 \times 4$  m (Fig. MB10). Most of the areas shown as till or bedrock on the geological map coincide with high backscatter, although some

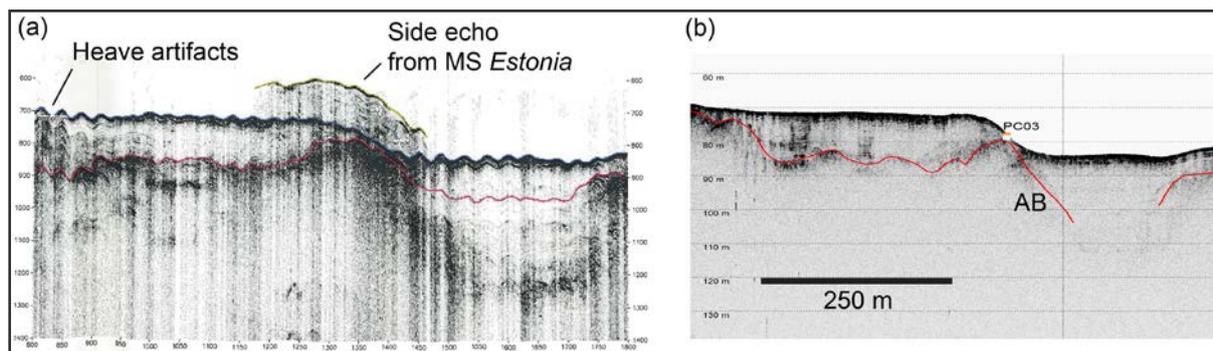
Figure SB3. Sub-bottom profile ESTON97 27 acquired by the Netherland Institute of Applied Geoscience TNO in 1997 (a). This profile runs along the path of 20210711234901 (b) with an offset to the north between about 0 and 25 m. The profile locations are shown in Figure SB2. The interpretation of a till surface inferred by Mesdag (1997) is shown in (a) with a red line while our interpretation of an acoustic basement is shown (b).

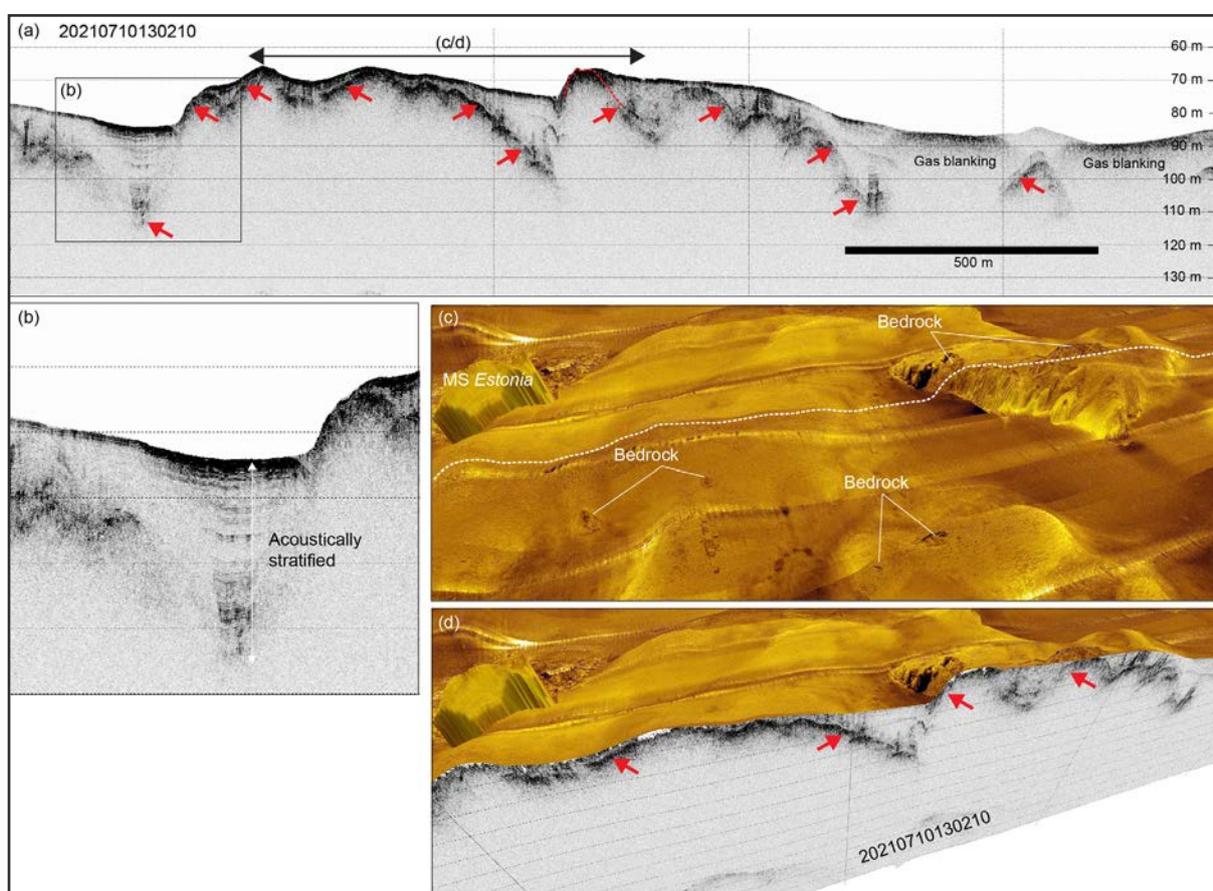
Figure SB4. (a) Sub-bottom profile 20210710130210 is shown to illustrate the occurrence of acoustically stratified sediment, interpreted to be comprised of varved glacial clay and in the uppermost part laminated postglacial gyttja clay, gas blanking and the interpretation of an acoustic basement (AB, red arrows). (b) Enlarged section with acoustically stratified sediments. (c/d) Side-scan imagery over the section of profile 20210710130210 showing where bedrock is exposed on the seafloor. This information has been used in our interpretation of the AB. In (d), the side-scan imagery is cut along profile 20210710130210.

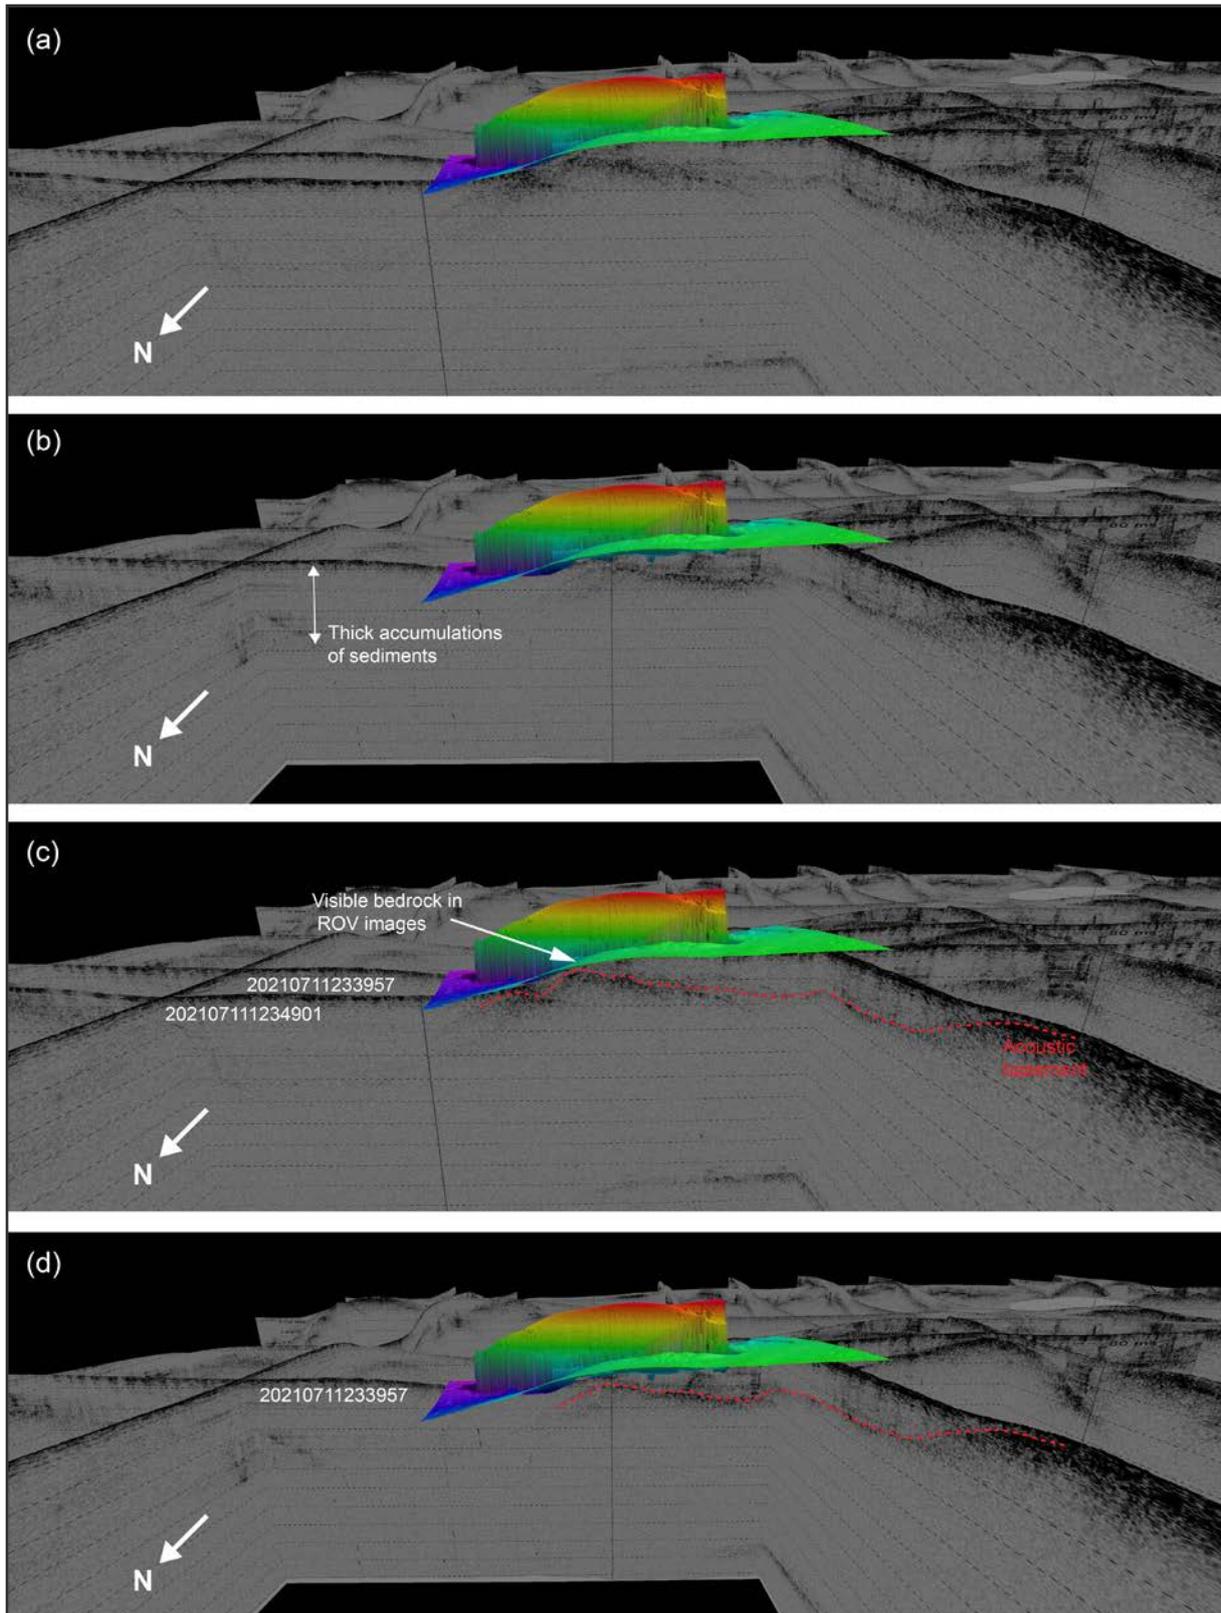
Figure SB6. 3D visualizations of the sub-bottom profile acquired with RV *Electra* running close to MS *Estonia*, which is shown on its right location with the multibeam bathymetry. The AB is seen to come up close to the seafloor, or even outcropping, in the closest profile 20210710130210 just north of the shipwreck.

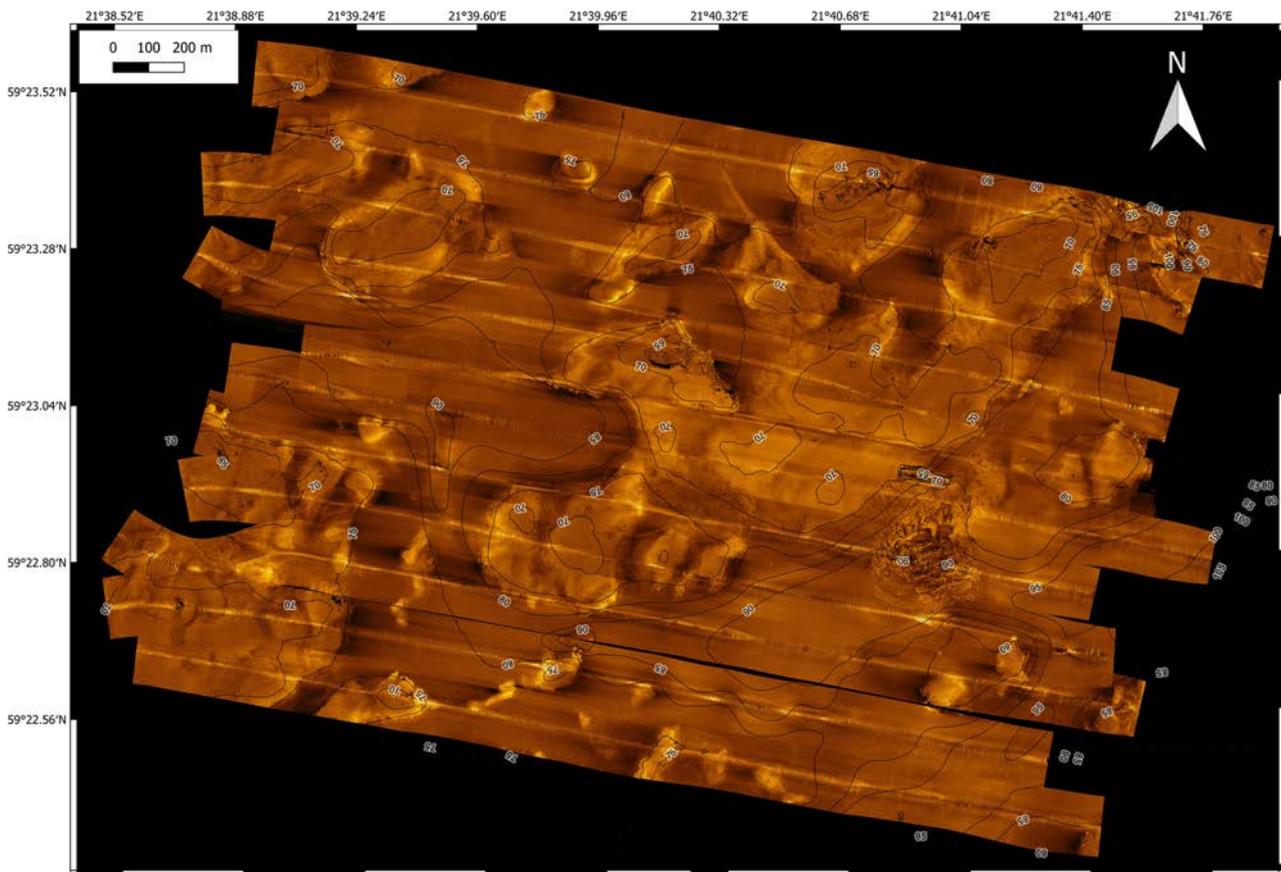
Figure SS2. Side-scan mosaic compiled at a pixel-size of 20×20 cm. A larger version of this map is found in Appendix 4.

A general pattern with high reflectivity on the bathymetric highs and lower in the deeper areas is observed (Fig. SS2), i.e. similar to what is observed in the backscatter data. Areas with exposed bedrock at the seafloor are readily identified at numerous locations (Figs. SS3 and SS4). These areas were digitized to be used together with the interpretation of an AB in sub-bottom profiles for the compilation of a gridded sediment thickness model described below under a dedicated section. Boulders and other objects are also seen in the side-scan imagery, which will be further addressed in the section describing the camera observations. The site where the bow visor of MS *Estonia* was recovered according to the JAIC final report shows a nearby high reflectivity area where till most likely makes up the seafloor geology and boulders may be present (Fig. SS5). There are no clear signs of an imprint in the seafloor from the bow visor itself in the side-scan images. The reported coordinates are assumed to be referenced to WGS84. However, coordinates of the bow visor location were also reported by the Finnish navy in the Finnish KKJ datum. These coordinates were here converted to WGS84 and are shown on the map in Figure SS5. A feature is here seen on the side-scan imagery that may be the imprint of the bow visor in the seafloor.
