Report of the MS *Estonia* shipwreck site survey with RV *Electra*

July 8th–15th, 2021

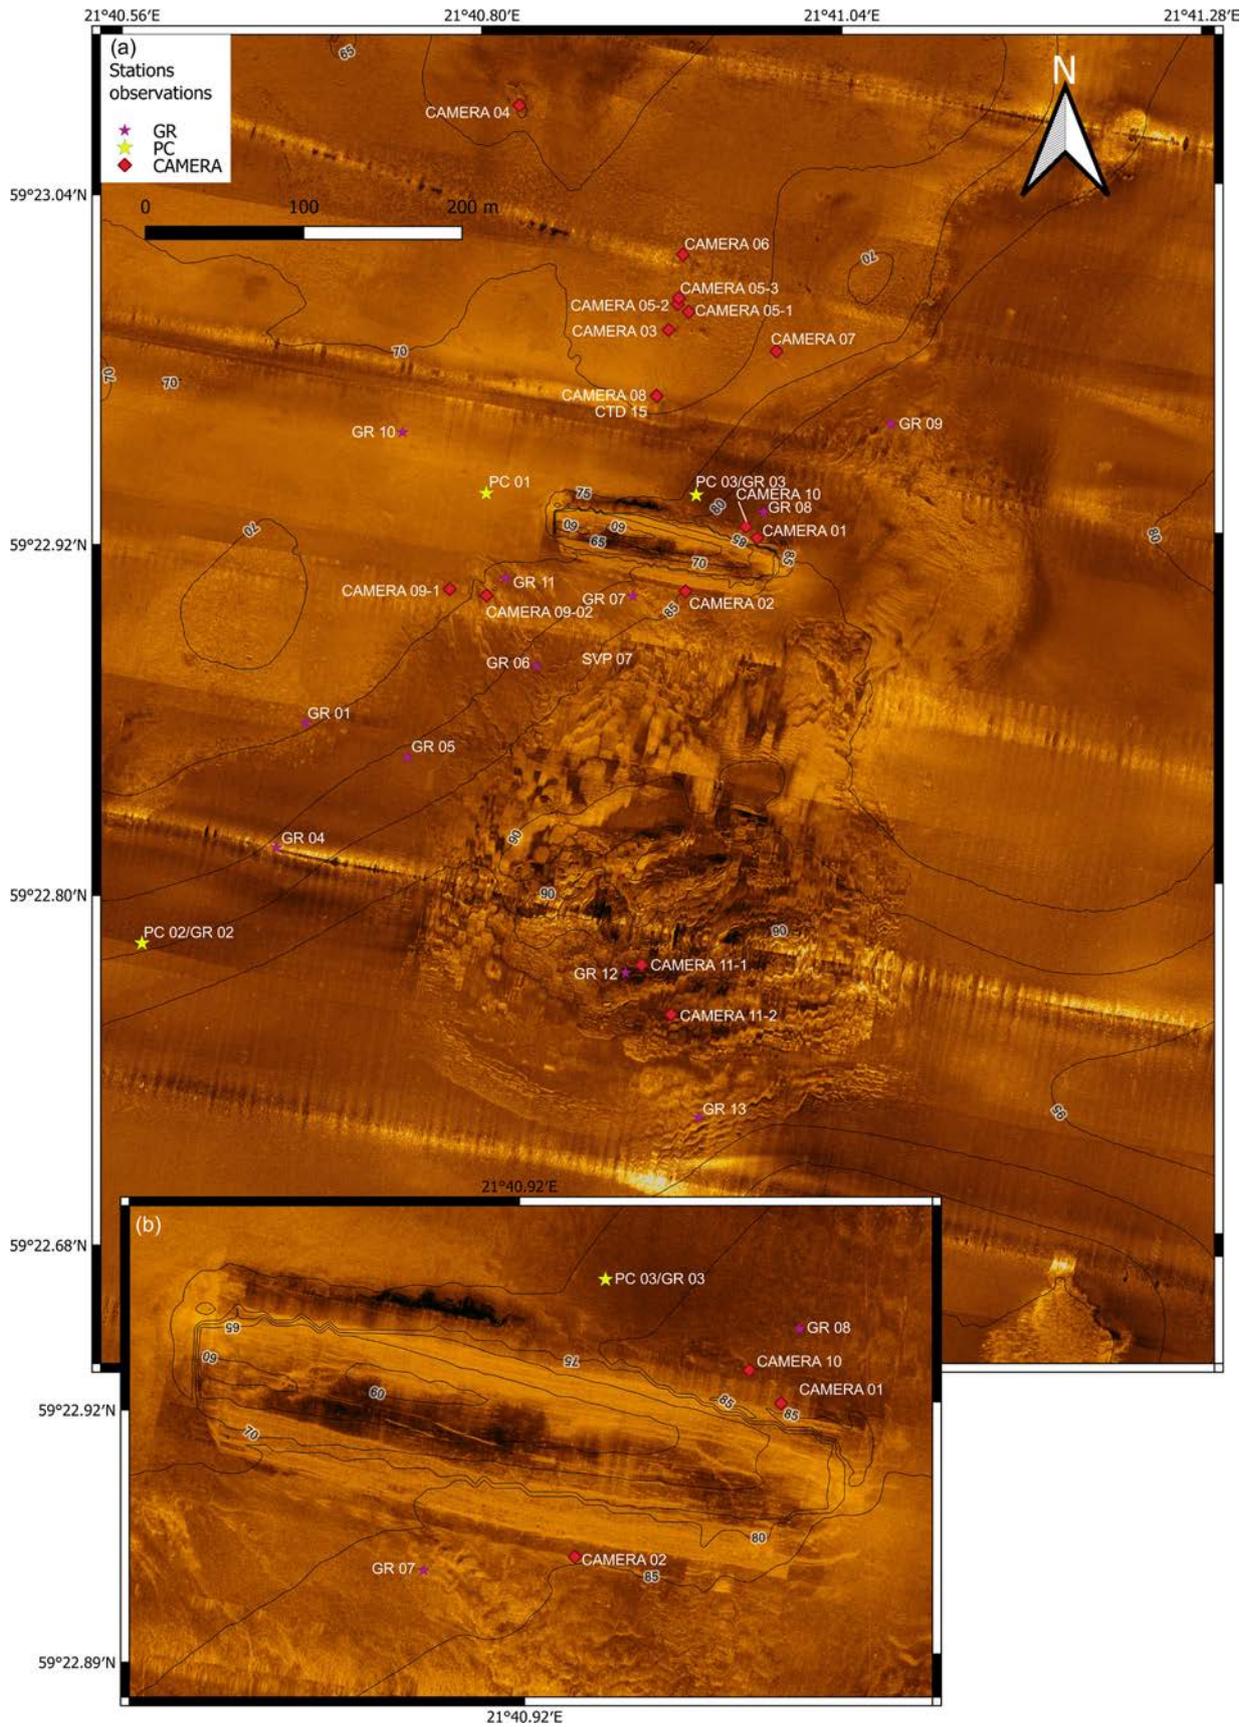
Figure 556. (a) Side-scan mosaic shipwreck site. Artifacts from tow-fish movements are seen as stripes in some lines. (b) Close up on MS Estonia.

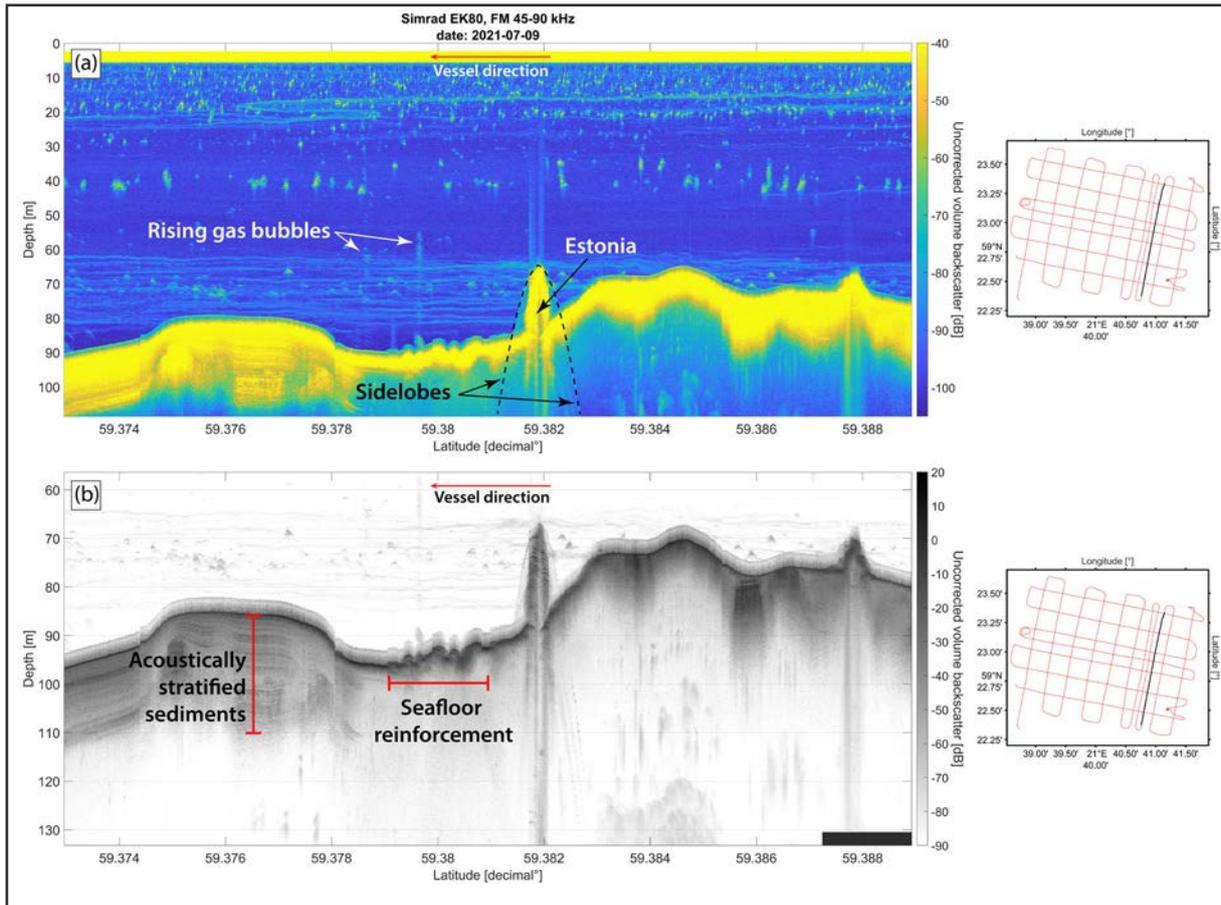
Figure MW2. Example EK80 echograms. a) Echogram across MS Estonia processed with focus on water column features. Visible features include the permanent halocline (see Fig. MW1), fish and fish aggregations, and rising gas bubbles. Also marked out is the Estonia shipwreck and associated sidelobes (acoustic artifacts from steep topography or objects). b) Echogram with focus on bottom and sub-bottom features. Visible features include, MS Estonia, acoustically stratified sediments and the manmade seafloor reinforcement south of the shipwreck. The vessel direction is shown as a horizontal red arrow. All EK80 survey profiles (including the 160–260 kHz transducer data) are found in Appendix 5.

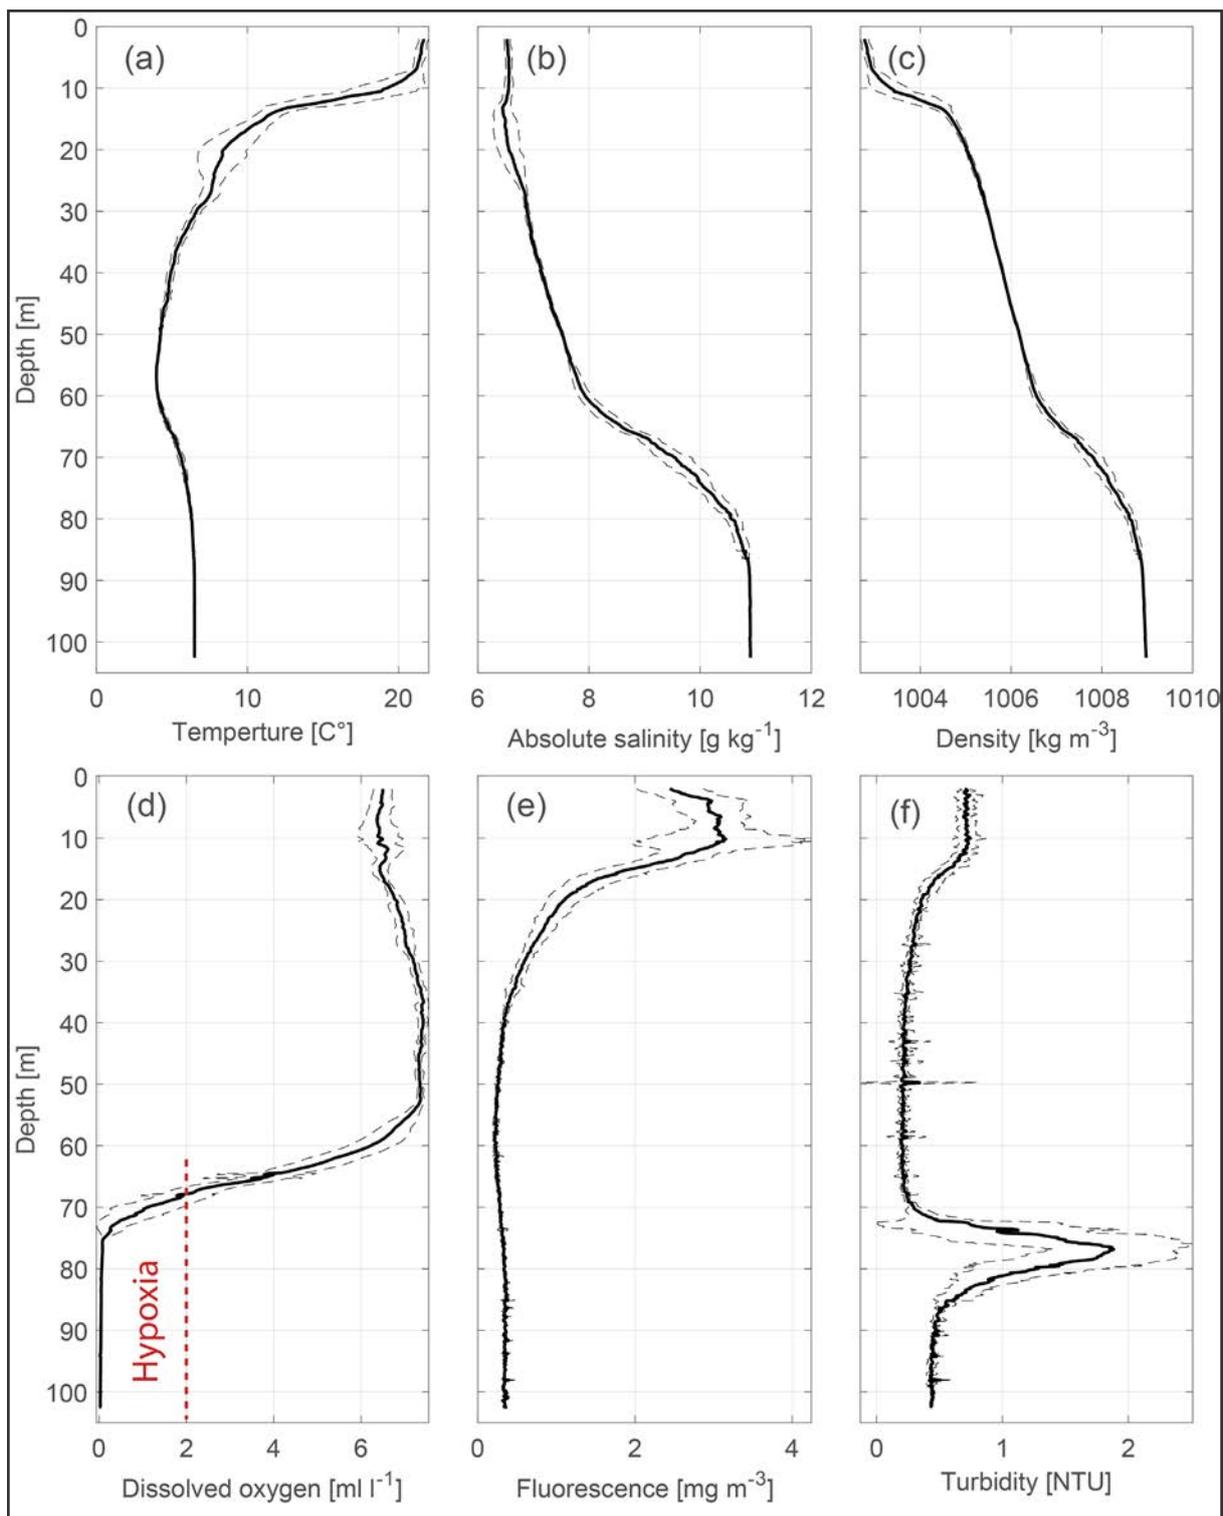
Figure WP1. Average CTD profiles. Average a) temperature, b) absolute salinity, c) density, d) dissolved oxygen concentration, e) fluorescence and f) turbidity are plotted against depth (solid black) and the corresponding  $\pm$  one standard deviation (dashed black lines).

Turbidity provides a relative measure of the amounts of particles in the water column (Fig. WP1f). The turbidity is slightly elevated in the surface mixed layer which is likely related to the higher fluorescence (and presumably higher concentrations of plankton). The lowest turbidity is found in the *surface water*, below the mixed layer. The peak in turbidity in the lower part of the permanent halocline might be related to the retardation of the particle sink velocities as the density increases. An important contribution to the turbidity maximum may also come from the strong bottom currents seen in the moored ADCP data (Fig. AM2) between 70–80 m with an associated sediment resuspension forming a nepheloid layer (Yurkovskis, 2005).

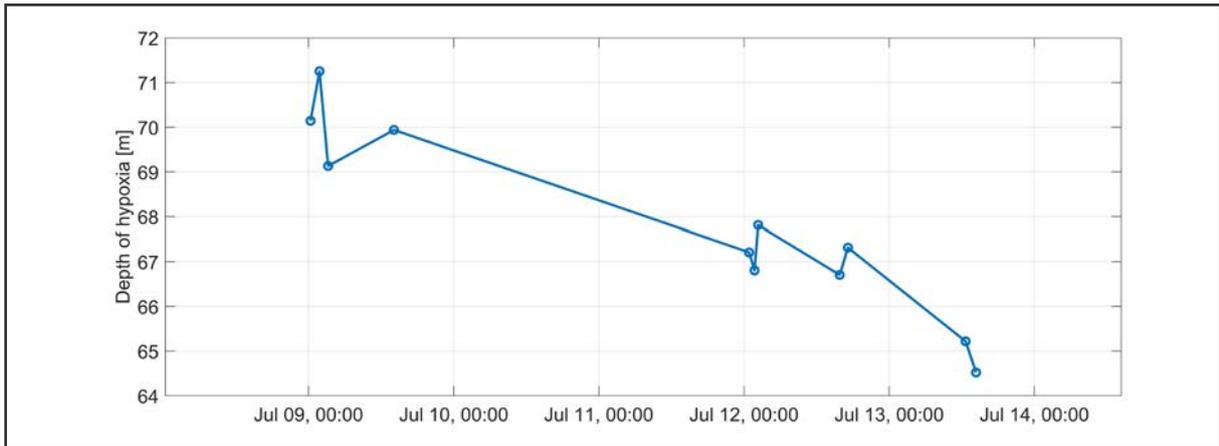
Figure WP2. Hypoxic conditions, defined as dissolved oxygen concentration  $< 2$  ml/l, are often found below the permanent halocline in the Baltic Proper. Here, the water depth at which hypoxia begins is plotted against time. The data covers the first 13 CTD stations and only CTD profiles that goes into the hypoxic zone are considered (11 stations in total).

The dissolved oxygen concentration drops drastically below the permanent halocline and below 75 m, conditions are more or less anoxic. Weidner et al. (2020) showed that in the Western Gotland Basin, the depth of the permanent halocline coincided with the transition between oxic and anoxic conditions, and that the depth of anoxia, defined as where the dissolved oxygen concentration drops below 2 ml/l, can change ~14 m over the course of about two days. Similarly, in the present data-set the halocline and oxycline coincide, and the depth at which hypoxia begins dropped about 5 m over the first 5 days of the survey (Fig. WP2).

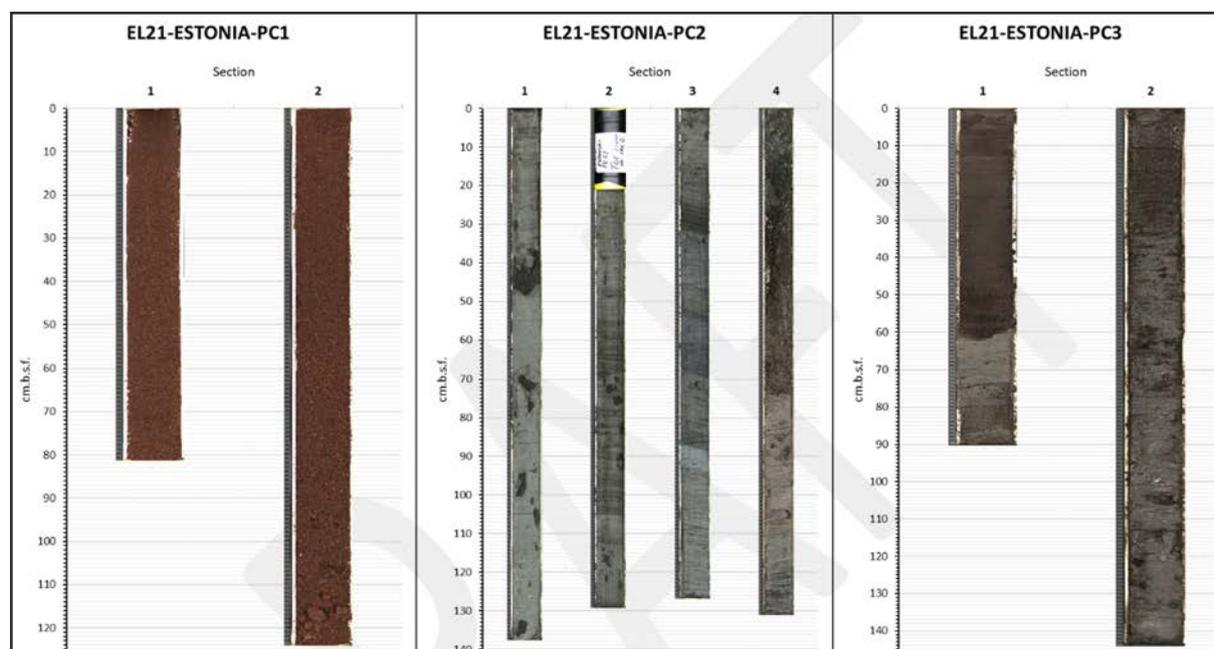
Figure SBI2. Images of the split sediment core sections. Higher resolution images are found in Appendix 7.

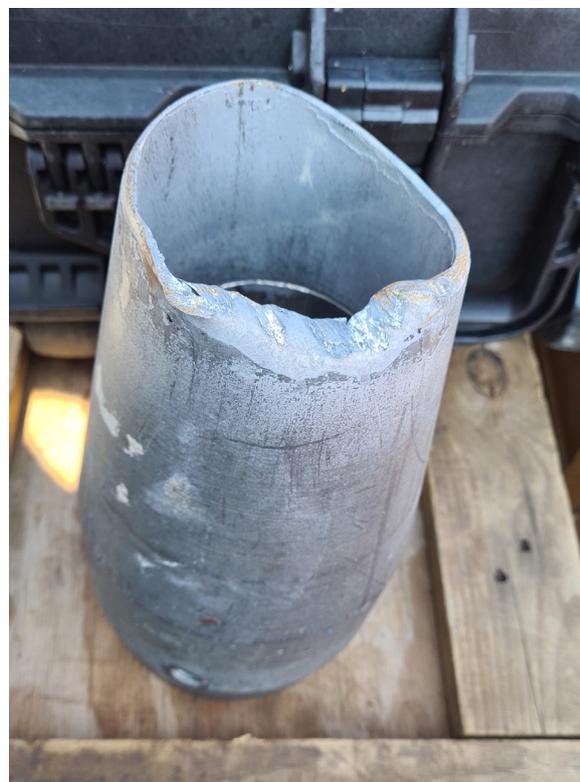
Photo SBI1. The damaged core cutter after retrieved PC03.

and alternating in colour between dark greenish grey and olive. The last core, PC03 was recovered approximately 15m north of MS *Estonia* midship for the purpose of probing the sediment depth and type. The core retrieved 234cm of sediments before reaching a hard substrate, which damaged the core cutter (Photo. SBI1). The upmost 56cm of this core is comprised of dusky red well sorted sand, which most likely was dumped at the site during the covering work. The composition is very similar to that in PC01, albeit slightly coarser. This is followed by a 10cm thick greyish brown clay unit, which in turn is followed by an additional 21cm of dusky red sand. The remaining 147cm of PC01 contains greyish brown, partly disturbed, clay with varying sand content. This lower unit may be a clayey till.

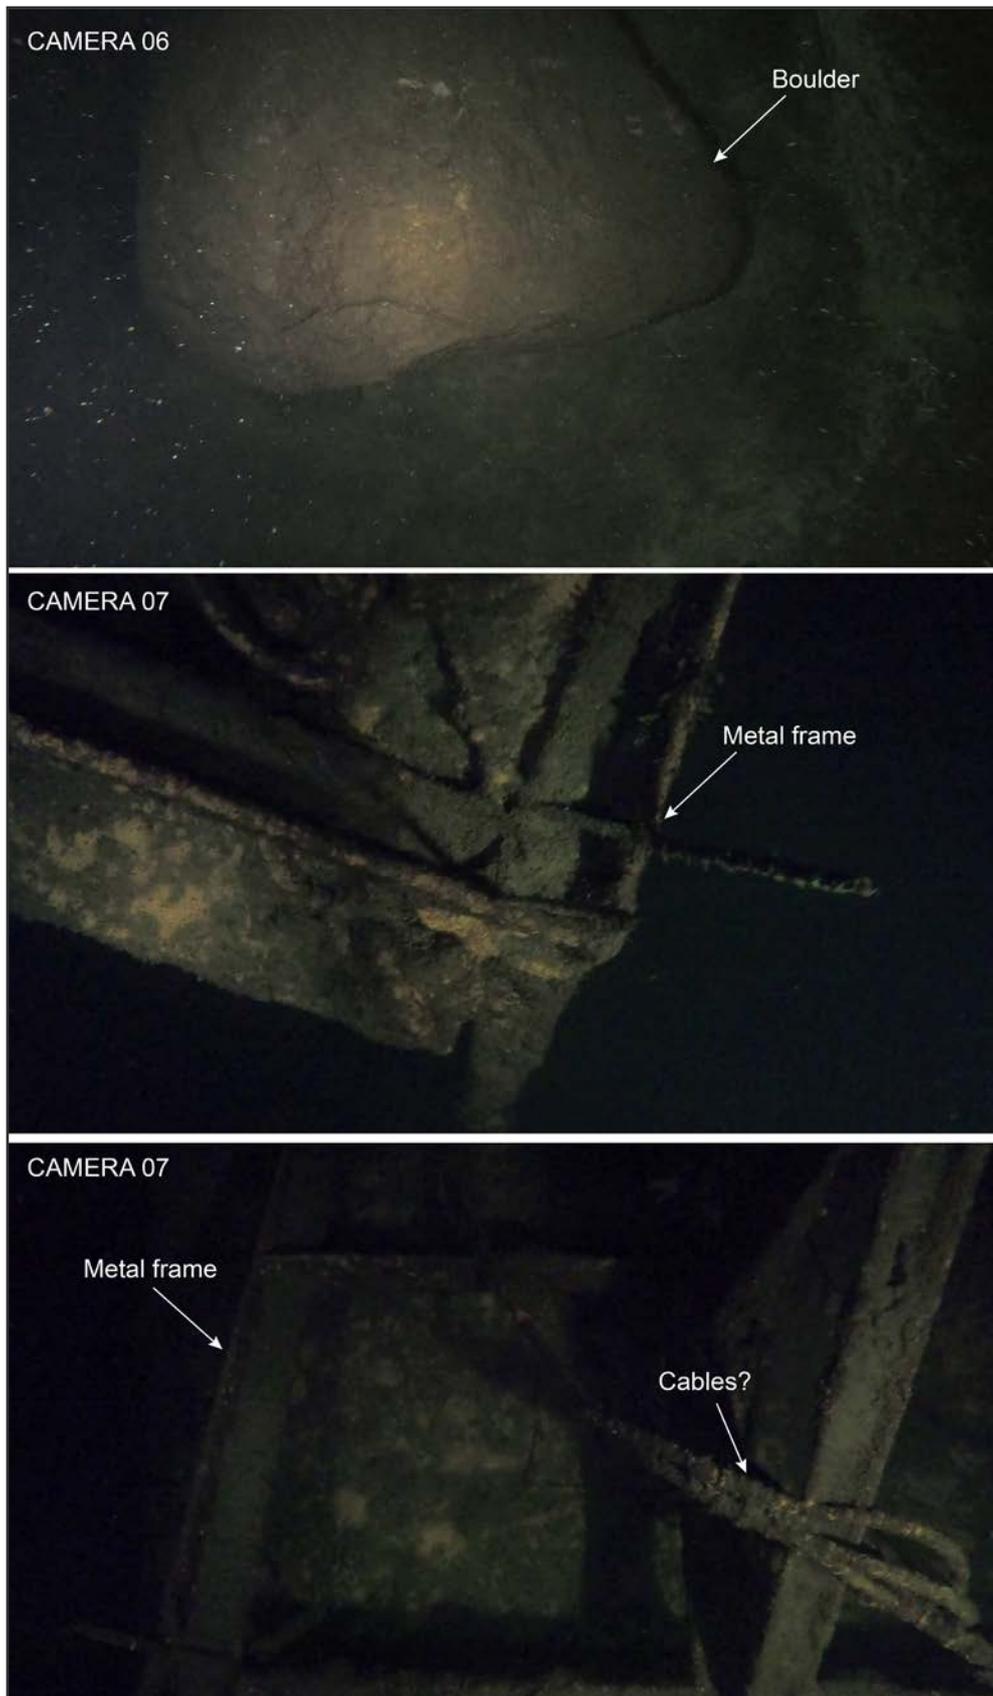
Figure SBI9. Snapshots from sites CAMERA 06 and 07.

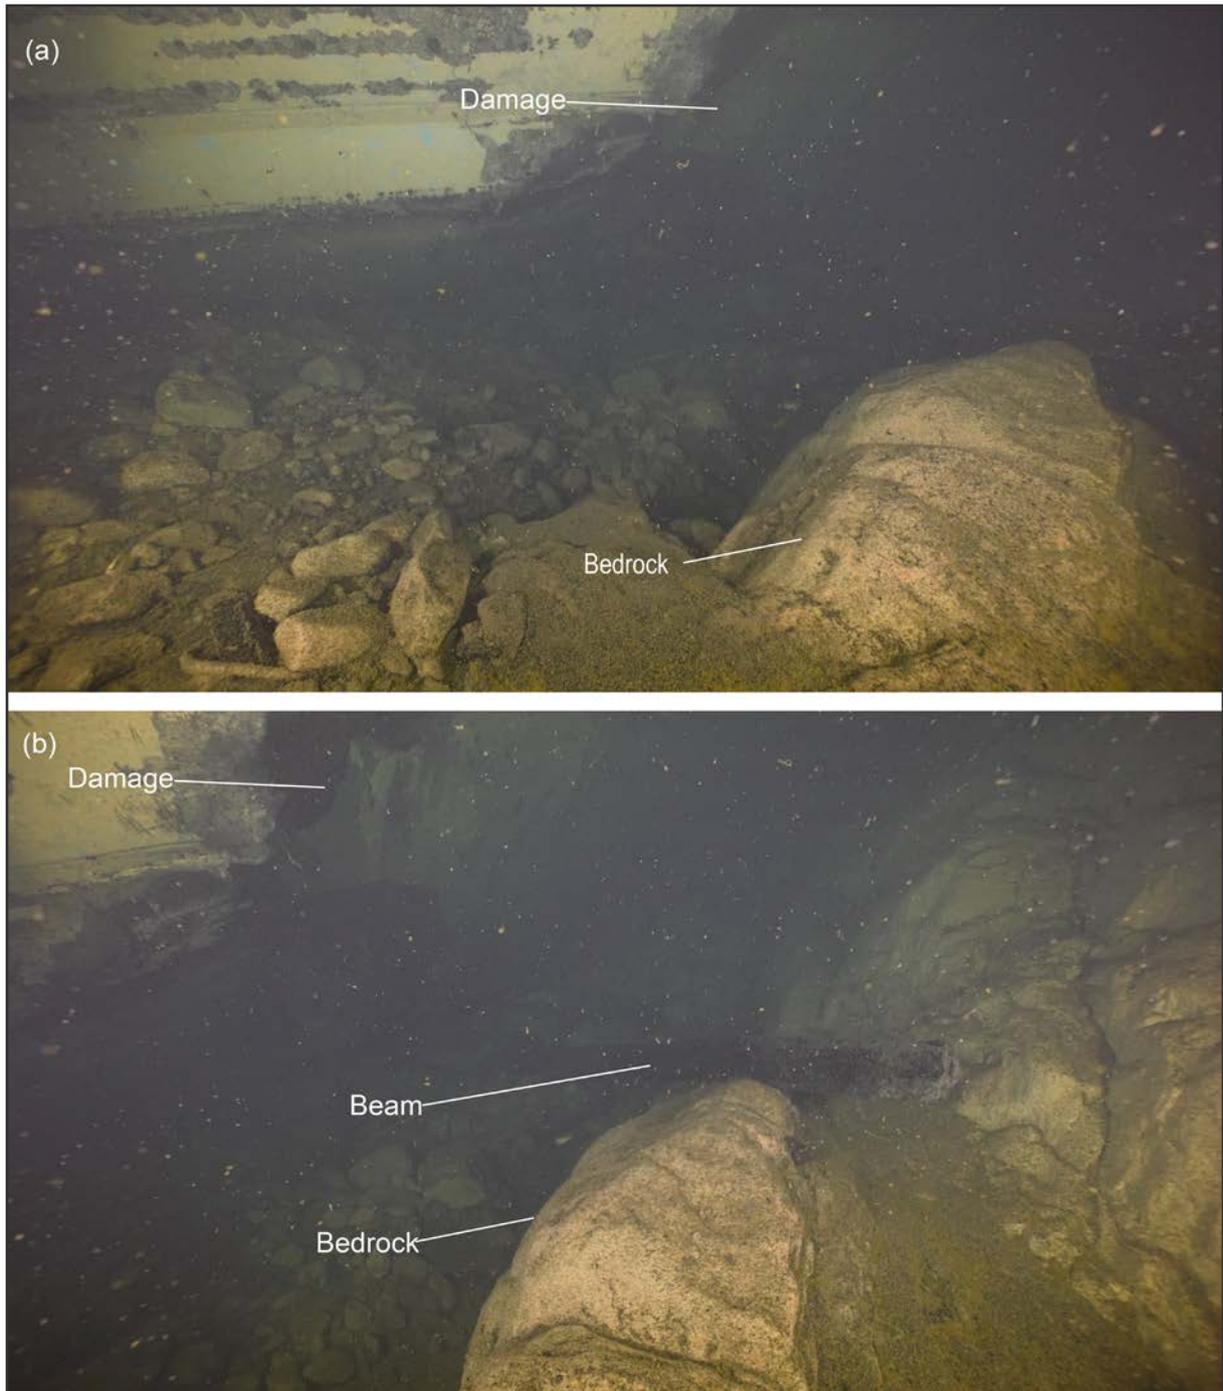
Figure SBI12. (a,b) Bedrock exposed next to the damage in hull of MS Estonia first observed in the Discovery+ documentary by Henrik Evertsson. (a) A beam has fallen out from the hole in the hull. Ocular inspection of the texture and parallel jointing of the bedrock suggest that it may be comprised of granite or syenite (Alasdair Skelton Personal communication).

The notes above refer to two main areas of damage observed in the hull of MS *Estonia*, of which the one located closer to the bow was first filmed and shown in the Discovery+ documentary by Henrik Evertsson. This damage is situated approximately 89m from the shipwreck’s stern and bedrock is clearly visible in the ROV film next to it (Fig. SBI12). From the texture and parallel jointing, it appears from ocular inspection to be granite or perhaps syenite (Alasdair Skelton, Stockholm University, personal comment). The second damaged region is situated approximately 20m further towards the stern, where a large hole in the hull is seen (Fig. SBI13). The hull rests here on bedrock, which appears to be of the same composition as by the other damaged area. Furthermore, bedrock is observed between the two major damaged regions in MS *Estonia*’s hull. Where bedrock lies close to the hull it seems to have caused denting (Fig. SBI14a). Finally, the ROV films show that exposed bedrock extends a bit further than between the holes, although it is hard to infer exactly for how long as the ROV lacks a position system and there are no clear references visible (Fig. SBI14b).

- Exposed bedrock is identified next to where the two major holes in MS *Estonia*'s hull are found along the northern side, approximately 69m and 89m from the stern respectively. From ocular inspection of its texture and visible parallel jointing, the bedrock appears to be igneous, likely granite or syenite. Denting in the hull is visible where it comes close to exposed bedrock in-between the two major holes.

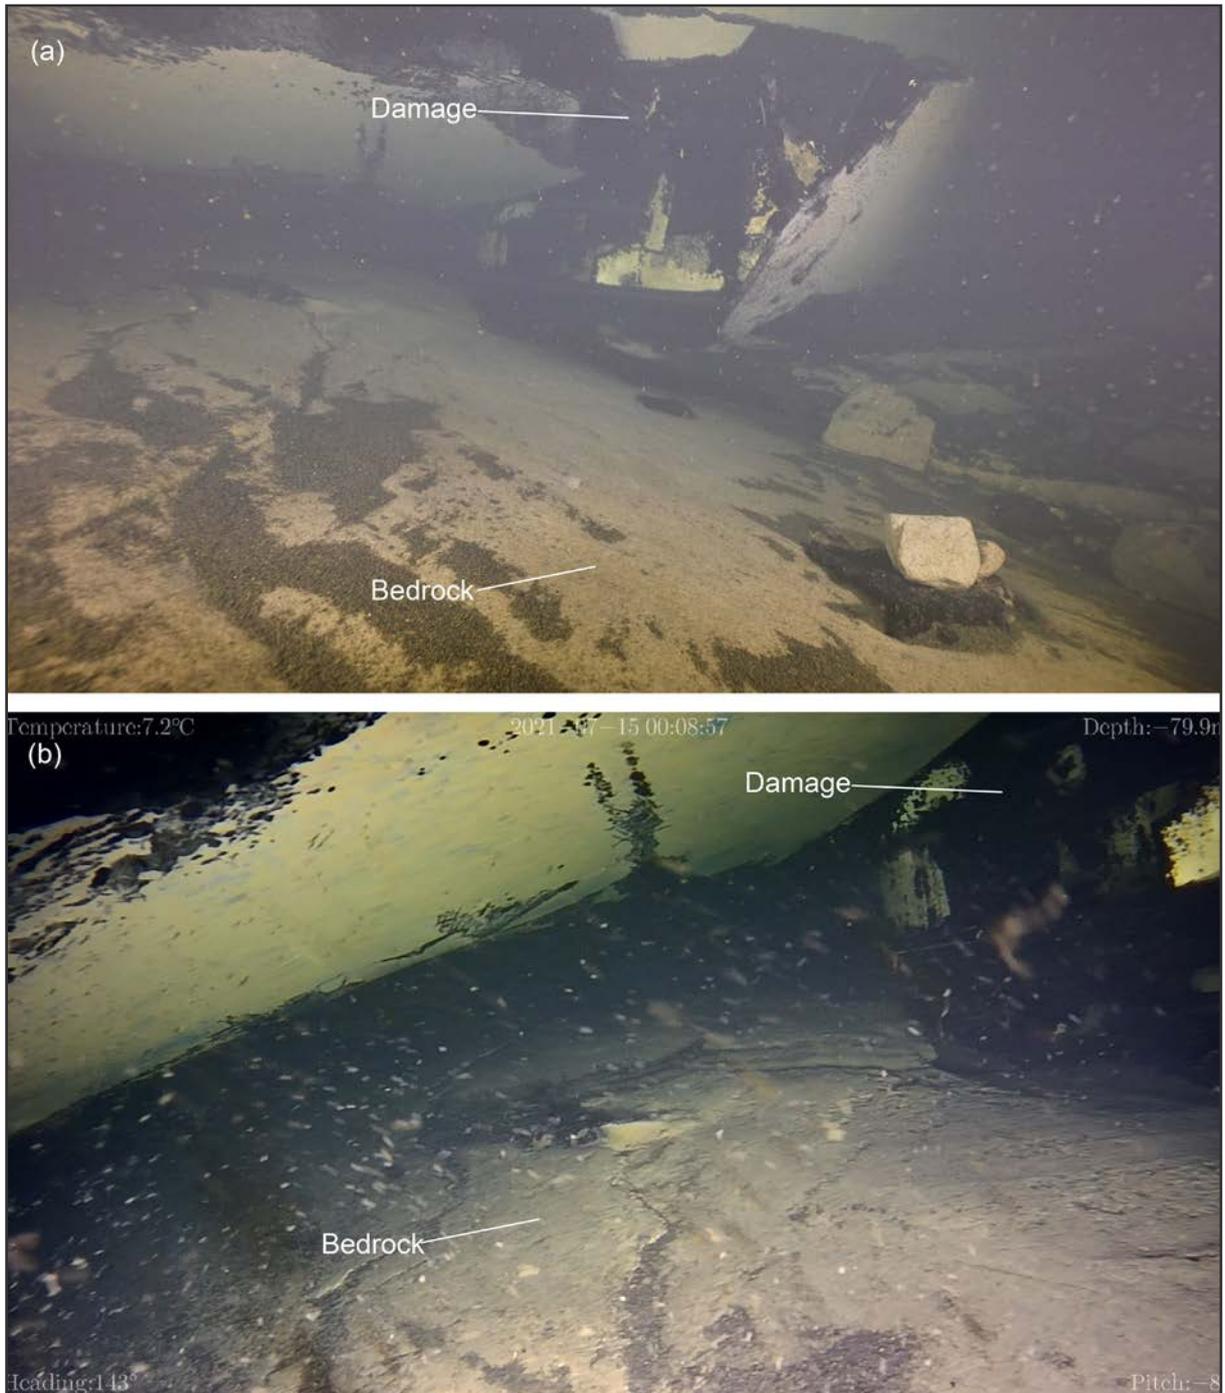
Figure SBI13. Bedrock underneath the hull of MS Estonia where another major damage is located approximately 20 m further towards the stern than first shown in Figure SBI12. (a) was filmed by Tuukritööde OÜ's using their Seaeye Falcon ROV while (b) was acquired with their smaller ROV.

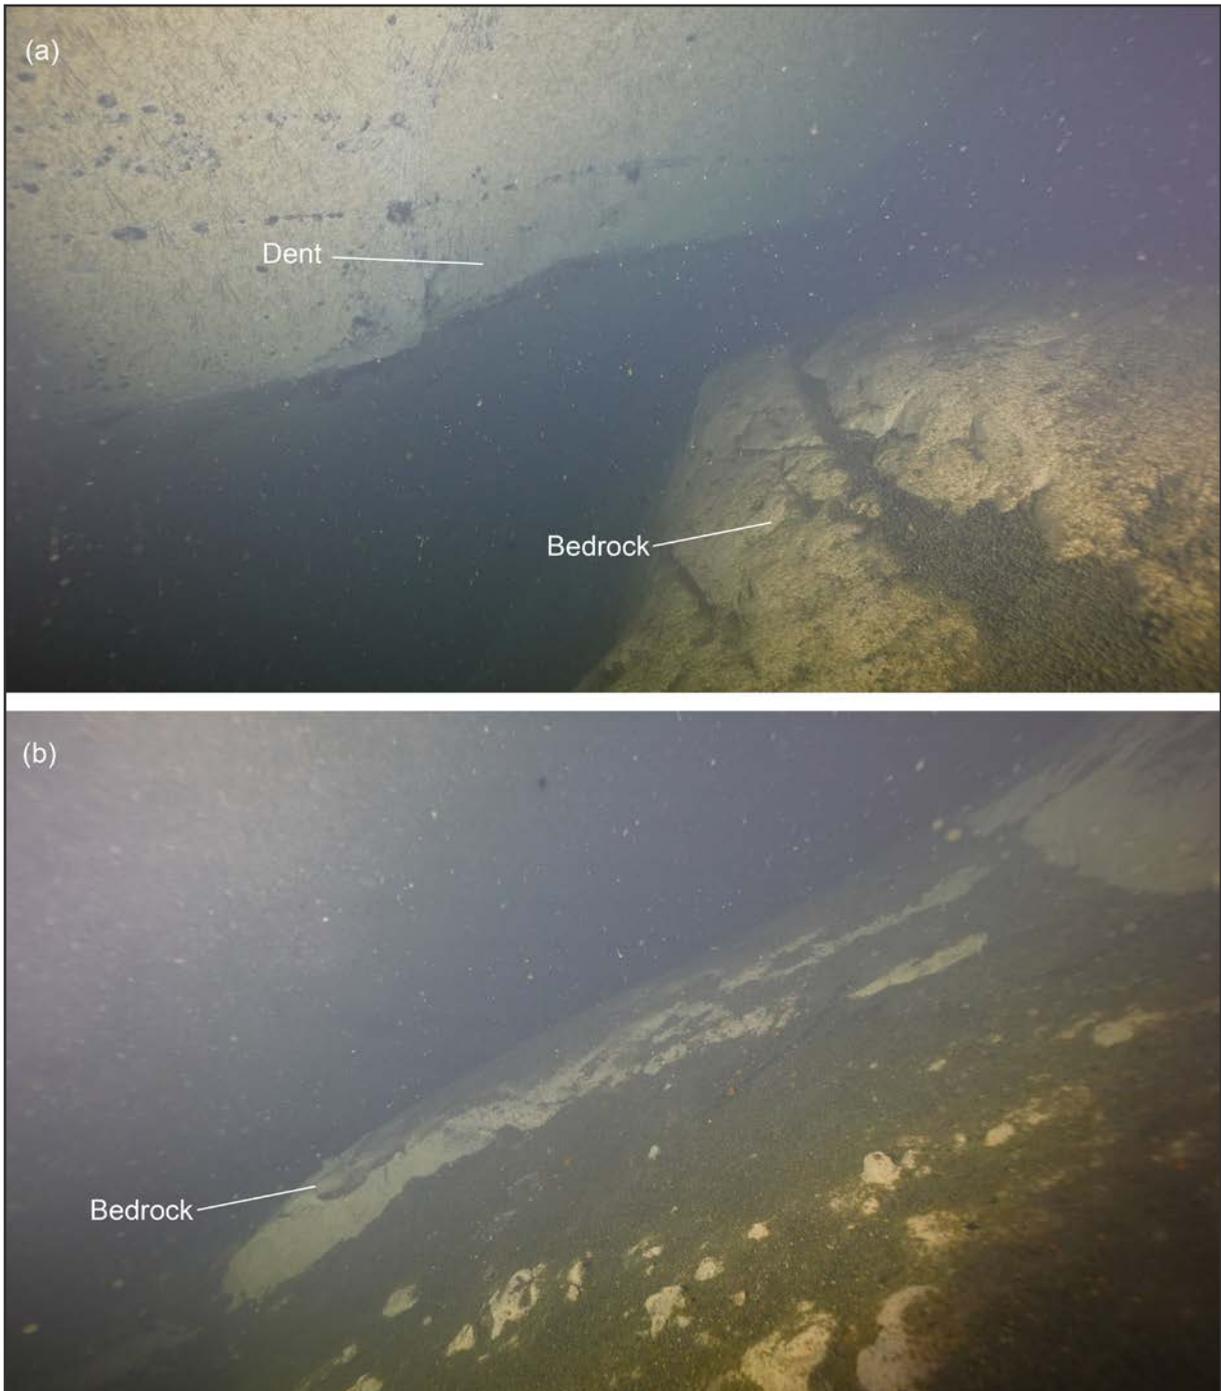
Figure SBI14. (a) Bedrock close to the hull of MS Estonia in between the two major holes shown in Figures SBI12 and 13. Denting of the hull can be seen. (b) Bedrock continuing towards the stern from the location of the rear hole.

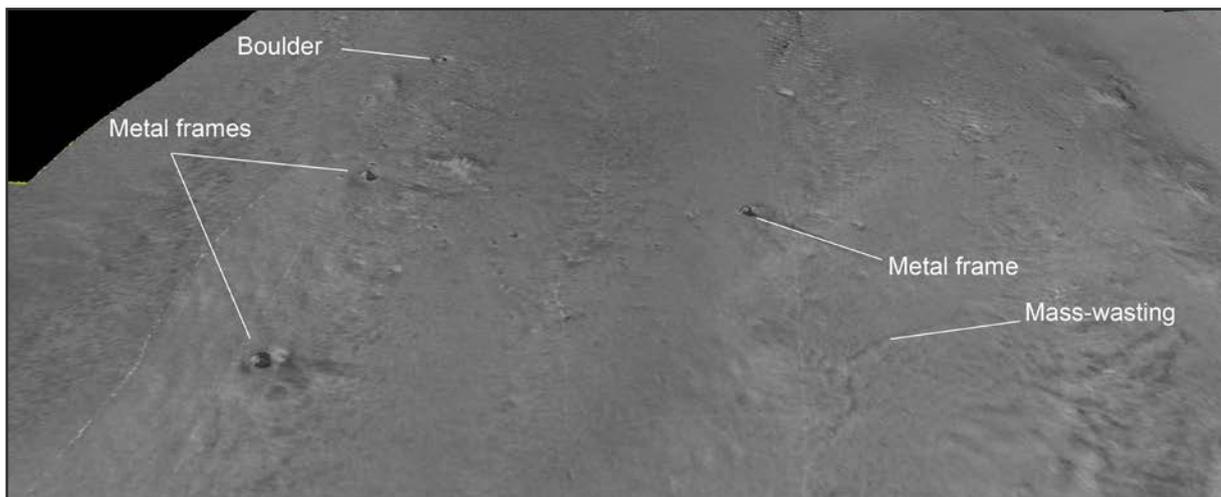
Figure SBI18. 3D-view of backscatter imagery draped on top the multibeam bathymetry in the area where the metal frames are located north of MS Estonia.

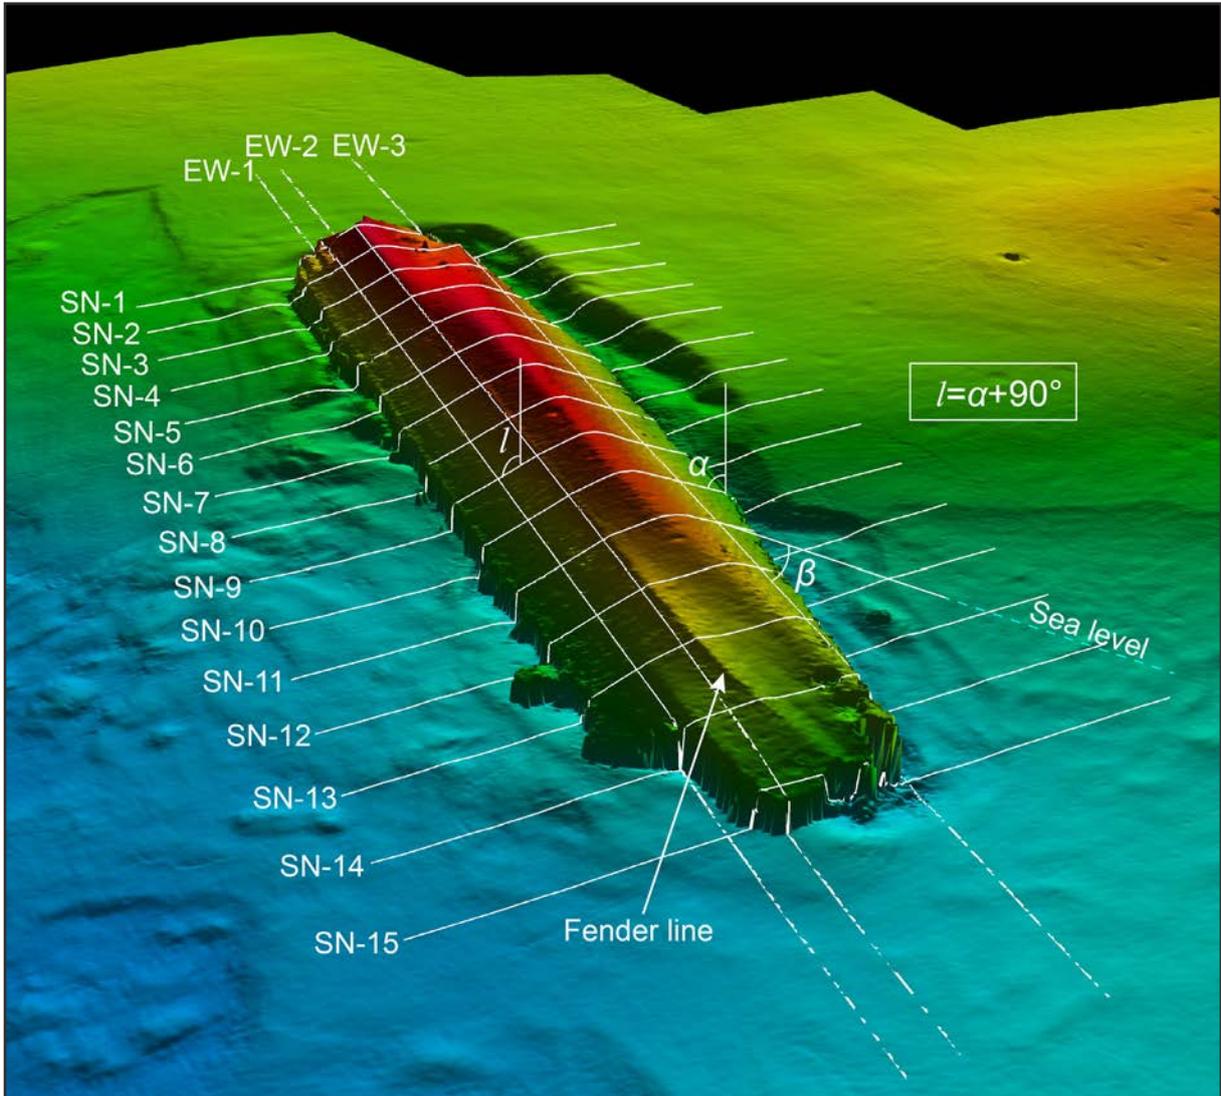
Figure ME2. 3D-view based on the 0.25×0.25 m multibeam grid showing the extracted profiles and how the listing of MS Estonia is calculated as  $\alpha+90^\circ$  and the trim  $\beta$  of the shipwreck along its length relative to sea level. Listing was also estimated based on the flat port side of the shipwreck.

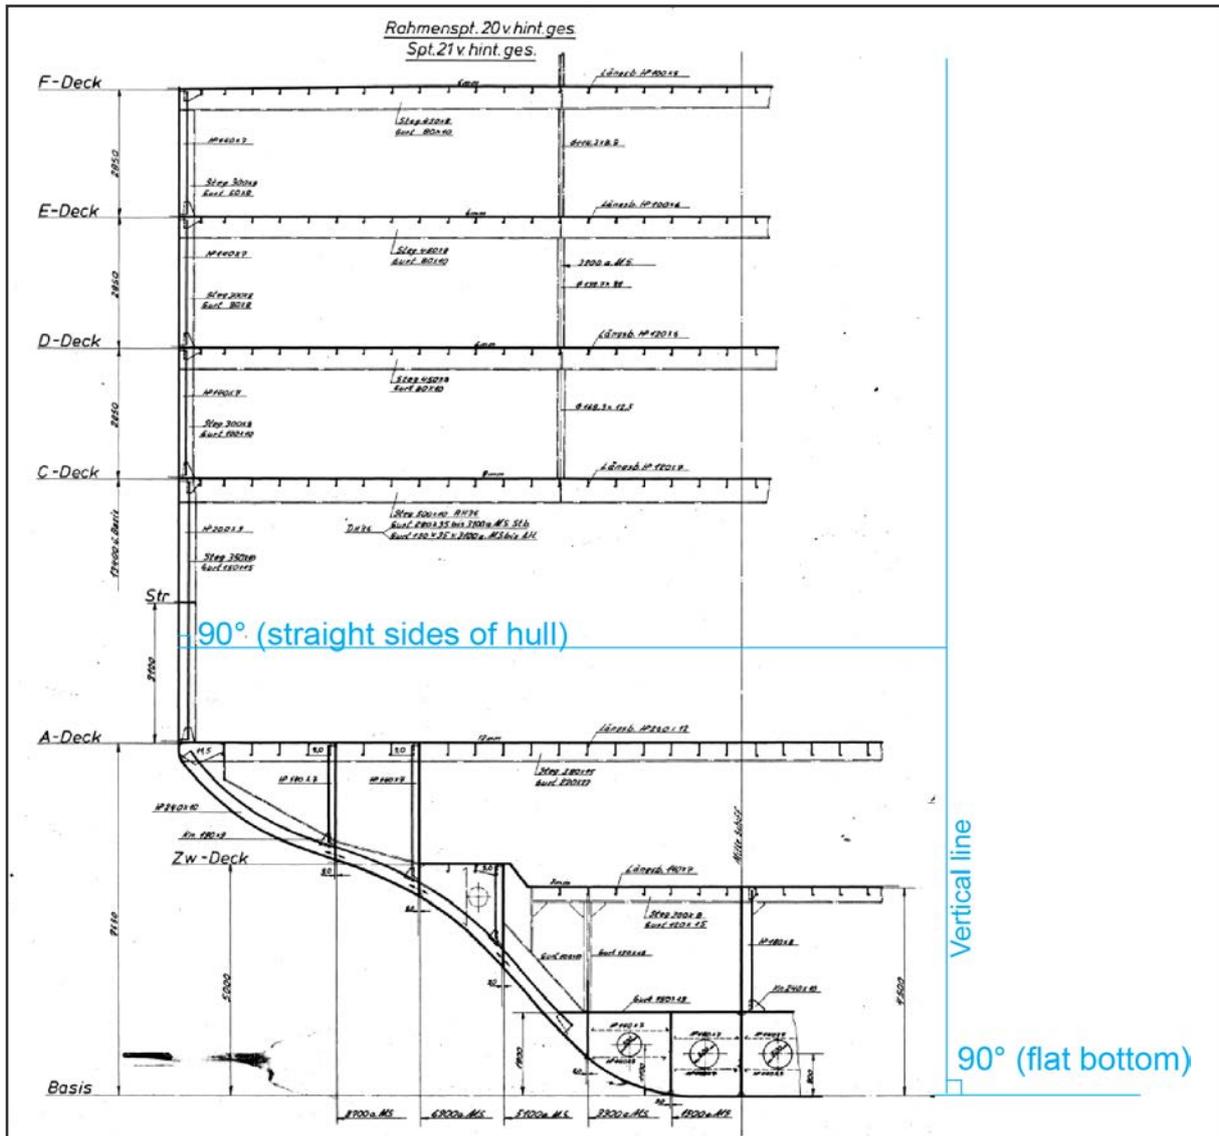
Figure ME3. Part of drawing of MS Estonia by Jos. L. Meyer Papenburg (Ems). The original drawings are from 1980-06-13. The blue lines are inferred to show that the bottom of the ship is flat and the sides are vertical and thus perpendicular to the bottom. This assumption has served as a basis for the measurements in this report of MS Estonia's present listing and whether any hull deformations can be found based on the multibeam bathymetric survey.

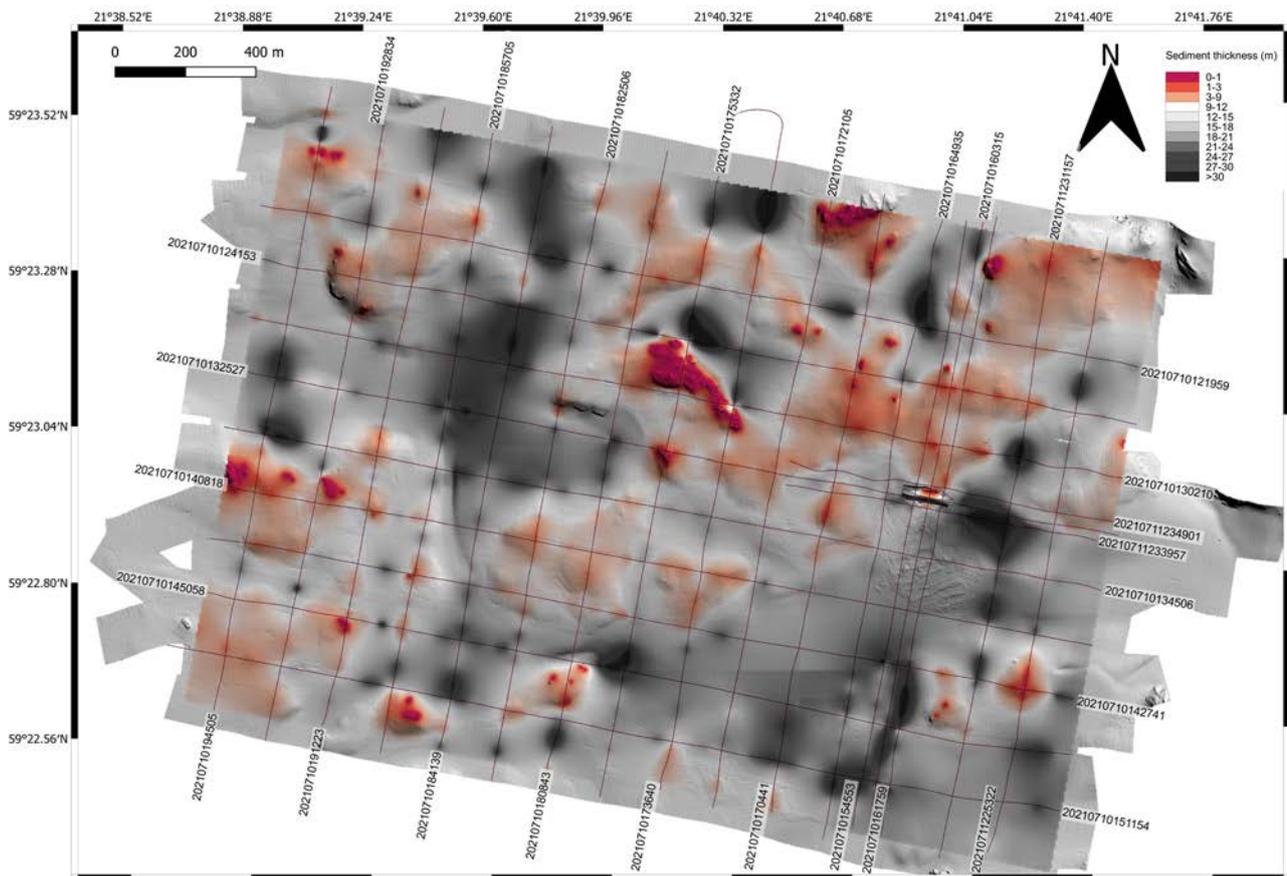
Figure ST2. Sediment thickness map in the survey area. Hill shading from the multibeam bathymetry is applied to provide a depth perception. Exposed bedrock (darker red) is commonly found at the bathymetric highs while the basins in between have the greatest sediment accumulations (darker colors).

- Large (>20m) sediment thicknesses are generally found in the surveyed area in the deeper bathymetric troughs between highs with thinner coverage, where exposed till and bedrock are found.
