Lower Crooked River Strategic Restoration Project Update

Crooked River Watershed Council

Pelton Round Butte Fisheries Workshop

July 18, 2019

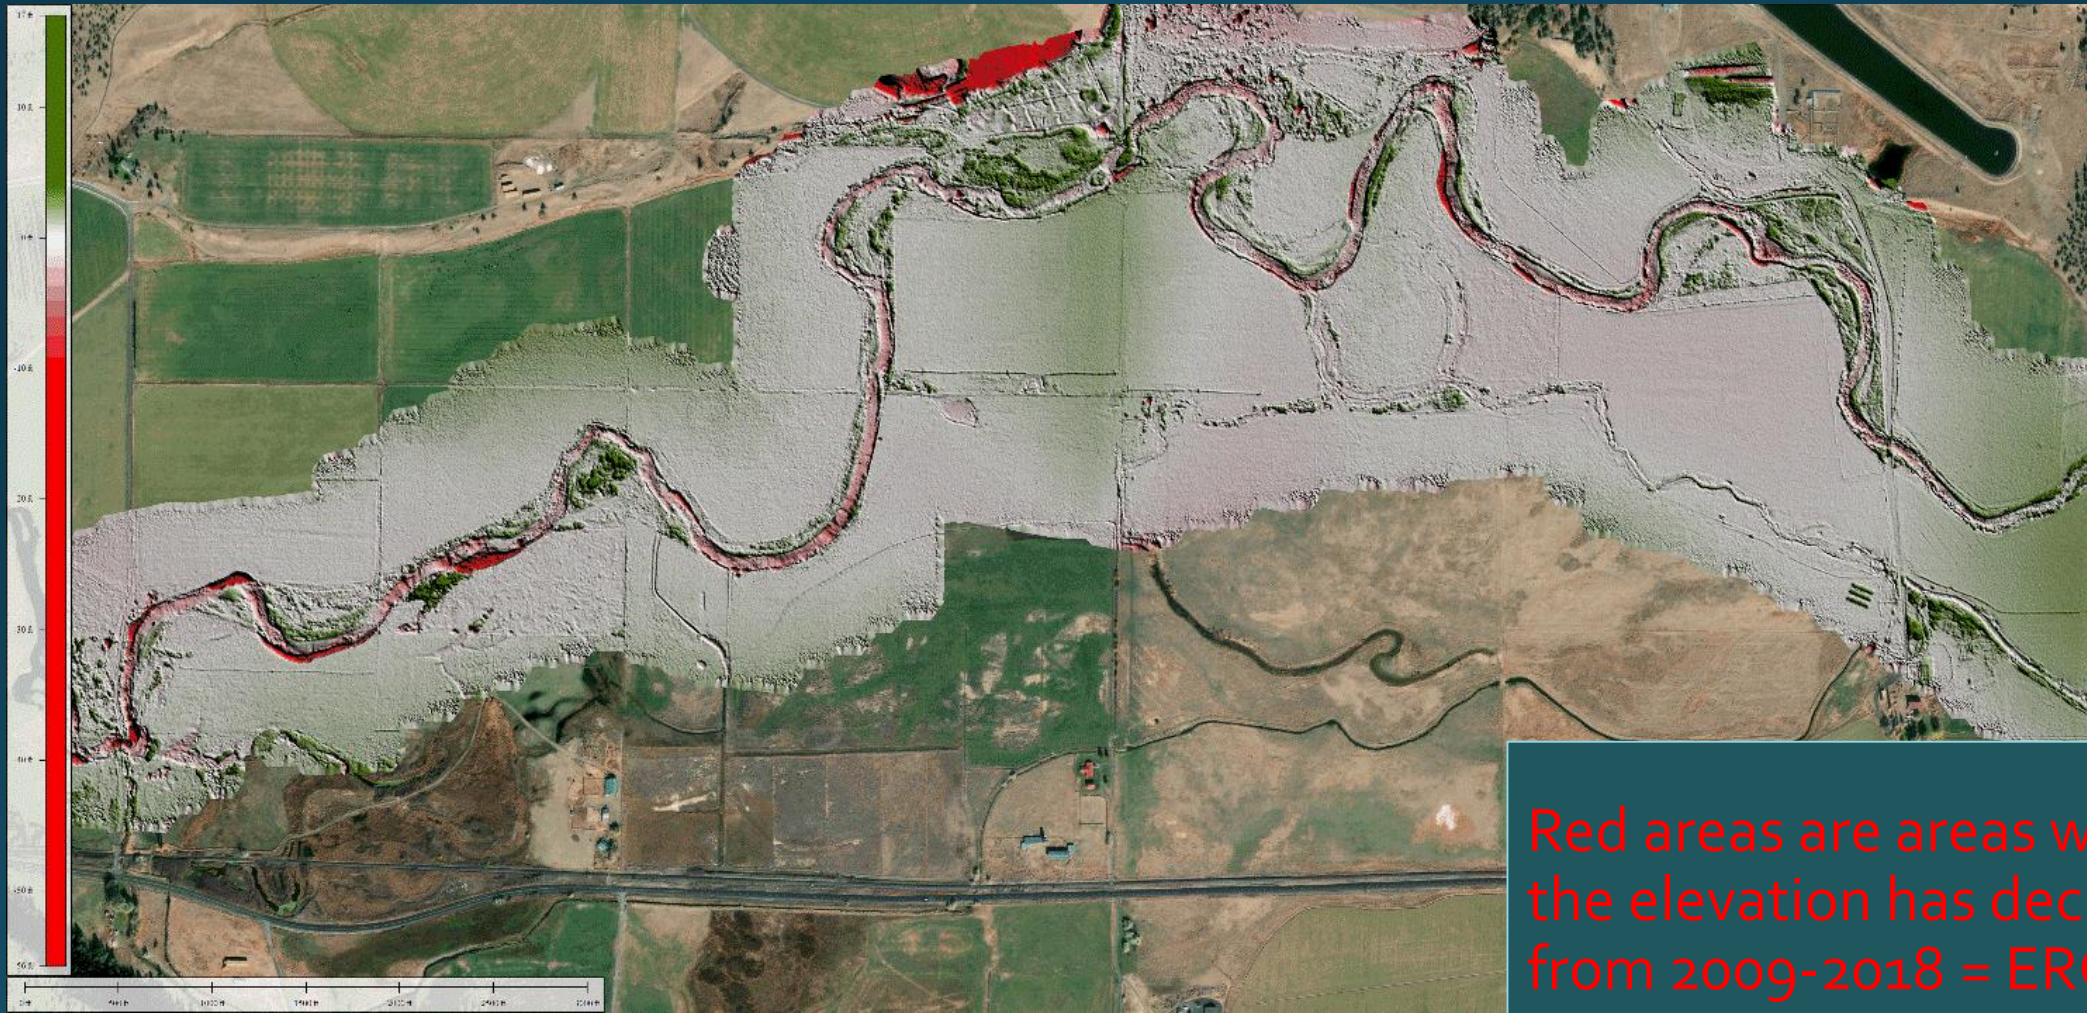
UAV/Lidar Comparison

Red areas are areas where the elevation has decreased from 2009-2018 = EROSION

- Use complete hydraulic model to estimate flow velocities, shear stress, etc. for design and engineering purposes
- Compare LiDAR (2009) and UAV (2018 and 2019) data to look for erosion
- Use hydraulic model to estimate fish habitat based on velocity and depth

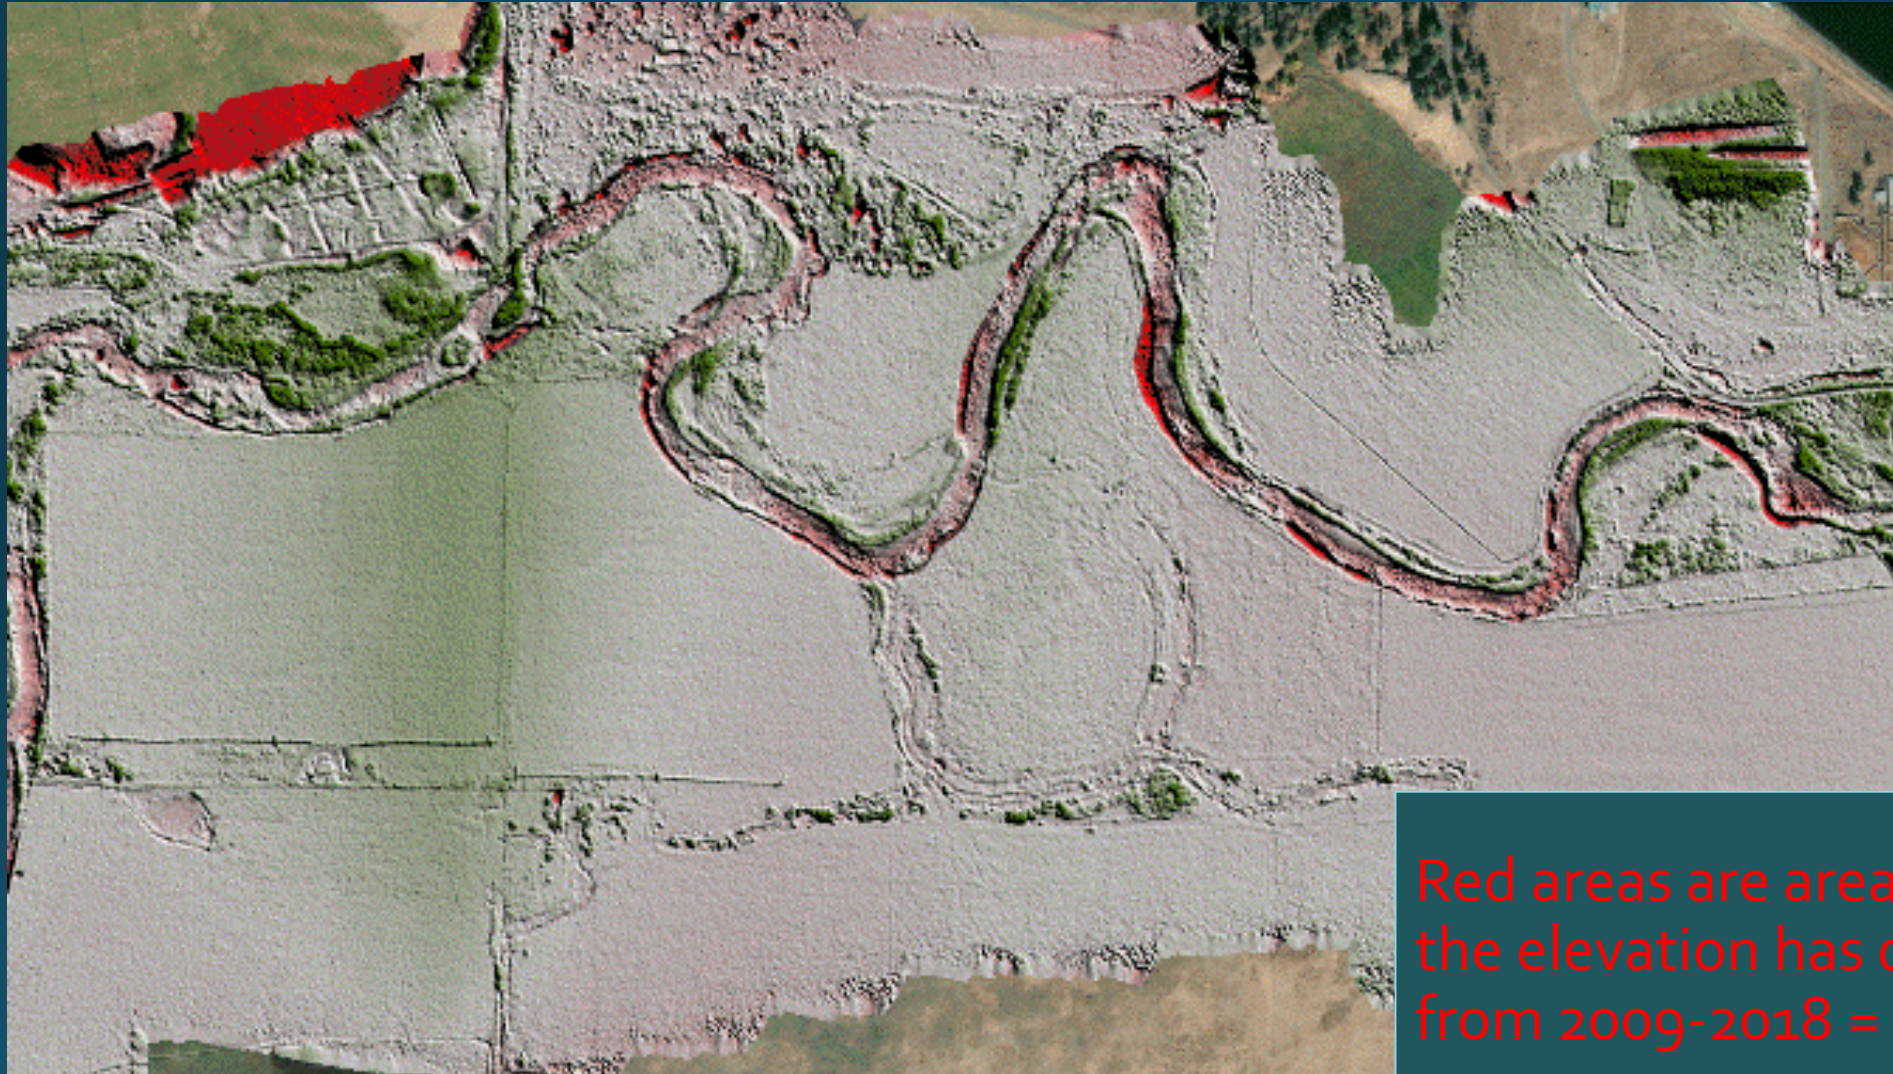
UAV/Lidar Comparison

Red areas are areas where the elevation has decreased from 2009-2018 = EROSION
