# Deschutes Large Wood Management Plan

**Micah Bennett:** Portland General Electric, Fish Biologist

Pelton Round Butte 31st Annual Fisheries Workshop

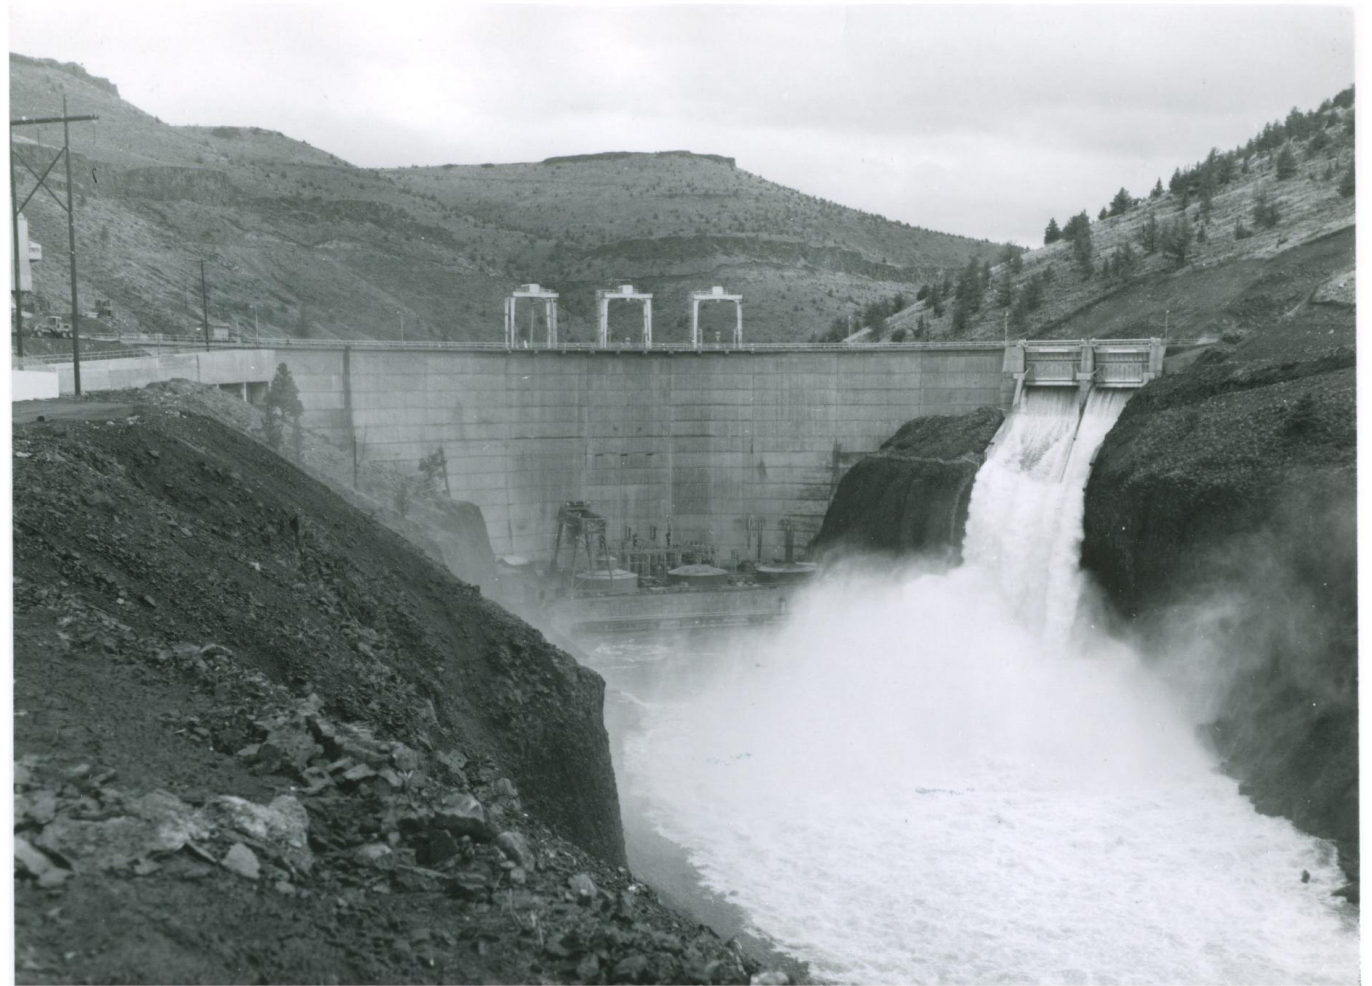
View of Pelton Dam and powerhouse with discharge through both spill gates January 27, 1958

In 1958, Pelton Dam construction blocked LWD transport into the lower Deschutes River (LDR) from the Metolius, Deschutes and Crooked Rivers.

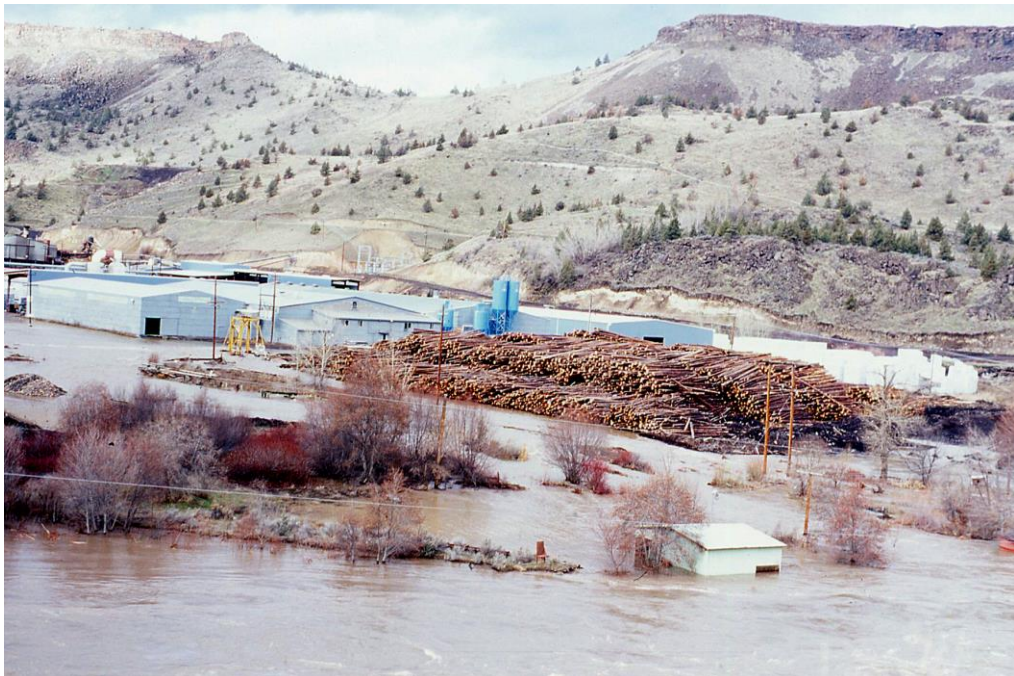
- As a partially spring-fed river, the Deschutes typically has a very stable flow compared to other river systems in Oregon.
- This means that much of the LWD in the LDR has a long residence time.
- Historical mean February discharge at the LDR Madras gage is about 5,250 cfs.
- In February 1996, the LDR at the Madras gage experienced a 19,100 cfs high flow event.

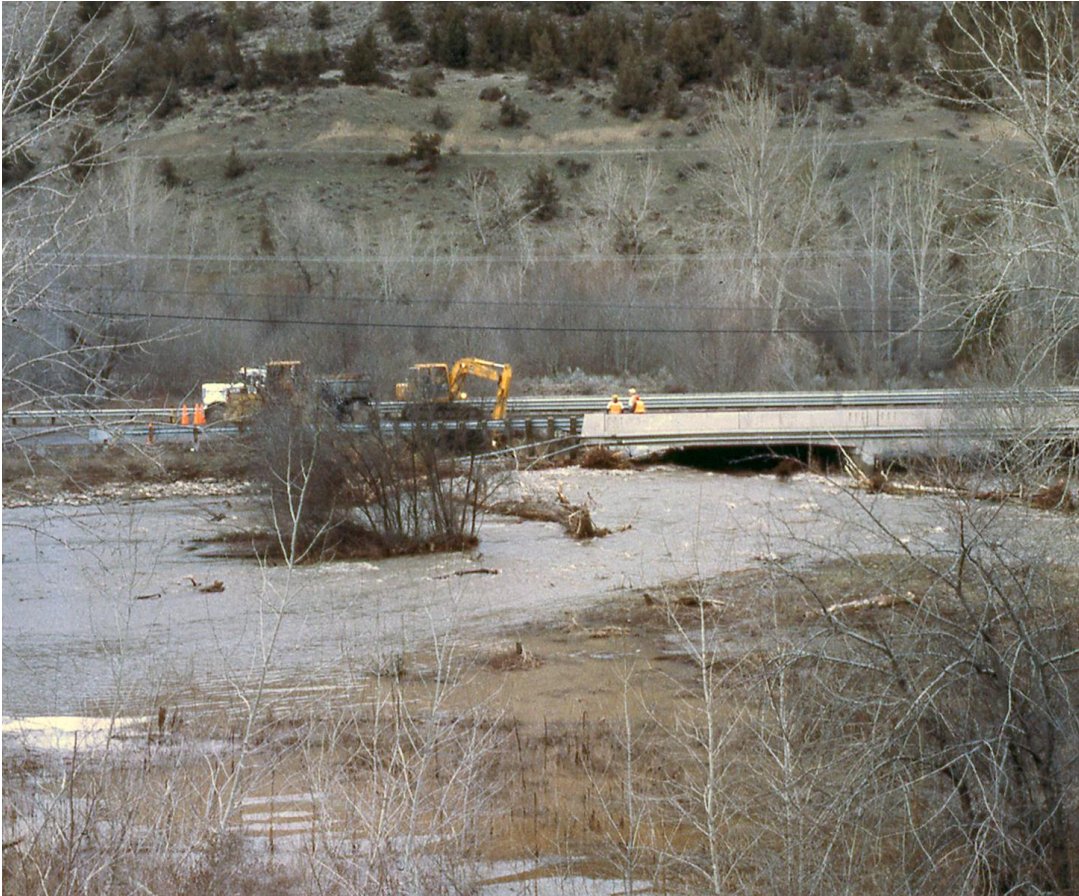
- Dam construction blocking recruitment from the upper basin Deschutes basin caused a slow decline of LWD.
- This was the most apparent between the Reregulating Dam and Shitike Creek near the Highway 26 bridge crossing.
- Between the Reregulating Dam and Trout Creek, there was an 85% decrease in Large wood after the 1996 flood (Minear 1999).

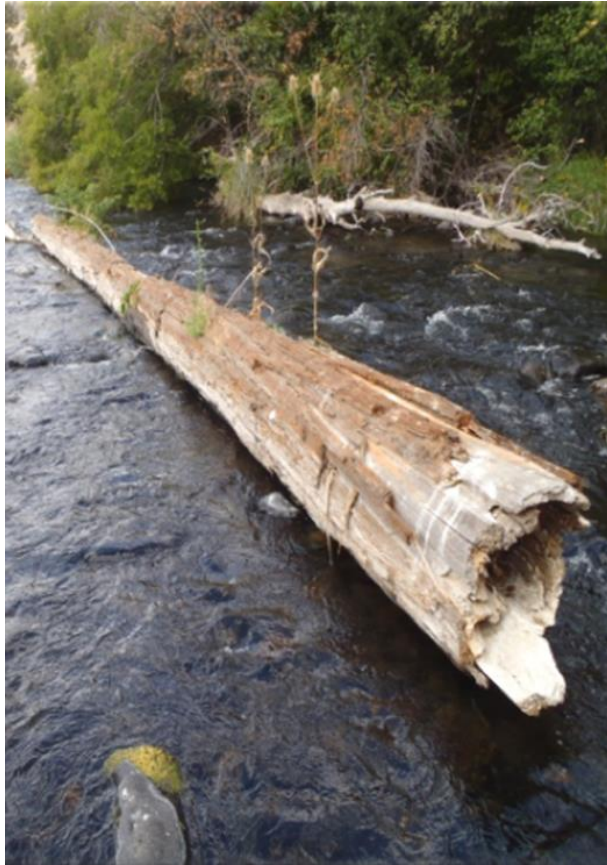
- Dam relicensing started in 1994 with a license granted in 2005 (FERC Project No. 2030).
- In 2007 the Large Wood Management Plan started with the placement of 24 logs.
- The goal of the Large Wood Management Plan is to reconnect LWD transport from the Upper Deschutes Basin to the LDR.

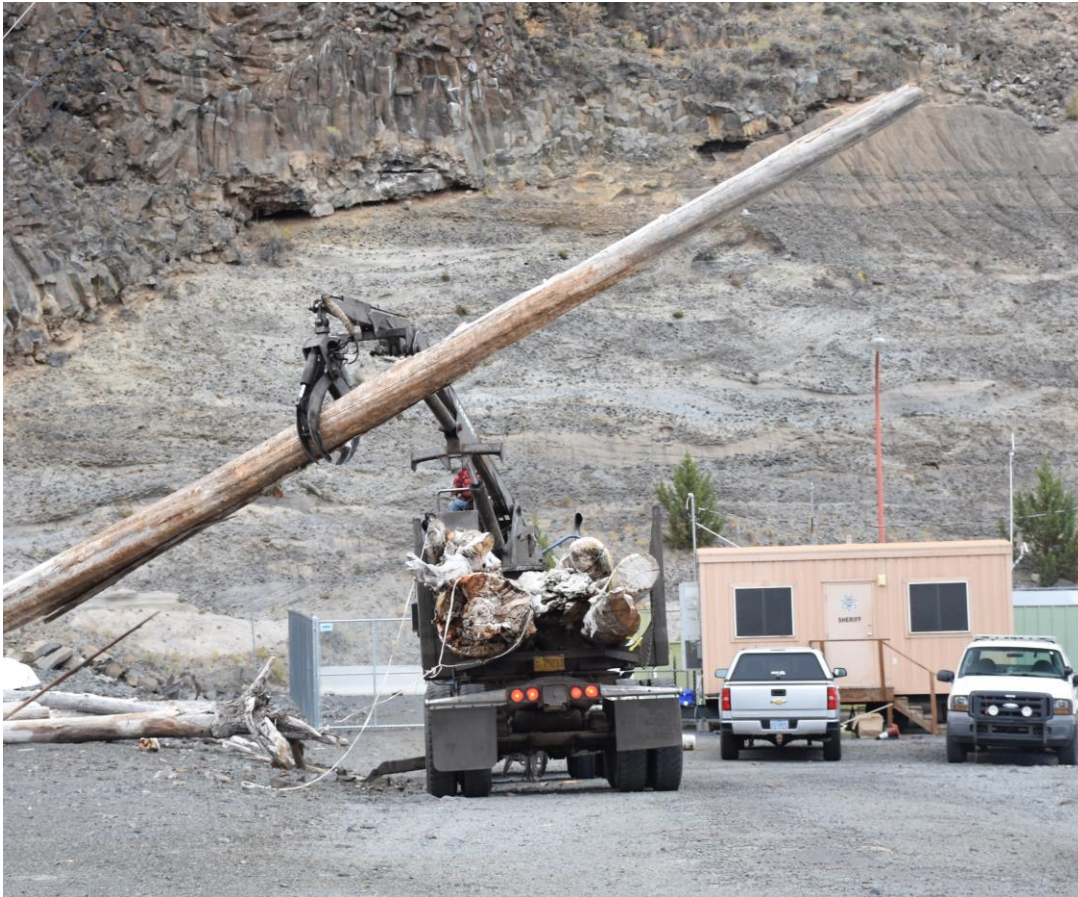
- Free floating LWD is removed from Lake Billy Chinook (LBC) on a yearly basis.
- To meet LWD criteria a log must be a minimum of 8" diameter and a minimum of 10 feet long.

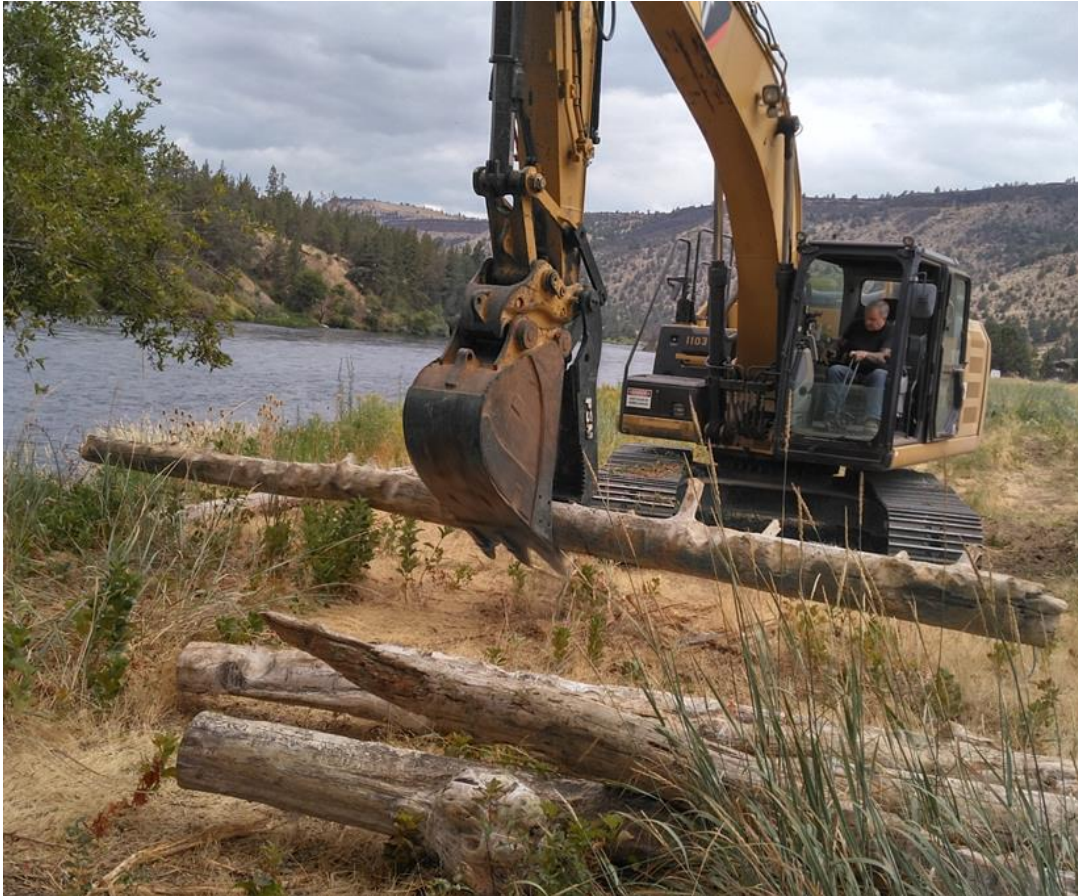
- LWD is placed in the LDR between the Reregulating Dam and the Warm Springs (Hwy 26.) bridge
- LWD placed in the LDR is not anchored, buried or otherwise secured and is placed in a manner that resembles natural recruitment.
- This method of placement allows for logs transport downstream to enhance a new spot along the river.

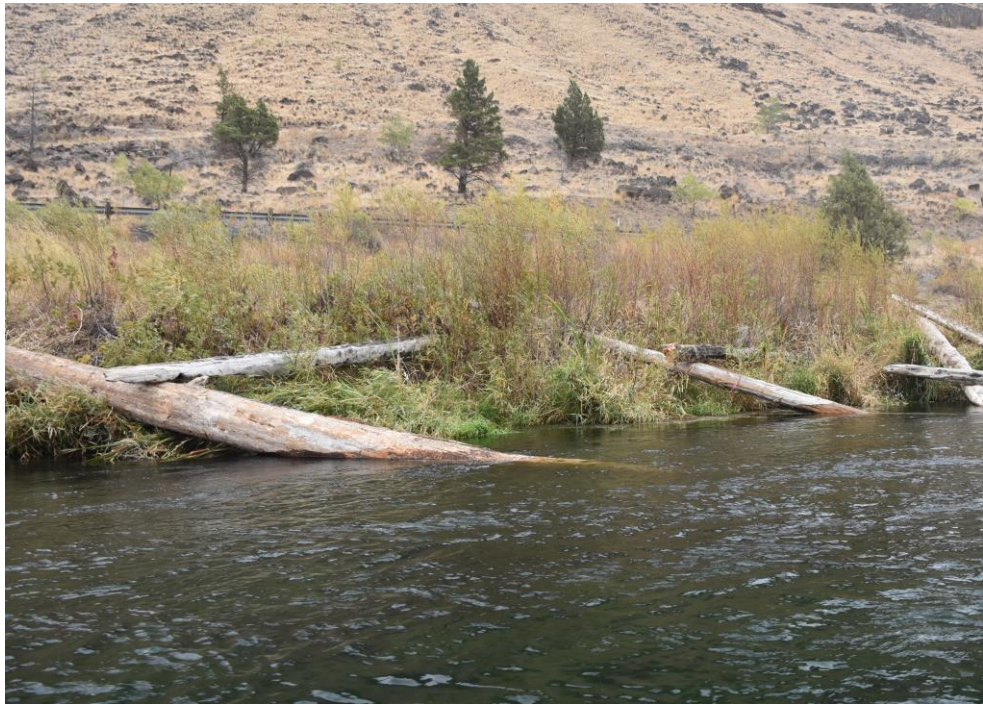
Year	Number of logs
2019	36
2020	33
2021	-
2022	26
2023	23
2024	22
<b>Total</b>	<b>140</b>

- There have been a total of 451 logs placed since 2007
- Large wood placement has affected 11.8% of the LDR shoreline from the Reregulating Dam to the Warm Springs bridge.

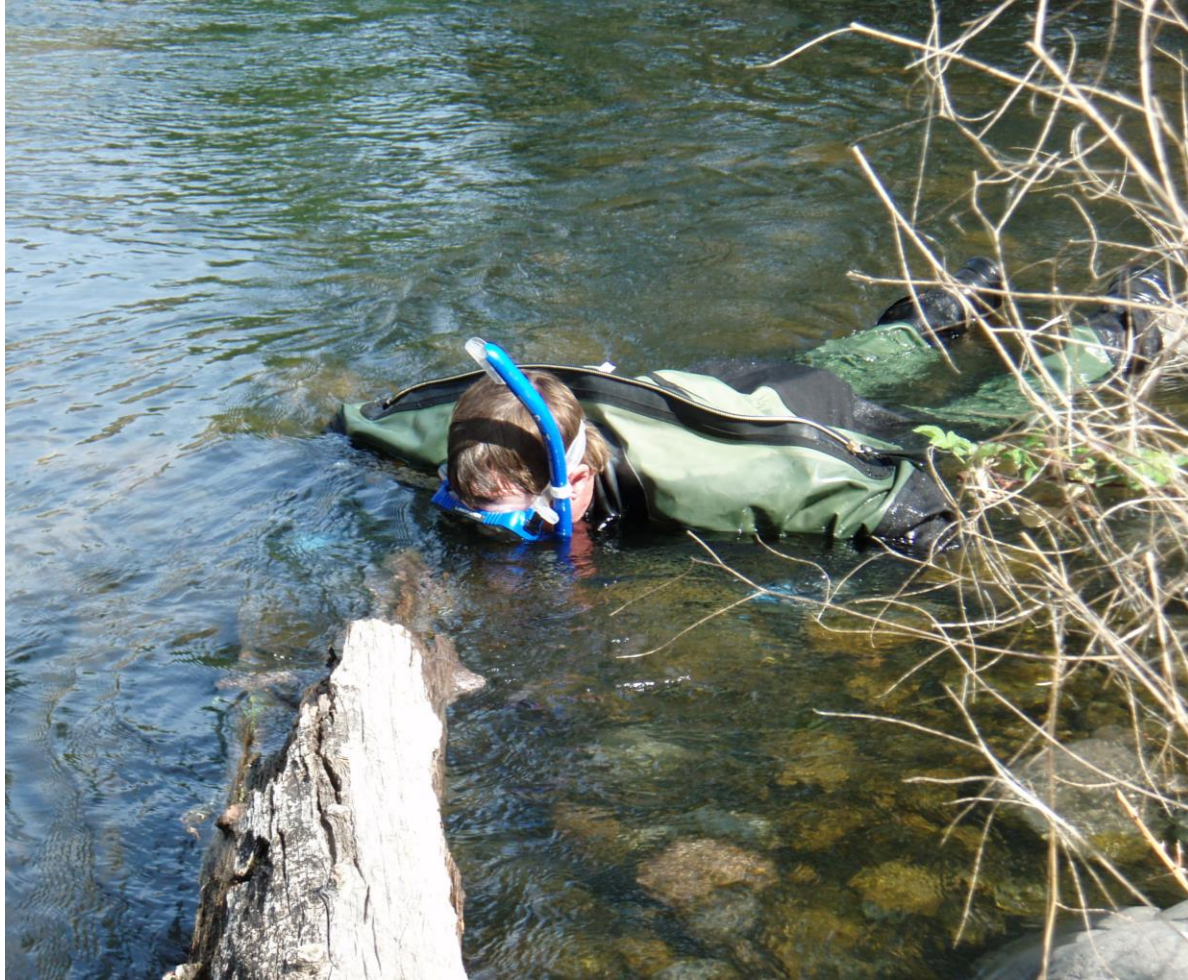
- In the LDR large wood enhances riparian habitat, mostly by creating current refuge and structure, resulting in an improvement in juvenile rearing habitat.
- Many large wood placement sites are directly associated with spawning habitat or directly downstream of spawning habitat.
- Placement locations near good spawning habitat give fry emerging from gravel quick access to rearing habitat.

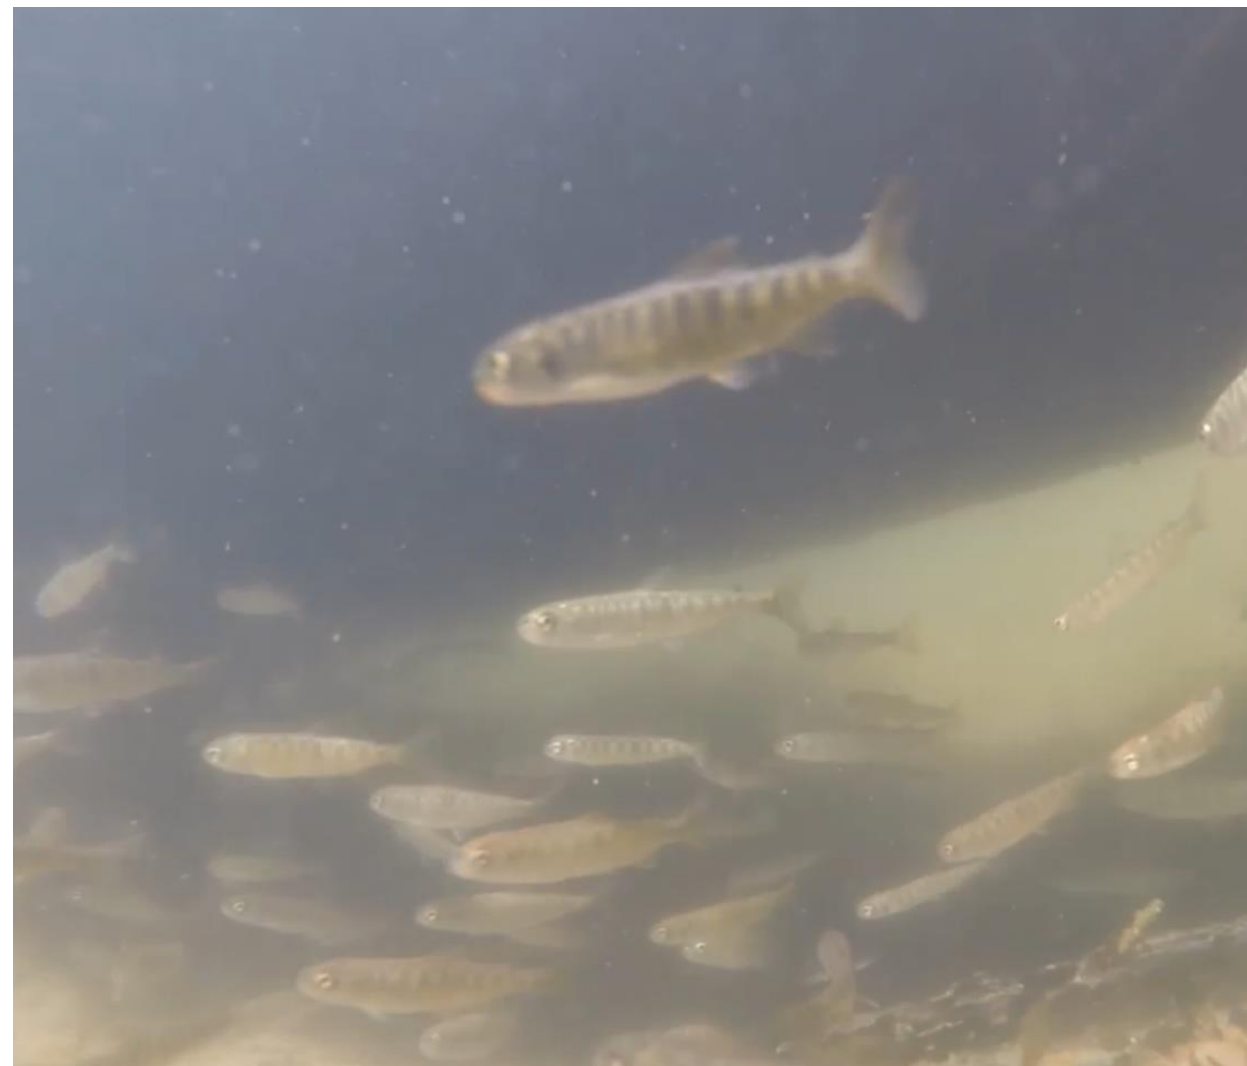
Fry Using Placed Large Wood

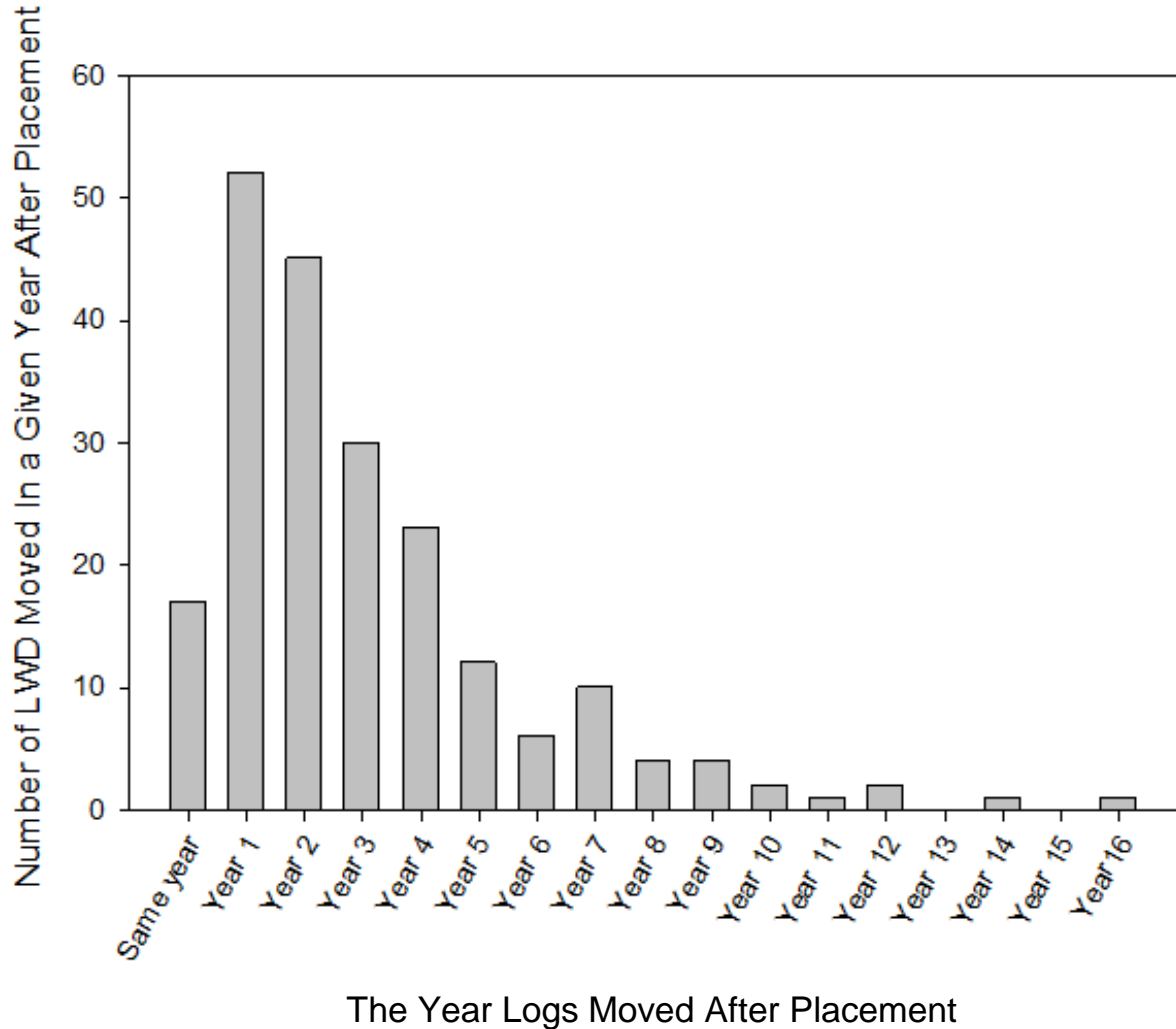
- 125 pieces of LWD have stayed where they were placed during the project.
- 52 LWD pieces moved the first year after placement.
- 43 LWD pieces stayed in place at least five years before their first movement
- 231 LWD pieces either moved without documentation, the log decomposed before movement, or the log was not found during tracking
