Trout Creek Habitat Restoration

Our commitment to the Deschutes Basin

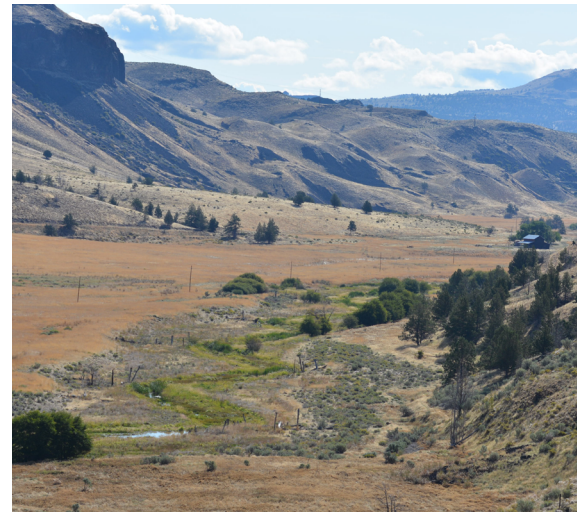
The Trout Creek watershed covers approximately 700 square miles.

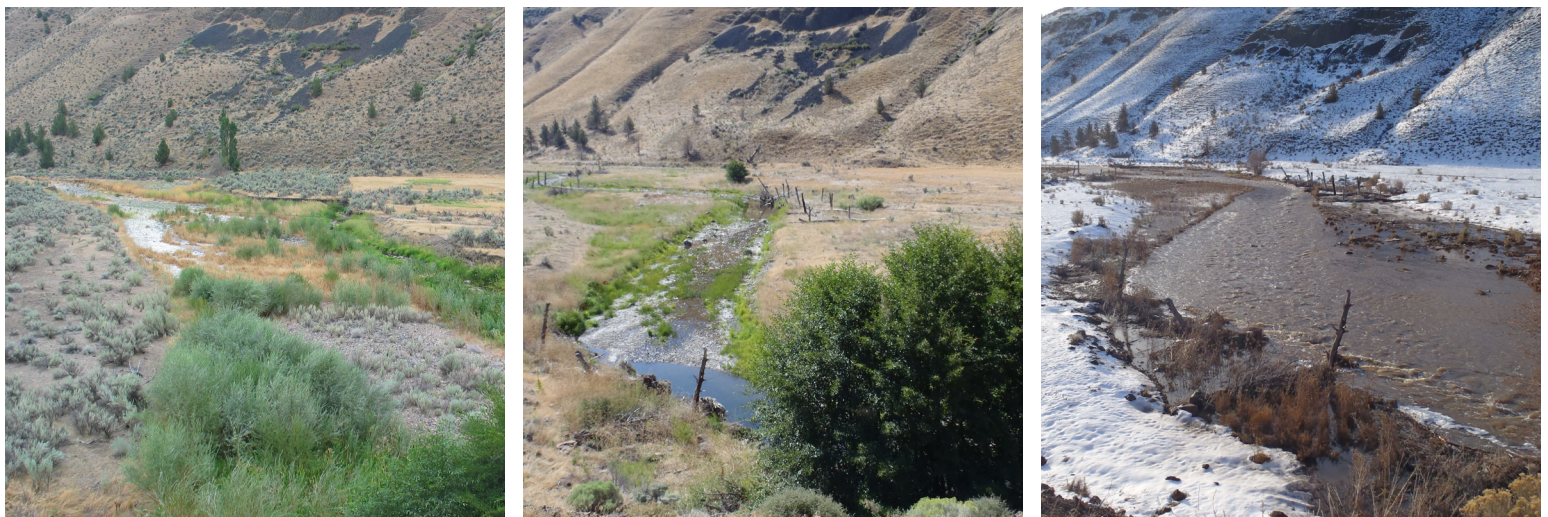
Before restoration (left): the Trout Creek channel banks were incised and easily eroded. After restoration (center and right): the project restored a meandering channel with wide floodplains and opportunities for riparian growth.

Gravel and cobble from the levees was removed and used to shape a new meandering stream channel, with alternating pools and riffles. Root wads and boulders were placed to stabilize the new streambanks. Excess material was excavated and reshaped to create a gently sloping floodplain. After construction was complete, we planted 25,000 native trees, shrubs and sedges along the banks, and seeded the floodplain with native grasses and forbs.

There have been several high flow events since project construction, during which water overflowed the channel and spread across the floodplain, depositing fine sediment that supports the growth of vegetative cover. Today, vegetation is growing around and into the channel, and the stream is becoming narrower. Steelhead now regularly spawn in the project area. However, during summer droughts, low flows are still a problem, resulting in standing water too warm for juvenile fish. Steelhead fry that hatch in the springtime move downstream to the Deschutes River to grow for one to two years before migrating to sea. After a few years of ocean growth, the steelhead mature and return to spawn in Trout Creek.
