**Heckington Fen Wind Farm  
S36 Variation Application  
by  
Ecotricity**

**up to 22 Wind Turbines with a increased rotor diameter  
of up to 103 m whilst retaining consented tip height of 125 m**

## **REPORT APPENDIX A**

**Background Noise Surveys (BNS)**

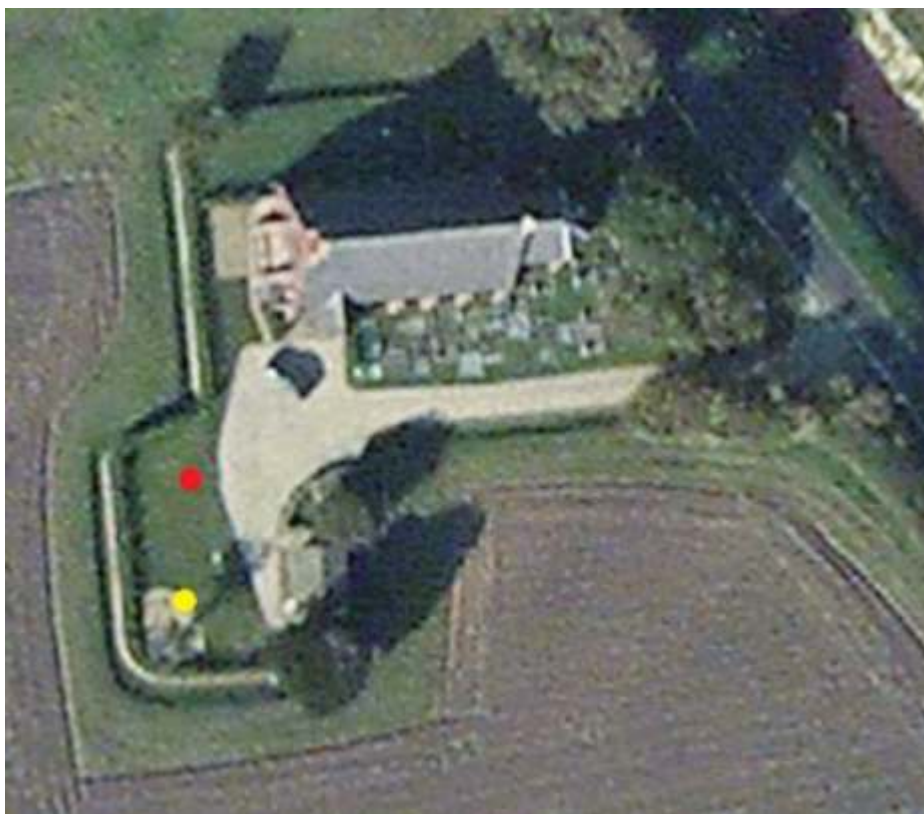
NIA Figure 7: Yellow dot shows applicant's microphone position at The Old Church. Red dot shows quieter alternative.

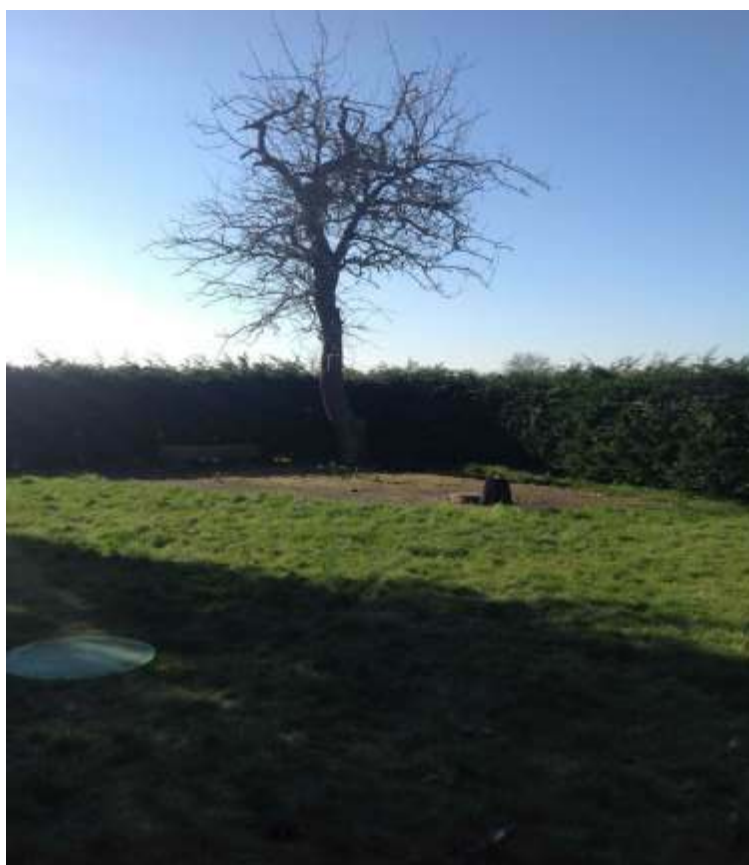
1.1 The Old Church Photo taken looking south west at BNS location. Photos C1-C4 taken March 2011 Leylandi hedging at that time recently planted.

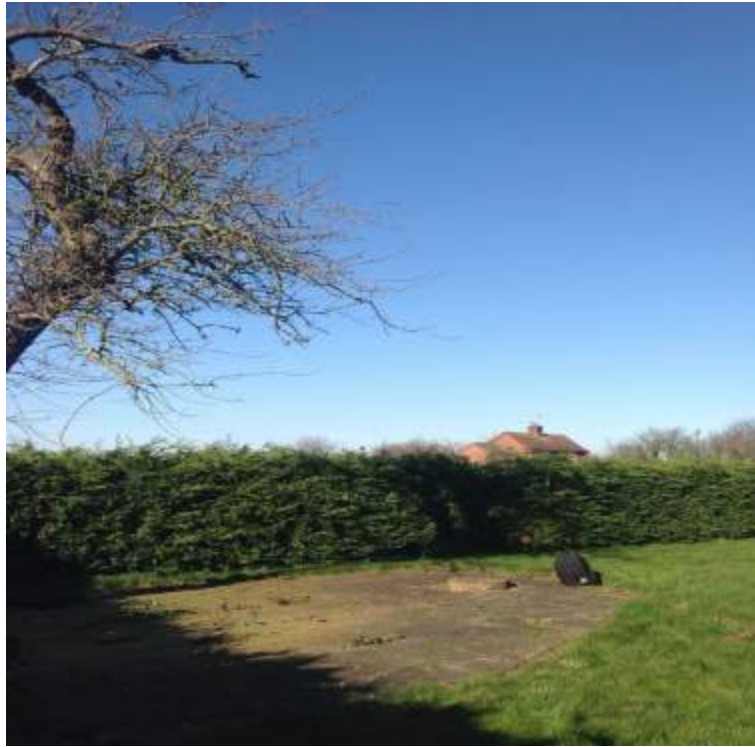
### 1.2 The Old Church BNS Location.

Looking North West further away from the comparable BNS location Figure C2.  
Note over hanging branches of the Pear Tree reducing separation distance from the monitoring equipment approximate position identified by bag.

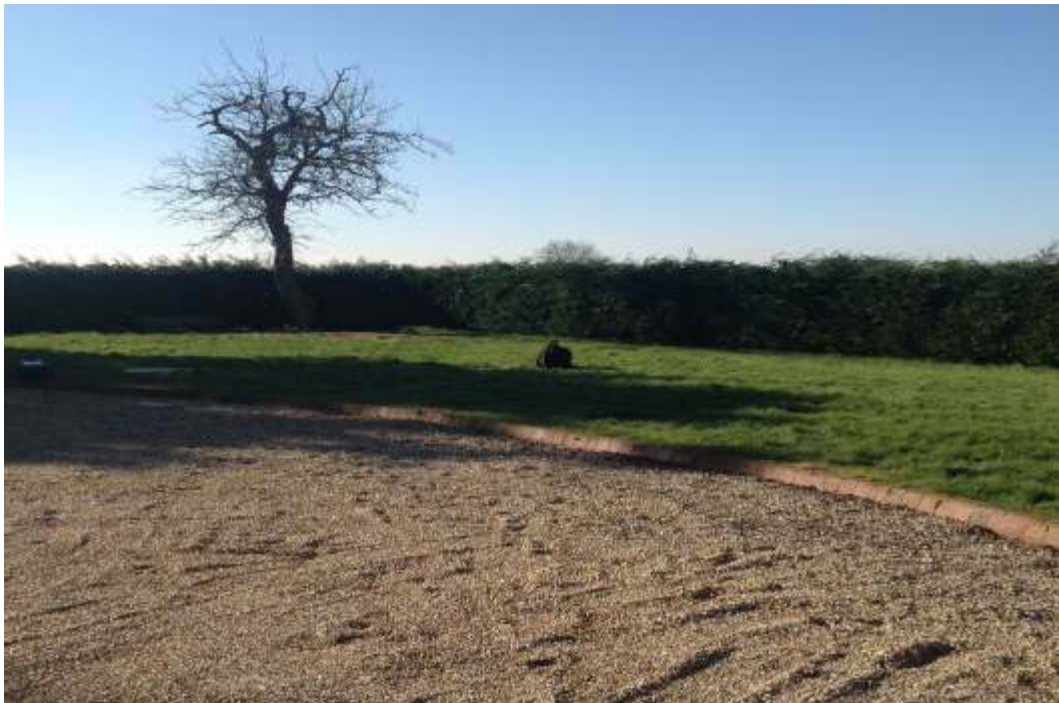
### 1.3 The Old Church BNS Location Looking South West.

Suggested correct location for Noise monitoring equipment. See Figure 7 Aerial map yellow spot is further away from over hanging branches of the Pear Tree and on soft ground (grass) not hard ground (paved area). Note separation distance from border hedging increased.

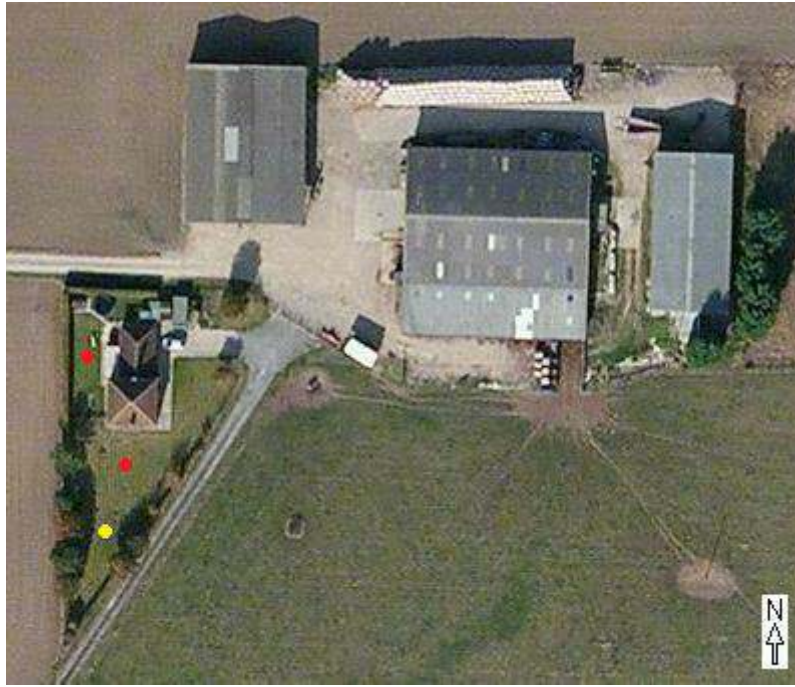
**NIA Figure 8: yellow dot shows applicant's microphone position at College Farm.  
Red dots show quieter alternatives.**

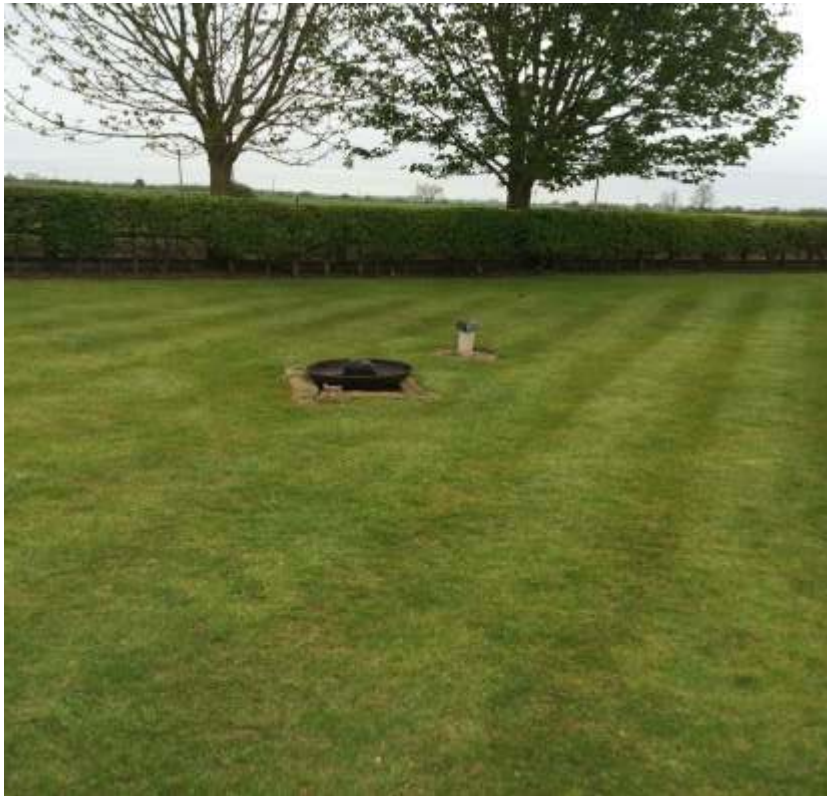
2.2 College Farm BNS CF2.

Looking South East. Note the main access drive to the farm is other side of lawn boundary hedge.

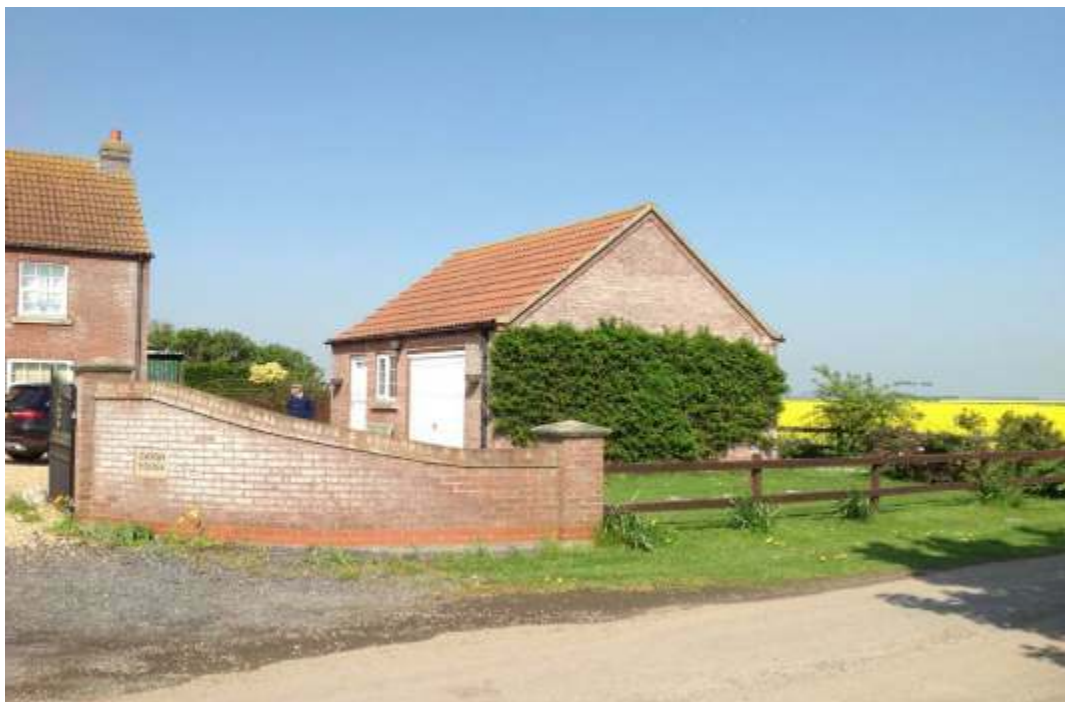
Figure 9: Caton House, omitted from ANIA1. Page 23 NIA Appraisal..

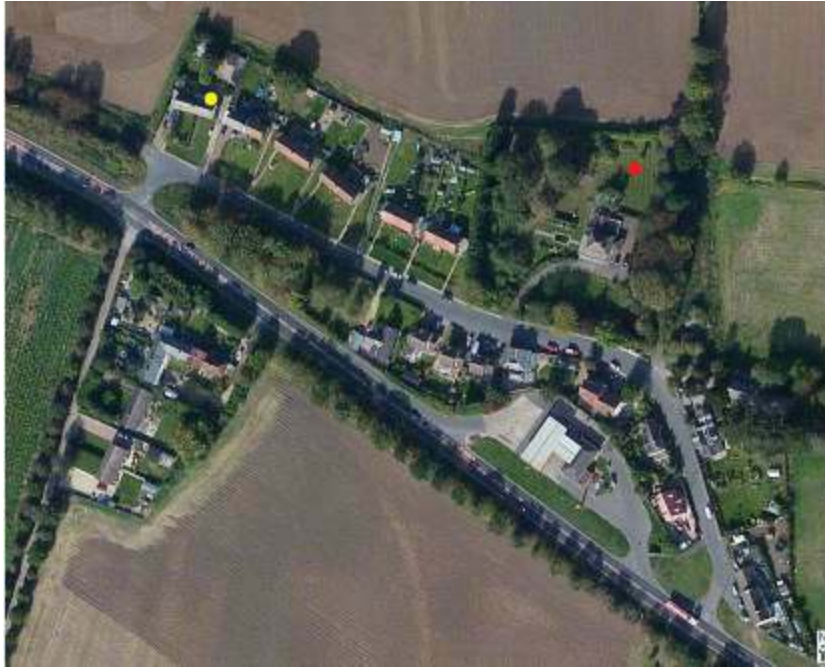
NIA Figure10:•East•Heckington•village•showing• applicant's•non-compliant microphone position at 2 Council Houses and proposed compliant position at Ashleigh House.

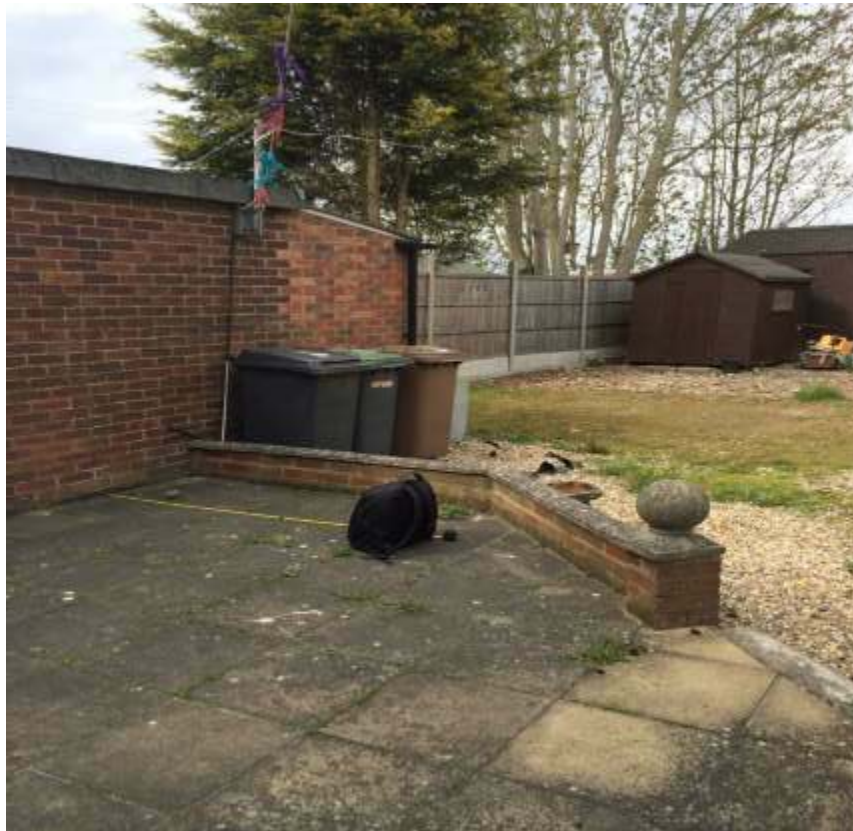
#### 3.1 No 2 The Council Houses BNS Location

The washing line with clothes pegs attached is close to NML. Tape measure confirms precise distance from the nearest wall.

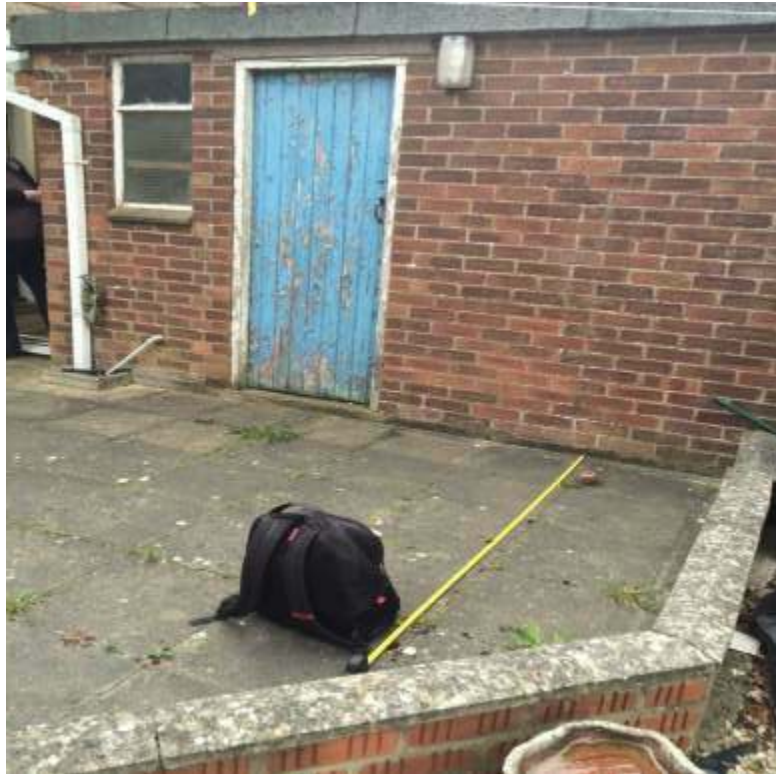
3.2 No 2 The Council Houses BNS Location.  
Tape Measure confirms distance from nearest wall.

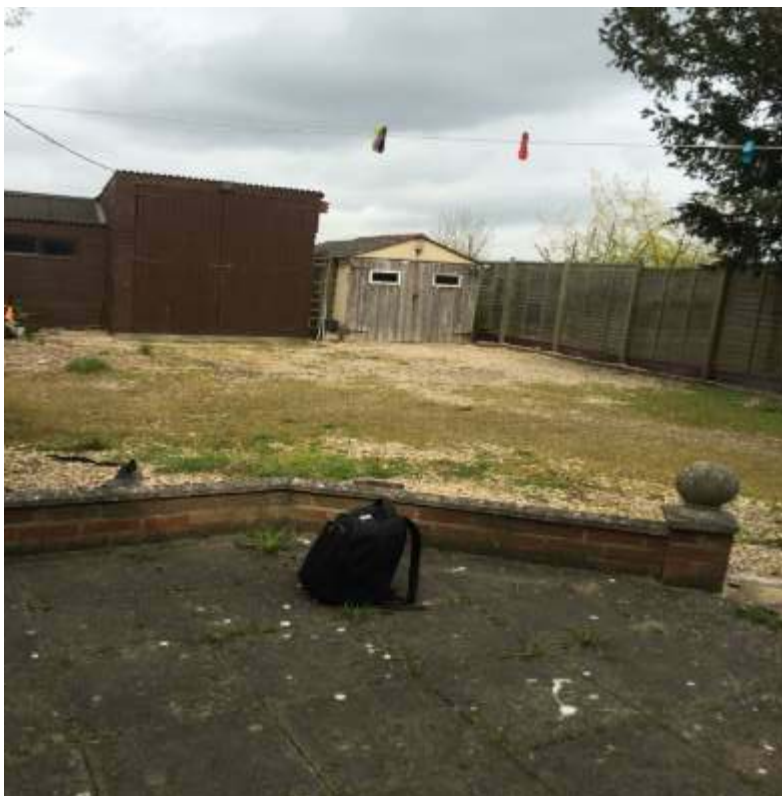
3.3 No 2 The Council Houses BNS location. Looking North East.  
Washing line in close proximity to noise monitoring equipment. (Equivalent BNS photo C12).

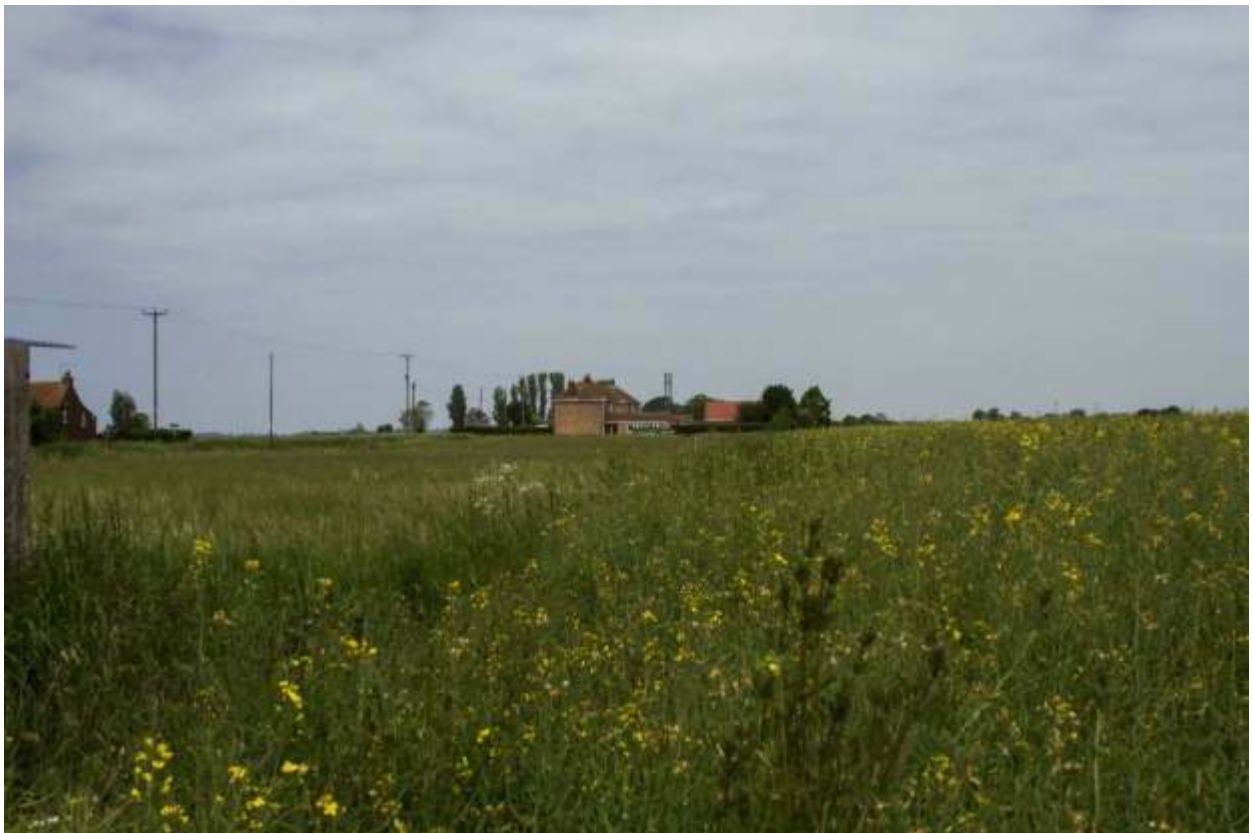
4.2 Actual View of the noise monitoring location from Fig C15 Looking North Hoare Lea chose to ignore.

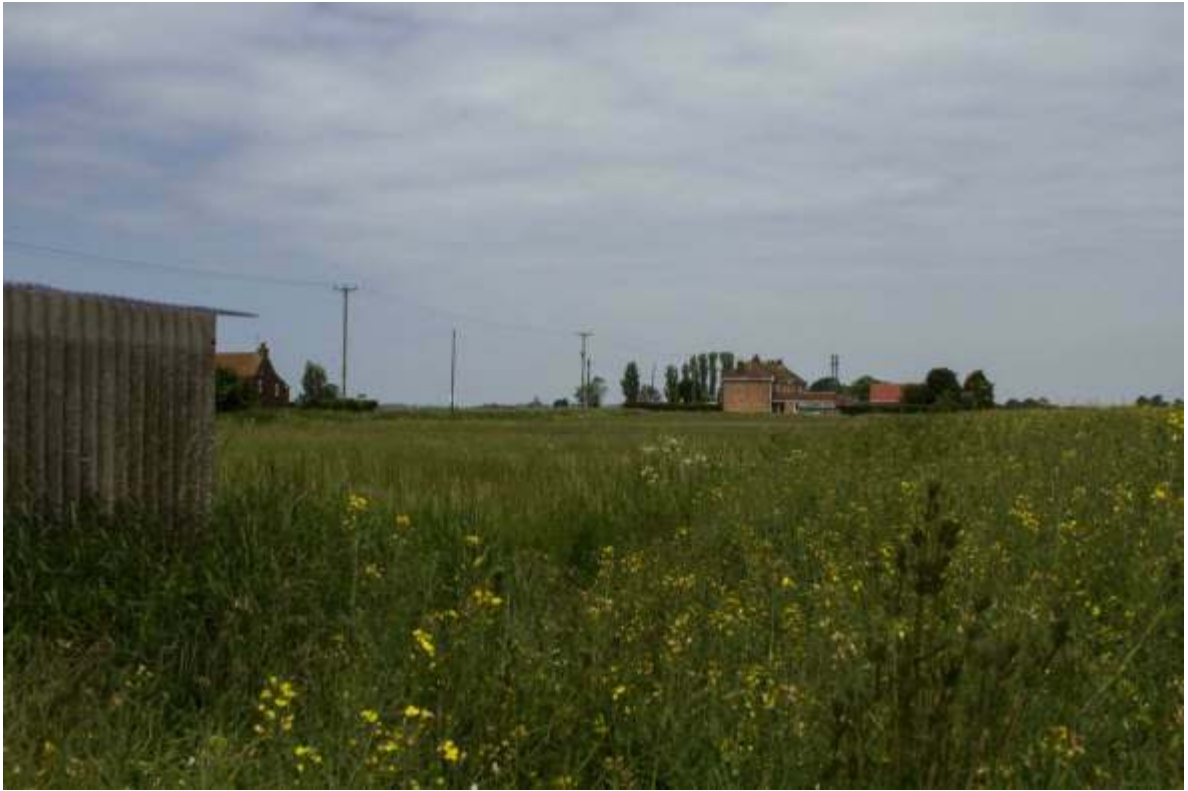
4.3 Figure C15 Wider angle of the view at noise monitoring location looking North HL chose to ignore.

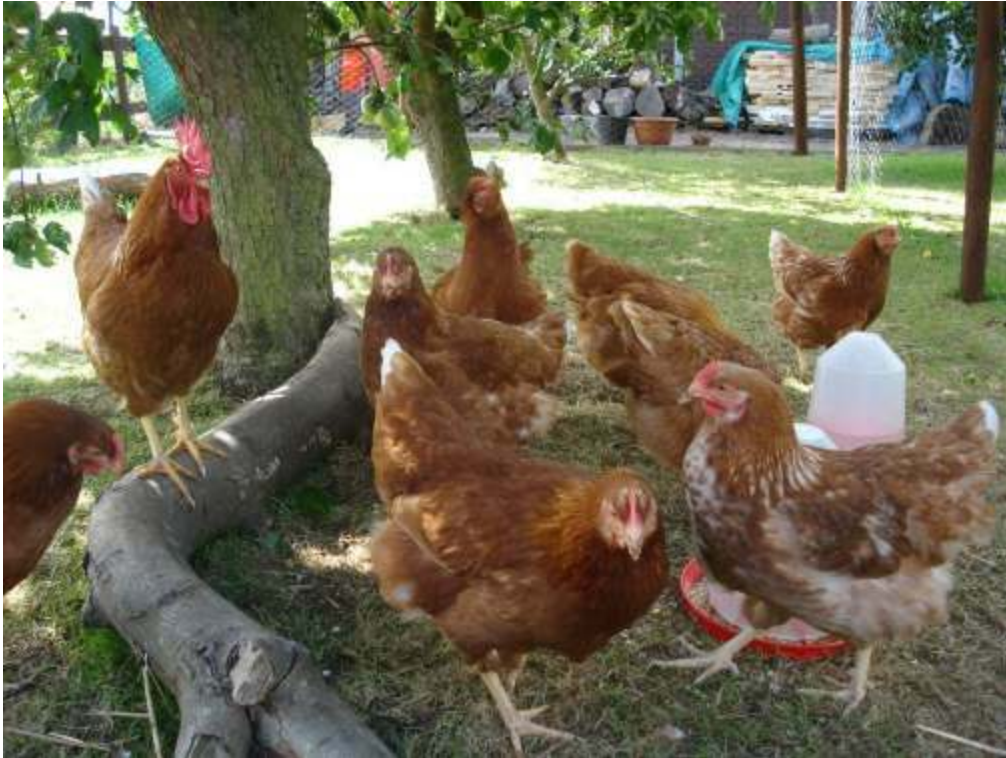
4.5 Derwent Cottage Photo taken of part of the flock of Chickens within the rear grounds of Derwent Cottage adjacent to the equipment during the BNS Side Bar Lane PROXY March/April 2011.

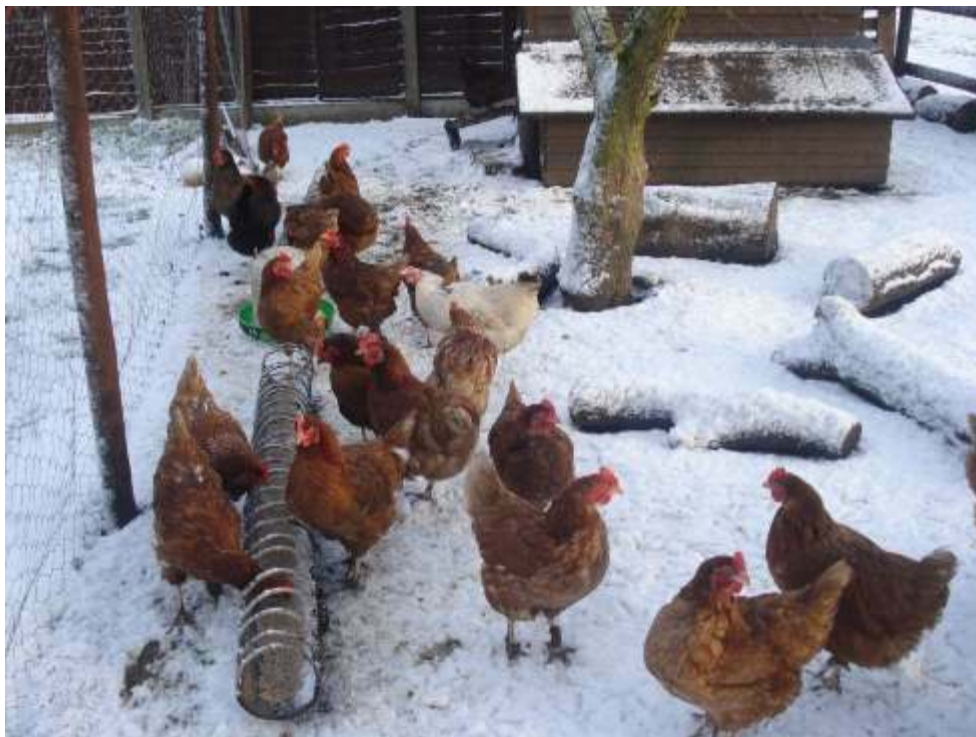
4.6 Derwent Cottage Photo taken of part of the flock of Chickens and one of the cockerels within the rear grounds of Derwent Cottage present during the BNS Location Side Bar Lane March/April 2011.

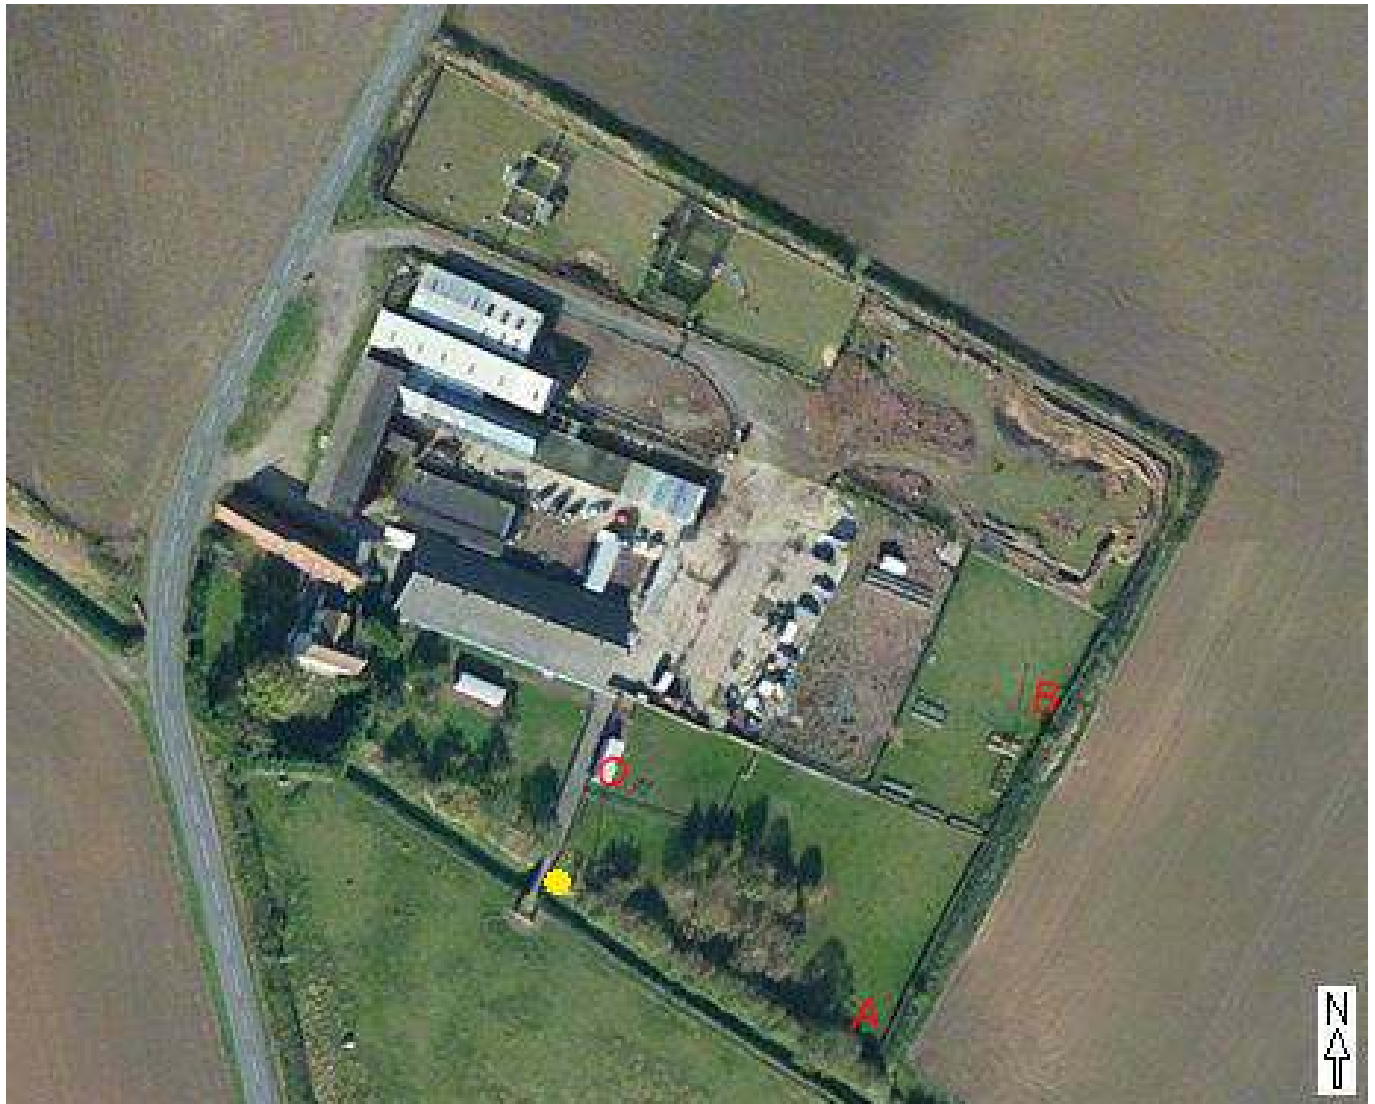
NIA Figure 14 Glebe Farm. A. marks the position of one microphone and B. the position of the second microphone. O. marks the position claimed by the applicant and the yellow spot marks the grid reference provided by the applicant.

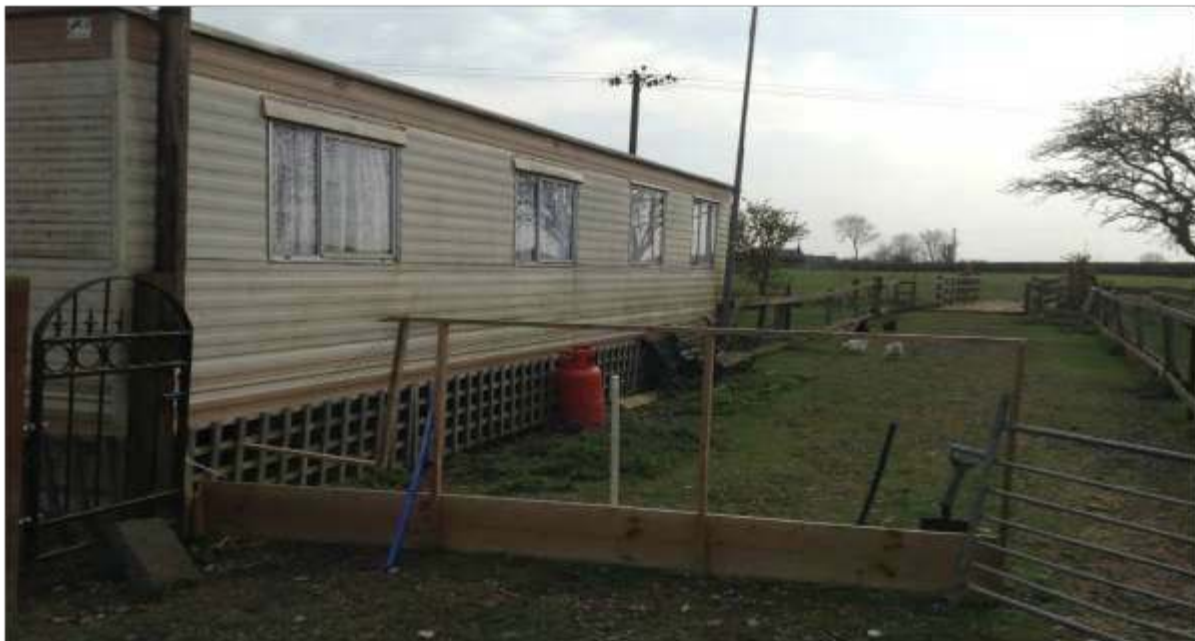
5.1 Reference Glebe Farm Hoare Lea BNS Location Fig C17 March 2011.

Now a static caravan at this location which was not in situ March 2011. BNS original position C17/GFA1 taken to the west of the monitoring location, looking south on the access track between the two paddocks.

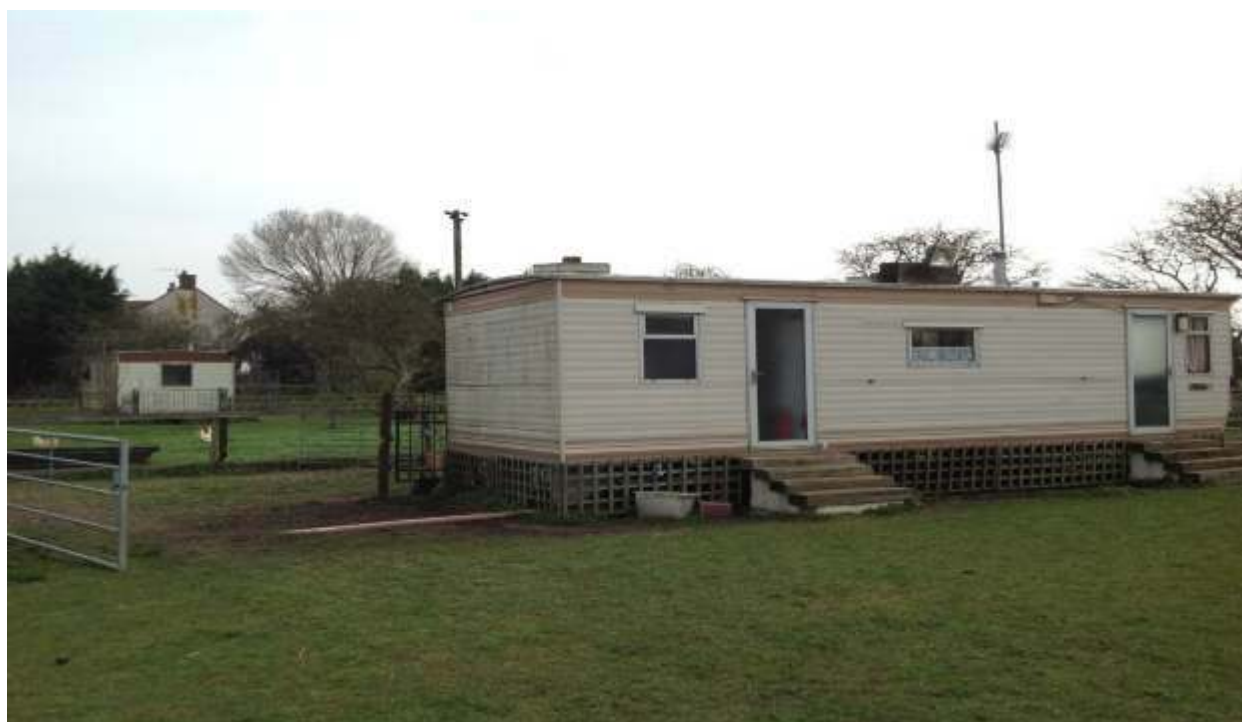
5.2 Reference Glebe Farm Hoare Lea BNS Location Fig C17 March 2011.

Now a static caravan at this location which was not in situ March 2011. Fig BNS original position C17/GFA2 taken to the east of the monitoring location looking west in the paddock where monitoring equipment was purported to have been placed in Figs C17, C18, C19 & C20. Note static caravan in Fig C17 still in situ.

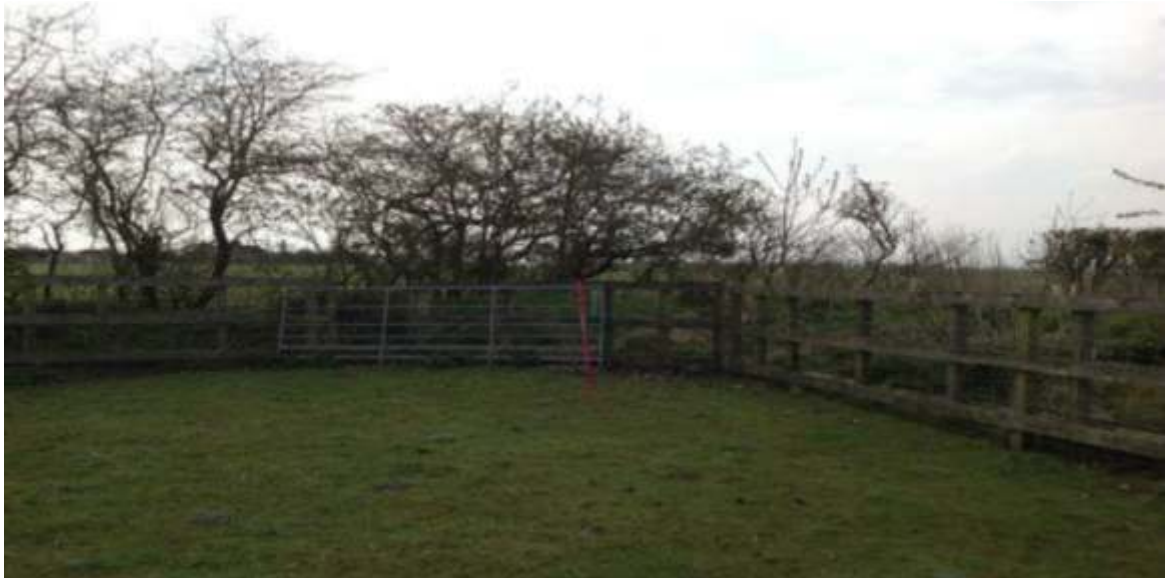
5.3. BNS GFA1 Actual Location A denoted by (Pitch Fork) within paddock looking South East.  
Photo taken April 2016.

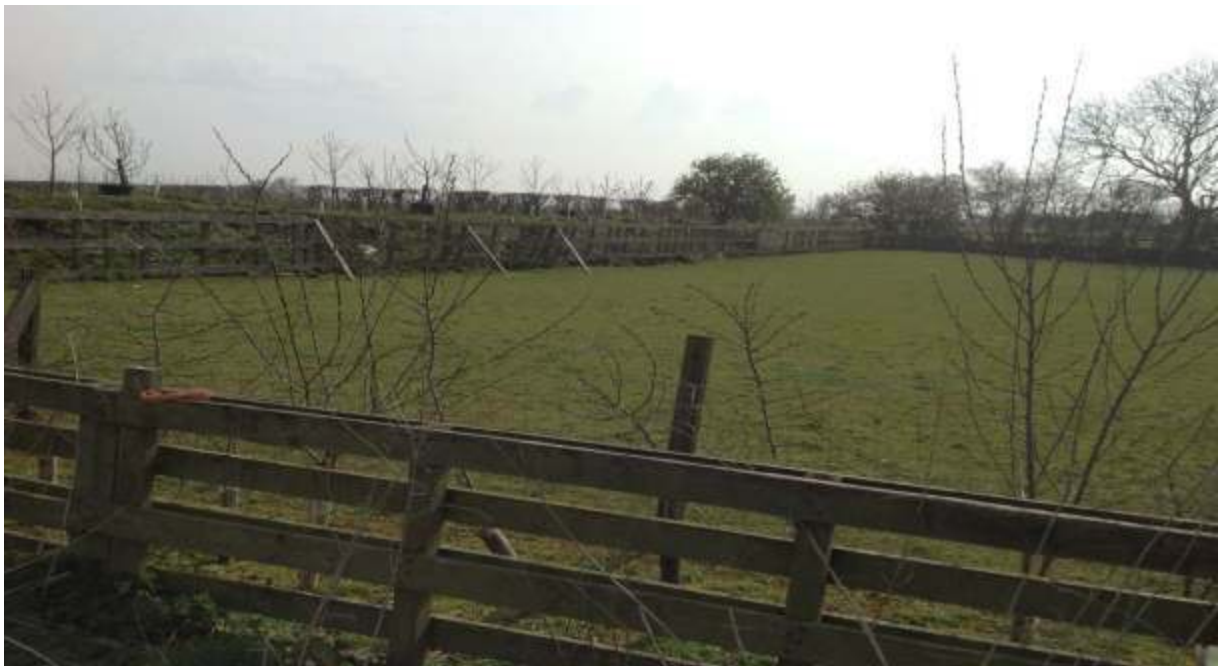
5.5 BNS GFA3 Outside of Paddock looking south towards the corner of paddock where BNS was located.  
Note the raised bank running alongside the other side of the paddock fence  
on paddock's eastern boundary.

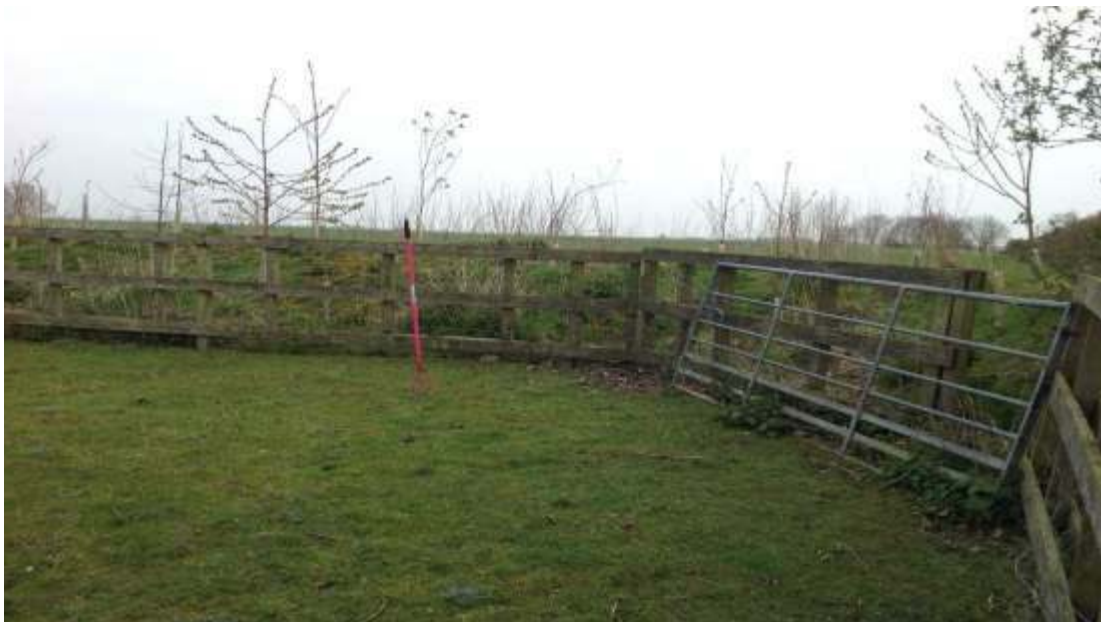
5.6 BNS GFA4 within paddock looking east towards wind farm site.  
Note raised bank other side of paddock fence.  
Digger was in use around this area at the time of monitoring.

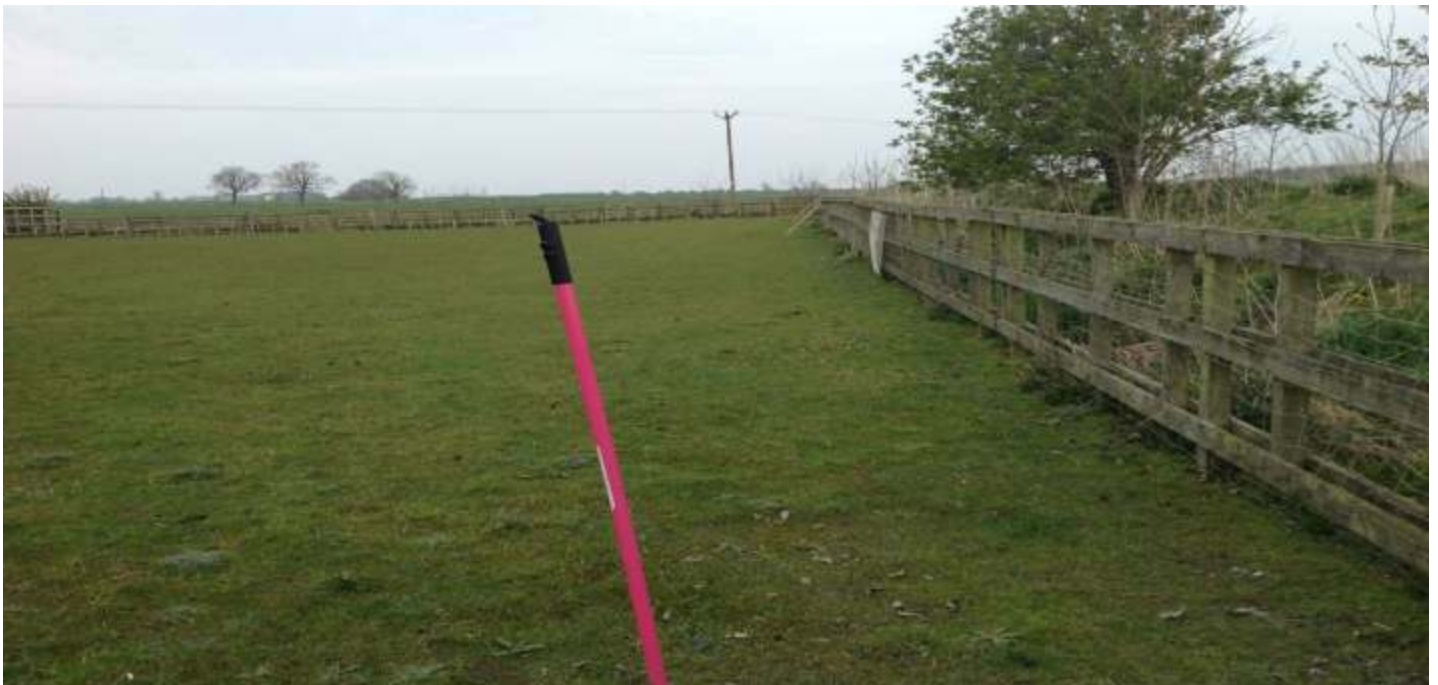
5.8 BNS GFA6 Looking North towards BNS Location B. other side of paddock fence located near to Electrical Power Transmission Pole visible in the photo.

(The northern paddock boundary fence is the View Point position of photos GFA2 & GFA3).  
The monitoring position is less than 3.5m from boundary fence.

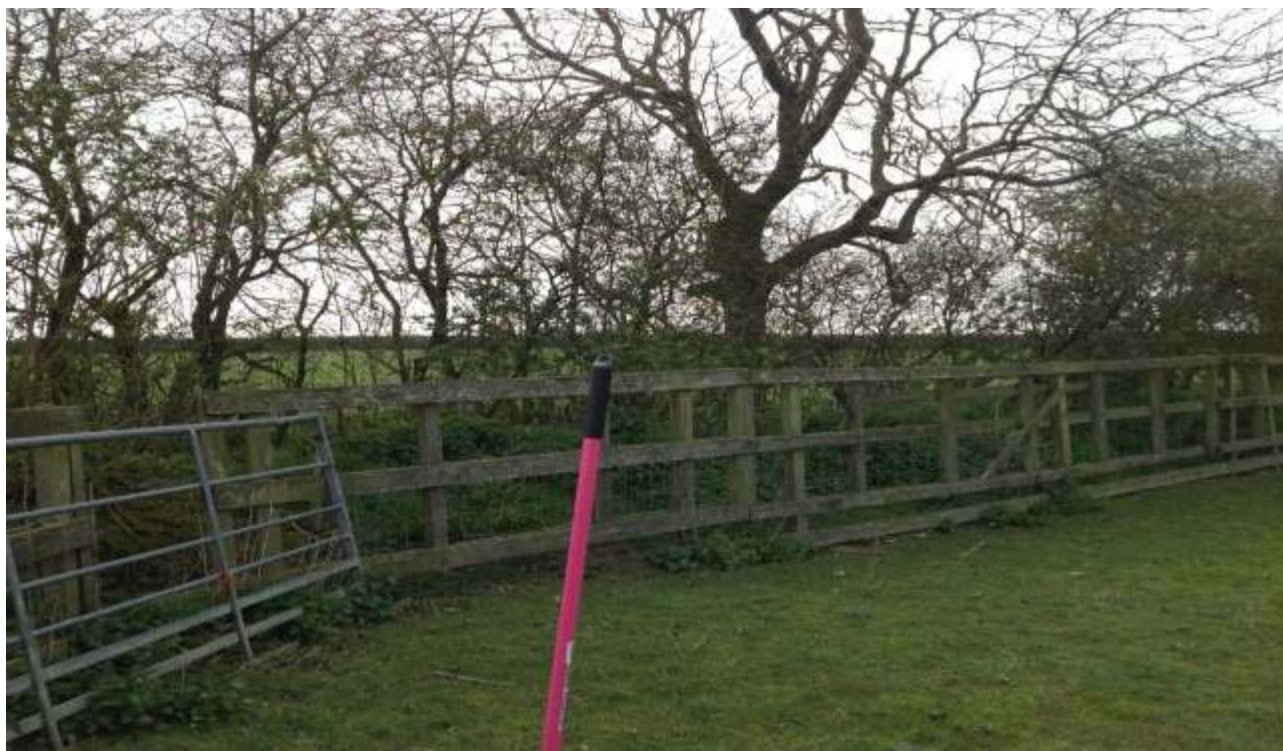
5.9 BNS GFA7. Looking south west.  
(Monitor was less than 3.5m from foliage in photo on the other side of boundary fence)

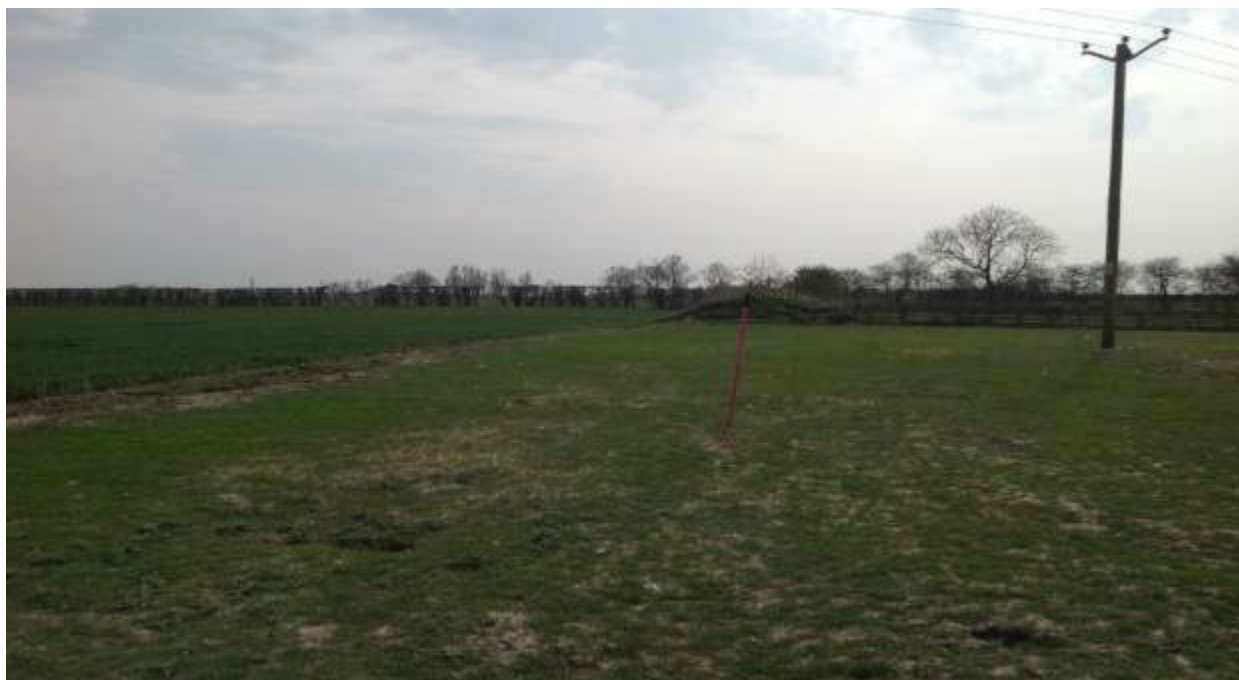
5.10 Glebe Farm BNS Location B Photo GFB1. Looking towards the south and in the same direction of BNS Location A positioned within the paddock adjacent to the mound visible in the photo.

Note the end of the mound is also visible cut away in this view.

This linear mound originally marked the full length of the eastern & Northern boundary of Glebe Farm at the time of the monitoring during March/April 2011. The mound around the whole area was being levelled by resident throughout the monitoring period using a mechanical digger. See Para 5.7.2 NIA Appraisal.

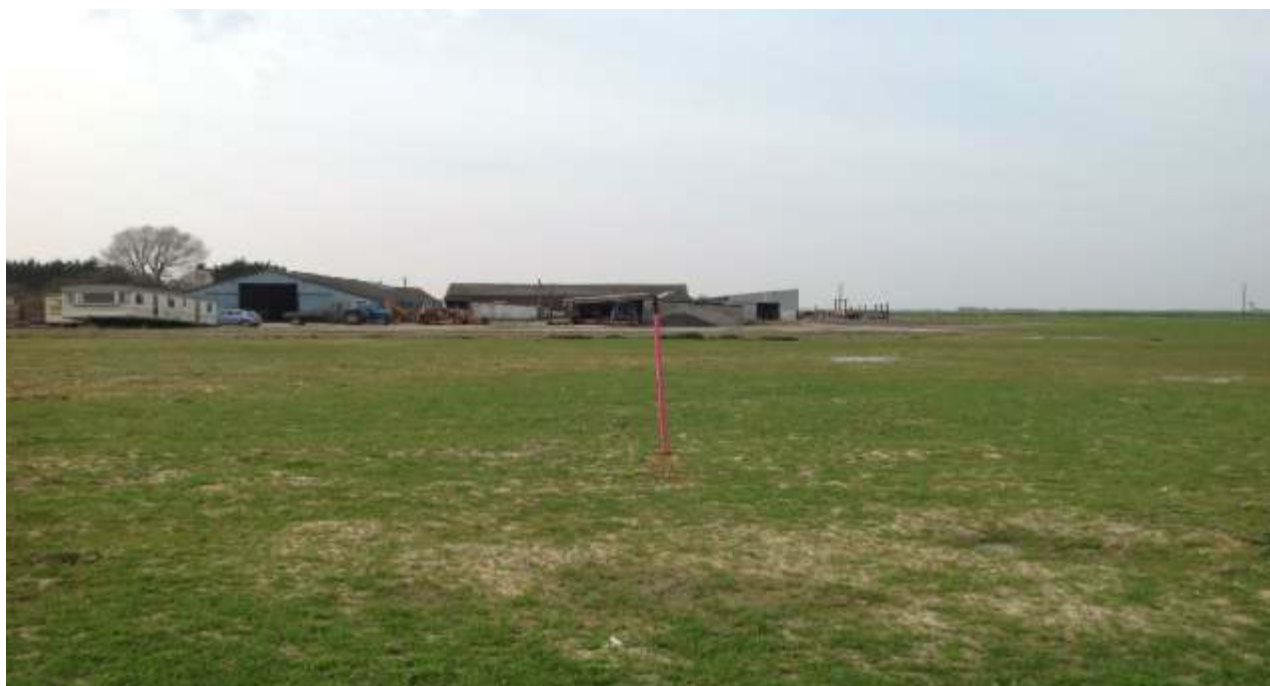
5.11 Glebe Farm BNS Location B Photo GFB2.

Looking due west and over the area which was being levelled during the entire noise monitoring period.

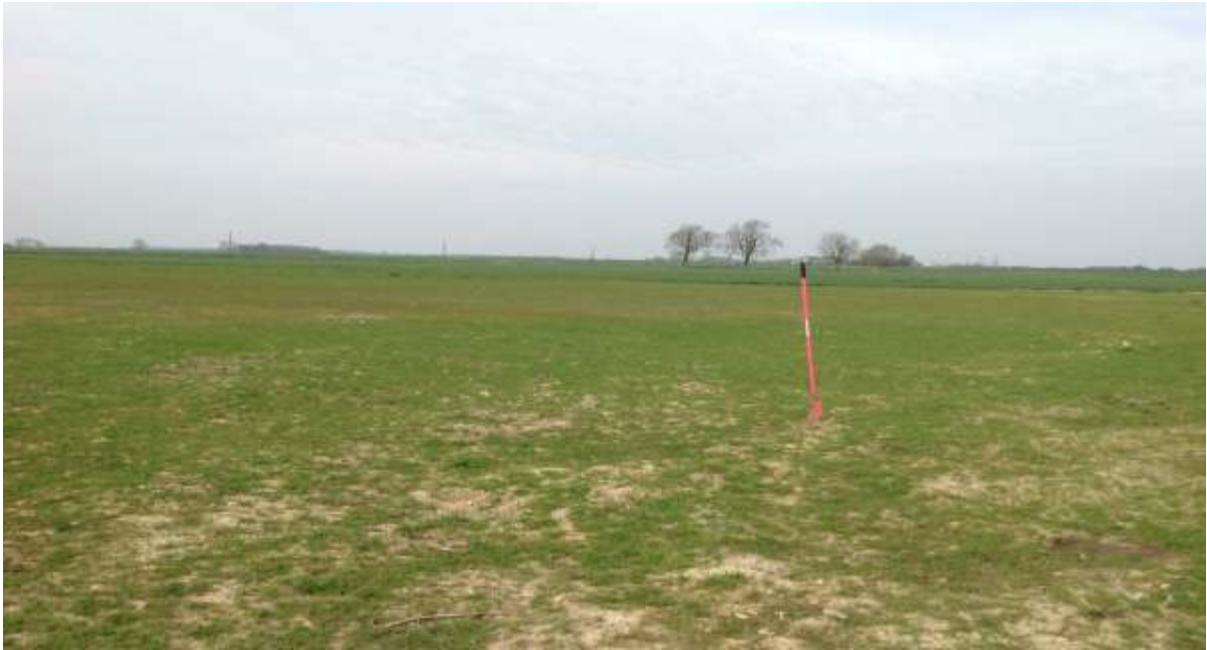
5.12 Glebe Farm BNS GFB3. Looking North East towards wind farm site.

Note the extent of the ground levelling undertaken along this eastern boundary of Glebe Farm visible in the photo at the time of the BNS. Aerial View Fig 14 shows the length of the boundary mound in view.

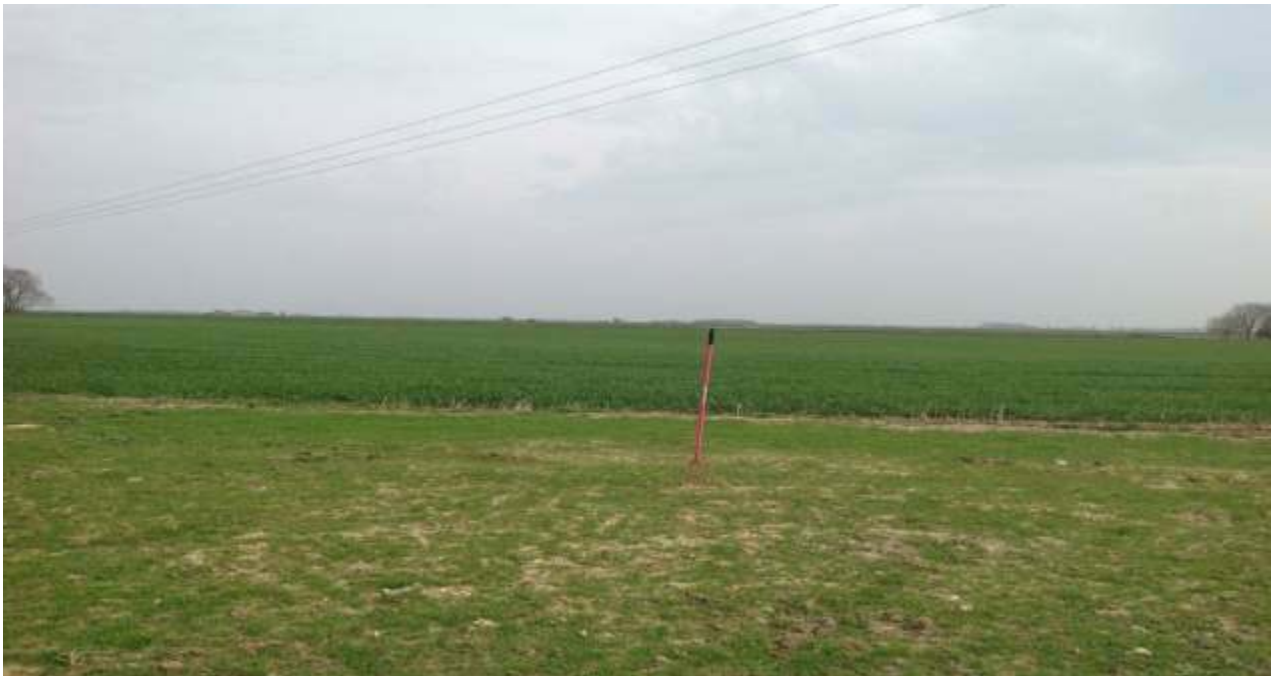
5.13 Glebe Farm BNS GFB4. Looking due east towards wind farm site.

Note the land surrounding the monitoring position is level to up to the adjacent field boundary.
