**Heckington Fen Wind Farm  
S36 Variation Application  
by  
Ecotricity**

**up to 22 Wind Turbines with a increased rotor diameter  
of up to 103 m whilst retaining consented tip height of 125 m**

## **REPORT APPENDIX A**

**Background Noise Surveys (BNS)**

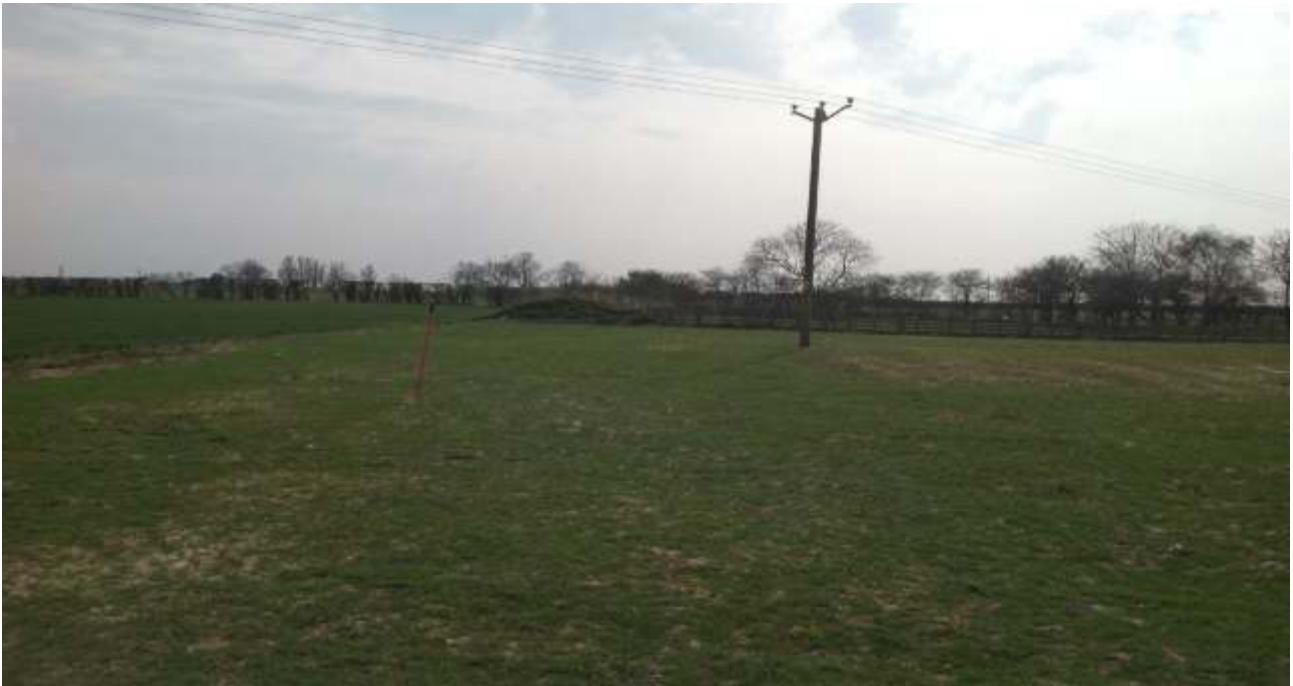
5.14 Glebe Farm BNS GFB5. Looking South East slightly further away from monitoring position than GFB1, to enable distance from the electrical power transmission pole to be cross referenced. Note the position of the remaining bank in line with the adjacent boundary. This angle of view confirms that the BNS location B was in line with the edge of the raised bank at the time of the BNS monitoring.

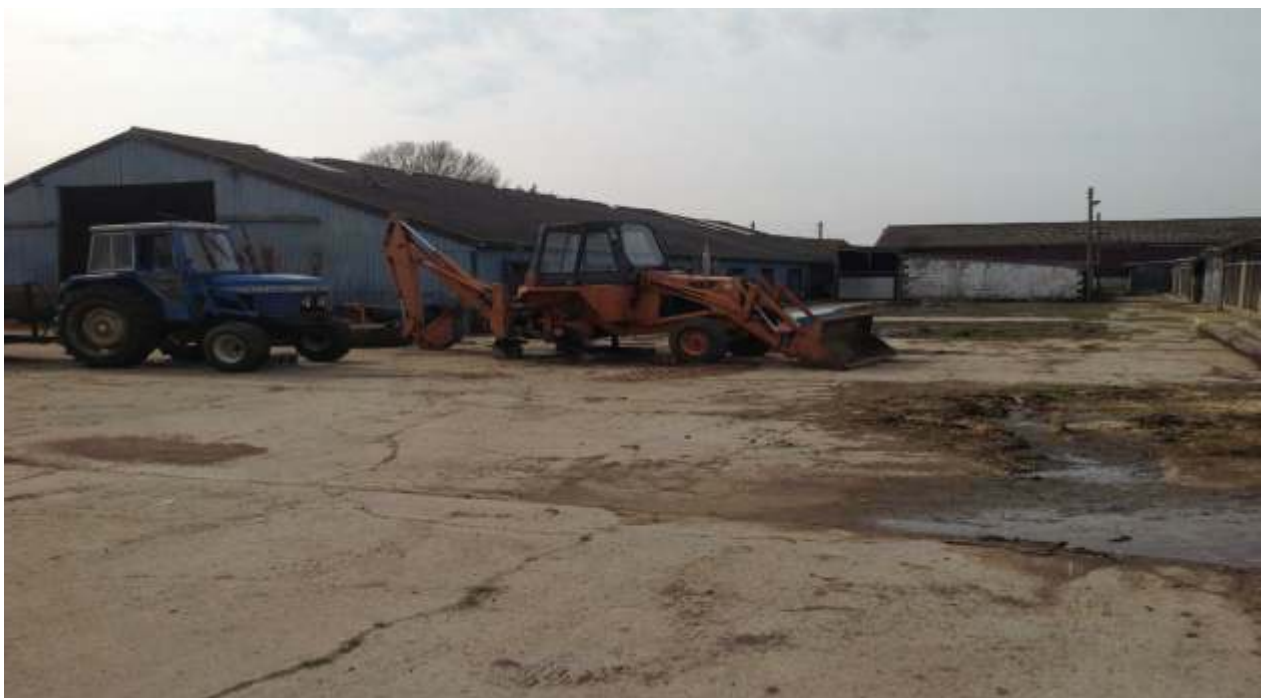
5.16 Glebe Farm GFB6 photo of the mechanical digger resident used to move and spread the soil from the raised bank while BNS monitoring equipment at locations A & B was in situ.
