**REPORT TO THE BOARDS OF DIRECTORS OF CRUISE LLC,
GM CRUISE HOLDINGS LLC, AND GENERAL MOTORS
HOLDINGS LLC REGARDING THE
OCTOBER 2, 2023 ACCIDENT IN SAN FRANCISCO**

January 24, 2024

¹⁰ This information is derived from three sources: (i) a detailed description of the October 2 Accident is set forth in a report by Exponent, titled “Cruise AV SF Incident – Pedestrian Collision (Exponent Project 2310645.000) Technical Root Cause Analysis,” (Dec. 12, 2023) (“Exponent Report”), a redacted copy, to protect confidential business information, is included as the Appendix in this Report; (ii) the San Francisco Police Department’s Traffic Collision Report (“Police Report”) about the Accident, (Oct. 6, 2023); and (iii) various Cruise documents discussing the Accident.

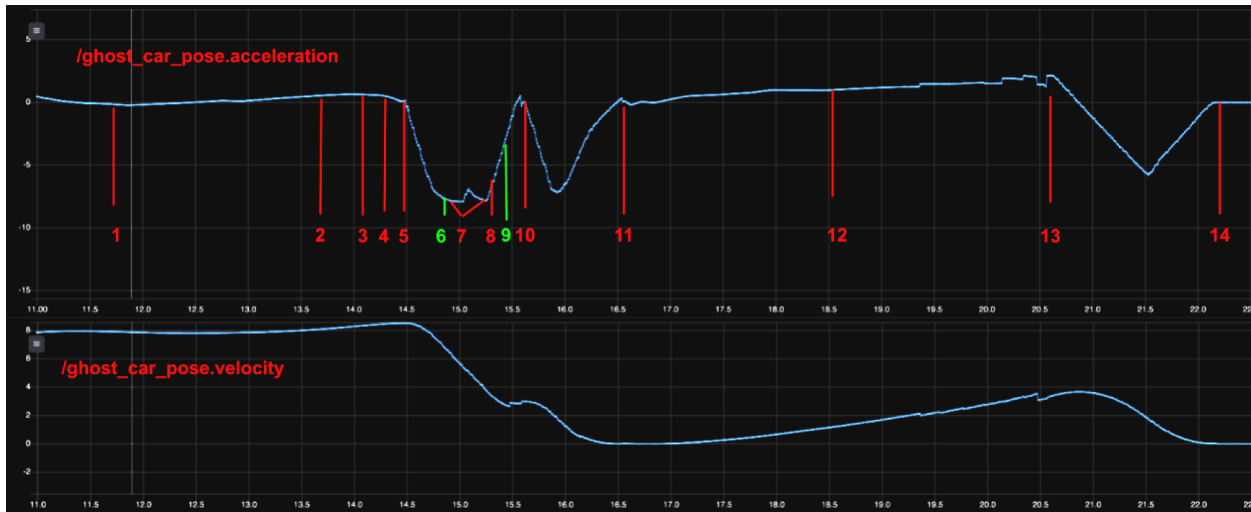
Figure 7: Overview graph of AV's movements created by Engineering team as part of Engineering Analysis into Accident, and presented at the 12:05 and 12:40 p.m. CMT and SLT meetings.

Shortly after noon, Cruise had a second CMT meeting with more than 100 invitees. The engineering and safety teams provided a comprehensive, in-depth review of their analysis, including the detailed graphical chart of the post-collision pullover maneuver, pictured below:

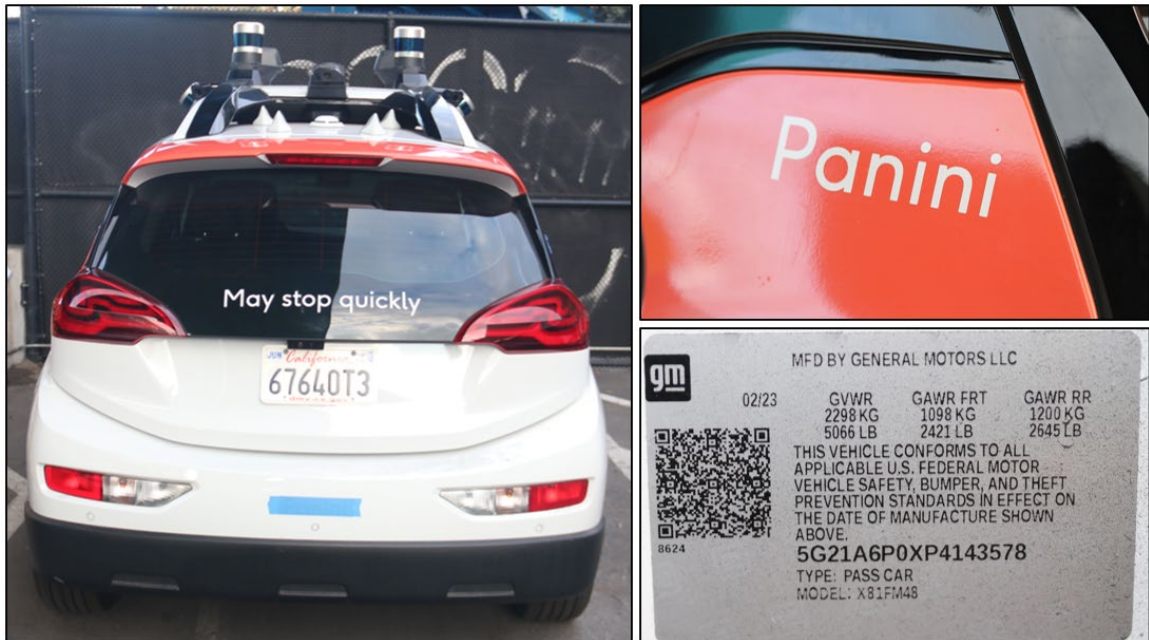
Figure 3. Photographs showing the rear of AV (left), vehicle moniker label on left side C-pillar (top-right), and vehicle VIN sticker (bottom-right).⁵

The Subject Vehicle is a model year 2023 Cruise AV (AV), which is small 4-door hatchback with an electric powertrain and is built on the Chevrolet Bolt electric vehicle (EV) platform. The AV bears the name “Panini”, and the Vehicle Identification Number (VIN) is 5G21A6P0XP4143578. According to the VIN plate, the AV was manufactured in February 2023 (Figure 3). The Cruise Automated Driving System (ADS), with a [REDACTED] hardware version and [REDACTED] software version, was added to the base Bolt EV platform.³ A review of the National Highway Traffic Safety Administration’s (NHTSA’s) recall database showed that the Panini vehicle did not have any unrepaired recalls. At the time of the subject collision, the Bolt had approximately 5,091 miles on the odometer.⁴

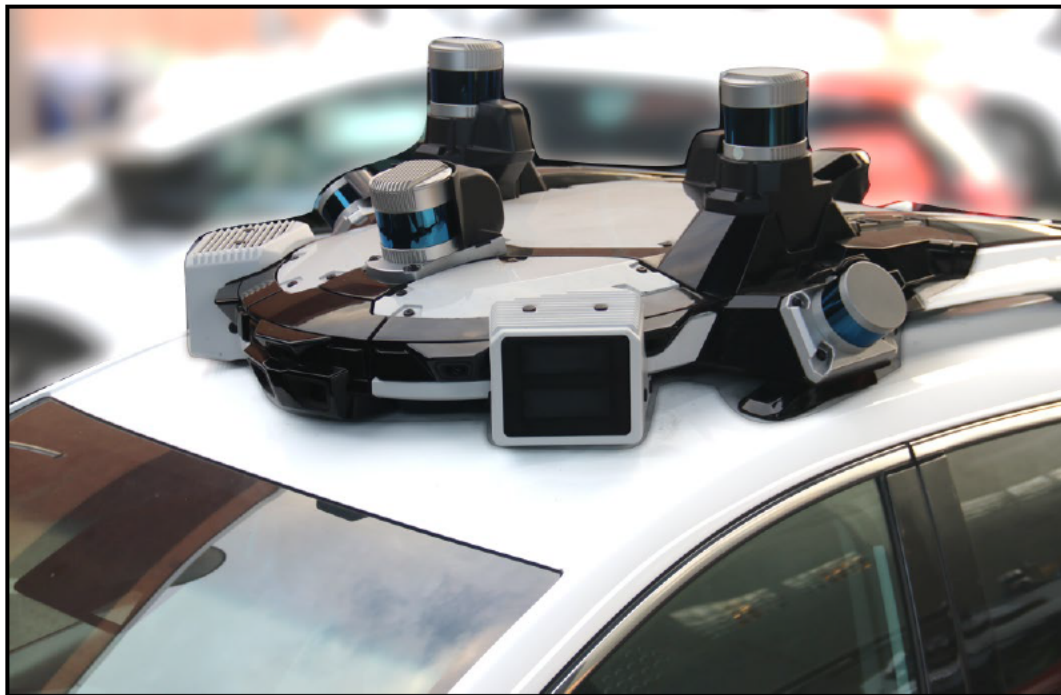
Figure 7. Roof mounted sensor array which includes lidars, cameras, and radars.

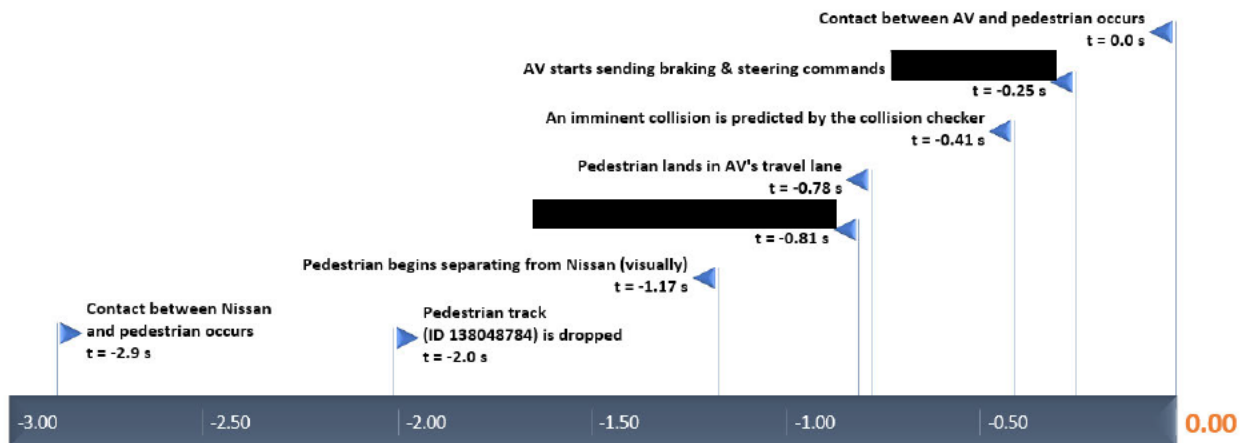
Figure 28. Timeline of salient events between pedestrian's collision with Nissan and subsequent collision with the AV.
