Clinical Case Report

Building trust and enhancing communication during oral health exams

The Align[™] Oral Health Suite, the latest tool on the iTero Element[™] Plus Series imaging system.

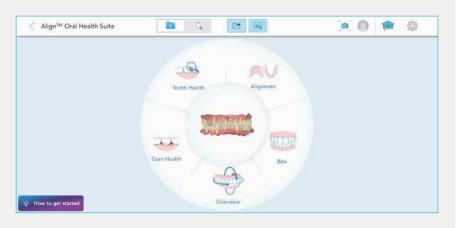
FIGURE 1: The landing page displays a wheel with five conditions, and the clinician can select where to start the consultation based on the patient's needs observed and the chief complaint.

After being absent for over a year, the patient presented for a periodic oral health exam. We had a previous scan from him, which we used to compare to the current oral health conditions using the Align[™] Oral Health Suite. After scanning the patient's oral cavity and submitting the scan, I accessed the tool, which presents five conditions in the shape of a wheel (Figure 1).

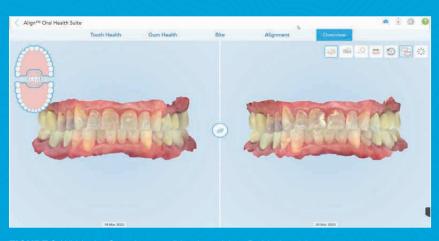
FIGURE 2: Within the Overview condition, I used the 3D side-by-side compare tool to contrast this patient's oral health condition in April 2021 with his condition in May 2023. In 13 months, this patient's oral health condition declined substantially.

I started showing the Overview condition to provide a general panorama of the oral health status. Using the side-by-side 3D compare feature we discussed general changes that occurred in the past year (Figure 2).

This patient's oral health drastically declined since his last visit 13 months ago. Overall, the following findings facilitated the conversation with the patient.

- White spots progressed into cavitated lesions that require composites, the clear evidence helped the patient understand and acknowledge the need for treatment.
- The oral hygiene did not improve, with evidence of dental plaque, impacted food, and calculus, especially in the lingual areas of

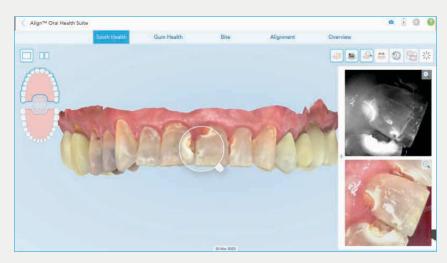
FIGURE 3: Incipient caries progressed into cavitated lesions in the upper incisors. Closeups of individual teeth are available through the iTero[™] NIRI technology ((Near Infra-Red Imaging) tool and the integrated 3D intraoral camera.

Leveraging the 3D model and the integrated 3D intraoral camera, I showed the patient how the white spot lesions from 13 months ago became cavitated lesions in teeth number 8, 9, and 10 (upper central incisors and upper left lateral incisor). Furthermore, the white spot lesions in the remaining upper and lower incisors and the canines expanded. A few teeth also revealed crazed lines and new white spots in the enamel (Figure 3).

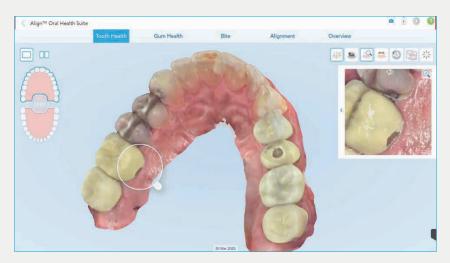
FIGURE 4: The integrated 3D intraoral camera supports the assessment of hard and soft tissues and the condition of restorations. The crown on tooth number 3 (upper first right molar) presents damage in the porcelain near the gingival line in the palatal surface.

The crown in tooth number 3 (upper first right molar) presents damage in the porcelain near the gingival line on the palatal surface (Figure 4), and the crown on tooth number 15 (upper second left molar) in the palatal surface presents with a significant gingival recession with the presence of debris and soft tissue when probed with an explorer (Figure 5). Significant areas of recessions are present on the buccal surface of tooth number 3 (upper first right molar), and on the buccal surfaces of the upper left premolars (teeth number 12, 13) (Figures 6-7).

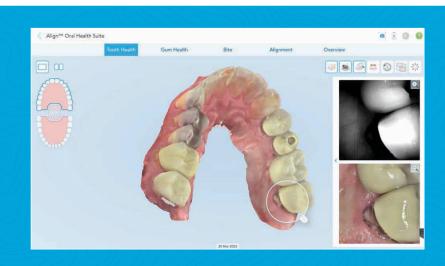
FIGURE 5: The integrated 3D intraoral camera assists in detecting a considerable gingival recession with potential radicular caries in the palatal surface near the gingival margin of tooth number 15 (upper second left molar). Tooth number 13 (upper second left molar presents an occlusal restoration to seal the access when an endodontic treatment was previously completed.

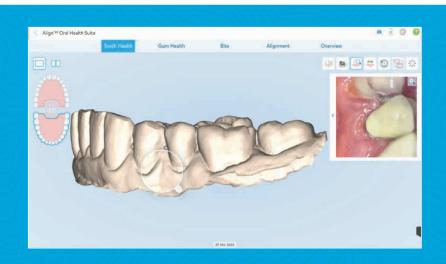
FIGURE 8: The stone model view aids in visualizing tooth wear, such as gingival recession, erosion, attrition, and abfraction. The lower left premolars show significant recession of the gingiva, exposing the roots and the cervical margin of the restorations.

In the lower arch, both left premolars showed significant recessions in the buccal surfaces. When switching to the stone model mode, these recessions became more evident, and we also found wear in the enamel and restorations (Figure 8). In the upper arch, we identified wear in the amalgams in the upper right premolars and in the incisal edges of the canines, lateral incisors, and the right central incisor. In the lower arch, we identified wear in the incisal edges of all anterior teeth and in the buccal cusps of the premolars (Figures 9-10).

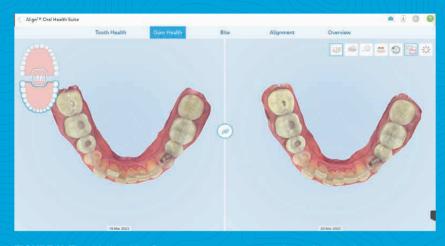
FIGURE 11: The side-by-side 3D compare supports contrasting oral hygiene between appointments. This patient presents calculus in the lingual surfaces of all lower anterior teeth. Lower crowding is one of the factors exacerbating this condition.

The Gum Health condition activates the stone model mode and the integrated 3D intraoral camera. The latter aids us in assessing the color, volume, and texture of the soft tissues and the presence of dental plaque, calculus, and impacted food. Looking at the 3D model in stone mode helped us evaluate for gingival recession, abfractions, attrition, and erosion. We had looked at these under the Tooth Health condition; however, here we can view it from the soft tissue aspect. Moreover, activating the iTero[™] TimeLapse technology will allow you to compare with a previous scan to highlight any changes in the characteristics of the gingiva. For example, teeth 20 and 21 (lower left premolars) experienced significant recession in 13 months. Furthermore, we also discovered crowns with compromised fit that progressed into dental and radicular caries or teeth with exposed root cementum, increasing the risk for sensitivity or further carious lesions in the future. Finally, we discovered calculus deposits in the lingual gingival area of lower incisors and canines. The sideby-side 3D compare tool was useful for this case to illustrate the recurrent issue with oral hygiene (Figure 11).

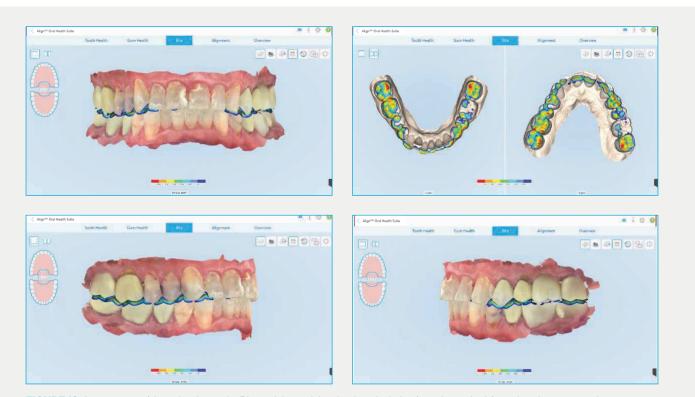
FIGURE 12: Assessment of the oclussion under Bite and determining the dental relation from the sagittal, frontal, and transverse views. The iTero[™] Occlusogram tool is activated to visualize the contacts between the upper and the lower teeth.

The iTero[™] Occlusogram tool automatically activates under this condition. I evaluated the dental relations from the sagittal, frontal, and transverse views. Furthermore, I observed the contacts between the upper and the lower teeth. Tooth wear facets on upper and lower incisors and large contact areas in the molar zone are concerning (Figure 12). We can return to the Tooth Health condition and look at any potential craze lines to cross reference these findings (Figure 3). This was an opportunity to discuss the potential need for a nightguard once the initial phases of treatment are completed to protect the remaining teeth, restorations, and facial muscles, and other parts of the stomatognathic system.

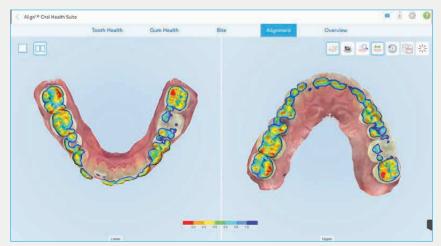
FIGURE 13: Minor crowding and wear facets are observed in both arches. Orthodontic therapy with Invisalign® aligners could improve the alignment.

The iTero[™] Occlusogram tool is automatically highlighted under this condition. The patient presents minor crowding in the upper and lower incisors (Figure 13). Orthodontic treatment with Invisalign[®] aligners would expand the arches in the premolar areas to improve the overall occlusion and facilitate oral hygiene maintenance, with which the patient is struggling.
