Clinical Case Report

Digital-driven new patient exams with the Align™ Oral Health Suite.

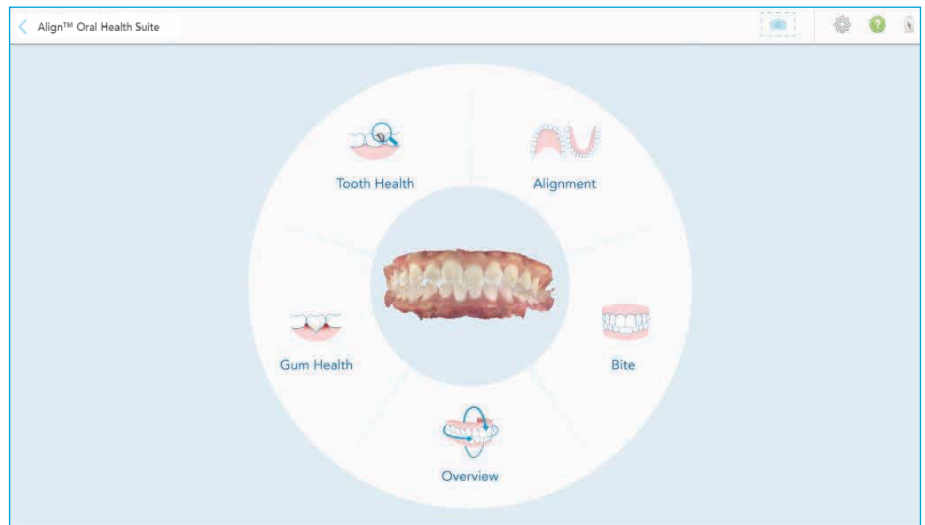
After scanning the patient, I accessed the Align™ Oral Health Suite, which showed me a wheel with five conditions to choose from to start the consultation. I started with Tooth Health and went around the wheel to finish with the Overview condition.

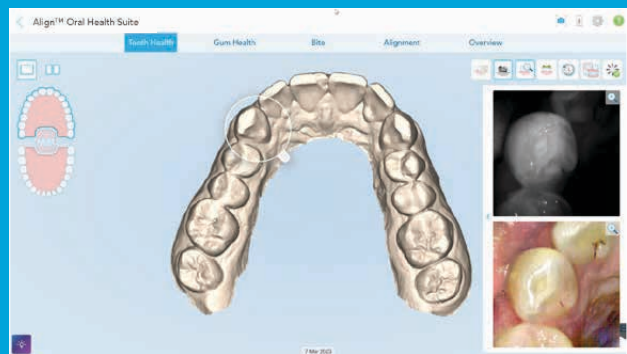
FIGURE 4: The stone model, in combination with the integrated 3D intraoral camera, helps highlight the tooth wear present along the incisal edges of the incisors, canines, and the buccal cusps of the premolars.

I activated the stone model to help identify tooth wear in the occlusal and incisal edges in both arches. The images reveal that this patient has mild and moderate wear in both arches and larger occlusal contact areas on the left side. The buccal cusps of the upper premolars and the incisal edges of upper and lower canines and incisors also reveal mild to moderate wear (Figures 4-5).

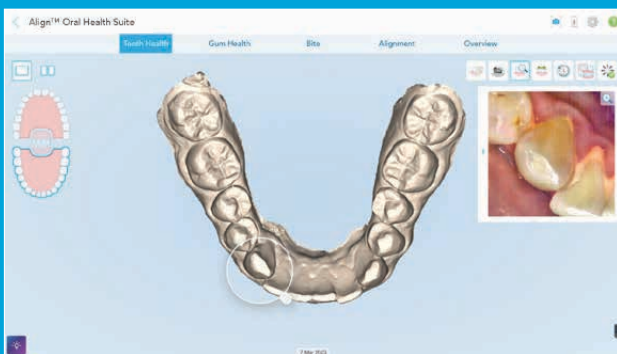
FIGURE 5: Tooth wear is present along the incisal edges of lower incisors, canines, and the buccal cusps of premolars.

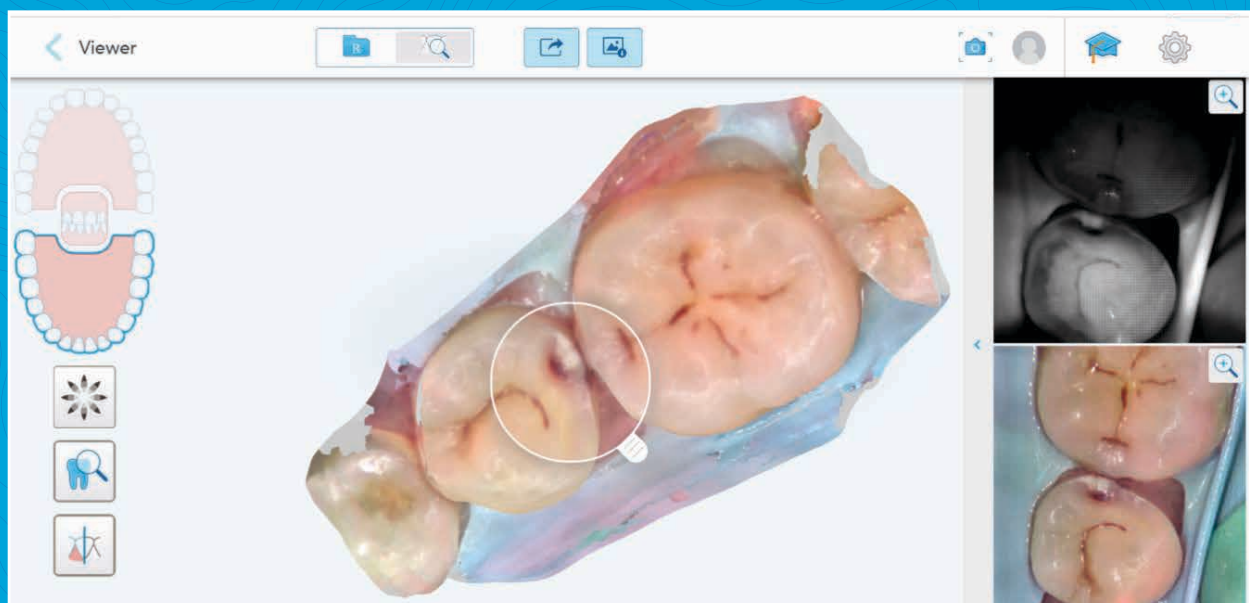
FIGURE 11: Scan from an interproximal composite preparation in tooth 3.5 (lower left second premolar) to demonstrate the width and depth. Doctor further prepared the tooth to remove carious tissue.

In my practice, I use the iTero Element™ 5D Plus imaging system for various purposes. I scan every time I prepare a tooth, whether it is for a crown, filling, or implant. This scan allows me to show the patient the work I am doing, it
