Test Report No.: TDAAGC-WTW-P21060688R1

Test Item : Wireless Gateway/Router

Identification : XR90 5G

Test Result : The test items of EN50155:2017 passed.

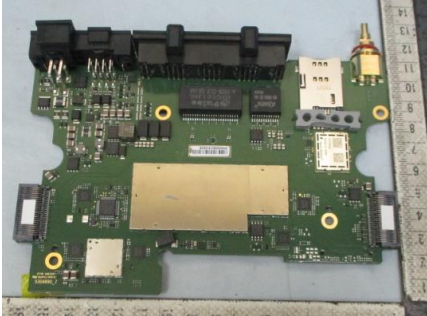
Environment Tests				
Clause	Requirement + Test	Result - Remark	Verdict	
	PCB (5306183_1) :

Position and description of test part of the sample:	Requirement Test	Flame Duration (First 30s)	Flame Duration (Next 30s)	Burning drop ignite tissue paper	Verdict
Main PCB (5304890_7)	Glow-wire test at 850 °C	No flame	No flame	No burning drop; No ignite tissue paper.	Pass
WiFi PCB (5304891-4)	Glow-wire test at 850 °C	No flame	No flame	No burning drop; No ignite tissue paper.	Pass
Cartridge PCB: Stack A: (5304893_4)	Glow-wire test at 850 °C	No flame	No flame	No burning drop; No ignite tissue paper.	Pass
Cartridge PCB: Stack B: (RJ45 board)	Glow-wire test at 850 °C	No flame	No flame	No burning drop; No ignite tissue paper.	Pass
Cartridge PCB2: (X55 5G modem)	Glow-wire test at 850 °C	No flame	No flame	No burning drop; No ignite tissue paper.	Pass

Remark:
 The details of PCB materials listed as below.
 1. Main PCB (5306183_1): WUS, Ltd. Type MV11, 94V-0.
 2. Wi-Fi PCB (5305233_4) : WUS, Ltd. Type MV11, 94V-0.
 3. Cartridge PCB: Stack A (5304893_4): Doosan, DSF-400G, 94V-0.
 4. Cartridge PCB: Stack B (RJ45 board): Shengyi, S1000, 94V-0.
 5. Cartridge PCB: X55 5G modem: AT&S, MX8, 94V-0.

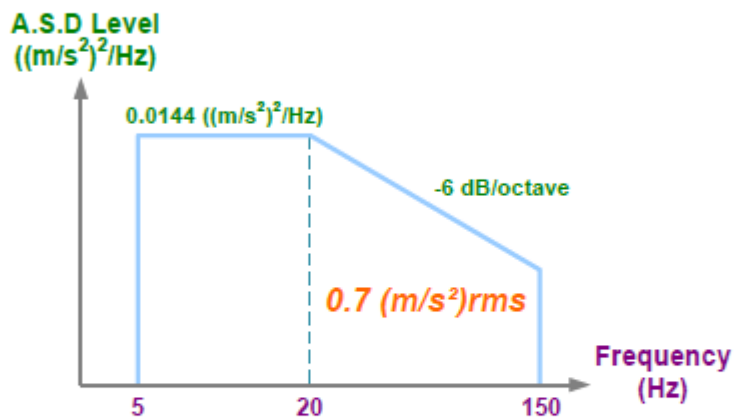
2.4.1 Test condition 1 (Operating / X axis)

Unit is operating.
 Vibration waveform : Random waveform

Duration of test / Vibration axis : 10 minutes for X axis

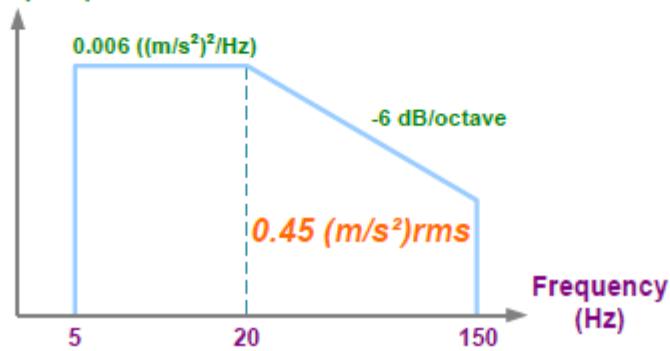
2.4.2 Test condition 2 (Operating / Y axis)

Vibration waveform : Random waveform

A.S.D Level
 $((m/s^2)^2/Hz)$

Duration of test / Vibration axis : 10 minutes for Y axis

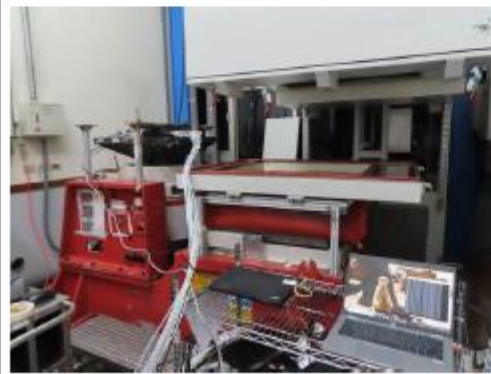
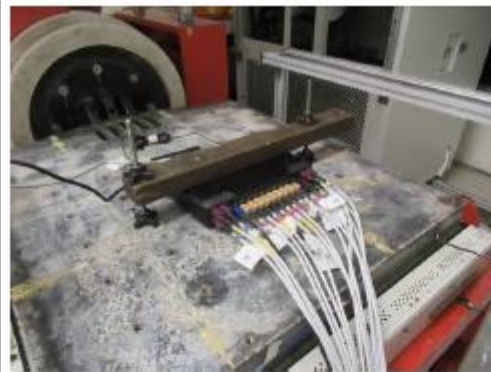
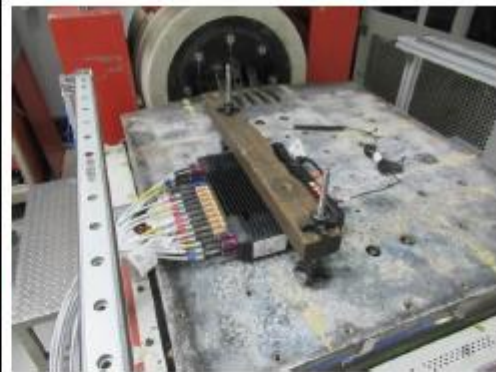
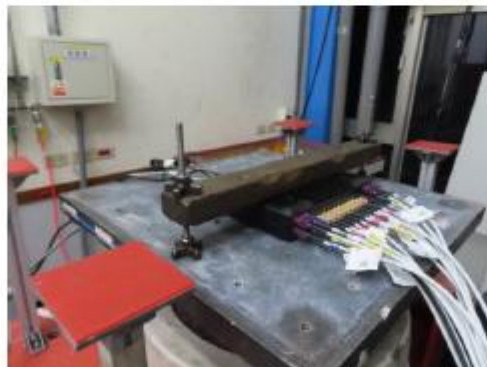
2.6 PHOTO OF TEST

Operating

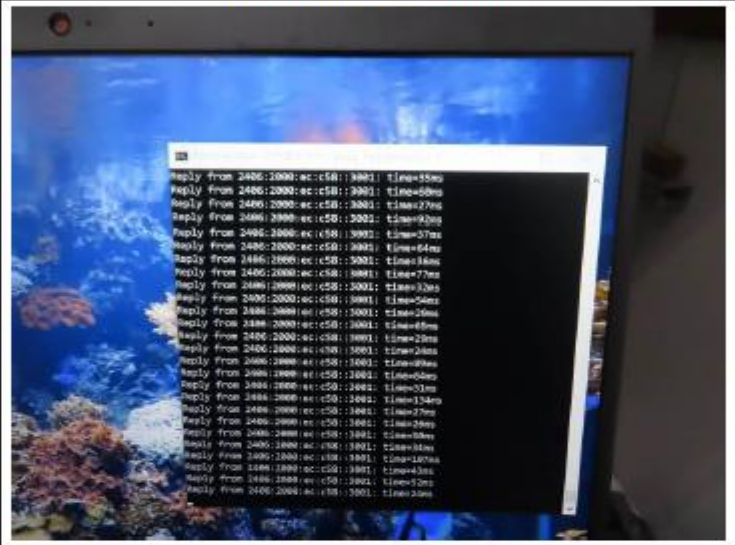
After testing

The function of unit was normal

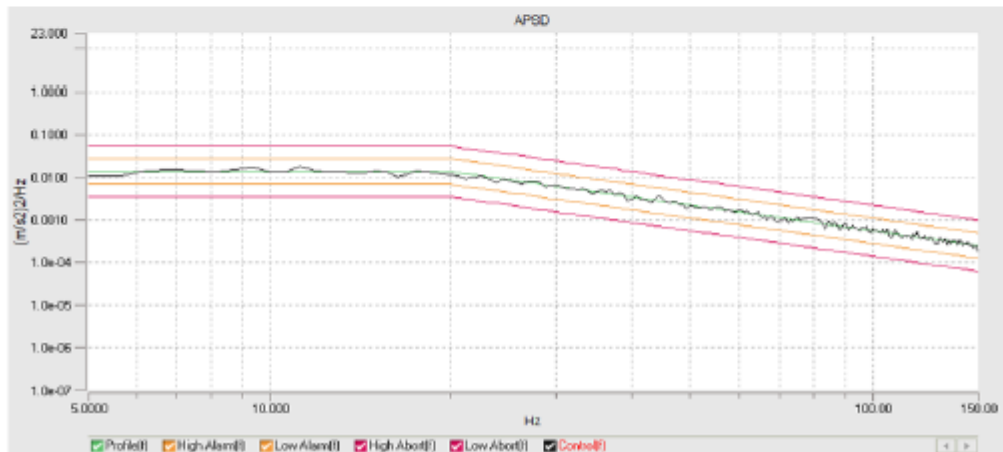
X axis

Current Level: 100.00 % Demand RMS: 0.683 m/s² Control RMS: 0.677 m/s²
 Frame Time: 1.6000 (s) Lines: 400 dF: 0.6 Hz
 DOF: 120 Current Level Time: 00:10:00 Remaining Time: 00:00:00

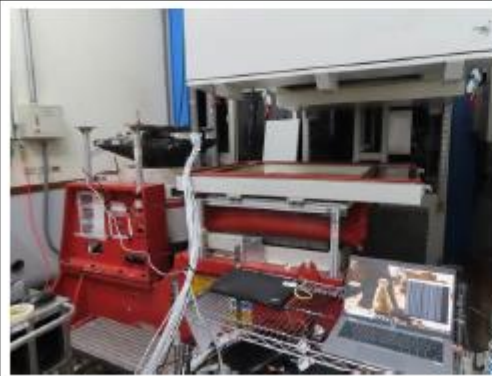
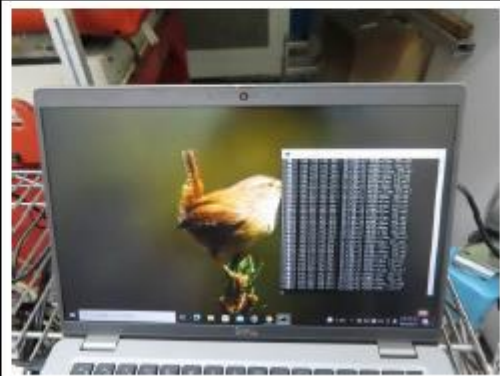
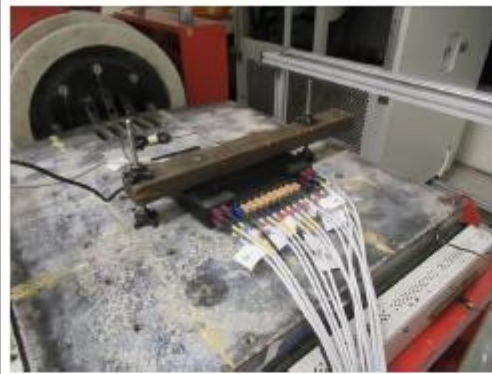
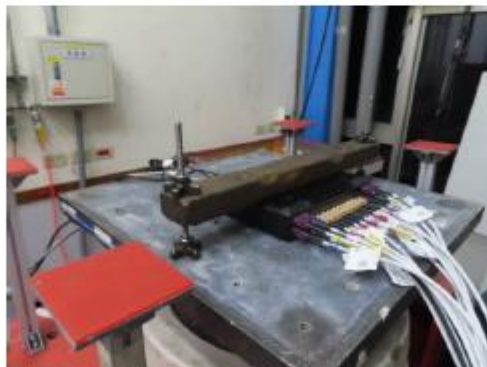
3.6 PHOTO OF TEST

Unit is operating.
Pulse shape : Half-sine waveform
Impact acceleration : 50 m/s²
Pulse duration : 30 ms
Number of shocks / Orientation : 6 shocks (3 shocks for ±X axis)

Unit is operating.
Pulse shape : Half-sine waveform
Impact acceleration : 30 m/s²
Pulse duration : 30 ms
Number of shocks : 12 shocks (3 shocks for each ±axis)
Orientation : ±Y and ±Z axes

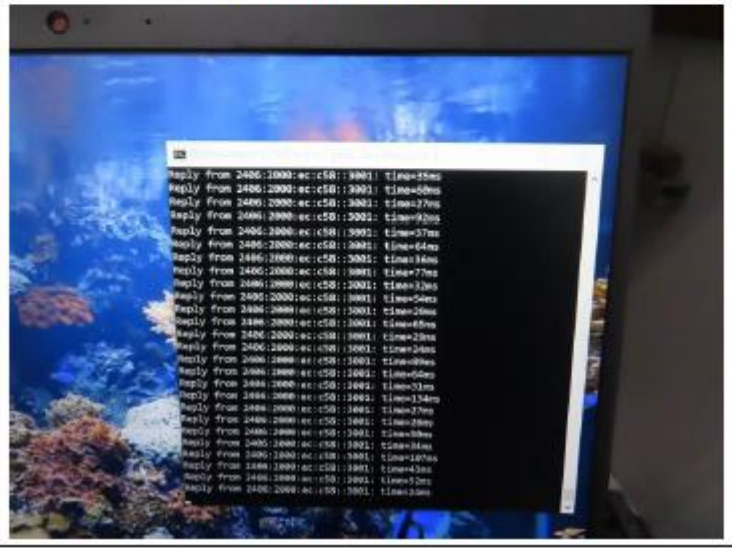
After testing

The function of unit was normal

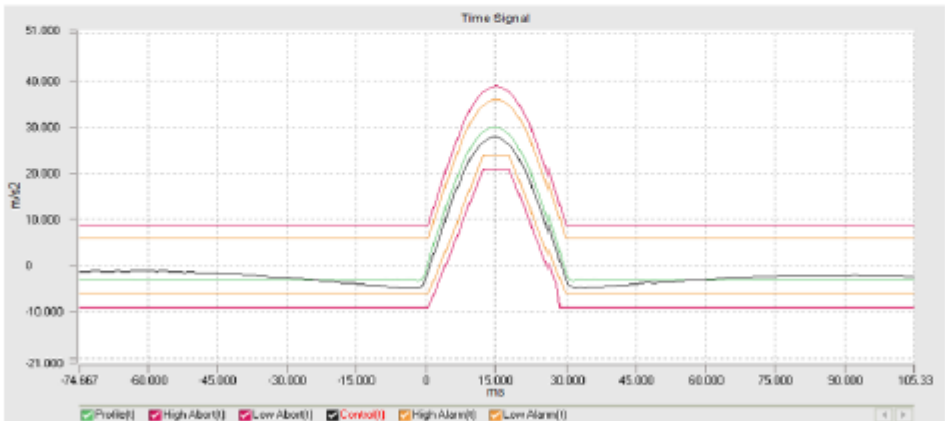
[+Y axis]

Shock Type: Half Sine Mag: 30.00 m/s² Pulse Duration: 30 ms
 Current level: 0 dB Demand peak: 30.000 m/s² Control peak: 28.072 m/s²
 Block Size: 2048 Frame Time: 1.3653 s dT: 0.000666667 s
 Current Pulses: 3 Output pulses: 11 Remain pulses: 6

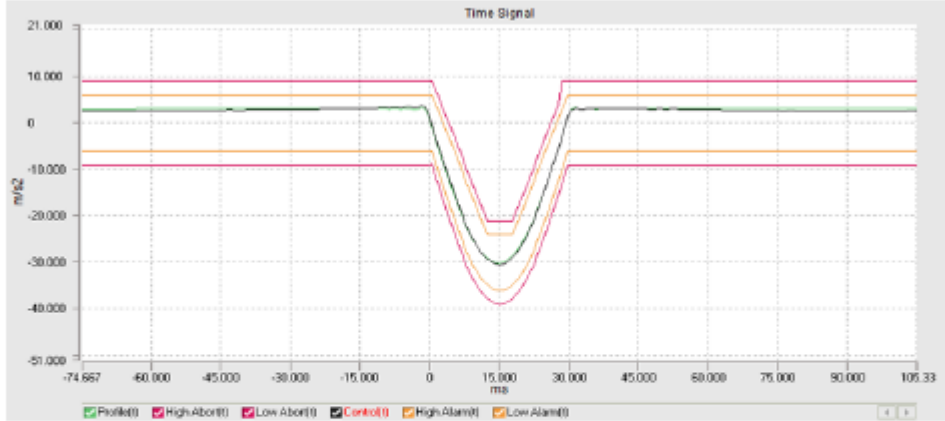
[-Y axis]

Shock Type: Half Sine Mag: 30.00 m/s² Pulse Duration: 30 ms
 Current level: 0 dB Demand peak: 30.000 m/s² Control peak: 30.368 m/s²
 Block Size: 2048 Frame Time: 1.3653 s dT: 0.000666667 s
 Current Pulses: 3 Output pulses: 17 Remain pulses: 0

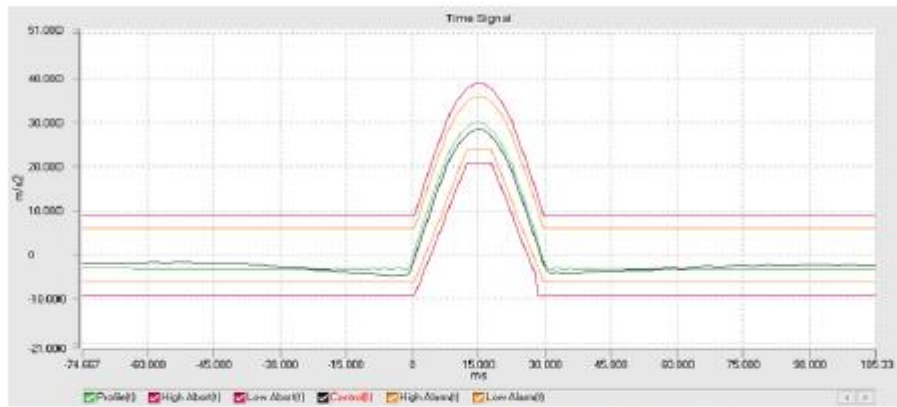
【+Z axis】

Shock Type: Half Sine Mag: 30.00 m/s² Pulse Duration: 30 ms
 Current level: 0 dB Demand peak: 30.000 m/s² Control peak: 28.533 m/s²
 Block Size: 2048 Frame Time: 1.3653 s dT: 0.000886667 s
 Current Pulses: 3 Output pulses: 11 Remain pulses: 6
