TAPPING

Direct Tapping of 6-Inch Pressure Class 350 Ductile Iron Pipe

by Richard W. Bonds, P.E.

Last Revised:
March 2017

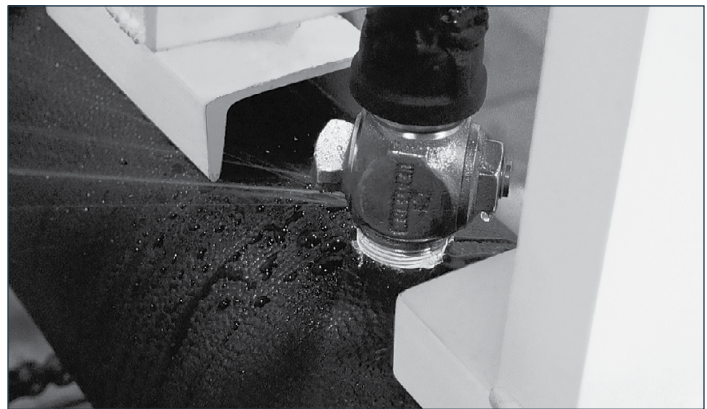
Forces exerted during pull-out tests, when sufficient, resulted in failure of the corporation stop, not the Ductile Iron Pipe or threads. The top photo shows leakage at the plug key of the corporation stop. Ultimate failure occurred to the corporation stop's threaded connection for the service line. The undamaged Ductile Iron Pipe and threads are shown in the photo below.

The pull-out tests were conducted to evaluate the strength and integrity of the corporation stops' threaded connection to the pipe. An average pulling force of 3,028 lbf initiated leakage around the closed plug key of the corporation stops (no leakage was observed at the threaded connection to the pipe). Actual failure occurred at an average of 6,969 lbf of pulling force. These failures occurred to the corporation stops' threaded connection for the service line, not the threaded connection to the pipe. These tests included only 3/4-inch corporations.

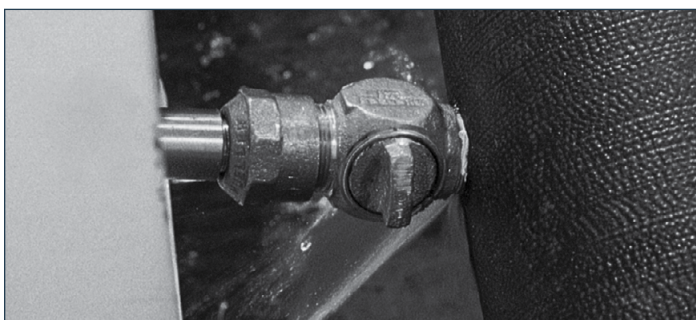
As was the case in the pull-out tests, sufficient cantilever forces damaged the corporation stop, causing the leakage seen in the photo above (top). Damage to the corporation stop is shown above (bottom).

Similar to the pull-out tests, the cantilever load testing was conducted to evaluate the strength of the direct tap connection to the pipe. The three corporation stops subjected to the cantilever loading began to leak at an average bending moment of 3,125 in-lbf. There was no leakage at the threaded connection to the pipe. Failure of the corporation stops required an average bending moment of 4,784 in-lbf and occurred at the two or three exposed threads just outside of the threaded connection to the pipe. These tests included only 3/4-inch corporations.
