TAPPING

Ductile Iron Pipe vs. Polyvinyl Chloride Pipe

Last Revised:
July 2020

Ductile Iron Pipe Research Association

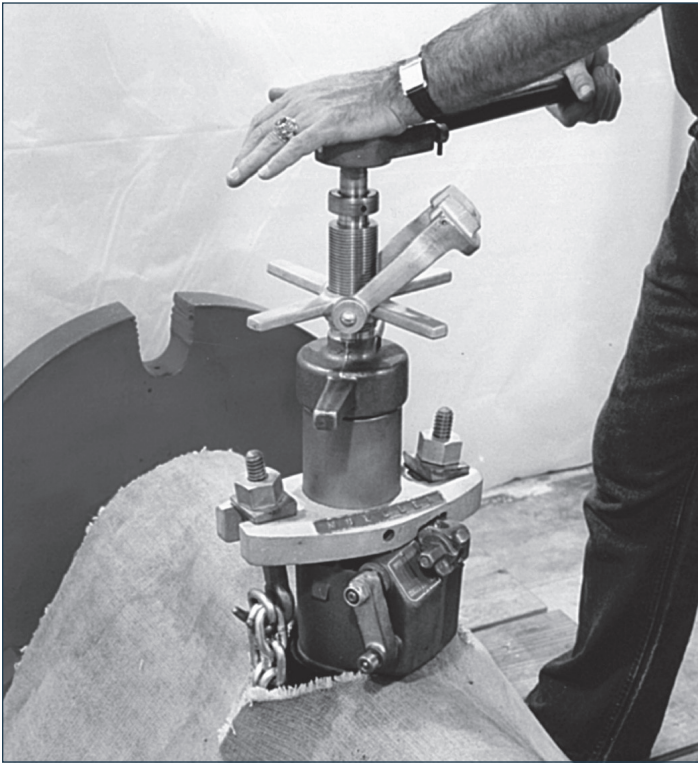
Each material was tapped according to recommendations. The average time to tap Ductile Iron Pipe (left) was 16 minutes; the average time to tap PVC (right) was 25 minutes. Note that a “protective blanket with a hole in the center” was used while tapping the PVC pipe to comply with Uni-Bell’s recommended procedures.

Each material was tapped according to recommendations. A moderate, thorough pace was used by the same tapping machine operator for all tests to achieve a representative comparison. All specimens were cut in 5-foot lengths, installed in the test press, and direct tapped under 60 psi internal water pressure. The tapping machine was positioned and mounted for each tap prior to the timing. The end of the tapping time was signaled after the corporation stop was inserted and torqued appropriately (30 ft-lbs for DIP and 27 ft-lbs for PVC).

Following recommended procedures, the researchers determined that tapping PVC pipe took approximately 56 percent longer than tapping Ductile Iron Pipe. The increased tapping time was

attributed to the fact that PVC pipe must be tapped slowly and gently to prevent the accumulation of local stresses that can cause the pipe to fail.

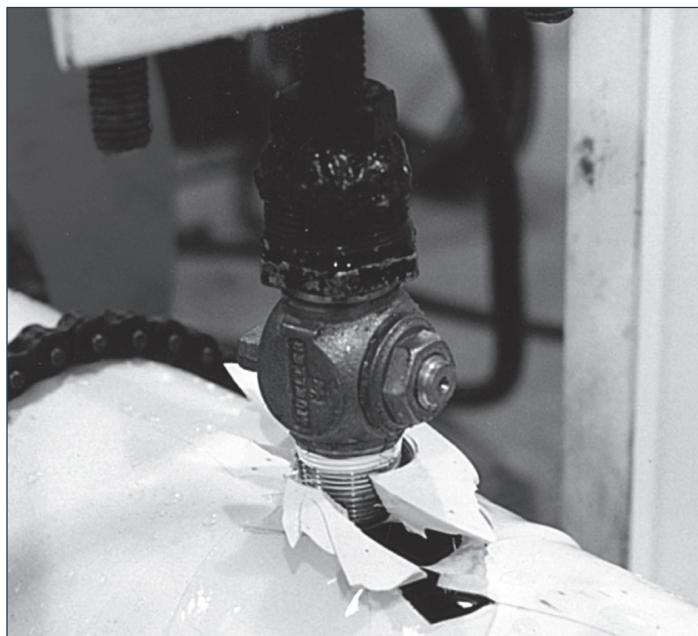
Pull-out tests were conducted to evaluate the strength and integrity of each threaded connection to the pipe material. For Ductile Iron Pipe (left), the leakage occurred to the corporation stops at an average of 2,834 pounds of pulling force. In every case, the leaks were observed on the corporation stop plugs and not at the threaded connection to the pipe. Failure, which occurred at an average of 9,644.1 pounds of pulling force, occurred at the threaded connection for the service line, not the threaded connection to the pipe. Pull-out tests on PVC pipe (right) resulted in leakage at the threaded connection to the pipe at an average of 2,800 pounds of pulling force; failure at an average of 4,558 pounds. In every instance, the pulling force caused the pipe wall to break in the area of the corporation stops, resulting in the destruction of the pipe itself in the general area of the direct tap connection.

Following the leak tests, pull-out tests were conducted to evaluate the strength and integrity of each threaded connection to the pipe material. Each pipe was securely installed in the test press, filled with water, and brought up to 60 psi internal water pressure. The 3/4-inch corporations were checked for proper torque ratings, and, when required, the DIP specimens were torqued to 40 ft.-lbs and PVC specimens were torqued to 35 ft.-lbs.

A “pull-out” apparatus was mounted on the test press directly over the corporation stop. This apparatus utilizes a 10-ton hydraulic ram that connects to a fixture threaded onto the respective corporation stop. A hydraulic pump with a previously calibrated gauge was used to apply hydraulic pressure to the ram.

The hydraulic ram with an effective area of 2.074 square inches enables a conversion from pressure in psi to pounds of force pulling on the corporation stop connection. This force was applied in increments of 250 psi, or approximately 500 pounds of force.

For Ductile Iron Pipe, leakage occurred to the corporation stops at an average of 2,834 pounds of pulling force. In all three cases, *the leaks were observed on the 3/4-inch corporation stop plugs and not at the threaded connection to the pipe.* Actual failure occurred at an average of 9,644.1 pounds of pulling force. This failure occurred to the threaded connection for the copper service line, not the threaded connection to the pipe where leakage never occurred.

The test on PVC specimens resulted in leakage at the threaded connection to the pipe at an average of 2,800 pounds of pulling force. *In all instances, the pulling force caused the pipe wall to break in the area of the corporation stop, pulling pieces of the pipe wall out in the area of the corporation stops, resulting in destruction of the pipe itself in the general area of the direct tap connection.* These failures occurred at an average of 4,558 pounds of pulling force, less than half that required to cause failure to the corporation service line connection on the Ductile Iron Pipe.
