TAPPING

Ductile Iron Pipe vs. Polyvinyl Chloride Pipe

Last Revised:
March 2016

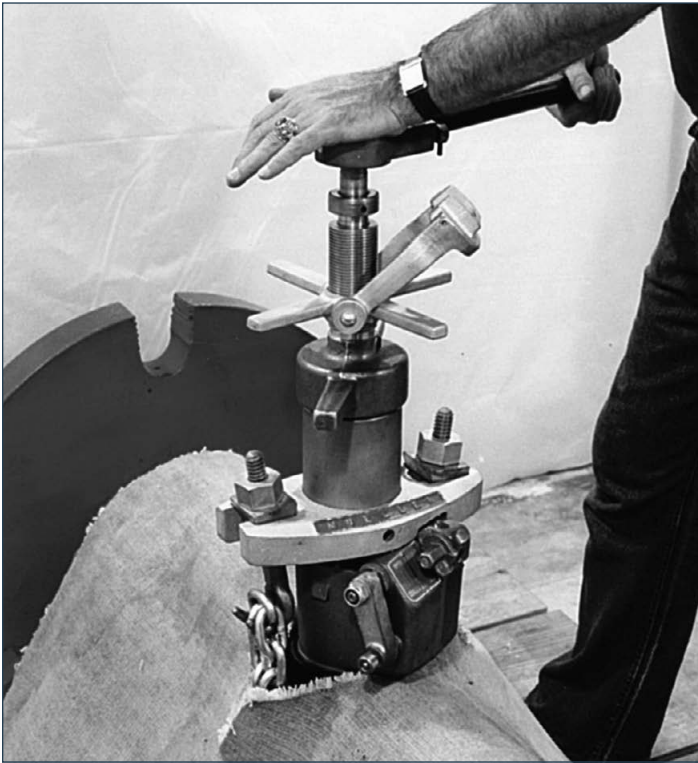
Each material was tapped according to recommendations. The average time to tap Ductile Iron Pipe (left) was 16 minutes; the average time to tap PVC (right) was 25 minutes. Note that a “protective blanket with a hole in the center” was used while tapping the PVC pipe to comply with Uni-Bell’s recommended procedures.

Each material was tapped according to recommendations. A moderate, thorough pace was used by the same tapping machine operator for all tests to achieve a representative comparison. All specimens were cut in 5-foot lengths, installed in the test press, and direct tapped under 60 psi internal water pressure. The tapping machine was positioned and mounted for each tap prior to the timing. The end of the tapping time was signaled after the corporation stop was inserted and torqued appropriately (30 ft-lbs for DIP and 27 ft-lbs for PVC).

Following recommended procedures, the researchers determined that tapping PVC pipe took approximately 36 percent longer than tapping Ductile Iron Pipe. The increased tapping time was

attributed to the fact that PVC pipe must be tapped slowly and gently to prevent the accumulation of local stresses that can cause the pipe to fail.

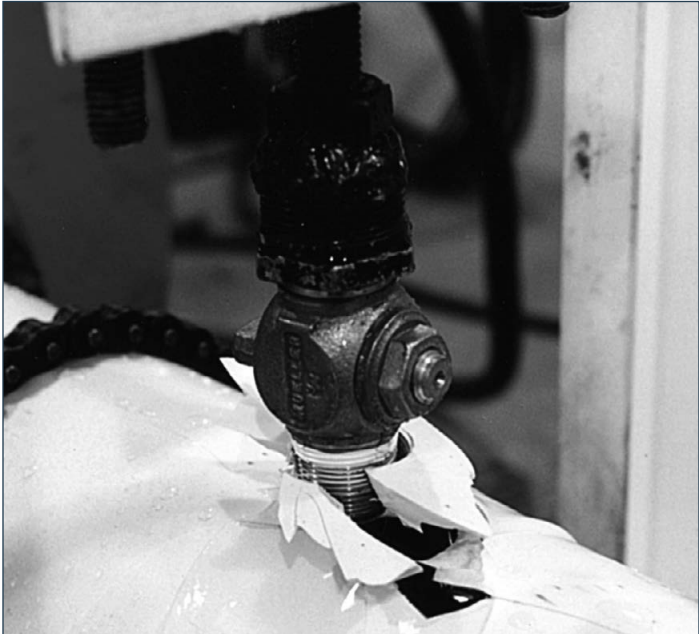
Pull-out tests were conducted to evaluate the strength and integrity of each threaded connection to the pipe material. For Ductile Iron Pipe (left), the leakage occurred to the corporation stops at an average of 2,834 pounds of pulling force. In every case, the leaks were observed on the corporation stop plugs and not at the threaded connection to the pipe. Failure, which occurred at an average of 9,644.1 pounds of pulling force, occurred at the threaded connection for the service line, not the threaded connection to the pipe. Pull-out tests on PVC pipe (right) resulted in leakage at the threaded connection to the pipe at an average of 2,800 pounds of pulling force; failure at an average of 4,558 pounds. In every instance, the pulling force caused the pipe wall to break in the area of the corporation stops, resulting in the destruction of the pipe itself in the general area of the direct tap connection.

A “pull-out” apparatus was mounted on the test press directly over the corporation stop. This apparatus utilizes a 10-ton hydraulic ram that connects to a fixture threaded onto the respective corporation stop. A hydraulic pump with a previously calibrated gauge was used to apply hydraulic pressure to the ram.

The hydraulic ram with an effective area of 2.074 square inches enables a conversion from pressure in psi to pounds of force pulling on the corporation stop connection. This force was applied in increments of 250 psi, or approximately 500 pounds of force.

For Ductile Iron Pipe, leakage occurred to the corporation stops at an average of 2,834 pounds of pulling force. In all three cases, *the leaks were observed on the 3/4-inch corporation stop plugs and not at the threaded connection to the pipe.* Actual failure occurred at an average of 9,644.1 pounds of pulling force. This failure occurred to the threaded connection for the copper service line, not the threaded connection to the pipe where leakage never occurred.

The test on PVC specimens resulted in leakage at the threaded connection to the pipe at an average of 2,800 pounds of pulling force. *In all instances, the pulling force caused the pipe wall to break in the area of the corporation stop, pulling pieces of the pipe wall out in the area of the corporation stops, resulting in destruction of the pipe itself in the general area of the direct tap connection.* These failures occurred at an average of 4,558 pounds of pulling force, less than half that required to cause failure to the corporation service line connection on the Ductile Iron Pipe.

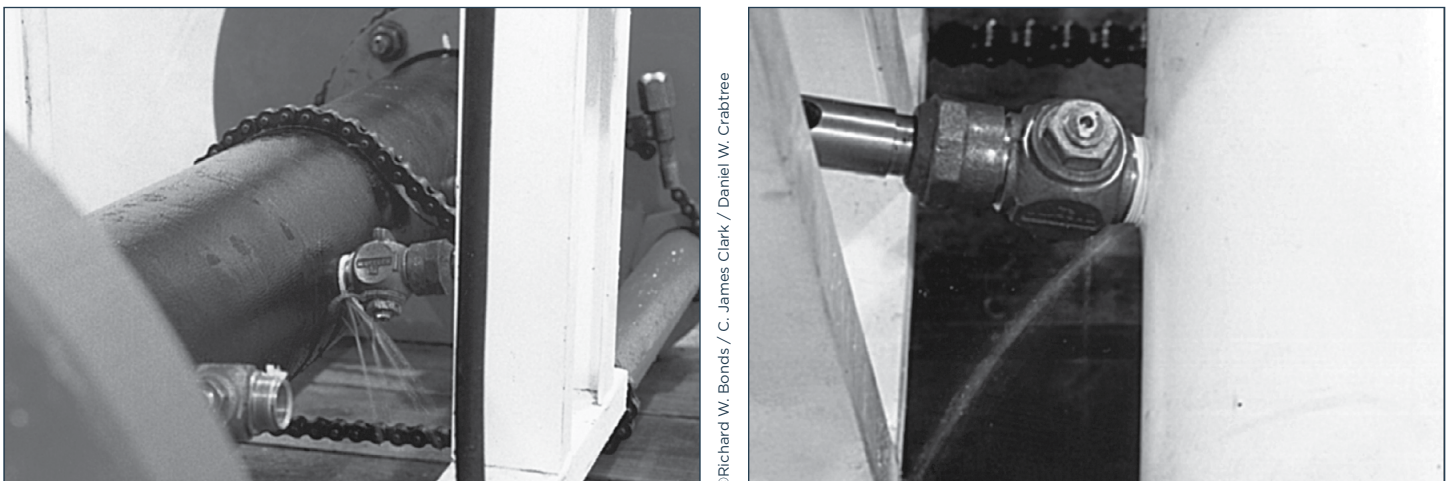
Cantilever load testing was conducted to evaluate the strength of the threaded connections of the two pipe materials. The average bending moment to cause leakage of the corporation stops in Ductile Iron Pipe (left) was 2,742 in-lbs. Leakage occurred at the corporation plug on the stop and not at the threaded connection. Failure of the corporation stops averaged 4,721 in-lbs and occurred at the exposed threads just outside the connection to the pipe. Tests on PVC specimens (right) resulted in leakage at an average of 1,990 in-lbs and, in all cases, the leak occurred at the threaded connection to the pipe. Failure occurred at an average of 3,269 in-lbs, resulting in an elongation of the threaded hole in the pipe wall. The threads in the PVC pipe wall stretched or compressed and stripped.

Cantilever load testing was conducted to evaluate the strength of the threaded connections of the two pipe materials. The procedure was similar to that used for the pull-out tests, the only difference being the specimens were rotated 90 degrees and a slightly different connection apparatus to the corporation stops was used. This apparatus had a pivot type connection point at the corporation, which allowed a deflection of approximately 15 degrees. Each cantilever test was done in increments of 25 psi hydraulic pressure, which was later converted to inch-pounds bending moment at the interface between the pipe and corporation stop. Failure was defined by the loss of pressure being applied.

The average bending moment to cause leakage of the corporation stops in Ductile Iron Pipe was 2,742 in-lbs. As in the pull-out tests, leakage occurred at the corporation plug on the stop and not at the threaded connection. Failure of the corporation stops averaged 4,721 in-lbs and occurred at the exposed threads just outside the connection to the pipe. Leakage never occurred at the threaded connection to the pipe.

Tests on PVC specimens resulted in leakage at an average of 1,990 in-lbs and, in all cases, the leak occurred at the threaded connection in the pipe. Failure occurred at an average of 3,269 in-lbs and resulted in an elongation of the threaded hole in the pipe wall. Closer examination revealed that the threads in the PVC pipe wall stretched or compressed and stripped.
