Technical Report – R20228
CWCT – Standard for systemised building envelopes – 2005

Generix Facades Limited
Generix Genbrix

1. Introduction

This report describes tests carried in order to determine the weather tightness of the sample with respect to water penetration, wind and impact resistance on sample supplied as follow:

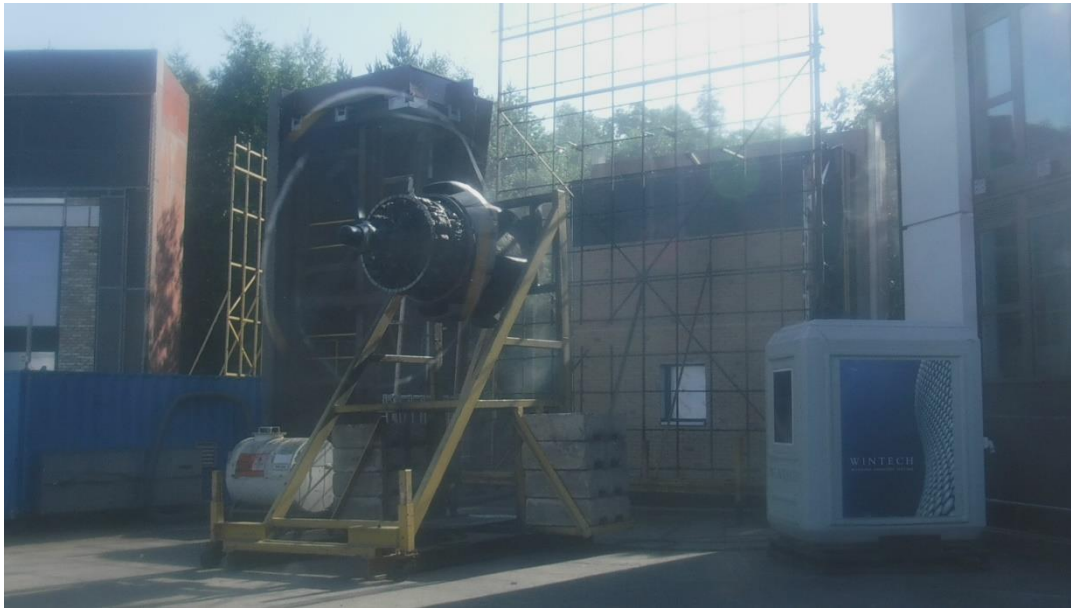
Photograph No. 1

Sample during testing

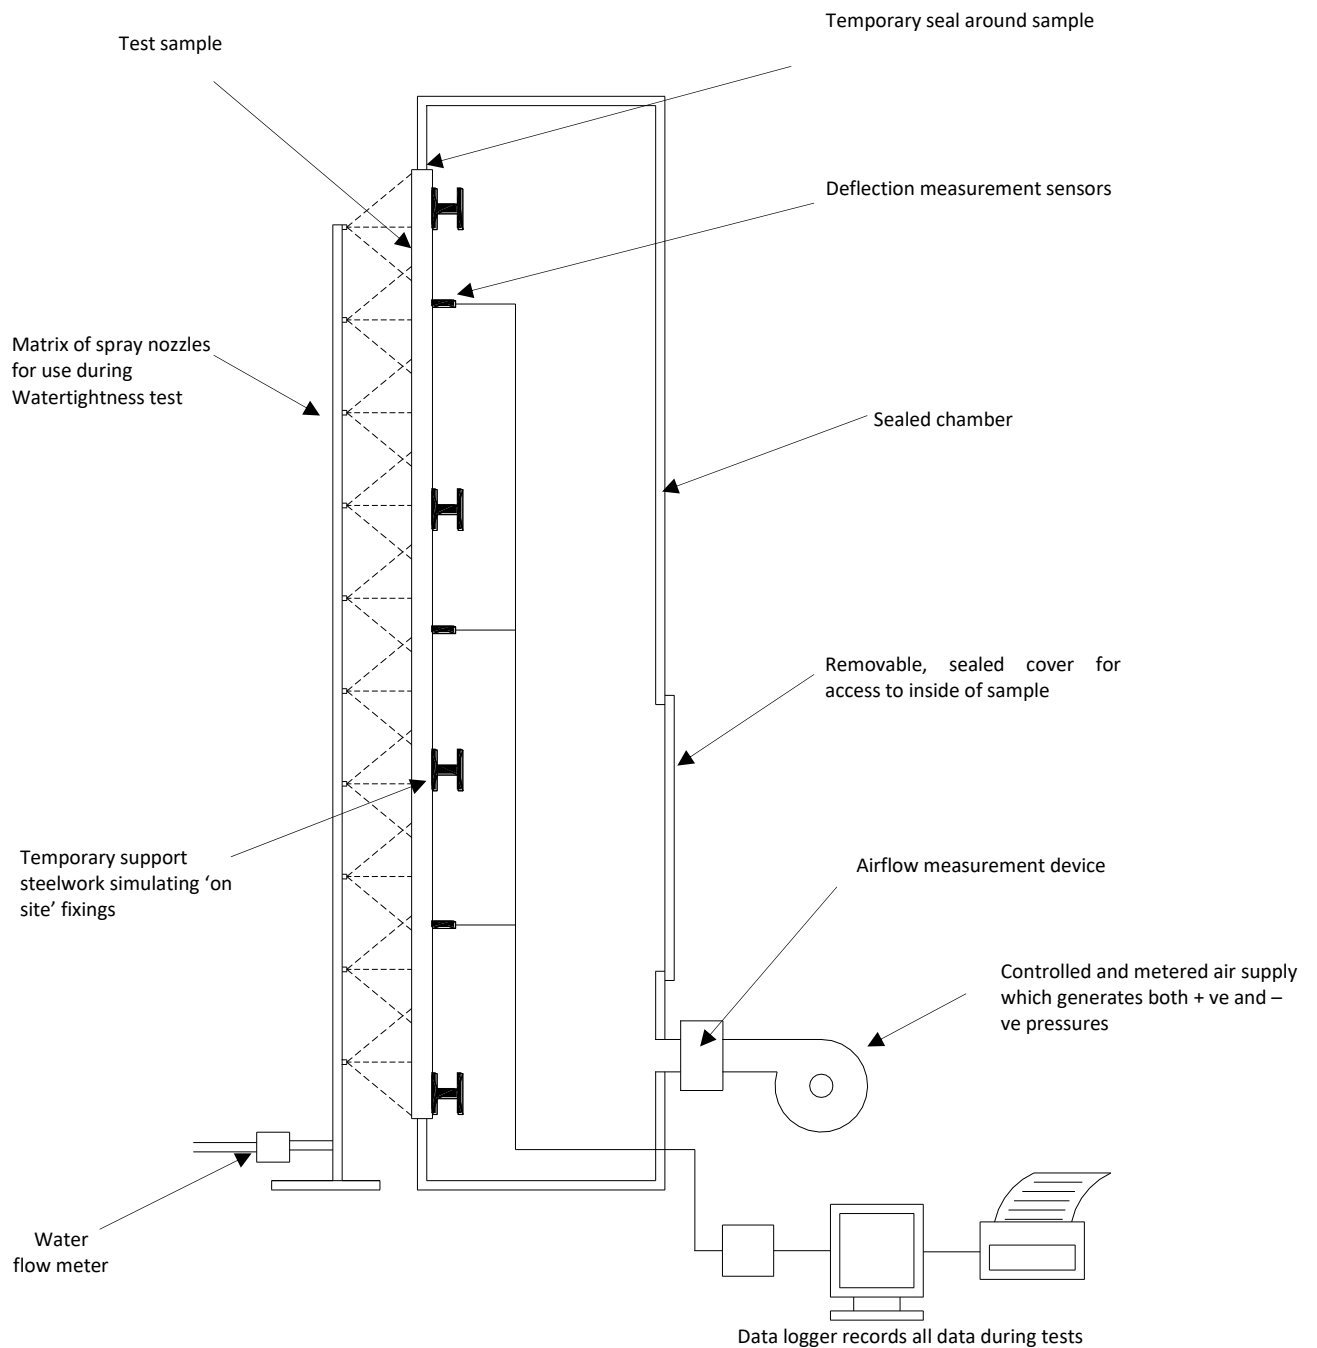
Figure 1 – Test arrangement

General Arrangement of a Typical Test Assembly

A specimen, supplied for testing in accordance with CWCT requirements, was mounted on to a rigid test chamber constructed from steel, timber and plywood sheeting.

The pressure within the chamber was controlled by means of a centrifugal fan and a system of ducting and valves. The static pressure difference between the outside and inside of the chamber was measured by means of a differential pressure transmitter.

A wind generator was mounted adjacent to the external face of the test sample and used to create positive pressure differential during dynamic testing.

A water spray system was used which comprised of nozzles spaced on a uniform grid, not more than 700 mm apart and mounted approximately 400 mm from the face of the sample. The nozzles provided a full cone pattern, as per the requirements outlined by CWCT. The system delivered water uniformly to the entire surface of the test sample at a rate of not less than 3.4 lt/m²/min.

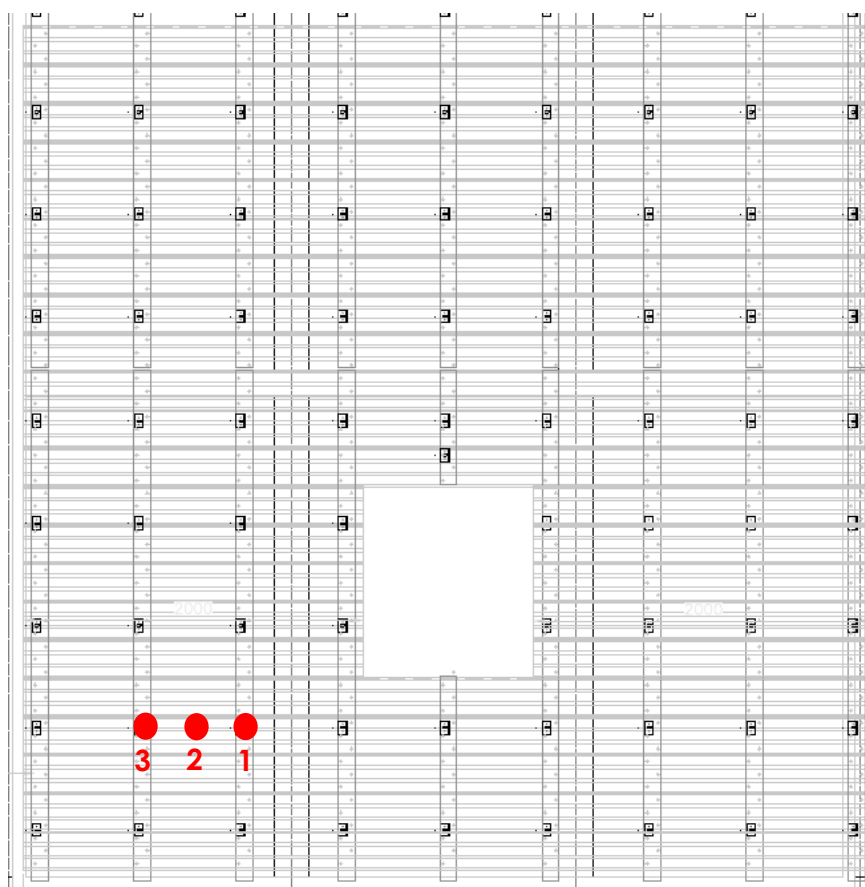
Figure 2

Probe Group Identification	Calculation of deflection
Group A comprised of probes 1, 2 & 3	= Probe 2 – ((Probe 1 + Probe 3)/2)

Positions of Deflection Measurement Probes

● - Deflection probe position

Positive Pressure Pa	Results
	Group A
0	0.0
600	0.0
1200	0.1
1800	0.0
2400	0.1
Residuals Immediately following test	0.0

Negative Pressure Pa	Results
	Group A
0	0.0
600	0.0
1200	0.0
1800	0.0
2400	0.1
Residuals Immediately following test	0.0

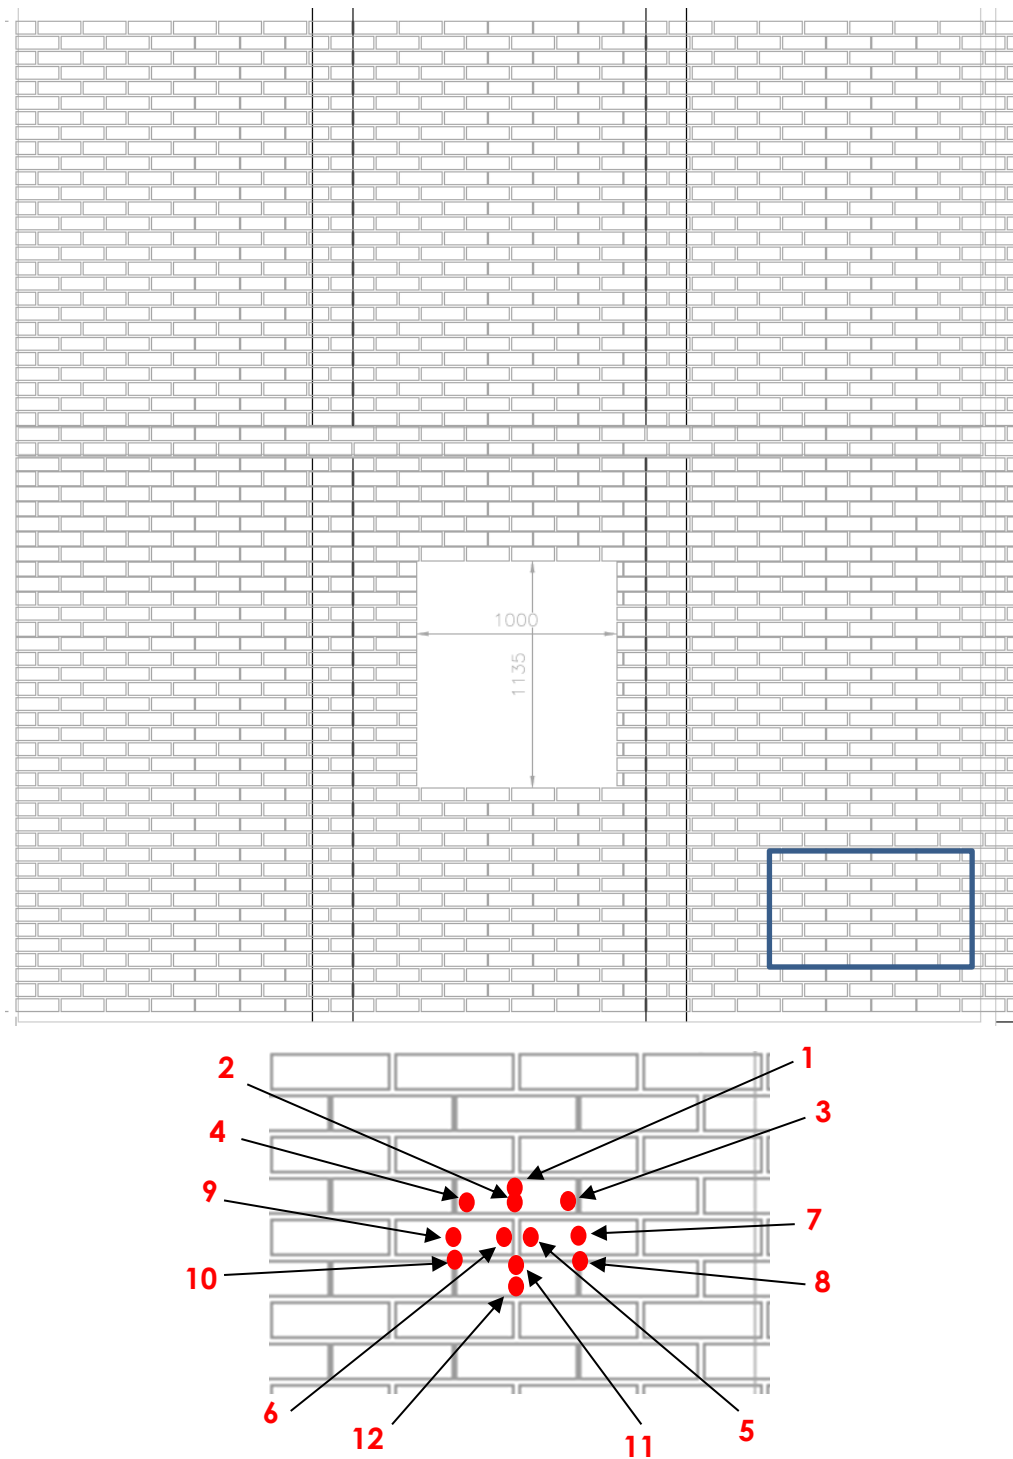
Figure 3

Soft Body - Retention of Performance Impact Positions

Impact Reference	Test Category	Impactor Type	Impact Energy (Nm)	Drop Height (mm)	Observations	Result
1	Cat B	Soft Body (S1)	120	245	No Damage	Class 1
2	Cat B	Soft Body (S1)	120	245	No Damage	Class 1
3	Cat B	Soft Body (S1)	120	245	No Damage	Class 1
4	Cat B	Soft Body (S1)	120	245	No Damage	Class 1
5	Cat B	Soft Body (S1)	120	245	No Damage	Class 1
6	Cat B	Soft Body (S1)	120	245	No Damage	Class 1
7	Cat B	Soft Body (S1)	120	245	No Damage	Class 1
8	Cat B	Soft Body (S1)	120	245	No Damage	Class 1
9	Cat B	Soft Body (S1)	120	245	No Damage	Class 1
10	Cat B	Soft Body (S1)	120	245	No Damage	Class 1
11	Cat B	Soft Body (S1)	120	245	No Damage	Class 1
12	Cat B	Soft Body (S1)	120	245	No Damage	Class 1
1	Cat B	Hard Body (H2)	10	898	No Damage	Class 1
2	Cat B	Hard Body (H2)	10	898	No Damage	Class 1
3	Cat B	Hard Body (H2)	10	898	Mortar broke from corner of brick	Class 1
4	Cat B	Hard Body (H2)	10	898	Small indentation	Class 2
5 Retest of area 3	Cat B	Hard Body (H2)	10	898	No damage	Class 1

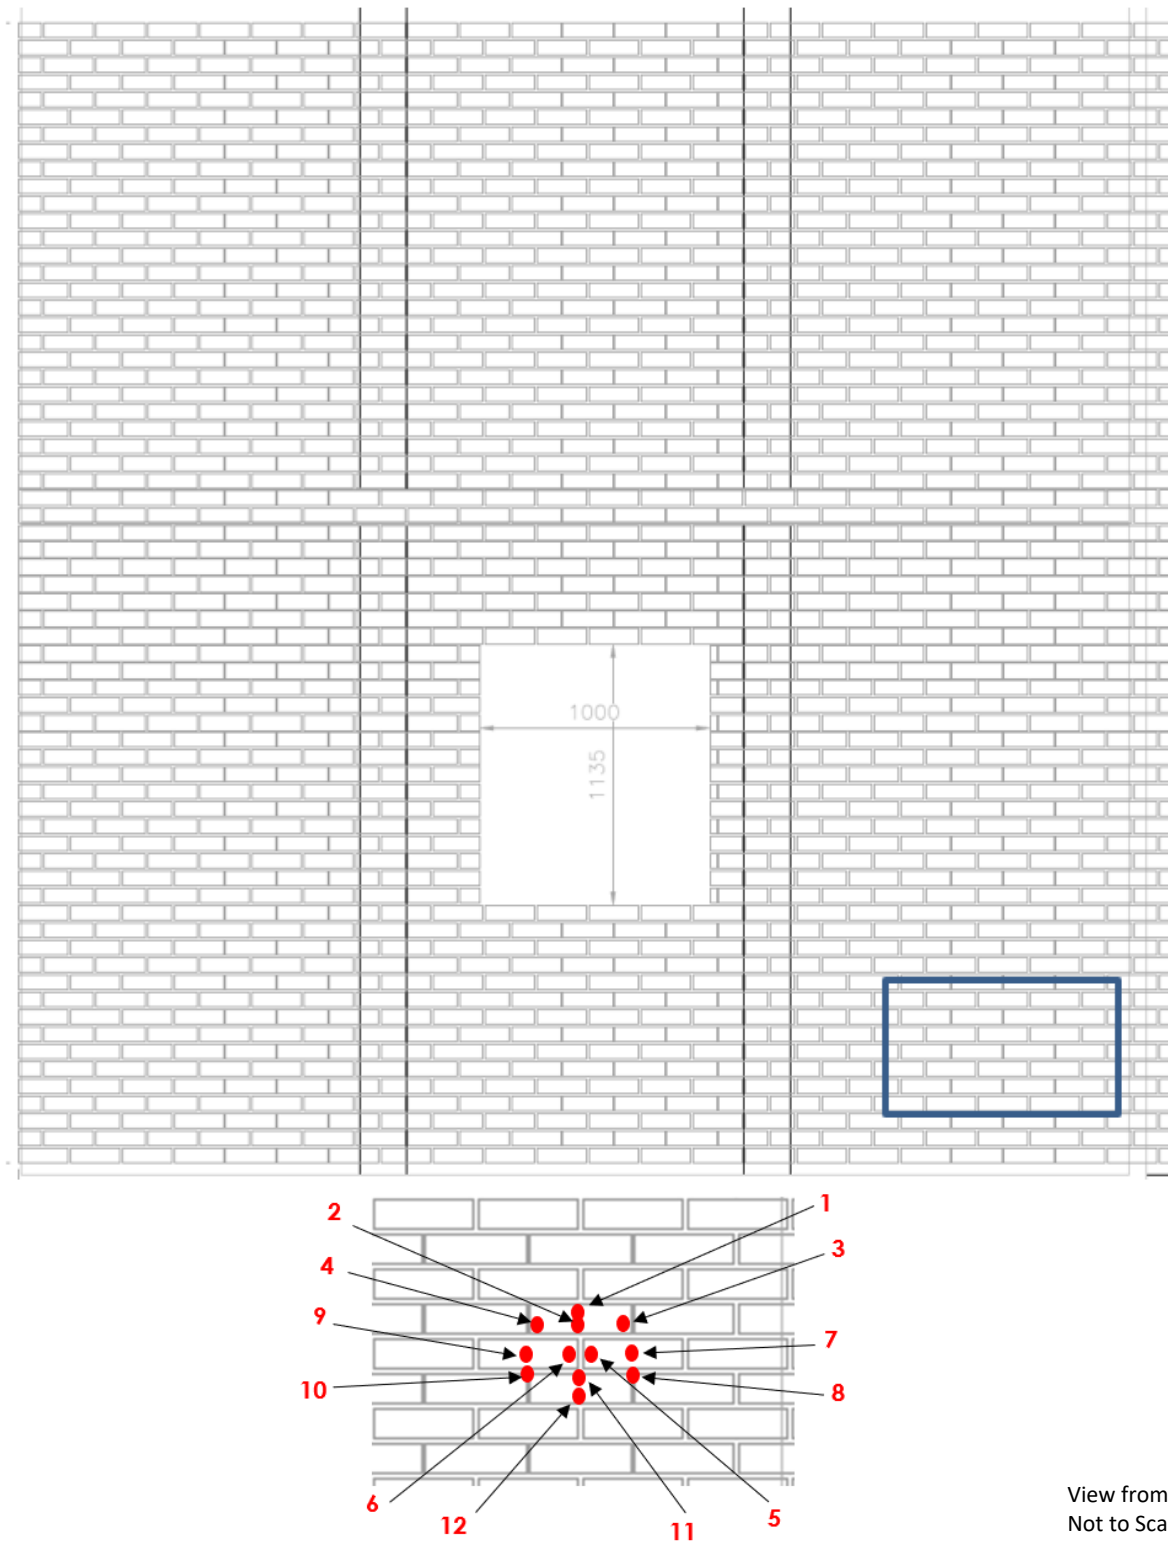
Figure 4

Soft Body – Safety to Persons Impact Positions

Impact Reference	Test Category	Impactor Type	Impact Energy (Nm)	Drop Height (mm)	Observations	Result
1	Cat B	Soft Body (S1)	500	1020	No Damage	Neg Risk
2	Cat B	Soft Body (S1)	500	1020	No Damage	Neg Risk
3	Cat B	Soft Body (S1)	500	1020	No Damage	Neg Risk
4	Cat B	Soft Body (S1)	500	1020	No Damage	Neg Risk
5	Cat B	Soft Body (S1)	500	1020	No Damage	Neg Risk
6	Cat B	Soft Body (S1)	500	1020	No Damage	Neg Risk
7	Cat B	Soft Body (S1)	500	1020	No Damage	Neg Risk
8	Cat B	Soft Body (S1)	500	1020	No Damage	Neg Risk
9	Cat B	Soft Body (S1)	500	1020	No Damage	Neg Risk
10	Cat B	Soft Body (S1)	500	1020	No Damage	Neg Risk
11	Cat B	Soft Body (S1)	500	1020	No Damage	Neg Risk
12	Cat B	Soft Body (S1)	500	1020	No Damage	Neg Risk
1	Cat B	Hard Body (H2)	10	898	No Damage	Neg Risk
2	Cat B	Hard Body (H2)	10	898	No Damage	Neg Risk
3	Cat B	Hard Body (H2)	10	898	Mortar broke from corner of brick	Neg Risk
4	Cat B	Hard Body (H2)	10	898	Small indentation	Neg Risk

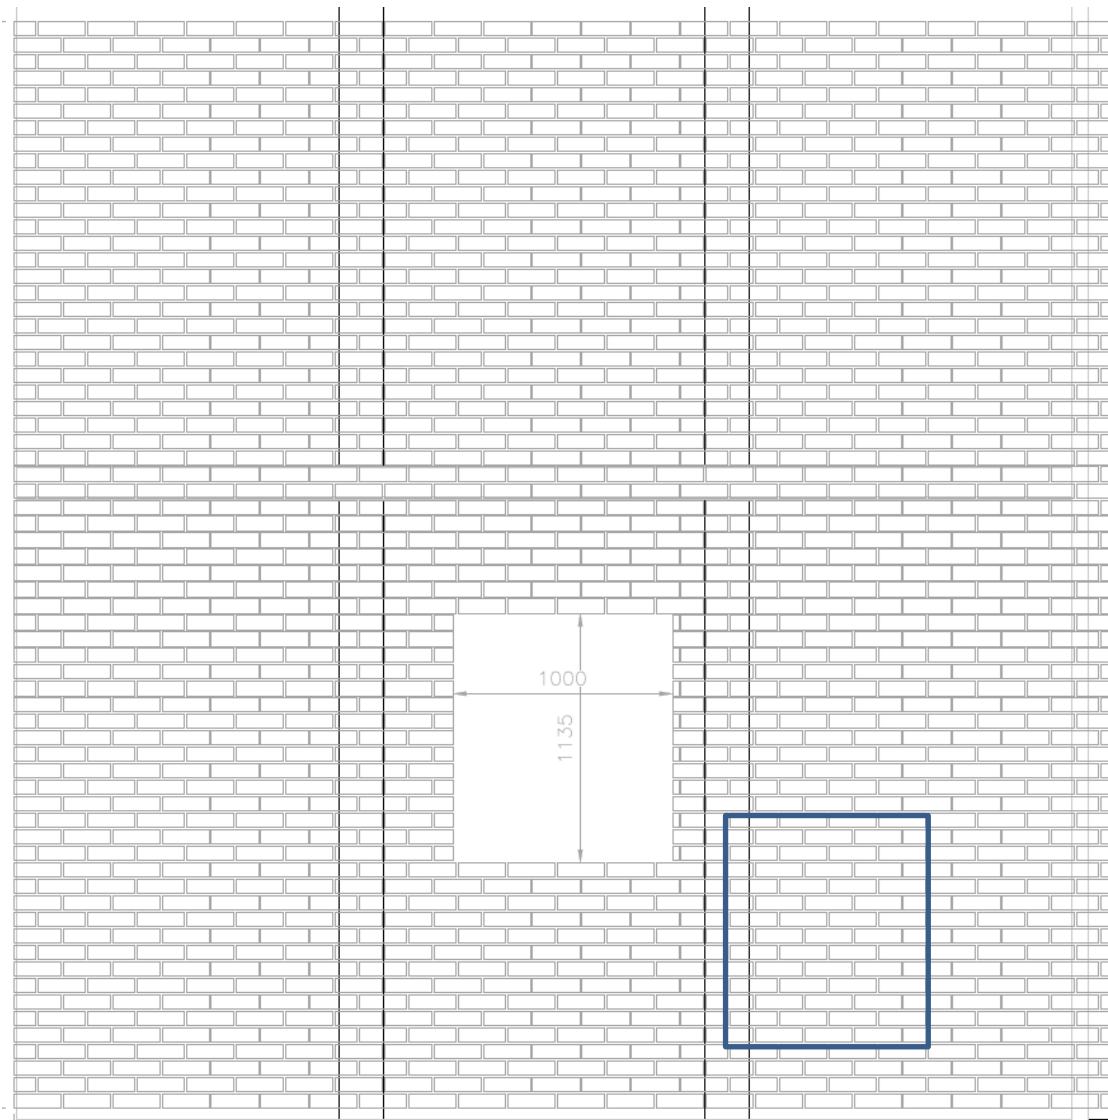
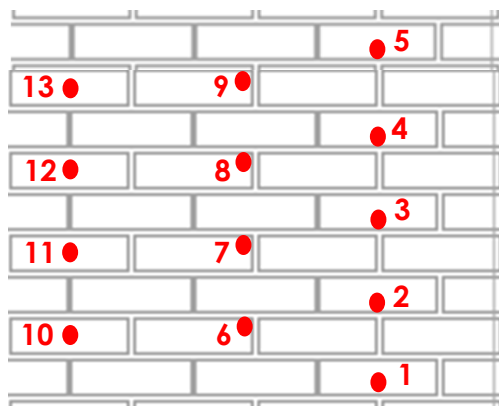
Figure 5

Hard Body – Retention of Performance & Safety to Persons Impact Positions

6	Cat B	Hard Body (H2)	10	898	No Damage	Class 1
7	Cat B	Hard Body (H2)	10	898	No Damage	Class 1
8	Cat B	Hard Body (H2)	10	898	No Damage	Class 1
9	Cat B	Hard Body (H2)	10	898	No Damage	Class 1
10	Cat B	Hard Body (H2)	10	898	No Damage	Class 1
11	Cat B	Hard Body (H2)	10	898	No Damage	Class 1
12	Cat B	Hard Body (H2)	10	898	No Damage	Class 1
13	Cat B	Hard Body (H2)	10	898	No Damage	Class 1

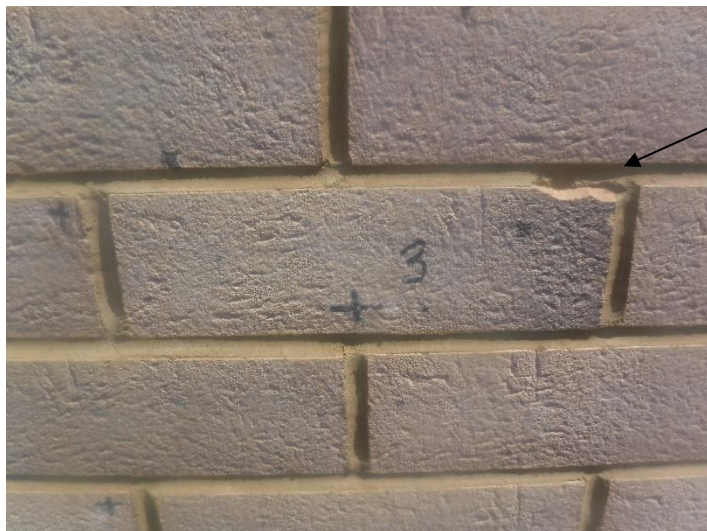
Photograph No. 3

Showing damage caused following hard body impacting. This area was found to have been previously been filled with mortar prior to testing being conducted. Following this impact, a further impact was conducted at impact reference 5 and no damage was found.

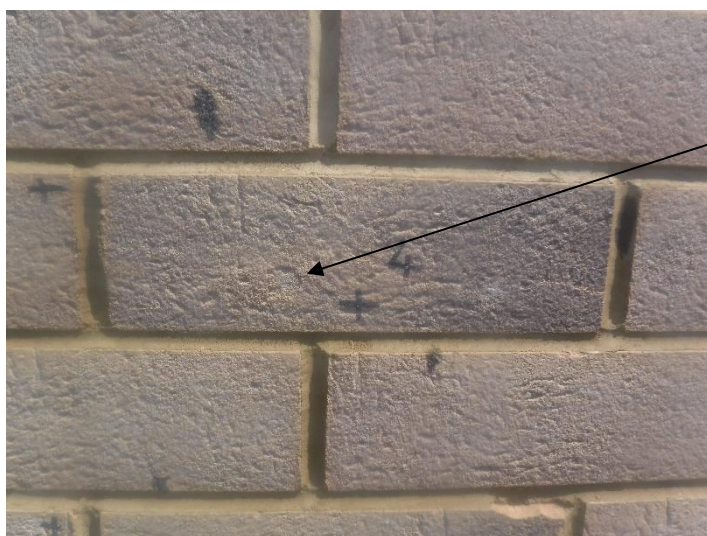
Photograph No. 4

Showing small indentation following hard body impacting, resulting in a Class 2

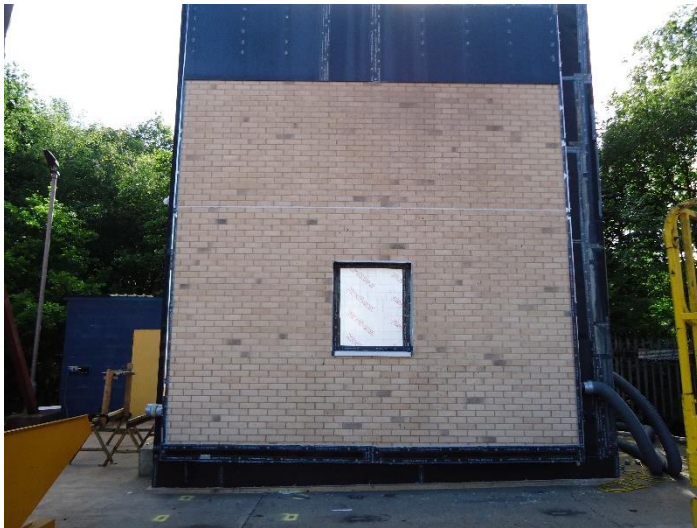
Photograph No. 5

Sample prior to dismantle

There was no water evident in the system in parts designed not to be wetted, and it was found that the system fully complied with the system drawings in Section 7 provided by Generix Facades Limited at the time of the dismantle.

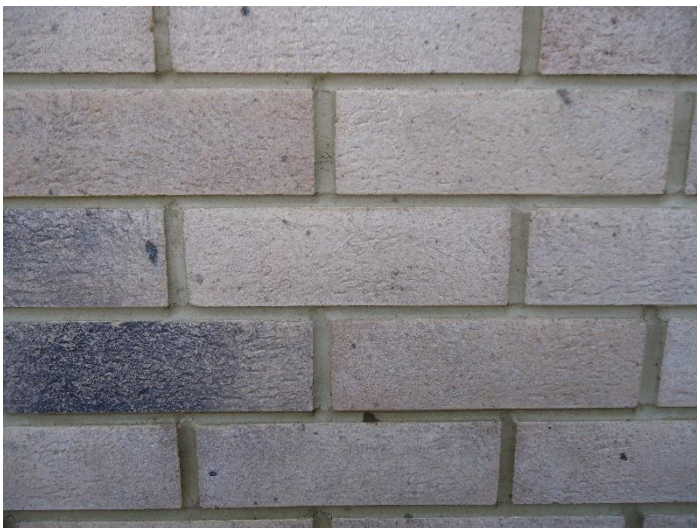
Photograph No. 6

Typical brick detail
with mortar

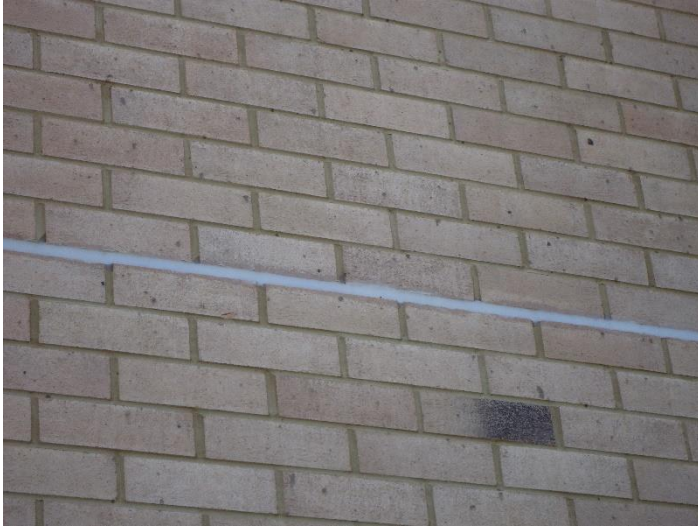
Photograph No. 7

Horizontal expansion
joint detail

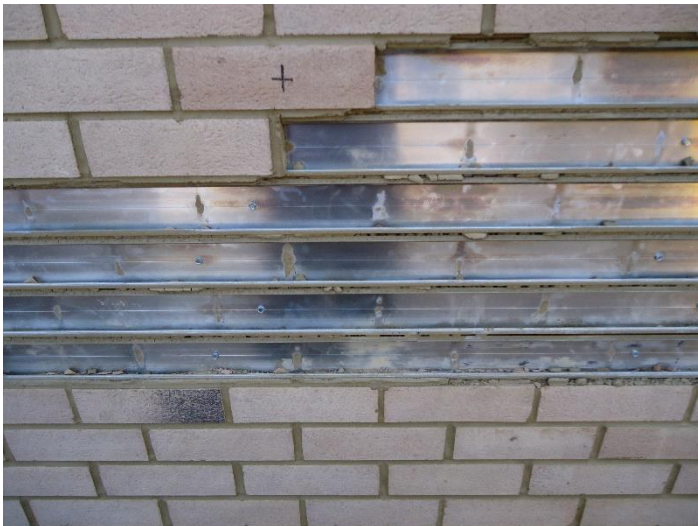
Photograph No. 8

Showing bricks removed
with horizontal fixing trays

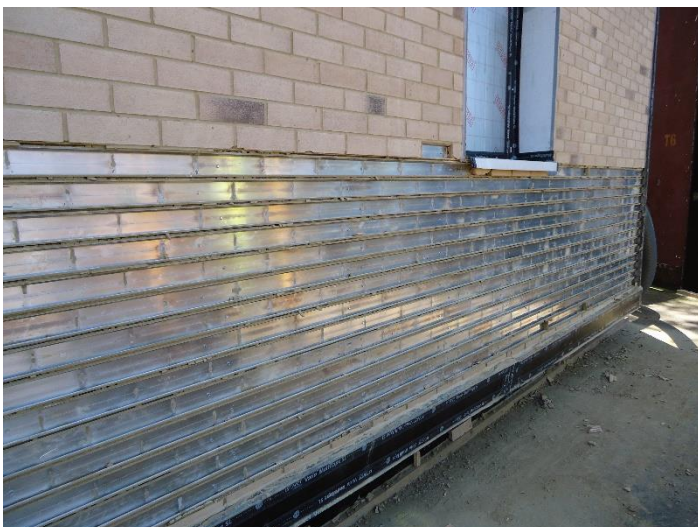
Photograph No. 9

Showing bottom section of
sample with bricks removed

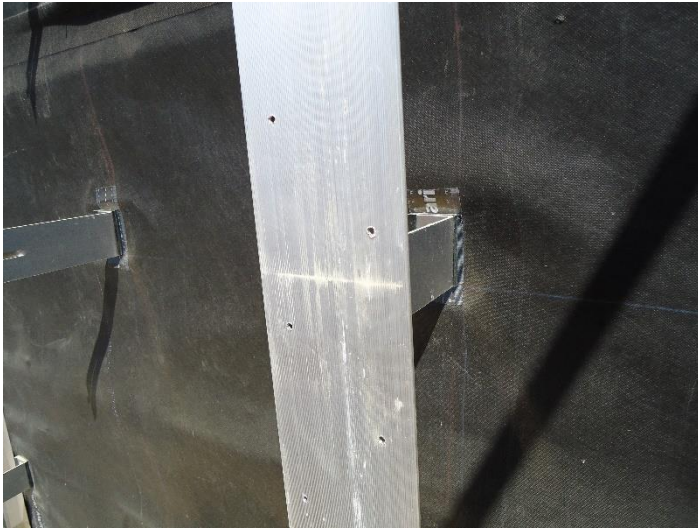
Photograph No. 10

Helping hand and T-rail

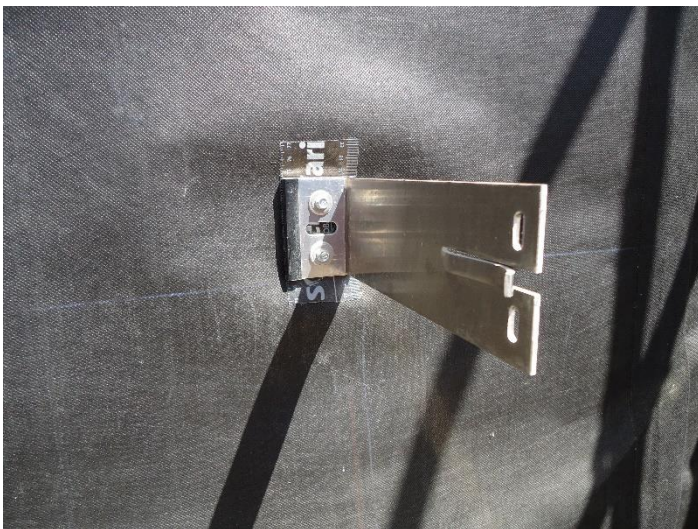
Photograph No. 11

Helping hand bracket

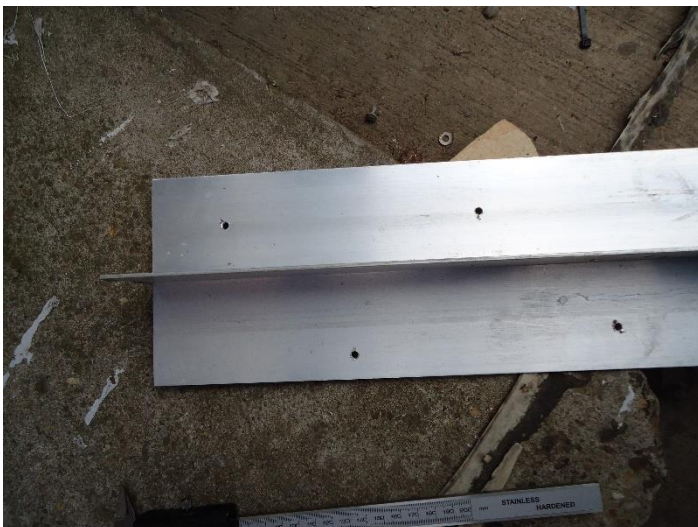
Photograph No. 12

Section of T-rail

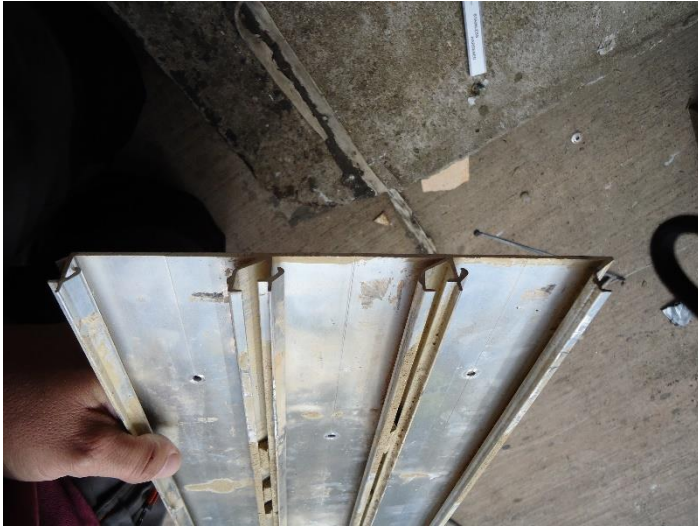
Photograph No. 13

Side view of brick tray

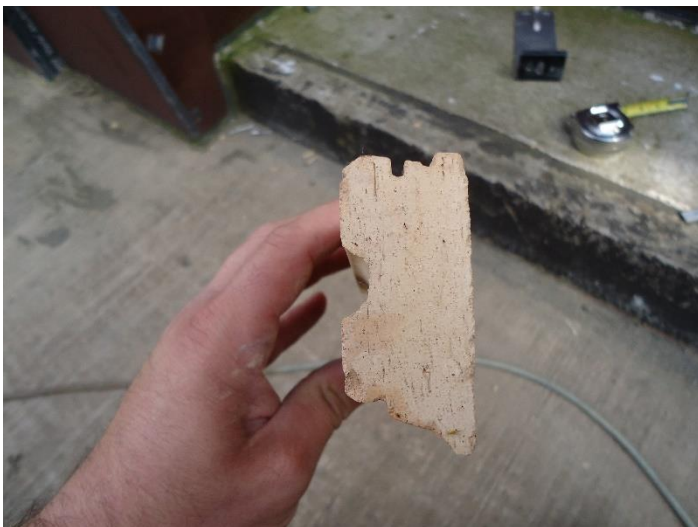
Photograph No. 14

Side view of brick

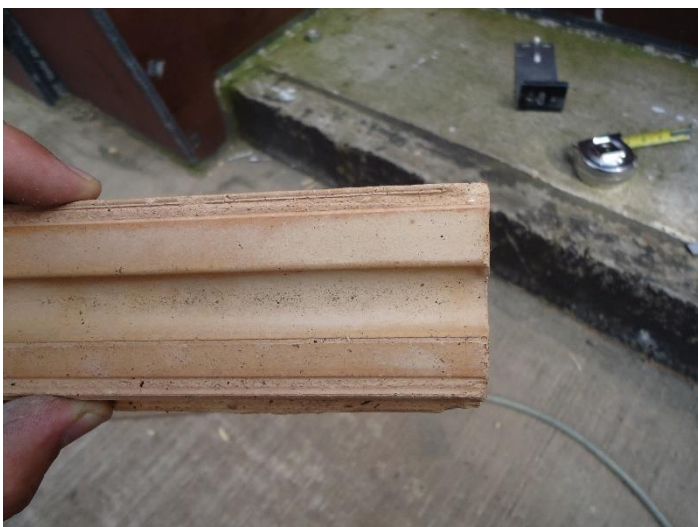
Photograph No. 15

Rear view of brick
