# Optimising Liner Maintenance with Wear Zone Kits

<b>Location</b>	Pilbara Region, WA, Australia
<b>Platform</b>	Deflector Asset
<b>Conditions</b>	Fixed Plant Wear Liners
<b>Solution</b>	Wear Zone Kits

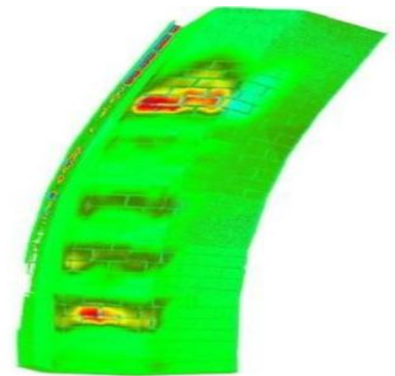
Condition monitoring heat map highlighting

Bradken collaborated closely with the customer's site engineer to address the inefficiencies and improve the maintenance process. By utilising condition monitoring data on the worn deflector over time, Bradken was able to determine those areas of the deflector regularly needing replacement while keeping the lower wearing areas in situ. This knowledge led to "High Wear Zone" and "Low Wear Zone" kits or BOM.

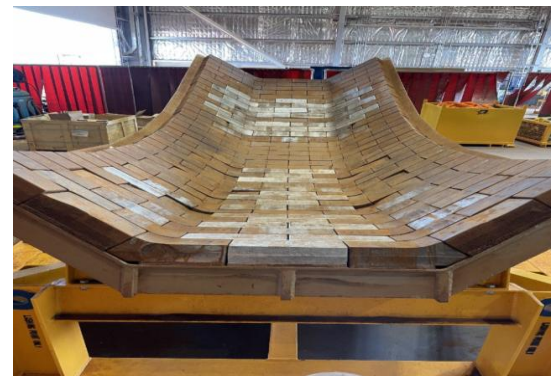
New blocks of the high wear area kit (silver/as cast) installed in the refurbished

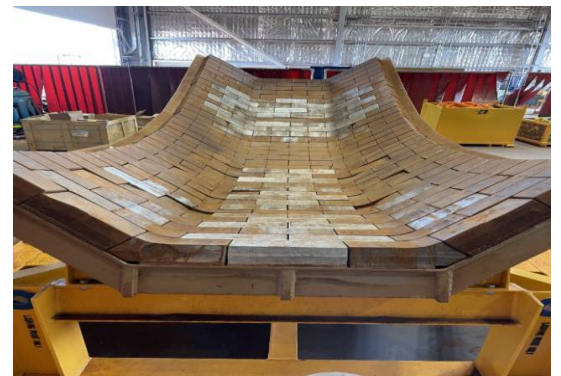
*New blocks of the high wear area kit (silver/as cast) installed in the refurbished*
