# CAT7495 Crawler Shoes

<b>Location</b>	Colombia, South America
<b>Platform</b>	CAT7495 Excavator
<b>Conditions</b>	Coal Overburden
<b>Solution</b>	Bradken OC7495S79-3A Induction Hardened Crawler Shoes

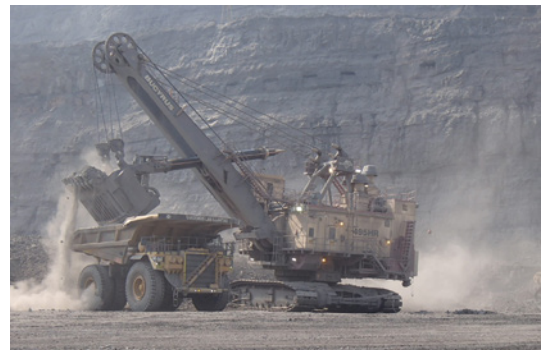
Bradken undercarriage on CAT7495 Excavator

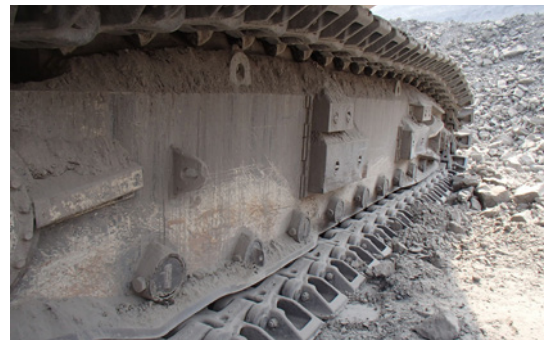
Bradken Induction Hardened OC7495S79-3A

Bradken collaborated with the customer to develop a 79" crawler shoe featuring an innovative ultra-deep wear surface hardening process, which resulted in reduced wear rates on the high wear surfaces; the pin eyes, and the roller paths. By hardening the pin bores, Bradken eliminated the need for a bush, which effectively eliminated shoe failures resulting from bush loss.

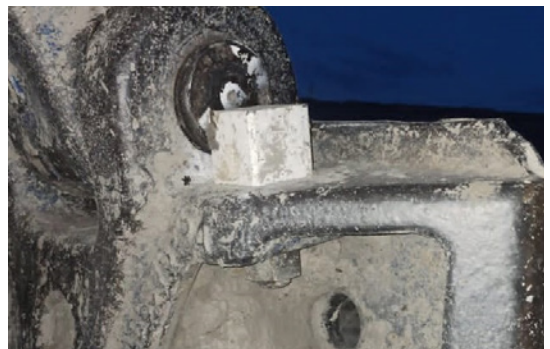
Bradken's upgraded pin retention hardware
