# Liners SB60 – Polywear RC in Cusco, Peru

<b>Location</b>	Cusco, Peru
<b>Platform</b>	Composite mill liners
<b>Conditions</b>	Polymetallic
<b>Solution</b>	Polywear RC

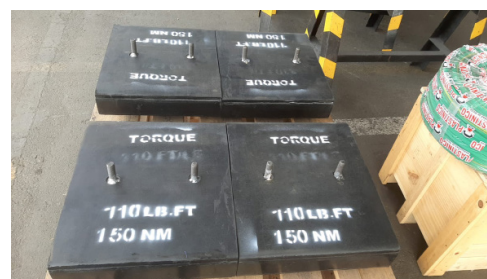
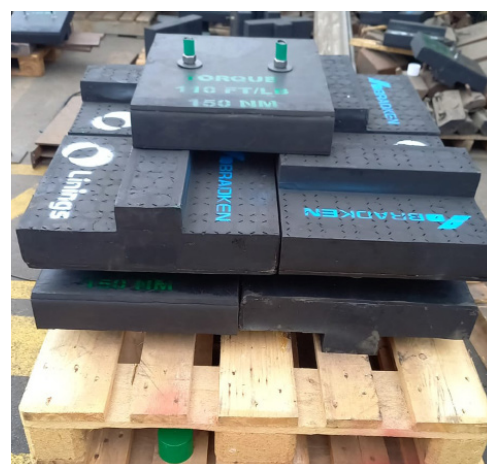
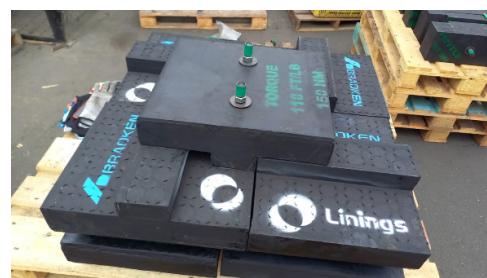
The Bradken Lima team proposed a new design which supported extending the life of the liners. Our innovative design proposal consisted of sectioning three pieces with ceramic rubber and incorporating a lifter bar in the most critical area of the liners.

This recreates a dead bed area of material resulting in prolonging the life of the Liners. This design also includes 500 HB rolled steel in strategic areas to avoid tearing or shattering of the ceramics, due to the high impact of the mineral rocks, keeping them in position until the end of their useful life.

For this project, 38mm high ceramic pads were used. These are overlapped in the direction of flow, thus avoiding wear lines that shorten the life of the liners. Finally, the configuration of the ceramic inserts has been created and is in the process of being patented by Linings.

The service life was increased to approximately 11 months; also, due to the increased lifetime of the ceramic tiles, the number of plant shutdowns to change ceramic tiles has been reduced.
