Upgrading Apron Feeder Skirt Liner Material to Enhance Resistance

Location	Pilbara, Western Australia
Platform	Apron Feeder
Conditions	Skirt Liner Upgrade
Solution	Ceramic Liners

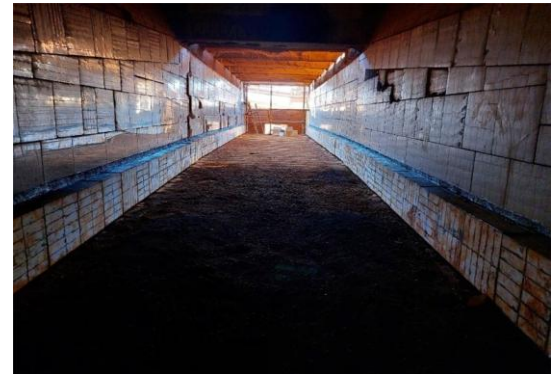
Primary apron feeder tunnel, viewing towards discharge end.

Bradken's design and engineering teams conducted a comprehensive assessment of the issue and leveraged advanced modelling to identify the most suitable liner solution for reducing maintenance cycles and ensuring consistent product flow through this analysis. Bradken determined that replacing the Ni-Hard cast liners with 112mm ceramic liners would provide superior abrasion resistance, significantly extend maintenance intervals, and minimise downtime. To expedite the solution, the redesigned liners were engineered to standard sizes, ensuring a quick and seamless supply. Additionally, Bradken incorporated a 135mm stud installation, as specifically requested by the customer, to enhance structural integrity and reliability.

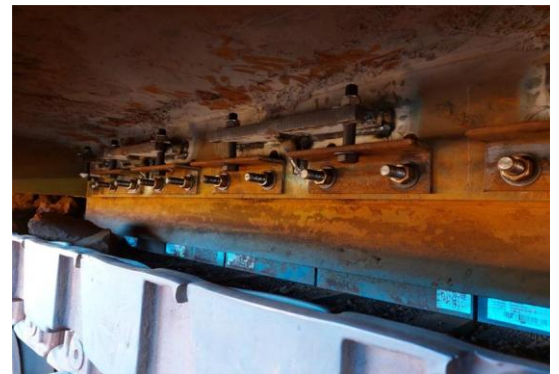
Skirt liner adjustable mountings.

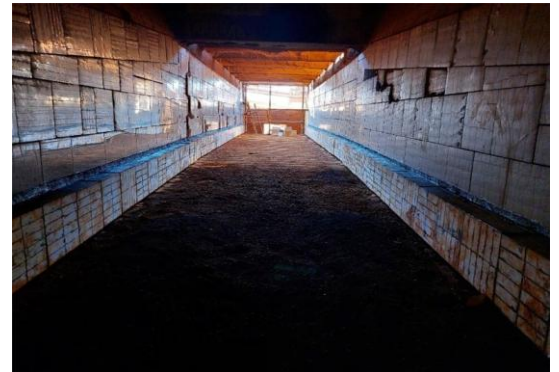
Primary apron feeder tunnel, viewing towards discharge end.

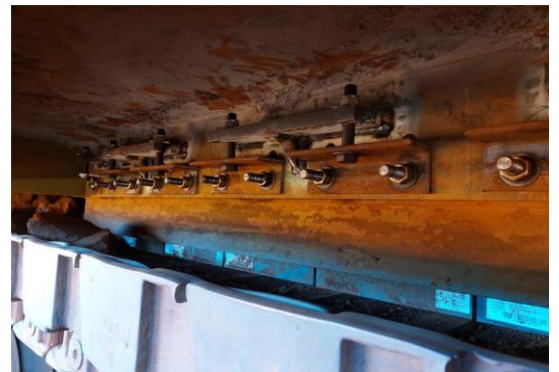
Skirt liner adjustable mountings.
