Upgrading Apron Feeder Skirt Liner Material to Enhance Resistance

Location	Pilbara, Western Australia
Platform	Apron Feeder
Conditions	Skirt Liner Upgrade
Solution	Ceramic Liners

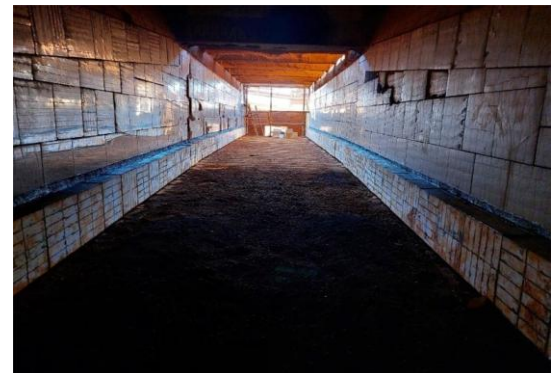
Primary apron feeder tunnel, viewing towards discharge end.

Bradken's design and engineering teams conducted a comprehensive assessment of the issue and leveraged advanced modelling to identify the most suitable liner solution for reducing maintenance cycles and ensuring consistent product flow through this analysis. Bradken determined that replacing the Ni-Hard cast liners with 112mm ceramic liners would provide superior abrasion resistance, significantly extend maintenance intervals, and minimise downtime. To expedite the solution, the redesigned liners were engineered to standard sizes, ensuring a quick and seamless supply. Additionally, Bradken incorporated a 135mm stud installation, as specifically requested by the customer, to enhance structural integrity and reliability.

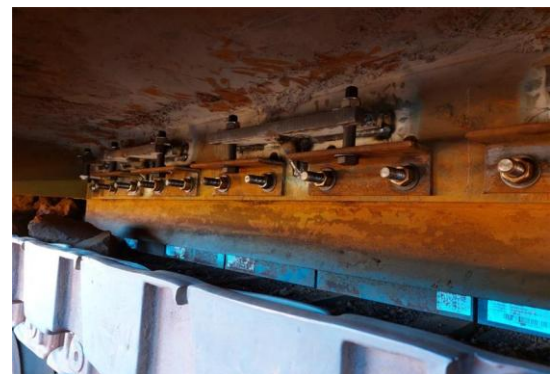
Skirt liner adjustable mountings.

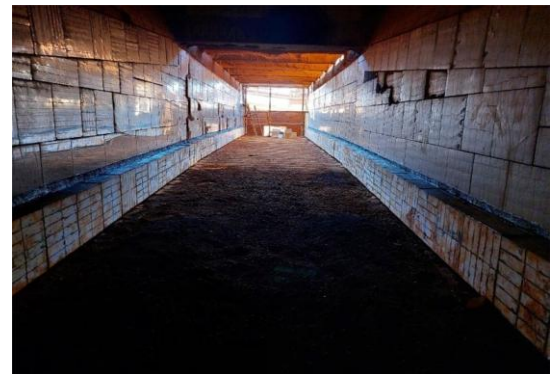
Primary apron feeder tunnel, viewing towards discharge end.

The installation of Bradken's ceramic liner solution delivered measurable improvements:

- Extended maintenance intervals, reducing shutdown frequency
- Minimised product spillage, enhancing operational efficiency
- Increased production output, ensuring smoother operations

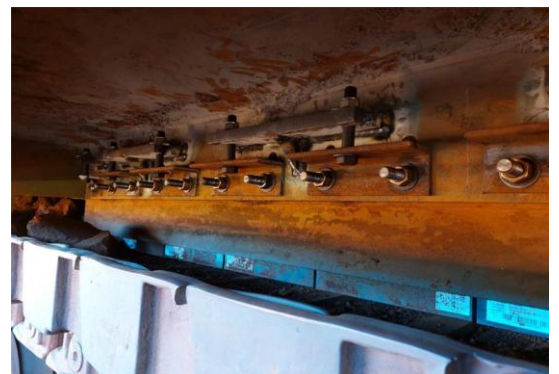
Skirt liner adjustable mountings.
