Combined Corner Liners

Location	CIS (Commonwealth of Independent States)
Platform	40ft SAG
Conditions	Primary Grinding
Solution	Combined Corner Liners

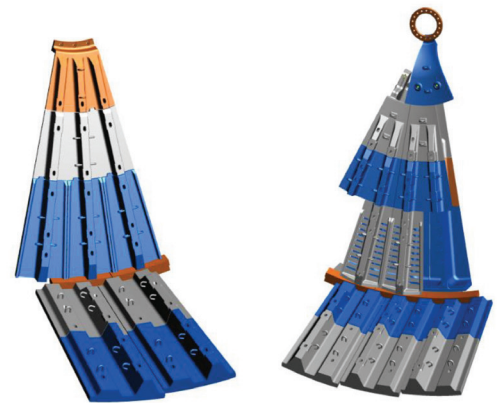
Bradken design Vs original design

The Product Development engineers redesigned the Feed End Outer Liner, Shell Liners and Discharge End Grates to eliminate the loose steel corner liners for improved safety.

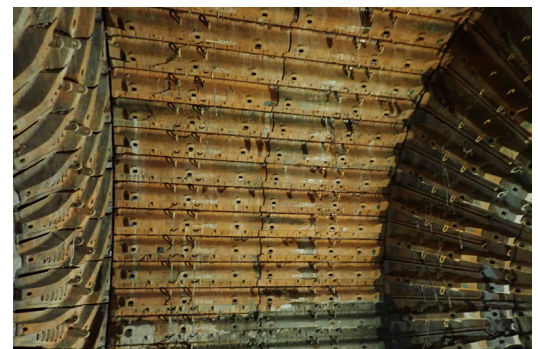
New installation with loose corner liners eliminated

The new liner design improved reline safety for the operation by removing a total of 60 loose steel corners liners and reducing the overall liner set mass by 19,644kgs. The reduction in parts saved 12 hours per mill reline, resulting in increased equipment availability.

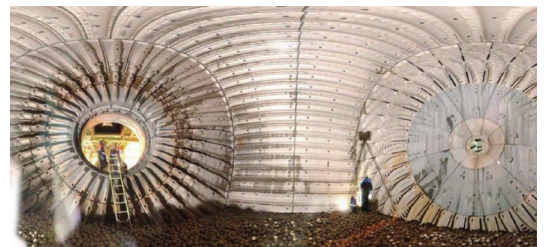
Vision Insight® 3D scanning

Using Vision Insight® 3D Scanning data to review wear patterns and the 3D DEM modelling to verify charge motion and trajectories, the engineers were able to eliminate the loose steel corners liners and remove 19,644kgs of liner mass. By utilising virtual simulation, it was verified that all the liners could be installed and removed independent of each other.
