Duracast® 18 High Chrome White Iron Vortex® Grates for a 32ft AG Mill

Location	North America
Platform	32ft AG Mill
Conditions	High Abrasion/Hard Rock
Solution	Vortex® Grate cast in Duracast® 18 High Chrome White Iron

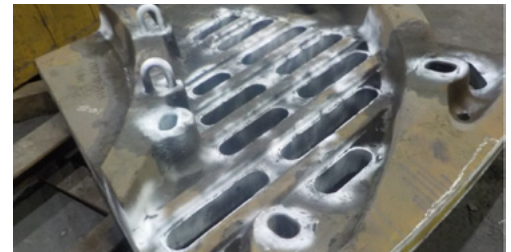
Inspection

Overall, the new Duracast®18 Vortex® Grates projected a 40% improvement in wear life over the DA85 material, and improved grind performance levels if left in service, as well as reduced reline frequency and increased safety. A thorough inspection confirmed that the Duracast®18 Vortex® Grate remained sound, with no cracking evident.

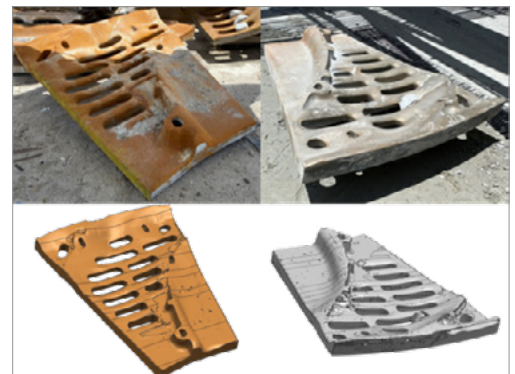
Worn Grates

Bradken's Duracast®18 Vortex® Grate performed well in operation and exceeded customer expectations in its end-of-life performance metrics. The Duracast®18 Vortex® Grates lasted 42 days longer in service compared to the DA85 Vortex® Grate; a 25% wear life improvement. They were also +15mm thicker in the critical wear zone when removed. The Duracast®18 Vortex® Grate also presented a 6mm smaller aperture size at end of life supporting improved grind performance.
