Rebuild ready: 3D mapping a quake-damaged Cathedral

6 JUNE 2019

Surveying a damaged building can be dangerous. Mapping using drones reduces risk to staff and costs to the community.

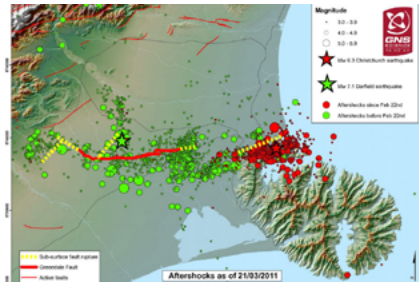
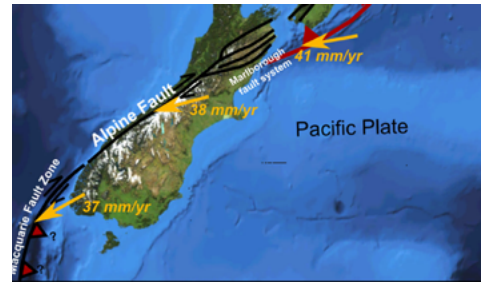
Map showing the mainshock and aftershocks above magnitude 3, and fault ruptures in Canterbury via GeoNet (left) and The Alpine fault line (right: image by Mikenorton - own work, CC BY-SA 3.0)

New Zealand is stretched across a fault line and earthquakes are common, although seldom as severe as the 2011 quake. By August 2012, the area had experienced more than 11,000 aftershocks of a magnitude 2 or higher. Aftershocks were felt up to 300 kilometers away from the epicenter.

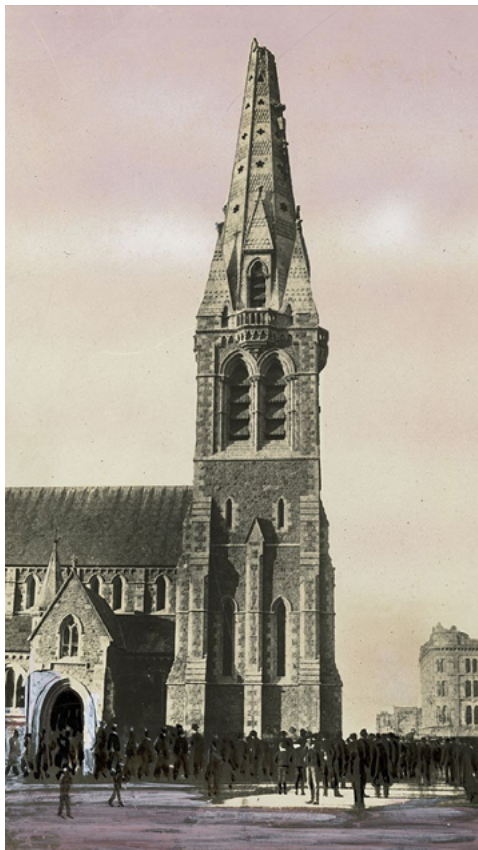
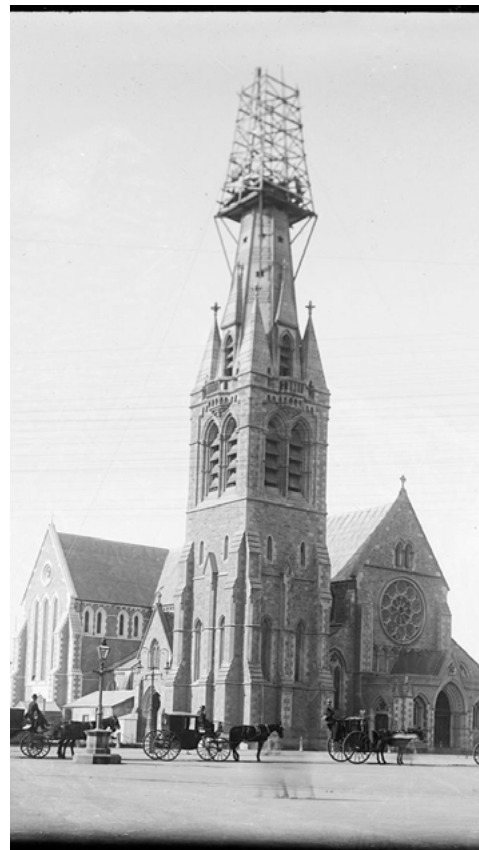
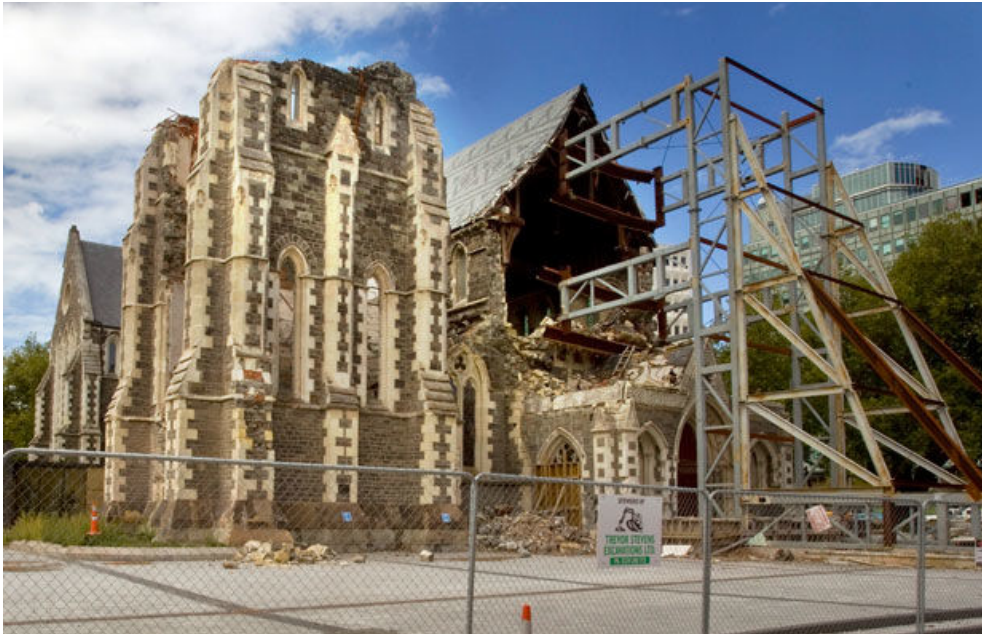
Three views of the Christchurch Cathedral (clockwise from top left) 1888, 1091 and 2012
(image John Kirk-Anderson/Fairfax NZ)

The greatest damage occurred in 2011. The first shake destroyed the spire and part of the tower, and left the rest of the building severely damaged. Aftershocks collapsed the west wall of the Cathedral, and what was left of the tower had to be demolished in 2012.

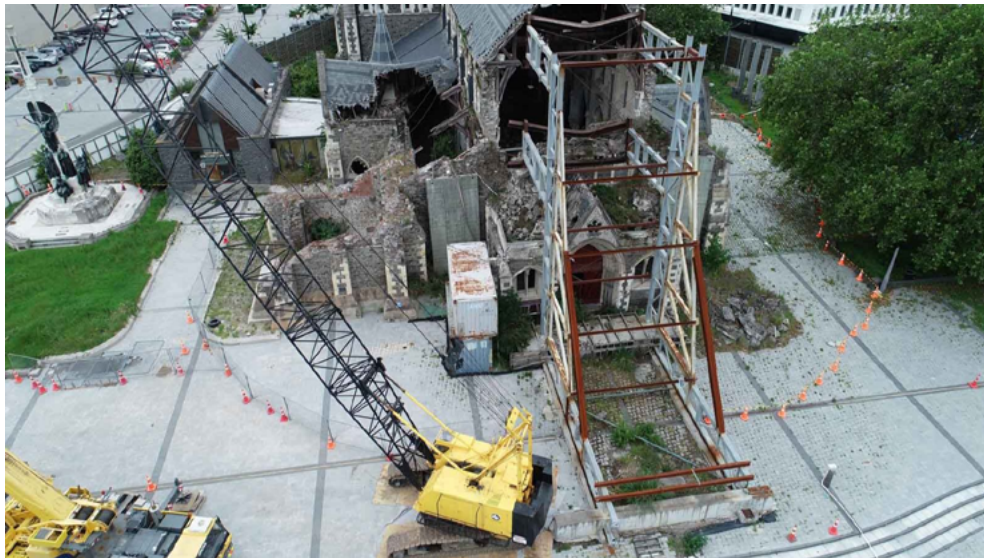
The drone flight captured the damaged Cathedral

A total of four flights were completed: two oblique and two grid nadir to capture as much information as possible.

“Unfortunately we had an issue with the connection to the drone on one of the flights,” says Clement. “That meant we were missing one set of oblique images over most of the square, which resulted in missed detail on the Cathedral and surrounding buildings.”

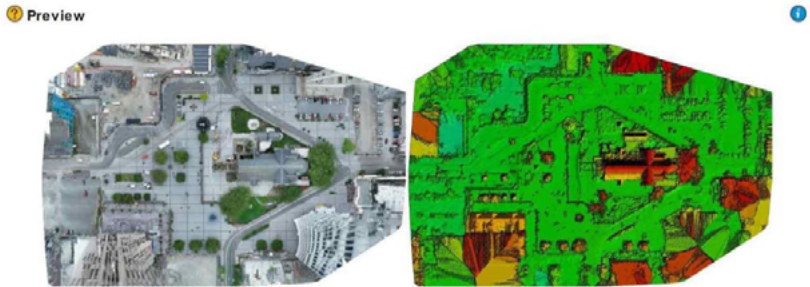
Figure 1: Orthonosaic and the corresponding sparse Digital Surface Model (DSM) before densification.

Detail of the project’s [quality report](#)

Images	median of 49784 keypoints per image	✓
Dataset	584 out of 584 images calibrated (100%), all images enabled	✓
Camera Optimization	0.1% relative difference between initial and optimized internal camera parameters	✓
Matching	median of 9227 matches per calibrated image	✓
Georeferencing	yes, 8 GCPs (8 3D), mean RMS error = 0.006 m	✓

Before takeoff, eight ground control points (GCPs) were levelled to a 5mm accuracy. A further 12 checkpoints were added during processing, giving the mapping project an average ground sampling distance (GSD) of 1.38cm.

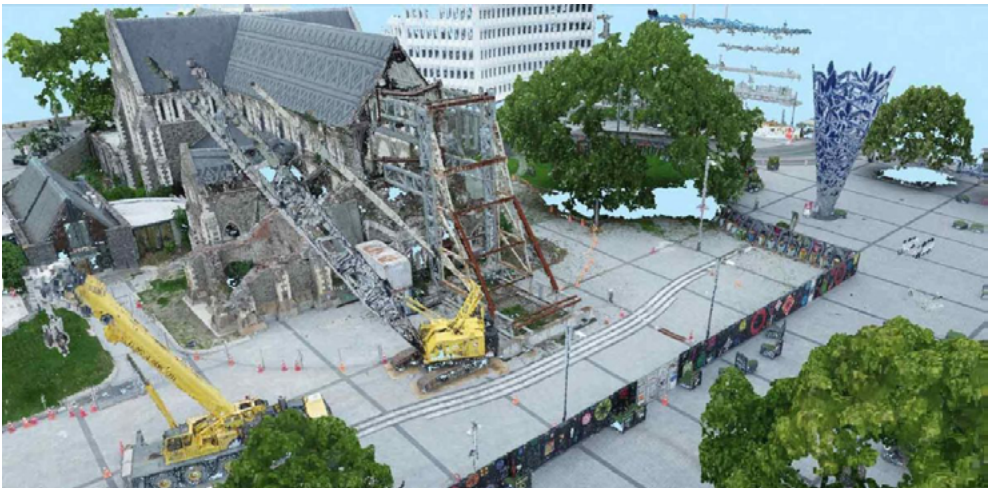
A 3D model of Cathedral Square and the Christchurch Cathedral in Pix4Dmapper
[Explore this model in Pix4D Cloud](#)

The model gave the team the certainty they needed to begin the detailed design phase of the southern portion of Cathedral Square rebuild.

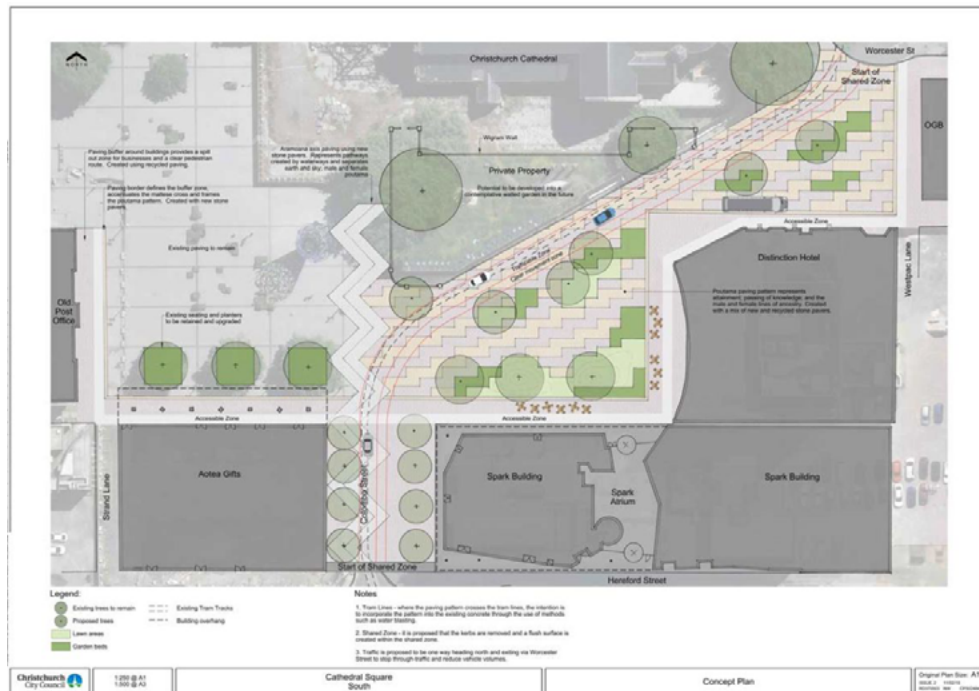
A plan to rejuvenate Cathedral Square, developed by the Christchurch City Council

This part of the rebuild is to coincide with the commercial development that is underway on the southern perimeter of the square, and is due to begin opening in late 2019.
