Clinical Case Report

Digital-driven new patient exams with the Align™ Oral Health Suite.

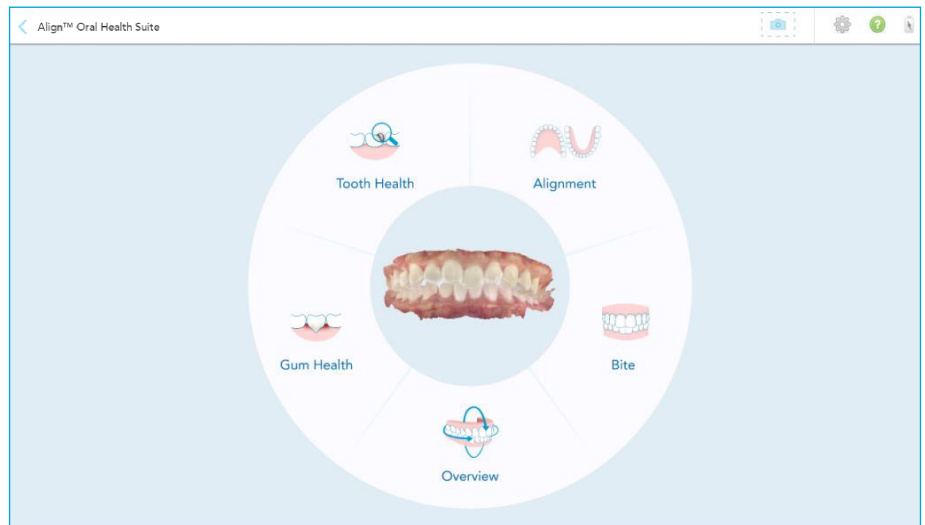
After scanning the patient, I accessed the Align™ Oral Health Suite, which showed me a wheel with five conditions to choose from to start the consultation. I started with Tooth Health and went around the wheel to finish with the Overview condition.

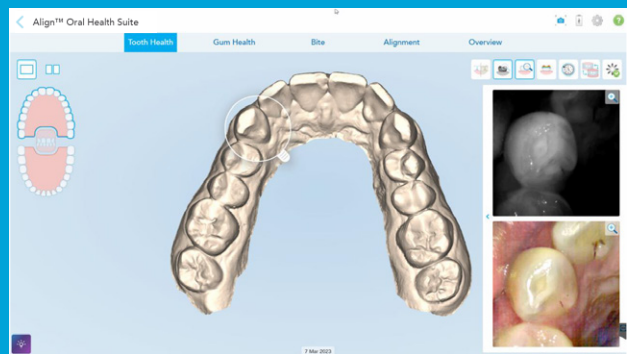
FIGURE 4: The stone model, in combination with the integrated 3D intraoral camera, helps highlight the tooth wear present along the incisal edges of the incisors, canines, and the buccal cusps of the premolars.

I activated the stone model to help identify tooth wear in the occlusal and incisal edges in both arches. The images reveal that this patient has mild and moderate wear in both arches and larger occlusal contact areas on the left side. The buccal cusps of the upper premolars and the incisal edges of upper and lower canines and incisors also reveal mild to moderate wear (Figures 4-5).

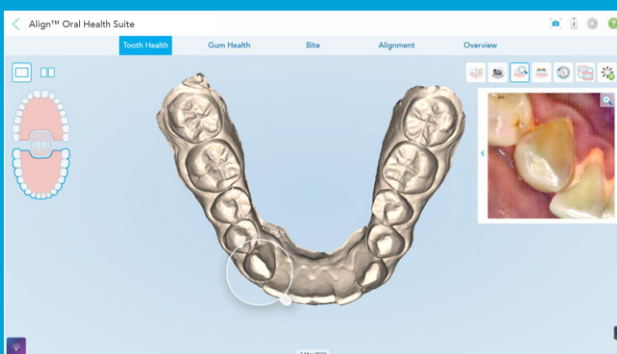
FIGURE 5: Tooth wear is present along the incisal edges of lower incisors, canines, and the buccal cusps of premolars.
