# **Flood Investigation Report**

## **Cataract Bridge Mill, Mellor, Stockport**

**Services to Place  
Engineering Services  
Drainage Section**

**May 2012**

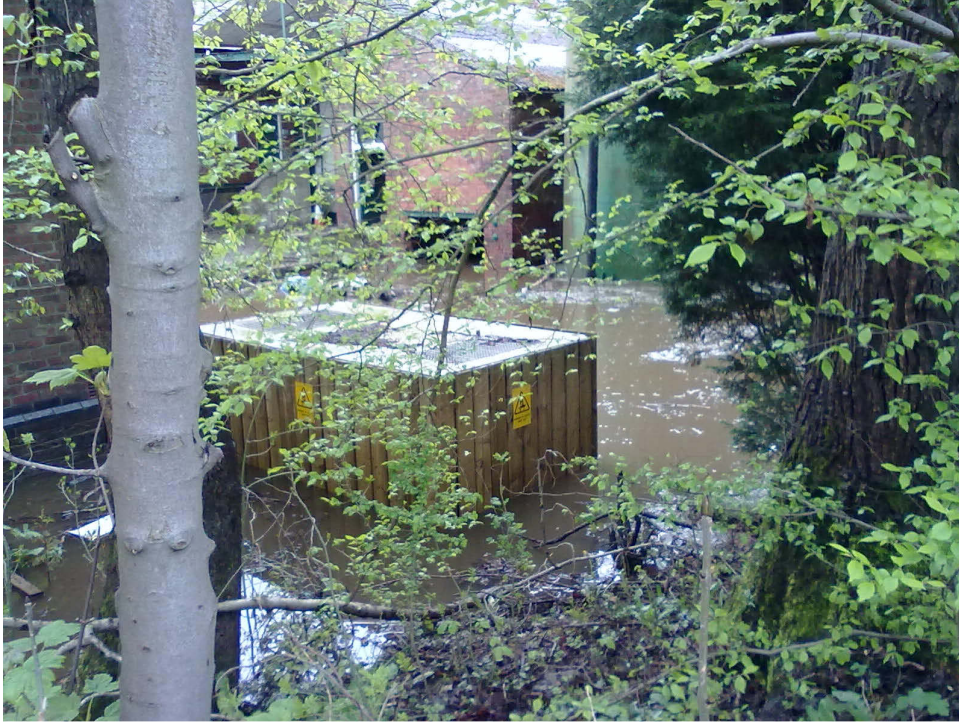
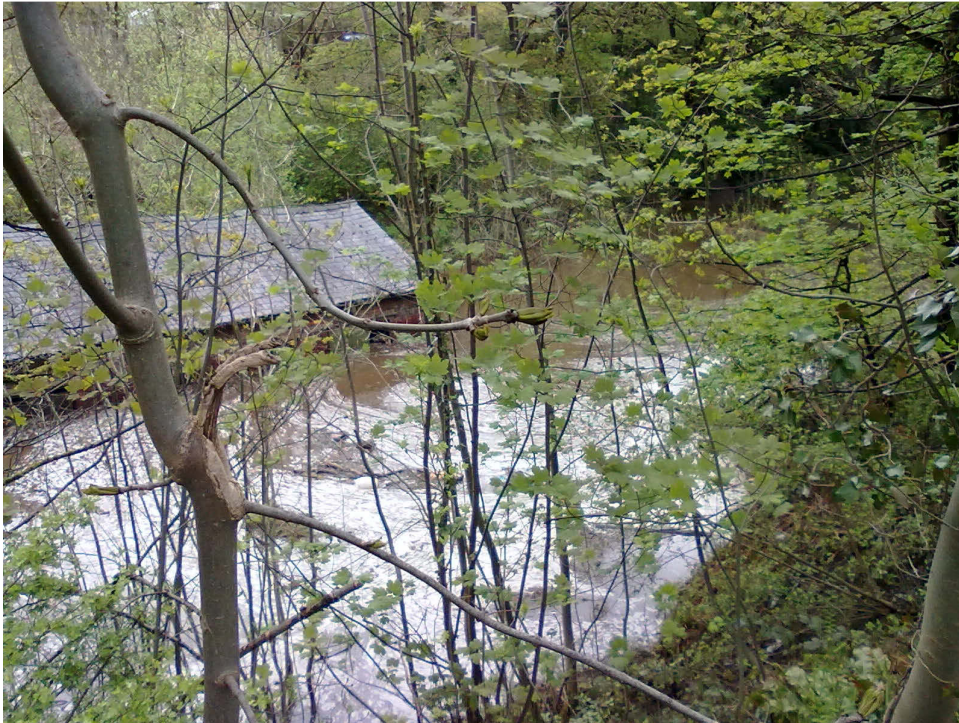
The flooding incident was reported by a member of public and passed to the Highway Structures section at SMBC on the 11<sup>th</sup> May 2012. The member of public also supplied photographs of the flooding incident (Figures 3 and 4).

**Figure 3: Flooding photograph (Source: member of public)**

**Figure 4: Flooding photograph 2 (Source: member of public)**

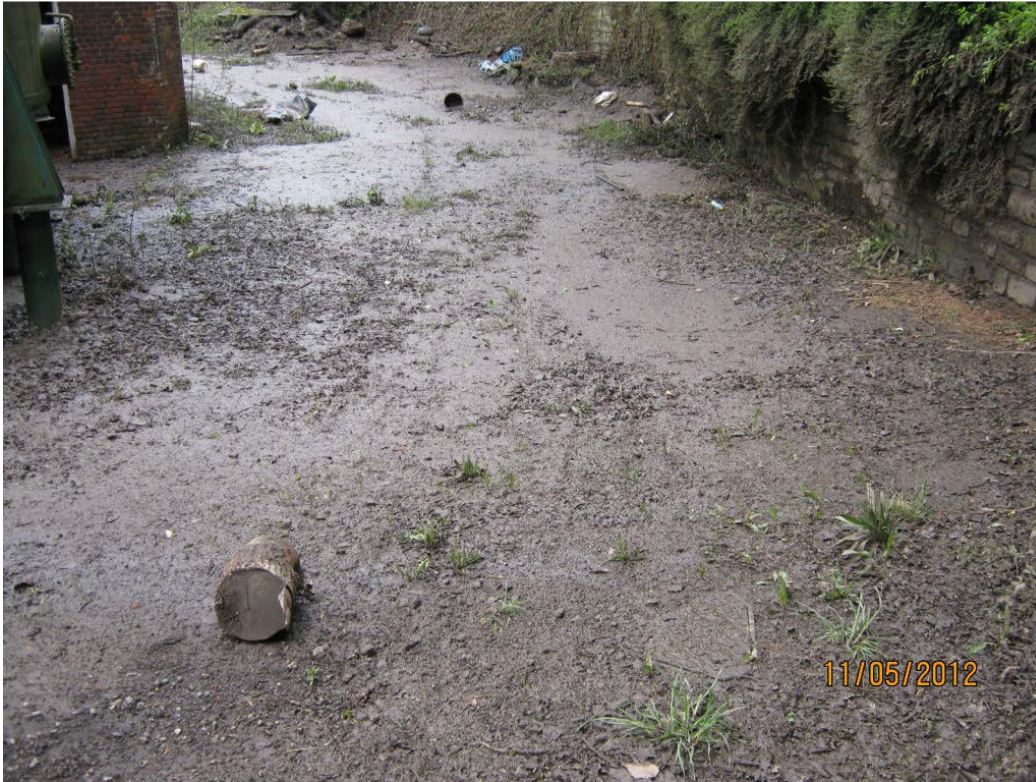
The site was inspected by SMBC and although flood waters had receded, photographs were taken and a partially blocked trash screen was found at the culvert inlet (Figures 5 and 6). The member of public informed the officers that the flood had not affected Longhurst Lane and that similar flooding had never been noticed at this site before.

**Figure 5: Flooding photograph (Source: SMBC Highway Structures)**

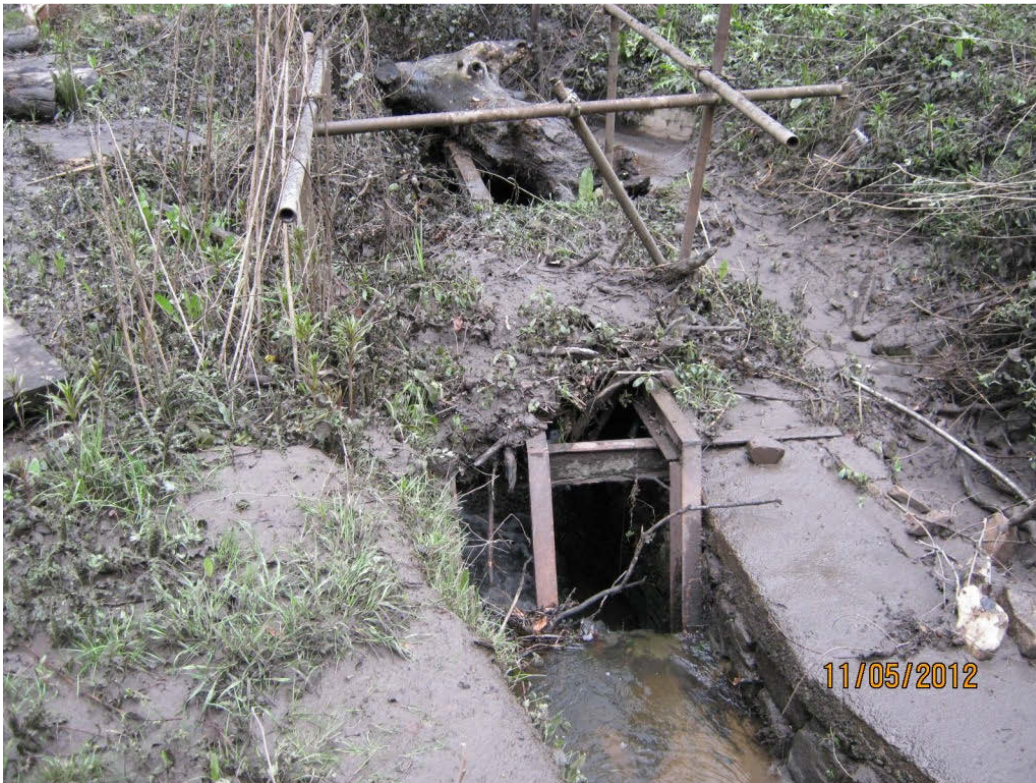
**Figure 6: Partially blocked inlet trash screen (Source: SMBC Highway Structures)**

The trash screen on the culvert inlet was found to be partially blocked on the 11<sup>th</sup> May 2012. A blockage at the inlet will cause water to pond and flood the adjacent land. The trash screen design also appeared poor which could lead to increased blockages or the screen working incorrectly. The Environment Agency has guidelines available for trash screen design.

A long term solution would be for the riparian owner, with consent from the EA, to improve the trash screen on the culvert inlet. When the trash screen is improved and a maintenance clearance schedule formulated, the risk of debris entering the culvert will be reduced, and hence the flood risk.
