HERITAGE ECONOMIC REGENERATION SCHEME (HERS)

COMPLETED FACELIFTING PROJECTS

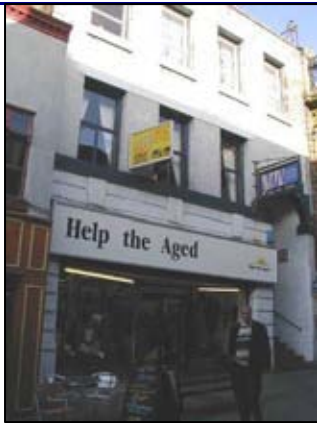
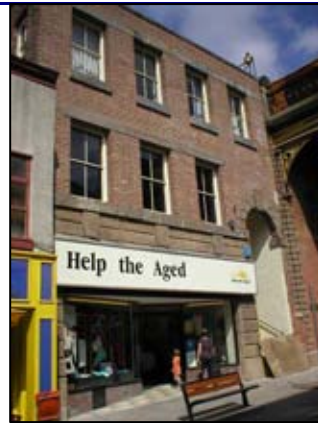
◀13 Little Underbank

Before

After

- Structural repairs to external elevations.
- Repoint external elevations where necessary.
- Remove existing paint from the front elevation.
- Remove existing windows and replace with 2 over 2 timber sliding sash windows.
- Improve lighting to the steps area.
- Decorate all new external woodwork and brickwork where required.

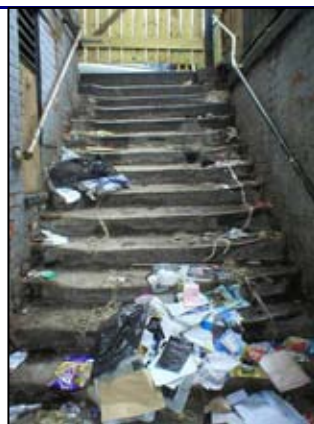
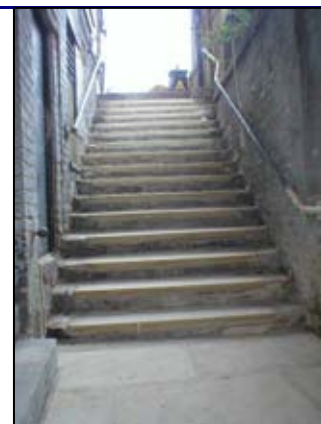
Aunt Sally's Steps adjacent to 13 Little Underbank▶

Before

After

- Repair existing stone steps to top flight by removing existing stone slips and replacing with new stone slips to match originals and install a new stone veneer across the full width of the bottom flight of steps and make good.

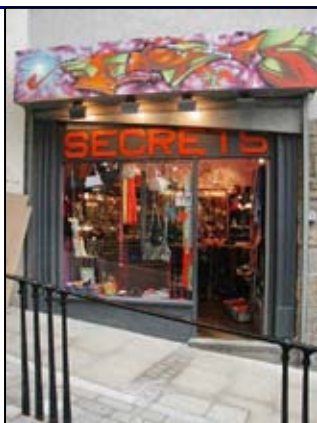
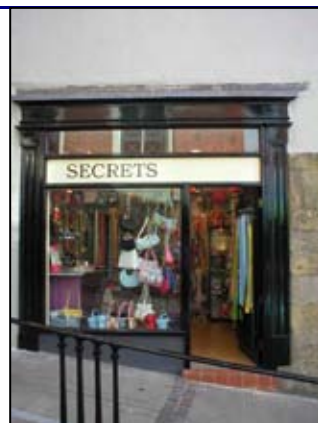
◀32 Bridge Street Brow

Before

After

- Remove existing box and external roller shutter.
- Remove inappropriate signage.
- Repair existing pilasters and fascia.
- Install internal security grille and laminated glass to shopfront and security panel to door.
- Redecoration of the shopfront and traditional signwriting to fascia board.

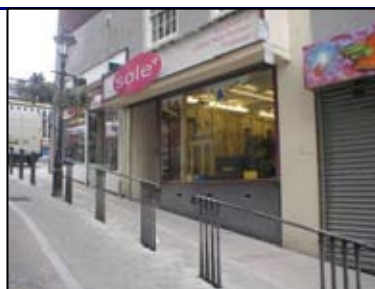
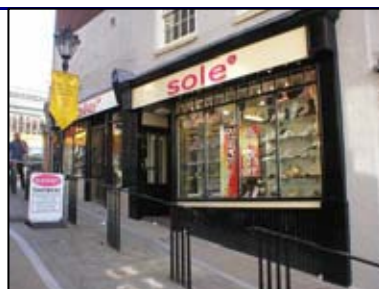
34-36 Bridge Street Brow▶

Before

After

- Remove inappropriate modern shopfronts and external shutters.
- Reinststate traditional shopfronts.
- Install internal shutters and laminated glass to shopfronts.
- Install gates to recessed door areas.

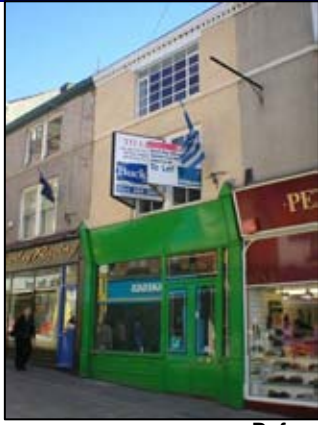
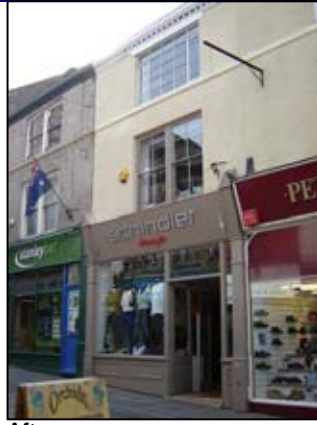
◀6 Little Underbank

Before

After

- Roof repairs
- Reinstall historic windows.
- Reinstall shop front.

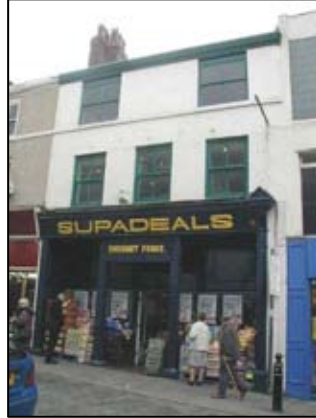
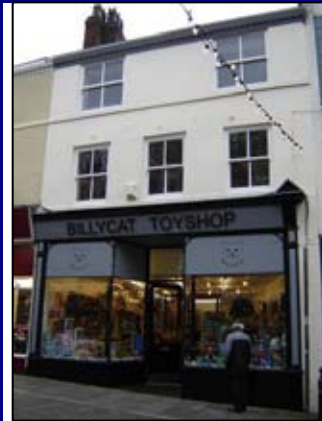
2 Little Underbank▶

Before

After

- Restoration of historic shopfront to match those on Nos. 4 & 6.
- Re-slating of roof & repairs to lead gutters.
- Reinstalling cast iron rainwater goods.
- Repairs to windows & reinstalling traditional sashes where missing.
