A2. Cheadle West

2.1. Overview

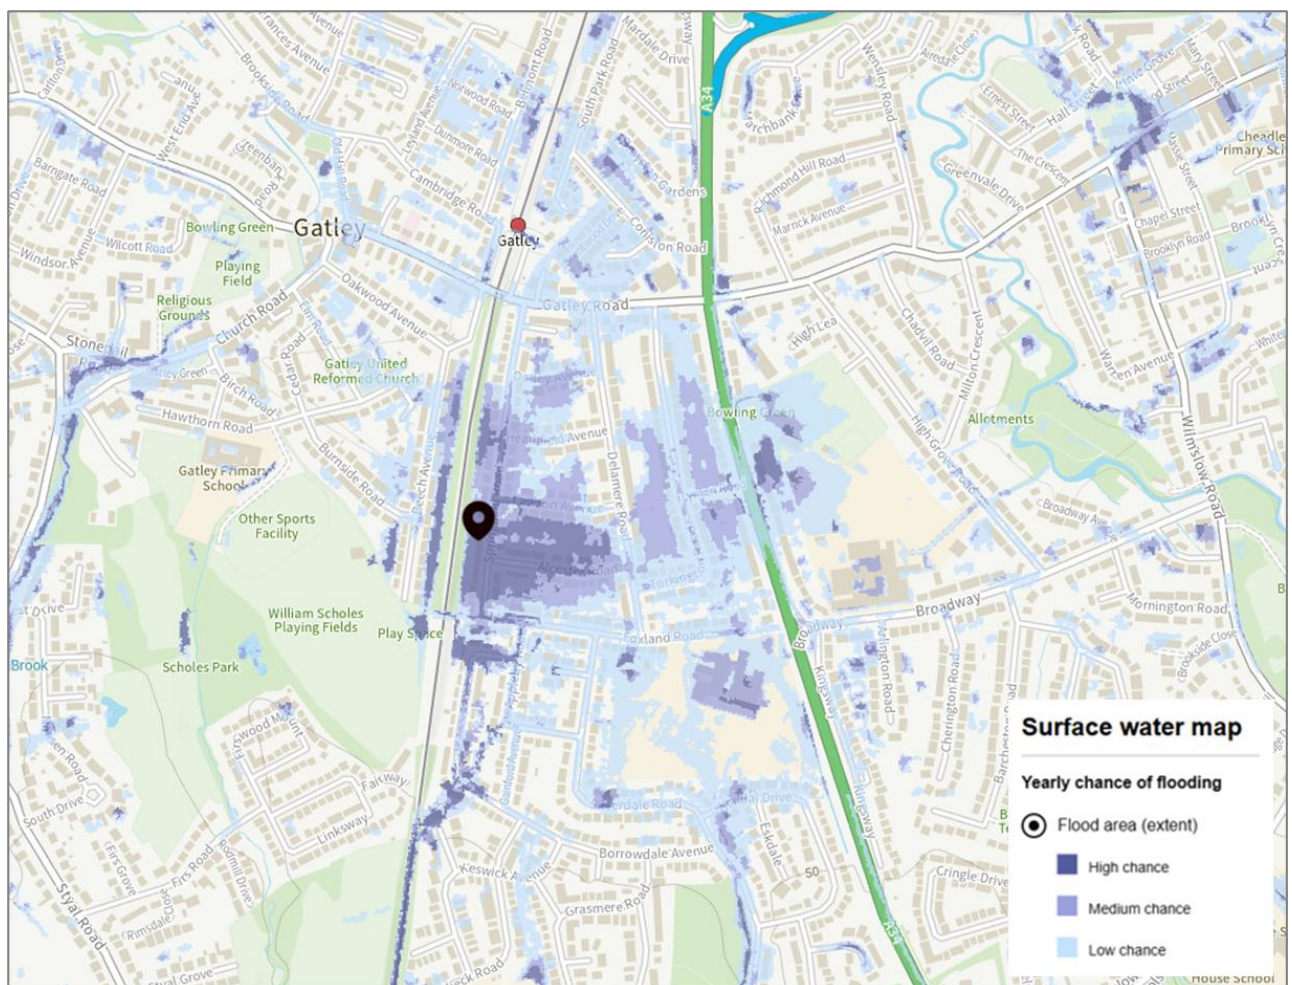
Figure A2.1. Cheadle West Surface Water Flood Risk. Image Source: Environment Agency.

The Cheadle West area of interest is classified as Flood Zone 1 and has a low risk of flooding from rivers. The Surface Water Flood Risk Maps (Figure A2.1.) show there to be a high chance of yearly flooding around the areas of Springfield Road, Alcester Road and Borrowdale Avenue to the east of the railway line as well as Beech Avenue to the west of the railway line.

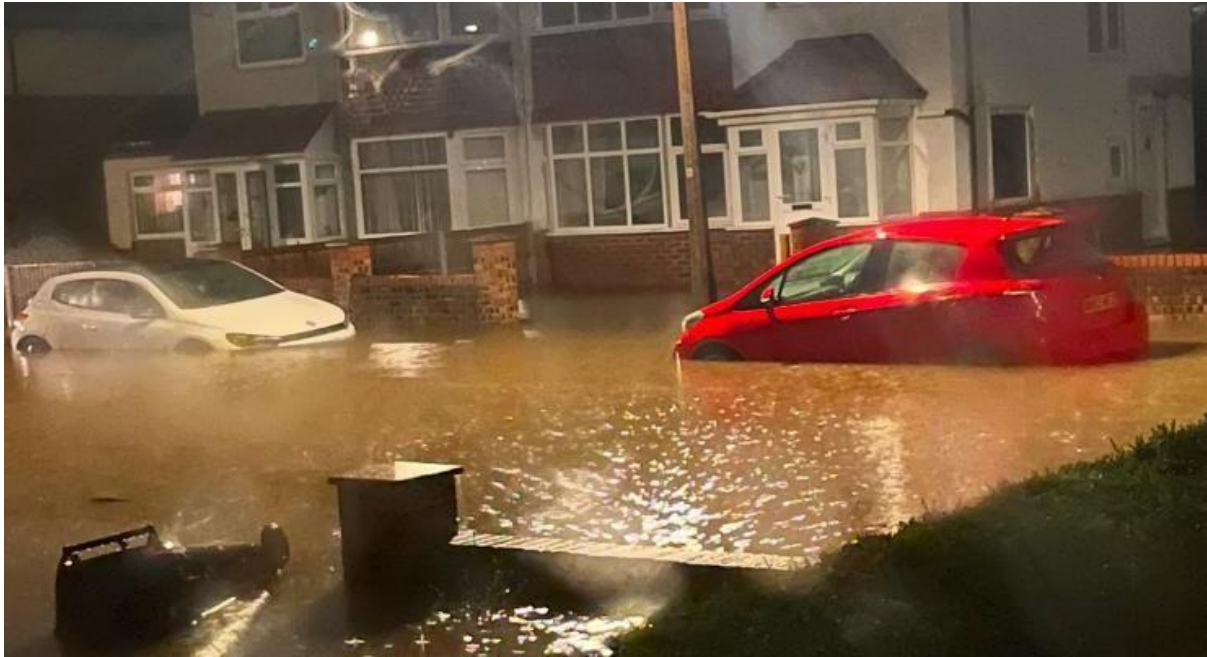
Figure A2.4. Image of the flooding during the event.

Figure A2.4. Image showing flood waters in Cheadle West on Alcester Road, early hours of 01.01.2025. Image Source: Beverley Johnson, BBC News.
