A1. Bramhall Green

1.1. Overview

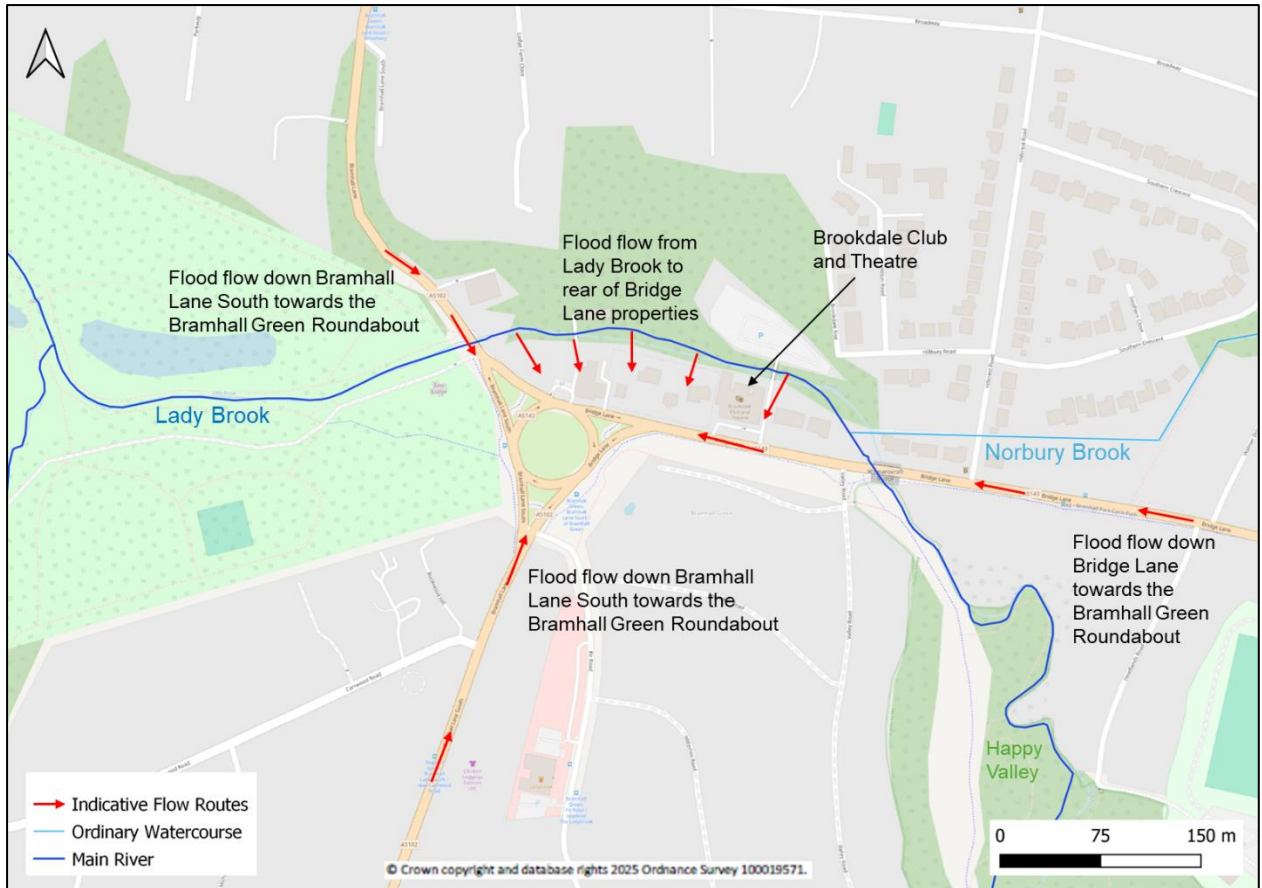
Figure A1.3. Bramhall Green Site overview Image with indicative flood flow routes.

Overnight the area experienced fluvial flooding from the river combined with surface water from the highways. Highway and property drainage was overwhelmed by fast flows from Bridge Lane and Bramhall Lane South. Both surface water and highway drainage systems drain and flow to Lady Brook which had overtopped its banks and so drainage systems were backed up and unable to discharge. The duration and intensity of the heavy rainfall in the Bramhall area and the runoff from the entire Lady Brook catchment caused the river levels to rise. The localised direct run-off from hard-standing drives and roads to the low spot on the roundabout added to the volume of surface water runoff that ponded in the low-lying areas.

River levels at Bramhall Park were to the top of the river embankment, although it is understood that levels did not exceed the embankment as there are no reports to suggest it did. The river levels were seen to be at the soffits of both the single span bridges at Bramhall Lane South so that indicates that debris was not collected at these bridges and flow was not constrained. However, flow was able to overtop low spots in the left bank of Lady Brook upstream of the Brookdale Club and Theatre.

Figure A1.3. summarises the indicative flood flow routes from Lady Brook to the rear of the Bridge Lane properties and also along Bridge Lane and Bramhall Lane South which contributed to the floodwaters at the low spot around Bramhall Green Roundabout.

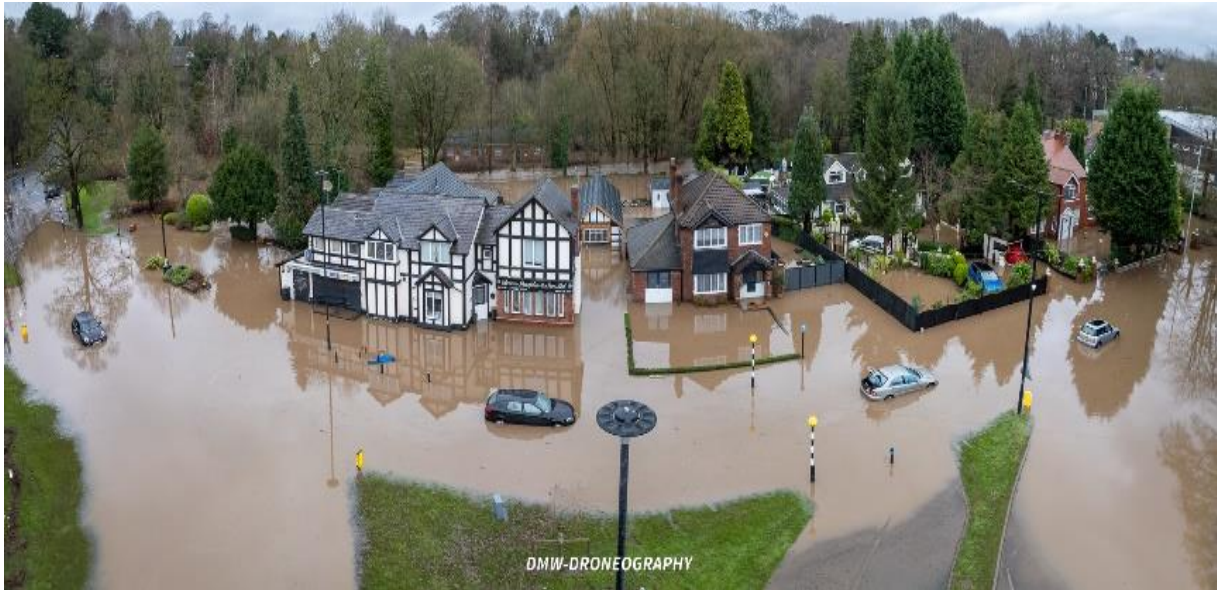
Figure A1.4. Image showing flood waters in Bramhall Green on 01.01.2025. Image Source: DMW Droneography (Facebook).

The properties and road were flooded along the north side of Bridge Lane. Bridge Lane and the roundabout were closed to traffic. The flooding was not as extensive as 2019 that covered a larger area, but some properties were flooded adjacent to the river.

Figure A1.4 shows the extent of flooding at Bramhall Green during the event.
