Draft Flood Investigation Report Woodbrook Road, Mellor, Stockport

**Services to Place
Highways & Transportation
Flood Risk Management Team**

September 2017 (amended March 2018)

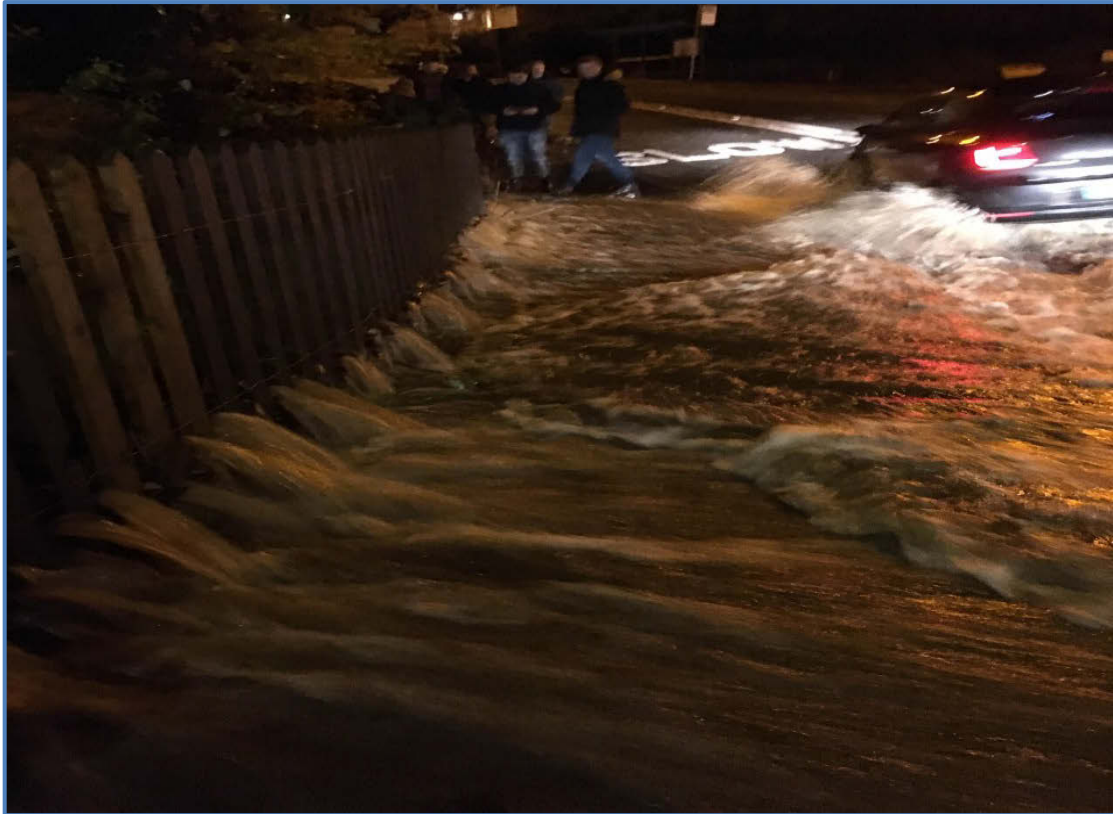
Photo 1: Flooding on to Longhurst Lane (Source: member of public)

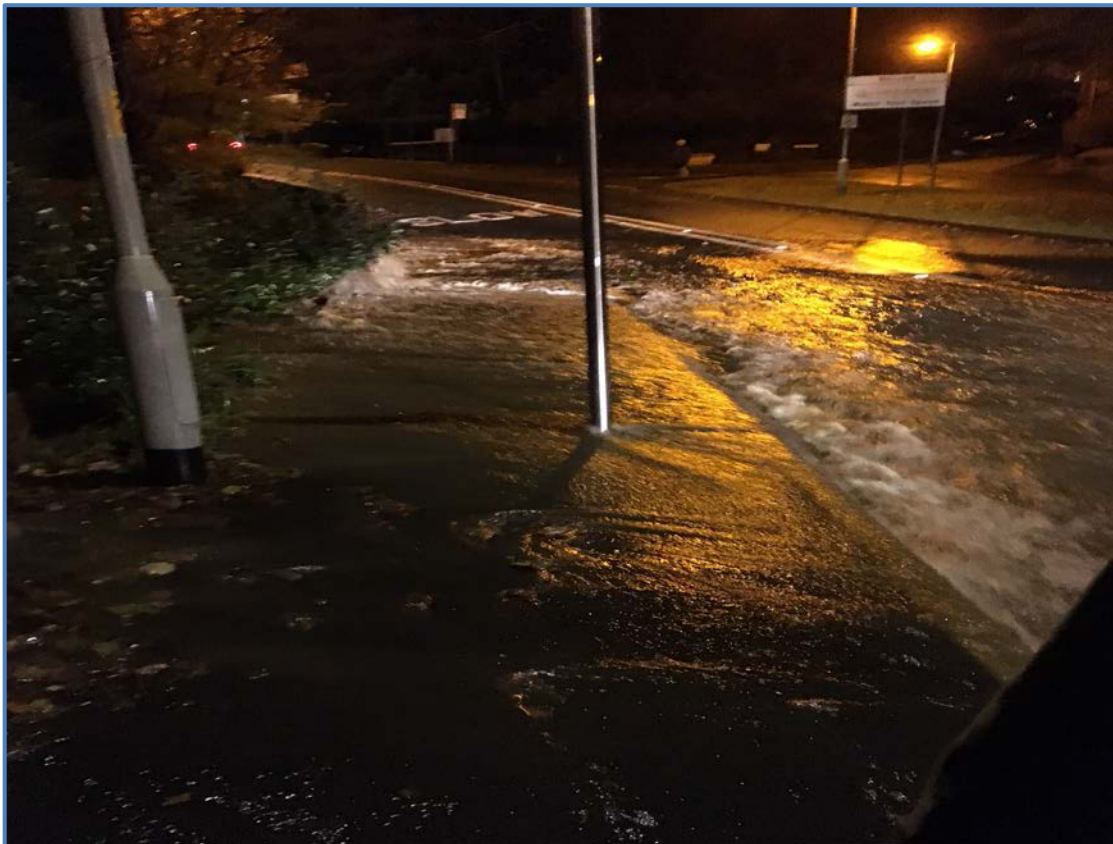
Photo 2: Flooding on to Longhurst Lane (Source: member of public)

- An additional gully to be installed on Longhurst Lane to take excess flows from the channel, this should provide a solution to the flooding problem along Longhurst Lane.

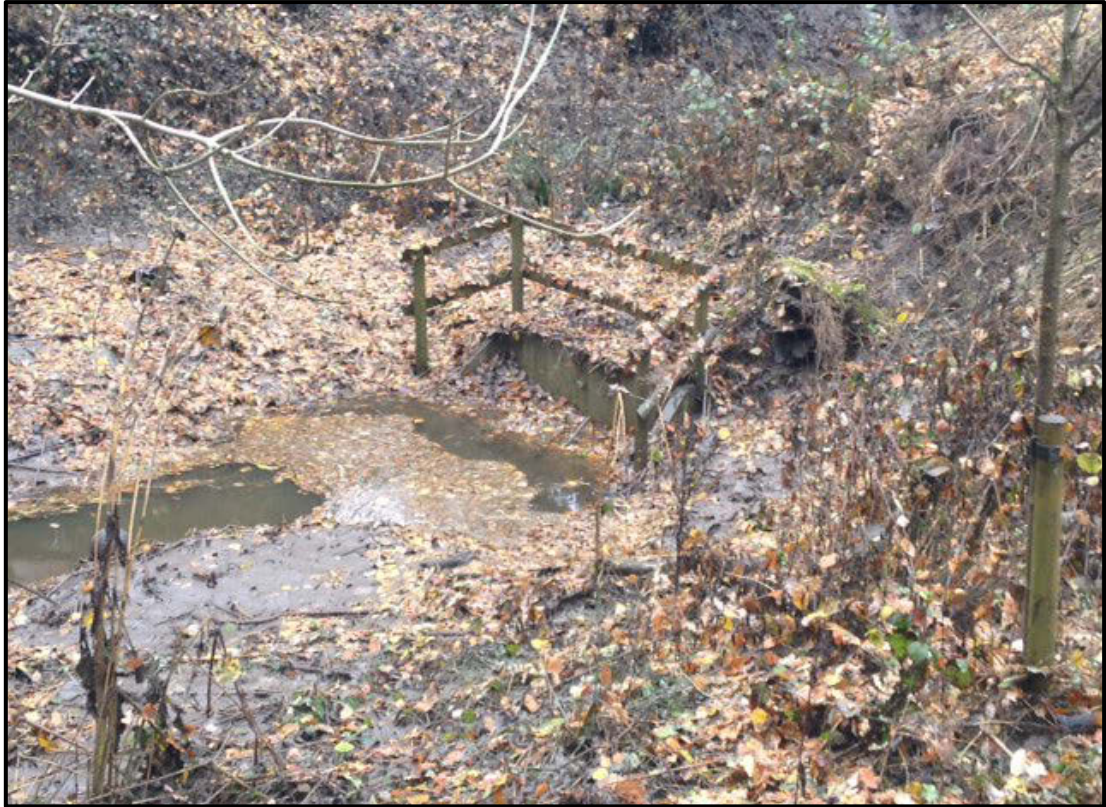
Photo 3: Blocked trash screen at culvert inlet (Source: Stockport Council)

The trash screen on the culvert inlet was found to be totally blocked on the 21st November 2016. A blockage at the inlet will cause water to pond and flood the adjacent land. The trash screen design resulted in bar spacings at 100mm which could lead to increased risk of blockages and consequential flooding in the immediate area. The 'as constructed' trash screen bars had 50mm spacings.

- Consider designing a new two-stage trash screen at the headwall with increased bar spacing; the design of the new trash screen should be in accordance with the latest design versions on the EA.

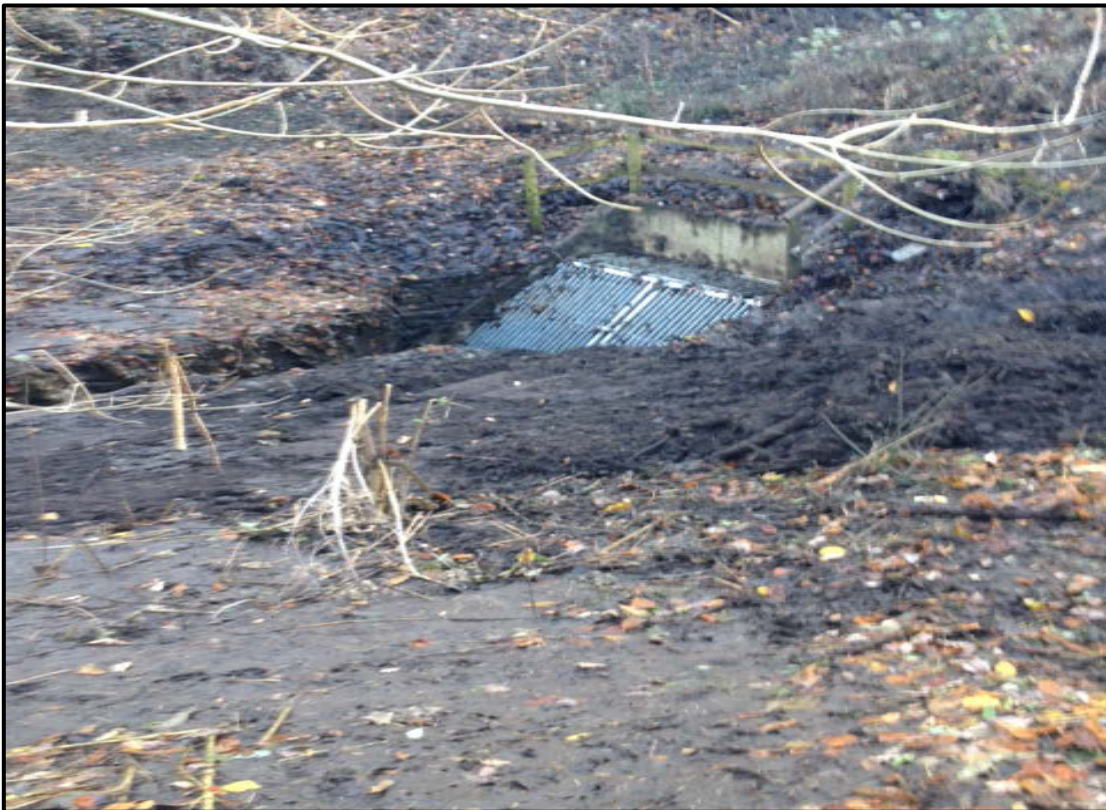
Photo 4: Cleared trash screen following flooding (Source: Stockport Council)

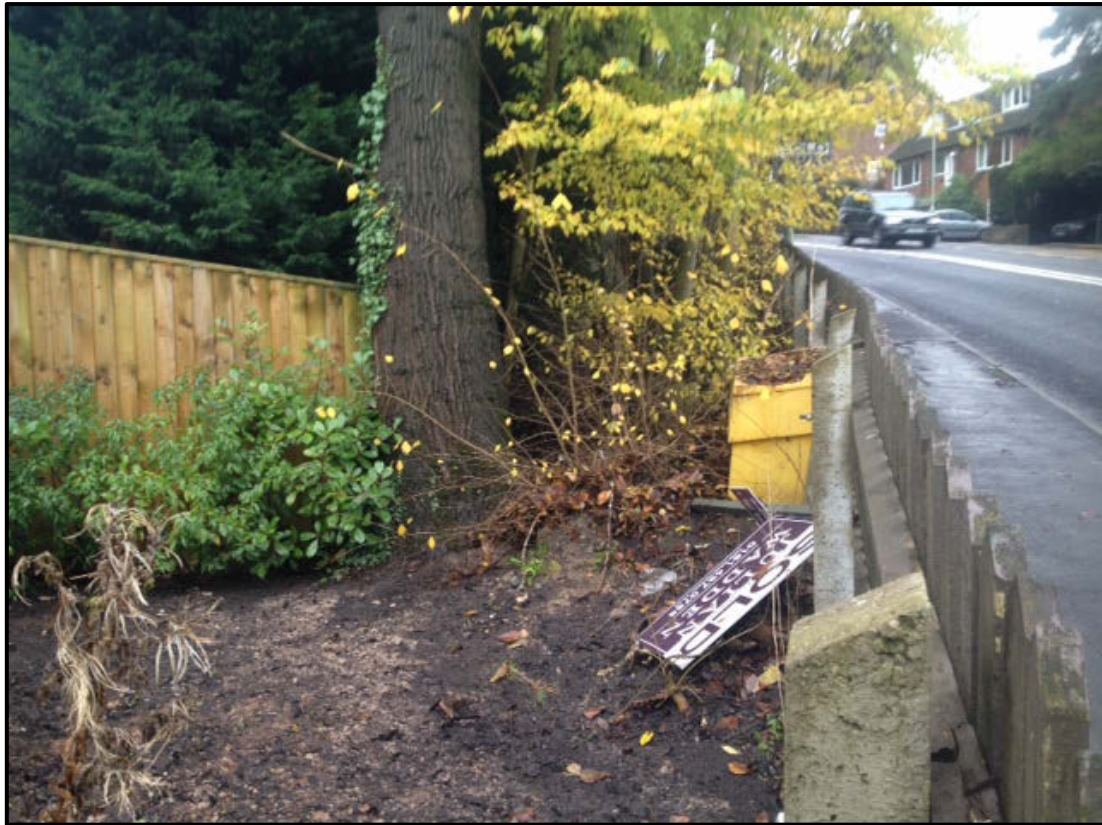
Photo 5: Overland flood flow channel with obstruction (Source: Stockport Council)

Additionally, there were a number of obstructions along the overland flood flow channel that would have impeded the flow during the event which would have also been a factor in the flooding to the Woodbrook Road properties.

The most prominent obstruction along the overland flow route revealed to be five fences running perpendicular to the flow of water. These fences sat on top of the overland flow route have subsequently been removed by PH Property (DCI) LLP prior to the Section 19 investigation. A 'high-level' water mark which stained the first

fence/obstruction along the overland flow route shows the water level rose to 116.476 AOD. The as built high point at which water overflows onto Longhurst lane is 115.372 AOD, suggesting that the fences restricted the flow of water along the overland flow route resulting in the water level rising by 1.104m above the low point at which it is intended to overflow onto Longhurst Lane.

- To excavate adjacent gully connection pipework into culvert and increase diameter from 150mm to 225mm.
- Any obstruction in the channel (e.g. trees and debris) needs to be removed and cleared. This includes the removal of trees within Highway verge.

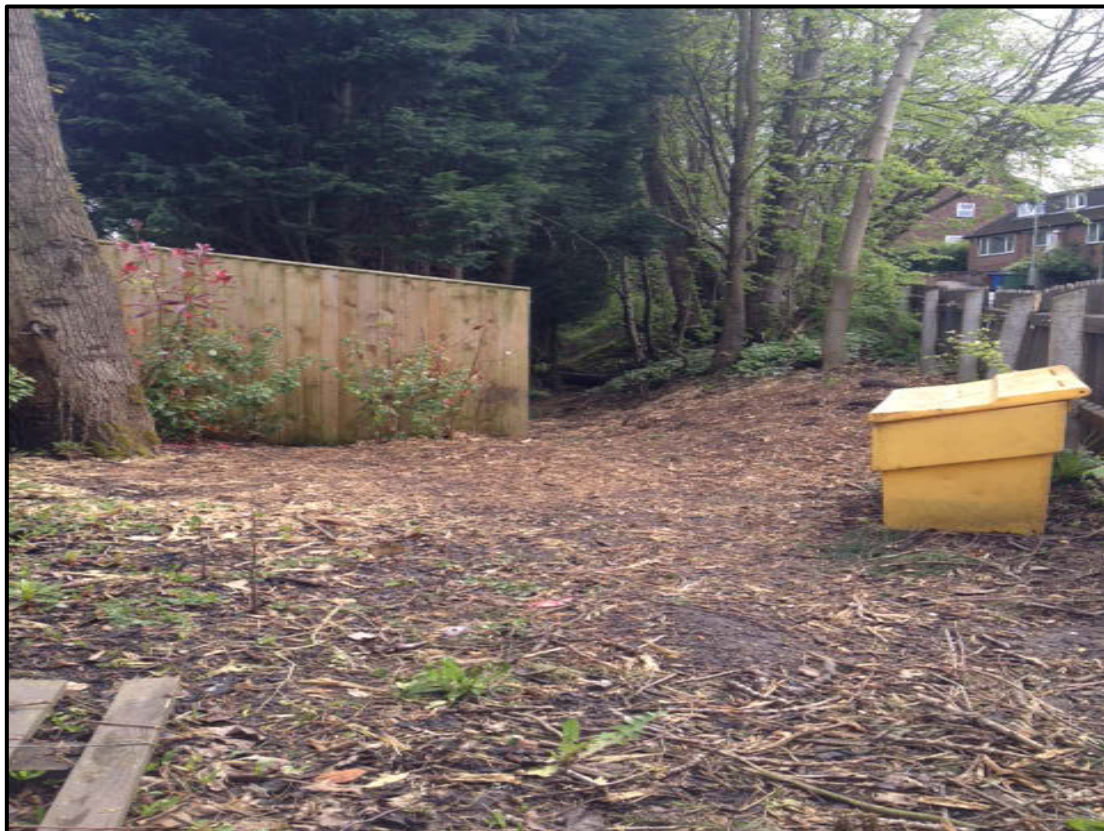
Photo 6: Overland flood flow channel following tree removal (Source: Stockport Council)

The other prominent obstruction is the presence of approximately ten trees along the overland flow route. The Highway Authority has subsequently removed one tree and Section 6 of the report recommends that the other work is carried out.

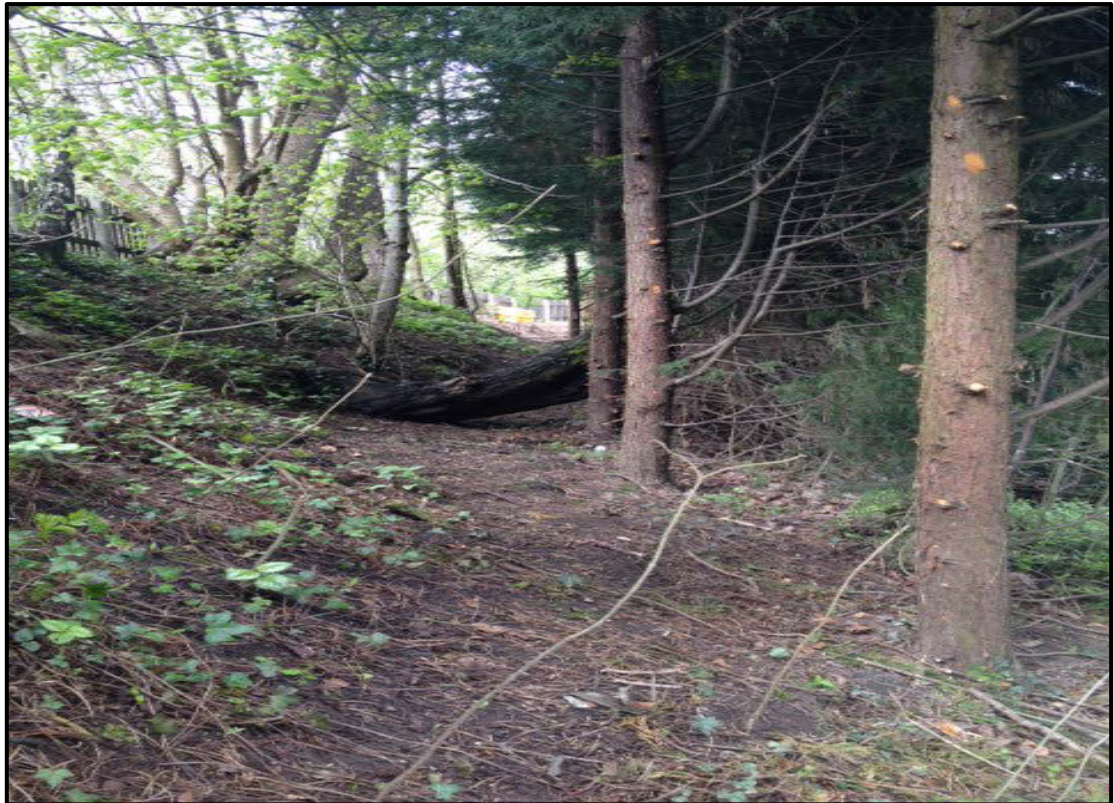
Photo 7: Overland flood flow channel with obstruction (Source: Stockport Council)

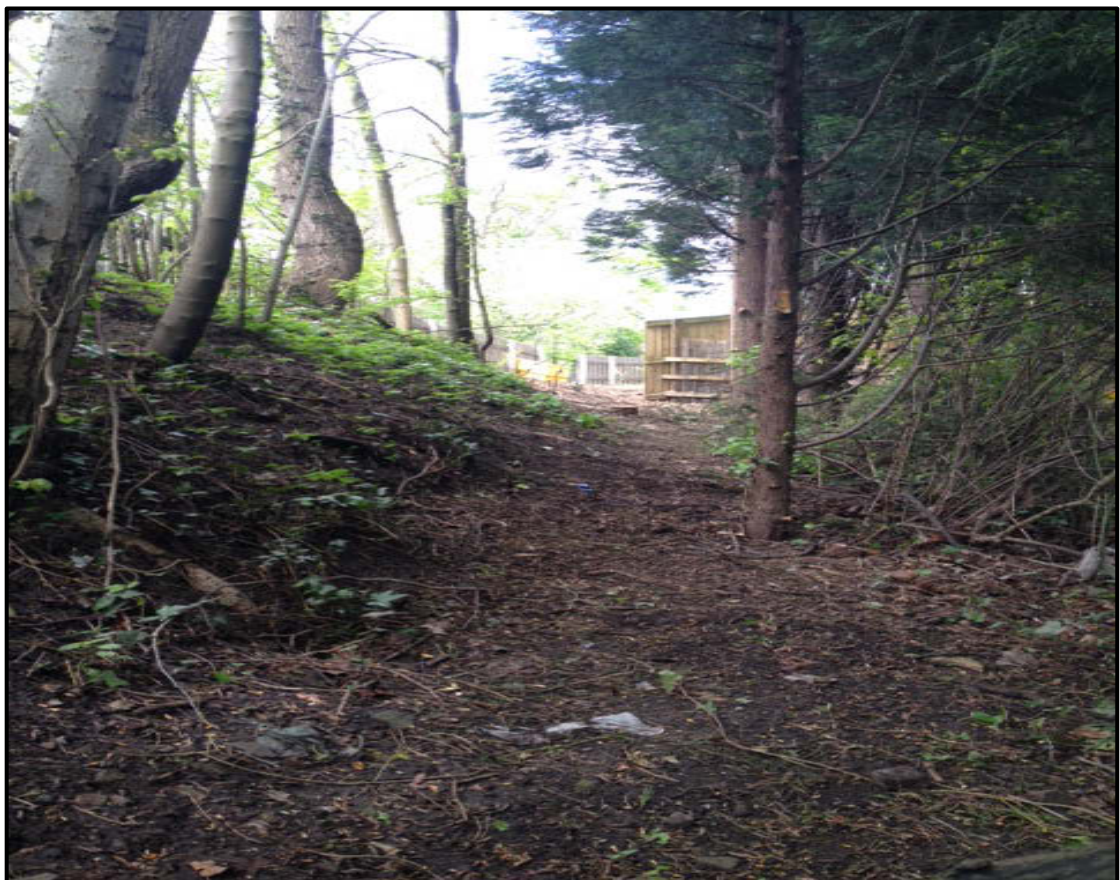
Photo 8: Overland flood flow channel to be reprofiled (Source: Stockport Council)

A recent level survey of the channel and the threshold of the properties carried out by Stockport Council has indicated that the threshold level of each property only has a clearance of 0.489 to 0.494 metres from the highest point taken within the flood relief route. Level survey and visual site inspection of channel indicated that the channel has 15 metres of negative gradient acting as a resistance to the flow through the flood relief channel increasing flood risk to the rear of properties in Woodbrook Road.

- The overland flood flow channel is to be re-profiled with the level of the channel to be 870mm below the level of threshold of each property. In order to achieve this, the level of the footpath and the kerb adjacent to Longhurst Lane need to be lowered by 100mm and approximately 15 to 20 metres of the channel is to be re-profiled.
