Reference Number	Bulletin 05 - 2019
Affected Product	All C and D series Caterpillar Compact Track Loaders, Multi Terrain Loaders and Skid Steer Loaders fitted with enclosed cabs
Risks Identified	Safety Maintenance Recommendation - Inspect secondary exit release mechanism functionality on enclosed cabs
Release Date	12 December 2019

Safety Maintenance Recommendation - Inspect Secondary Exit Release Mechanism Functionality on Enclosed Cabs

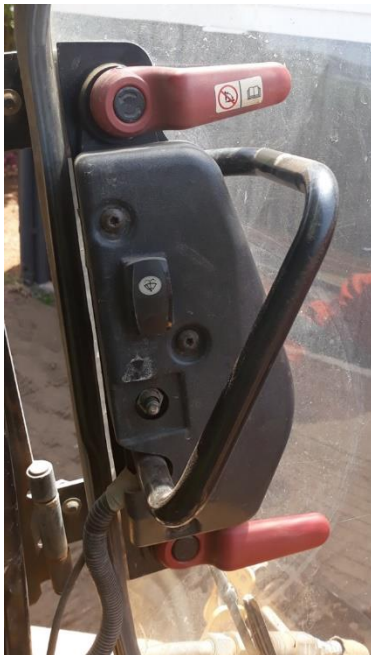
Figure 1 - C-Series secondary exit handles

The primary alternate exit is via the cab rear window, and the secondary alternate exit path is via the front cab door hinge release mechanism. This bulletin only concerns the secondary alternate exit system in the front door of the enclosed cab - refer Figure 1 and 2.

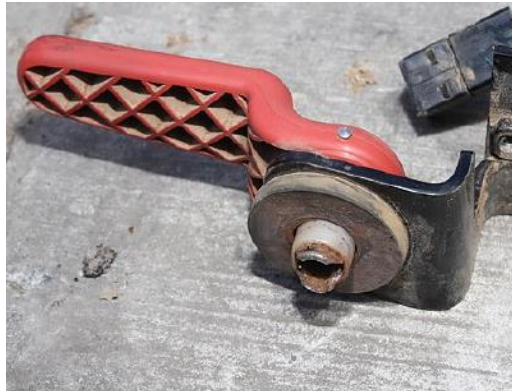
Environmental or application conditions may cause corrosion of the secondary exit release mechanism components. If corrosion occurs, the secondary release mechanism handles may become seized to the latch components, which may render the handles inoperable.

An example of a seized secondary exit handle is provided in Figure 3.

Figure 3 - Example of a seized secondary exit lower handle. This handle was seized to the latch component on the outside of the door window, preventing rotation of the handle pictured here.

A rubber washer is placed on each side of the window section to provide a resilient weather seal for the secondary exit release components, so degradation or looseness of the washers may indicate the seal is compromised. Note: older models have black handles that can also be affected.

1. With the machine shutdown and isolated, attempt to operate either the upper or lower secondary exit release handle with moderate force. Do not operate both handles at the same time for this inspection otherwise the window section may be dislodged. If operable with moderate force, the handle should also separate from the door on the inside.

2. If a handle is not operable, do not force it, or the components or door window may be damaged. If one or both of the handles is inoperable, **immediately place the machine out of service** and contact your Caterpillar dealer customer support representative and quote this Equipment Safety Bulletin number.

3. If the handle is not seized, inspect both the handle and the latch for corrosion and replace if corroded. If the components are free of corrosion and serviceable, reinstall into the door and resecure the handle to the latch and test the security of the window section. Refer to Figure 4 and Figure 5 showing the correct component orientation for reassembly, noting that one rubber washer must be fitted on each side of the window to form a conformable seal – the washers are compressed slightly once the handle is in the shut position.

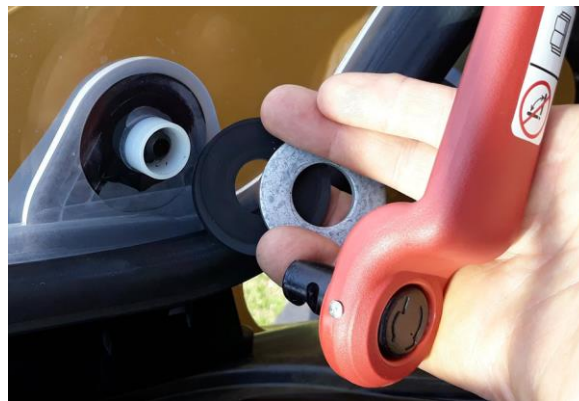
Figure 5 - This image shows the correct relationship of the inner components of the lower handle assembly. Note the rubber washer is next to the window and the steel washer is next to the handle. The lower handle components are assembled in the same order as that shown in Figure 3 for the upper handle.
