General Equipment Safety Bulletin

Bulletin 002/2012

Subject: Off Highway Truck (OHT) Front Suspension Wheel Spindle Accident

Affected Product: All Caterpillar Rigid Frame Off-Highway Trucks **Risks identified:** Crush injuries related to wheel spindle removal

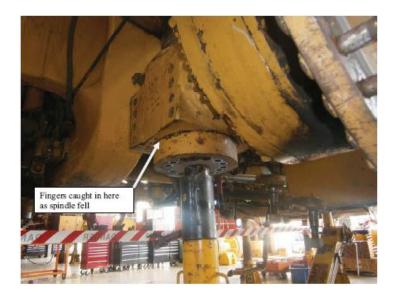
The retaining plate that secures the front wheel spindle to the suspension cylinder rod taper was supported by a hydraulic jack. A forklift with a jib attachment, polyester sling and two link brackets was attached to the spindle assembly (including brake and hub). It was intended that this would support the weight of the aforementioned assembly.

The retaining plate bolts were removed, and the retaining plate lowered approximately 50mm by lowering the jack. The fitter attempted to remove a shim pack sitting on the retainer plate. At this point, the spindle and hub assembly unexpectedly released from the tapered section of strut rod. The lift and sling arrangement was unable to restrain downward movement of the spindle and hub assembly. The fitter had parts of both left and right hands crushed between spindle and retainer plate.

- Perform a Job Hazard Analysis (JHA) prior to undertaking all complex and potentially dangerous tasks
- Develop a written work procedure addressing identified hazards
- Ensure appropriate supervision for task is in place
- Do not work under suspended loads
- Follow Caterpillar service procedures
- If you elect to use an alternative procedure, ensure that this procedure is risk assessed, and that all hazards identified are addressed
- Ensure tooling and lifting equipment is appropriate for task, currently certified, in good working condition, and used within its rated capacity*.
