| Reference Number | Bulletin 2020-01 |

Caterpillar 9U-7763 Puller Studs with date code '05 19' – potential for failure at less than rated capacity.

Equipment Safety Bulletin

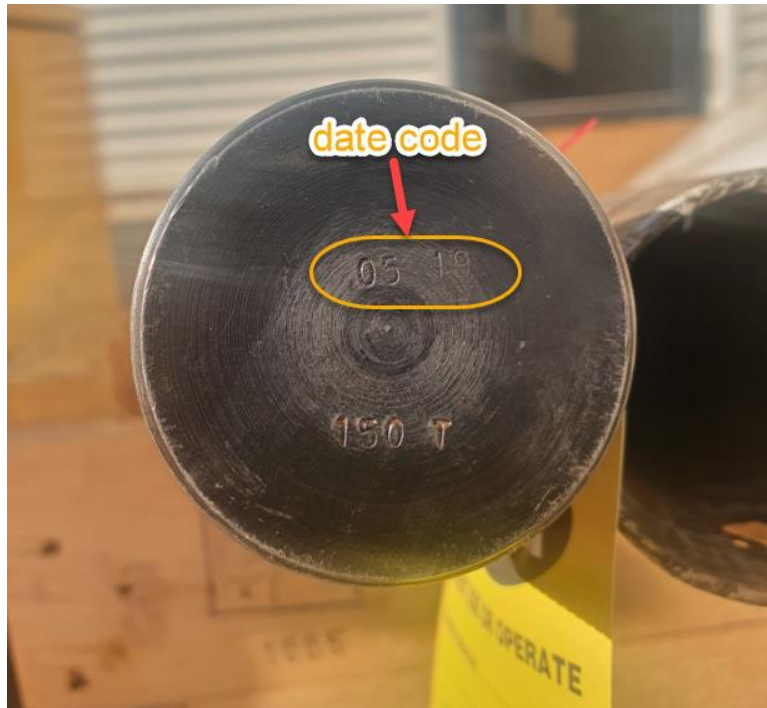
The date code is marked on one end of the stud (refer to Figure 1). The date code can be a sequence of two groups of two numbers, or three groups of two numbers. A date code that has the sequence '05 19' is the date code to look for.

Figure 1 - Date code '05 19' found on 9U-7763 puller studs to be removed from use.

In addition to any recommended inspections for serviceability, immediately inspect all 9U-7763 puller studs in use and held in tool stores/parts warehouses or service facilities. If a 9U-7763 stud with the date code '05 19' is found, immediately withdraw the part from use or storage and hold in a quarantine location so that there is no risk of the puller stud being used or repurposed. Contact a Hastings Deering Mining Support Representative immediately upon identifying this date code for further advice.

Note: All other date codes on 9U-7763 studs do not have this issue and can be reused if serviceable. All puller studs should be inspected for serviceability prior to each use by a competent person, and considered as a consumable product when regularly used at rated capacity. Always ensure the nuts and other hardware used in the pulling assembly are fit for purpose and only use the tooling specified for the task in accordance with the applicable service procedure.
