Reference Number	Bulletin 01 – 2019*
Affected Product	Potential failure of motor grader front wheel spindles in mining applications
Risks Identified	Failure to apply the recommendations in this Equipment Safety Bulletin may increase the risk of spindle failure
Release Date	18 January 2019 (Revised 06 November 2019 and 25 August 2020)

## Problem Overview

**A New Spindle Assembly for the Front Axle Group is Now Used On Certain 24H and 24M Motor Graders {4205}  
(SEPD1533)**

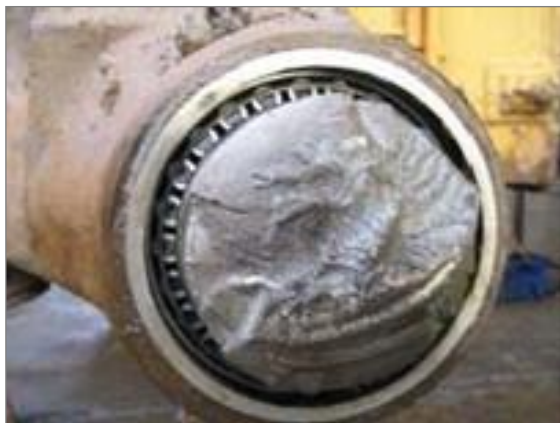
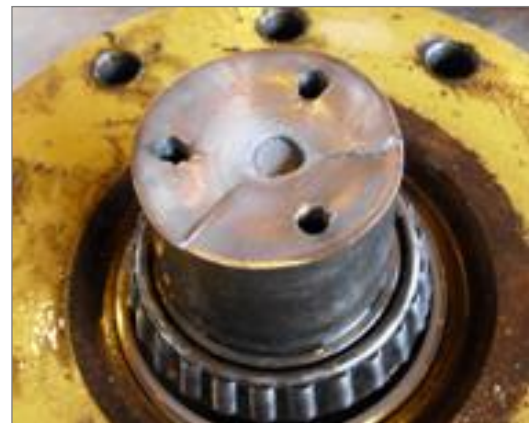
Fractures have occurred in front wheel spindles on Motor Graders used in mining applications, surface, and underground mines. The images below demonstrate damage from the two failure modes observed.

Front wheel spindle fractures have occurred at the base of the spindle behind the outer tapered roller bearing, and near the bottom of the retainer bolt holes. Current part number spindles have a radius at bottom of bolt holes and an improved hardening process to make the spindle more durable.

To reduce the risk of an unexpected spindle failure, this bulletin outlines recommendations for additional inspection for the spindle and replacement of the spindle. It is recommended to record the outcome of all inspections performed in accordance with this bulletin in the machine's maintenance log.

On 16 and 18 series machines, remove and inspect the front wheel spindles at 12,000 spindle hours or first life overhaul. Perform visual inspection and 100% magnetic particle examination of the spindle. Also perform ultrasonic testing in the area around the retaining bolt holes. Do not reuse spindles that have crack indications at any location. Do not reuse spindles where the service life cannot be reliably established.

Immediately remove machines from service that have crack indications in the locations identified in Special Instruction [M0068684](#)\*. Discard the front wheel spindle and replace with new, using the latest part available. Replace any other damaged parts. Operation of a machine with a cracked spindle can lead to catastrophic failure and result in property damage and injury.

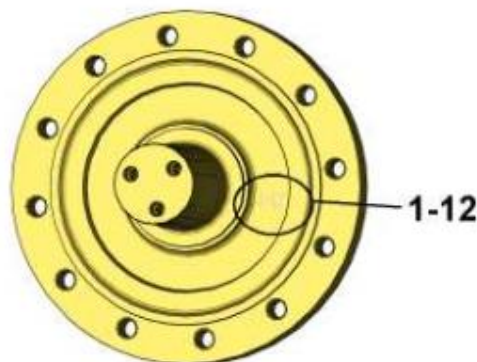
If no cracks are detected, mark the front wheel spindle as an acceptable reusable part with an air engraver or steel stamp set. Mark all front wheel spindles on the inboard face of the rim flange as per the illustration below.

If "1 - 12" was marked on a front wheel spindle, the "1" would indicate the first inspection, and the "12" would indicate that there were 12,000 hours on the part at the time of inspection.

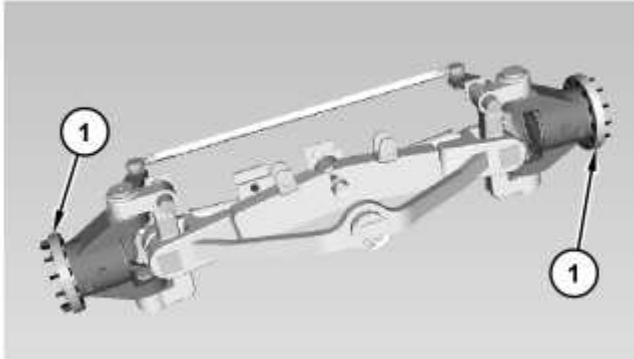
Illustration 1

The new **383-1185** Spindle As is part of the **8X-8974** Front Axle Gp on the 24H Motor Graders and the **266-5908** Front Axle Gp on the 24M Motor Graders.

The new **383-1185** Spindle As is a direct replacement for the **162-4228** Spindle As for the 24H Motor Graders and the **281-0074** Spindle As for the 24M Motor Graders.

**Description of Change:** A new spindle assembly with improved induction-harden heat process improves the service life of the spindle. A new spindle assembly with improved manufacturing process increases the service life of the front axle group.

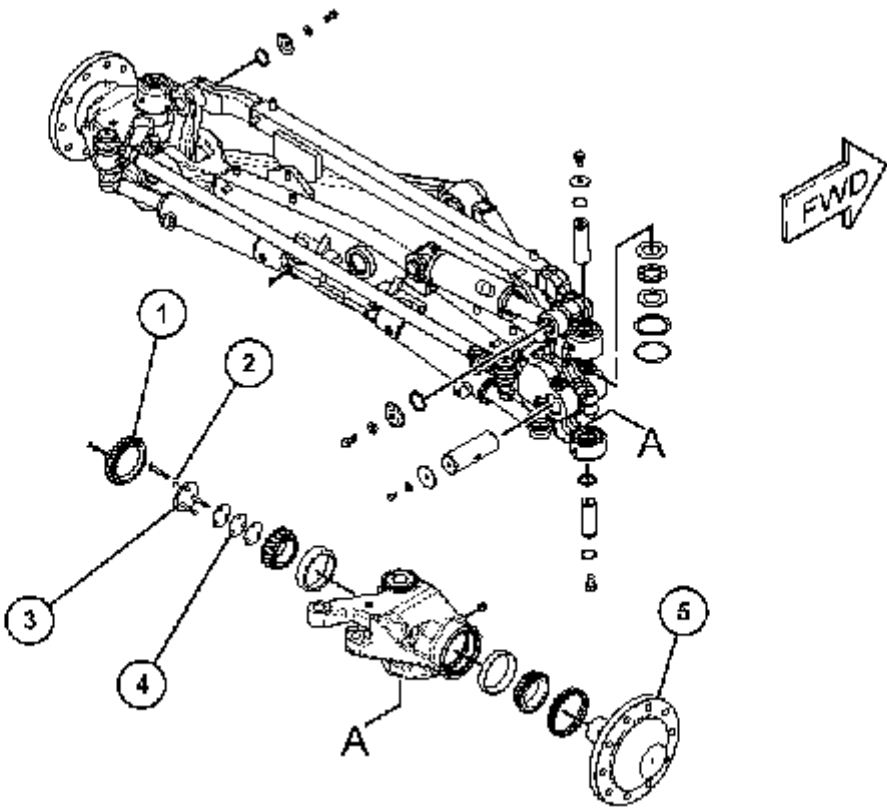
Illustration 1

(1) 437-8984 Cover

(2) 7D-1649 Hard Washer

(3) 437-8982 Retainer

(4) 426-4334 Shim

(5) 437-8983 Spindle

New **437-8983** Spindle (5) is a direct replacement of **264-1161** Spindle.

**Description Of Change:** The new spindle with improved design of tapped holes will better withstand high stress and increases the service life of the front axle group.

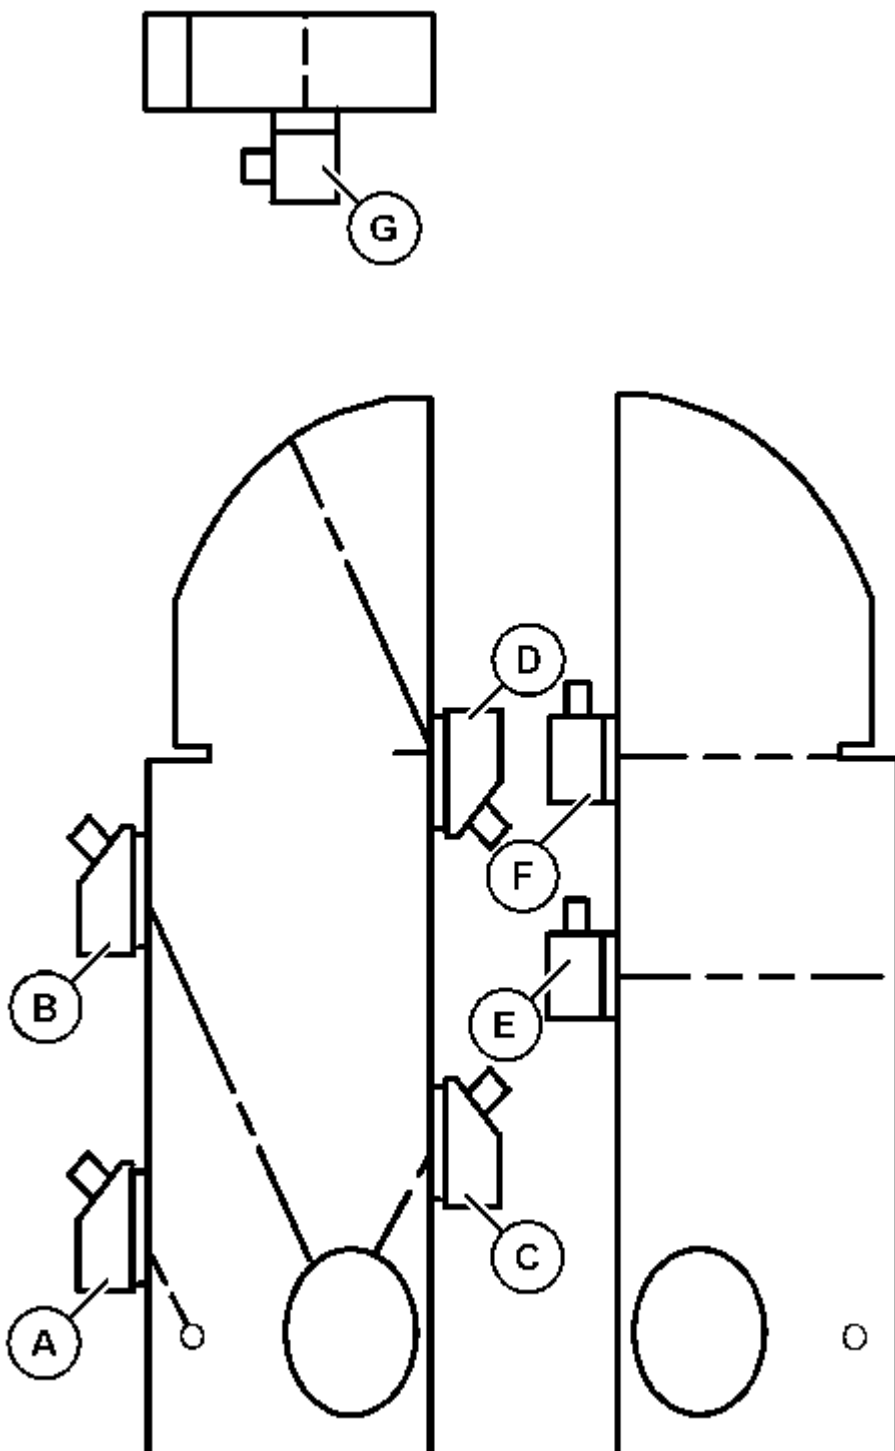
With the Range set to 300 mm (12 inch), use the 25 mm (1 inch) (see illustration 1, position (G)) and 100 mm (4 inch) (see illustration 1, position (E)) thicknesses on the IIW-type reference block for distance calibration in straight beam applications.

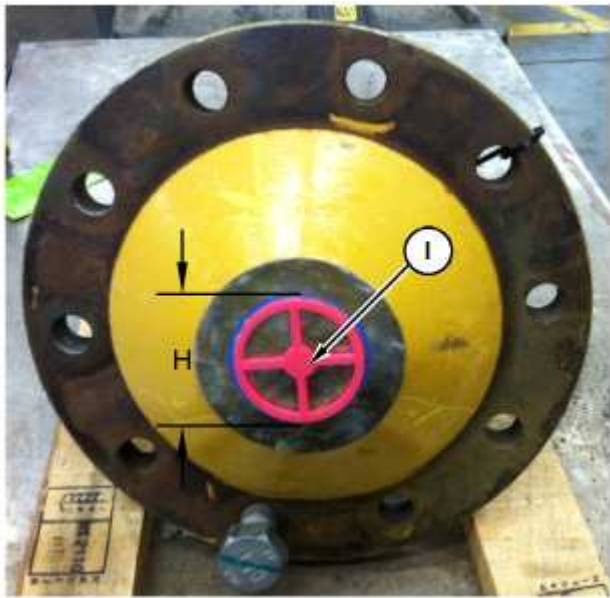
14, 16, and 18 Front Spindles Non-Destructive Evaluation (NDE) Inspection Areas and Part Detail

Illustration 2 g06039999  
(H) Diameter of Scan Area Ø 70.0 mm (2.75 inch) 14 and Ø 80.0 mm (3.15 inch) for 16 and 18 models  
(I) Outline Marking Template

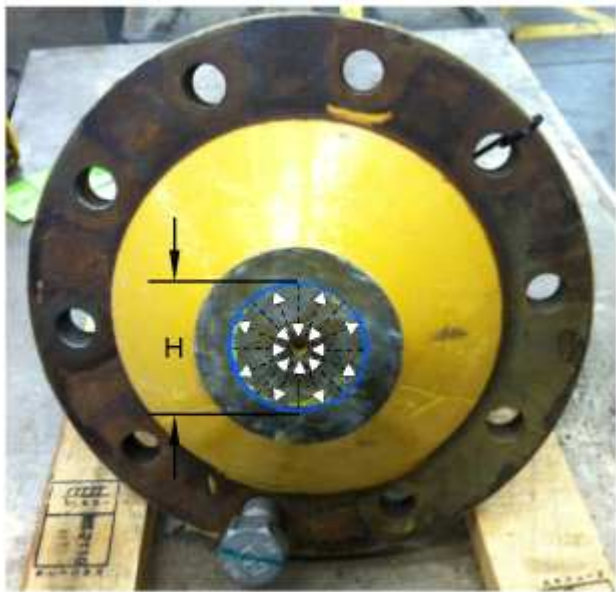
Illustration 3 g06040021  
Scan Pattern and Area  
(H) Diameter of Scan Area Ø 70.0 mm (2.75 inch) 14 and Ø 80.0 mm (3.15 inch) for 16 and 18 models  
Inspections can be conducted on built machines with no need to disassemble and remove front spindles.

After marking the inspection area outline and correctly calibrating the UT instrument, scan the entire area highlighted in Illustration 3. The nominal through spindle thickness is 240.0 mm (9.50 inch) 14 and 273.0 mm (10.75 inch) 16 and 18.

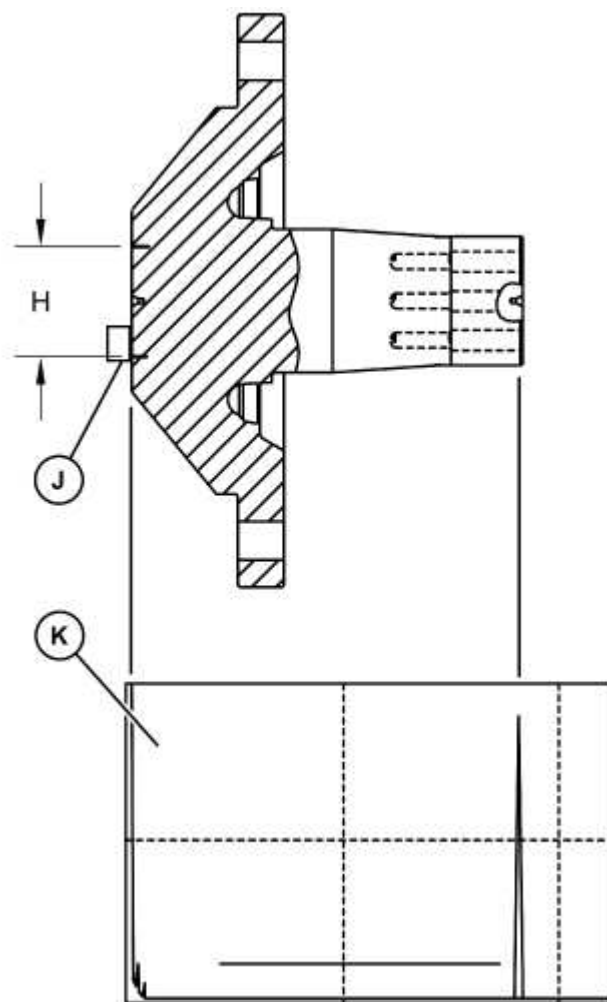
(K) UT Scan Indication Graph

Illustration 4 shows a large indication at the back wall thickness of the spindle. This back wall indication will be present and consistent throughout the inspection area on acceptable spindles. The transducer position is within the inspection area highlighted. Generally no indications, or low amplitude indications will be present from the drilled and tapped holes on the spindle end because of the drill taper.

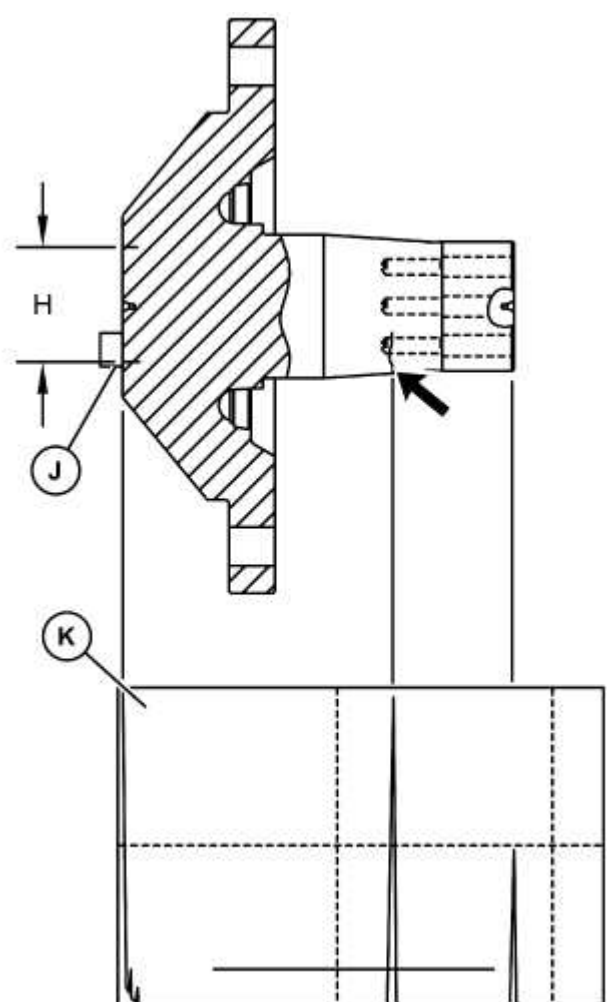
UT indication from a crack in the spindle

Illustration 5 shows that an indication is found between the back wall indication and the front surface indication. The transducer position is within the inspection area highlighted and the indication location is within the area of interest. This spindle is rejectable.

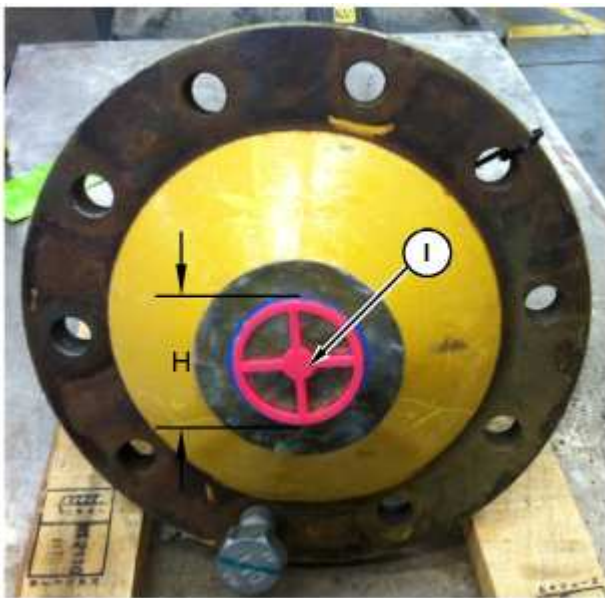
Illustration 7

(I) Outline marking template

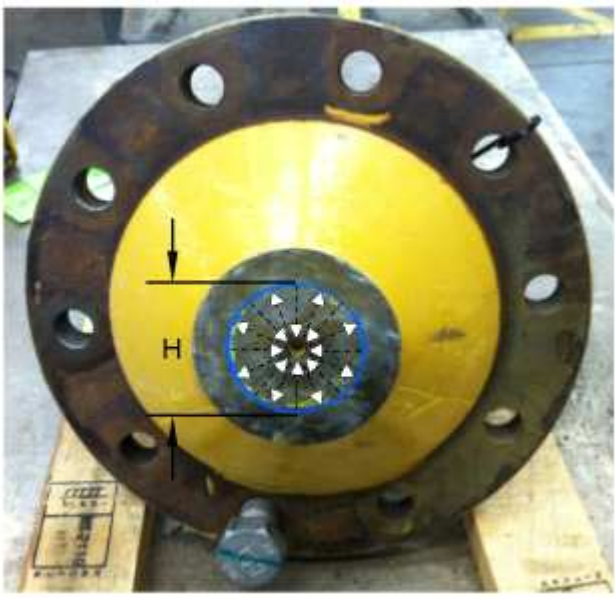
Illustration 8  
Scan pattern and area  
(H) Diameter of scan area 80 mm (3.15 inch)

After marking the inspection area outline and correctly calibrating the UT instrument, scan the entire area highlighted in Illustration 8. The nominal through spindle thickness is 273 mm (10.75 inch).

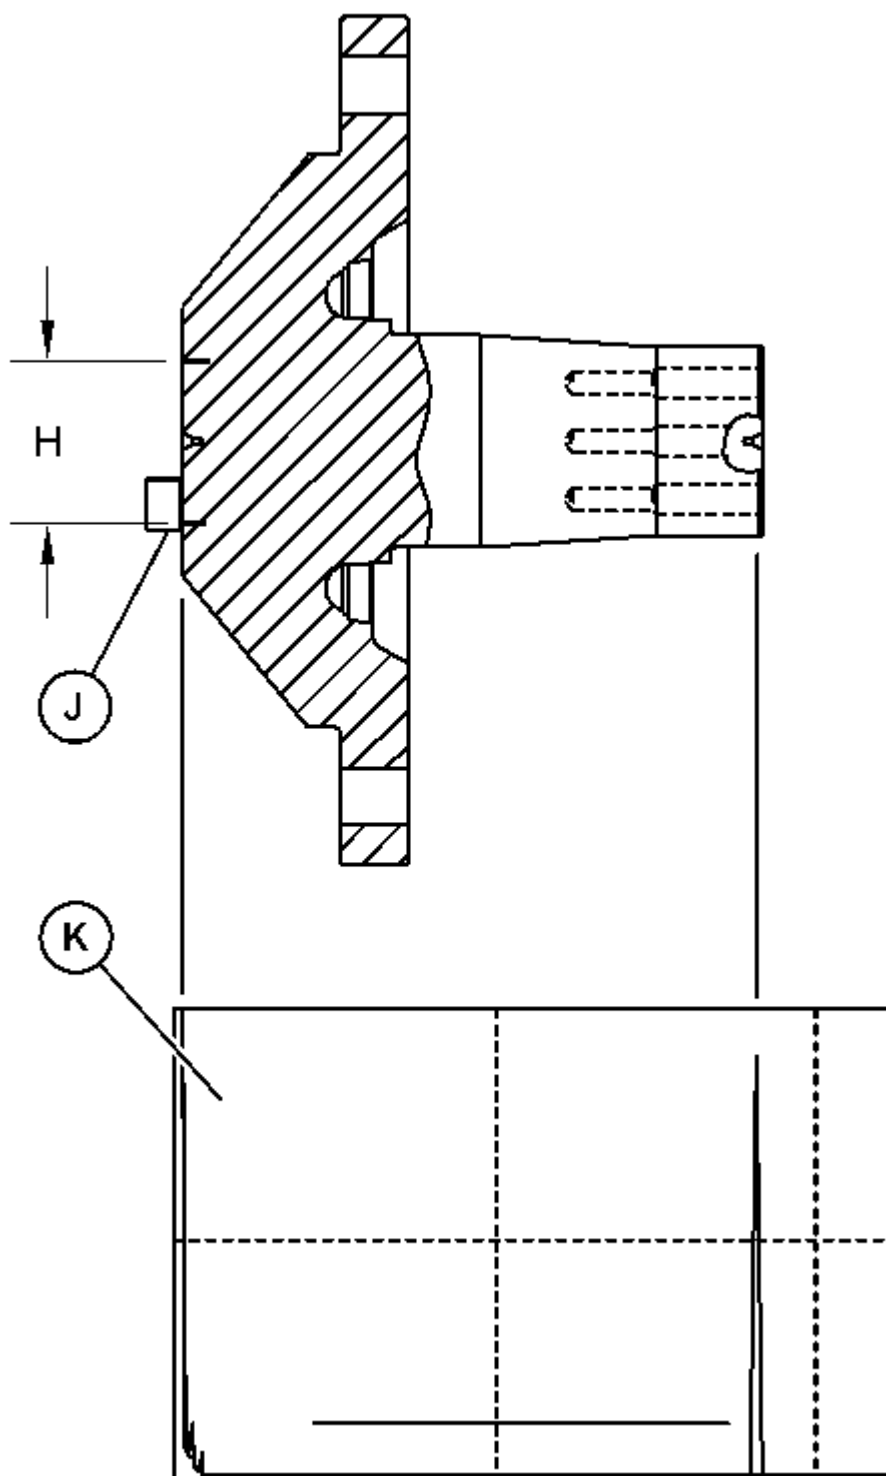
Illustration 9  
Normal back wall UT scan indication  
(H) Diameter of scan area 80 mm (3.15 inch)  
(J) UT transducer  
(K) UT scan indication graph

Illustration 9 shows a large indication at the back wall thickness of the spindle. This back wall indication will be present and consistent throughout the inspection area on acceptable spindles. The transducer position is within the inspection area highlighted. Generally no indications, or low amplitude indications will be present from the drilled and tapped holes on the spindle end because of the drill taper.

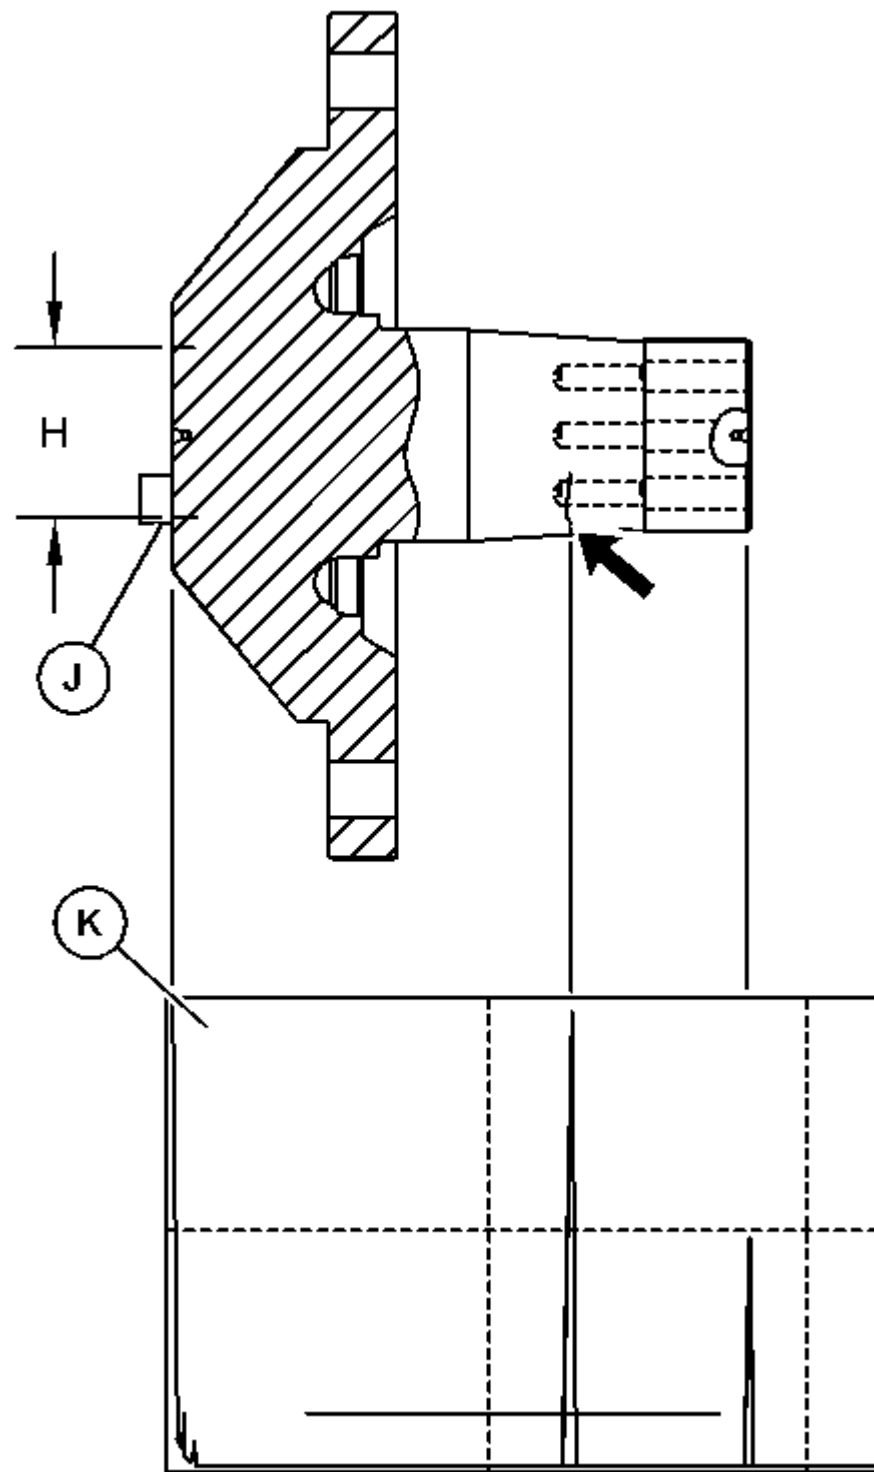
Illustration 10  
 Indication from a material defect  
 (H) Diameter of scan area 80 mm (3.15 inch)  
 (J) UT transducer  
 (K) UT scan indication graph

Illustration 10 shows that an indication is found between the back wall indication and the front surface indication. The transducer position is within the inspection area highlighted and the indication location is within the area of interest. This spindle is rejectable.

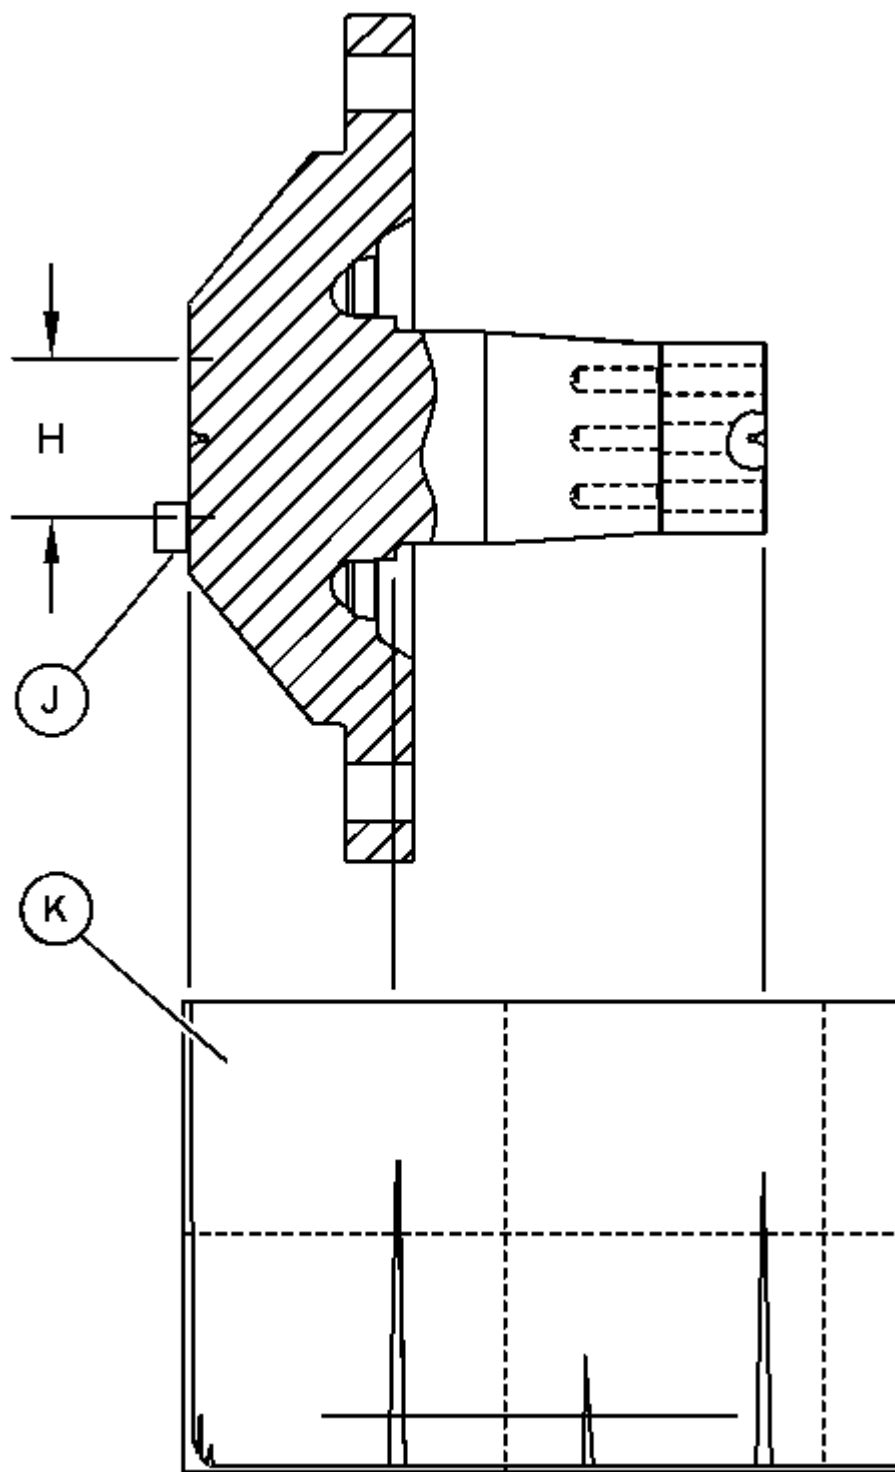
Illustration 11  
False UT scan indication caused by measuring outside of scan area  
(H) Diameter of scan area 80 mm (3.15 inch)  
(J) UT transducer  
(K) UT scan indication graph

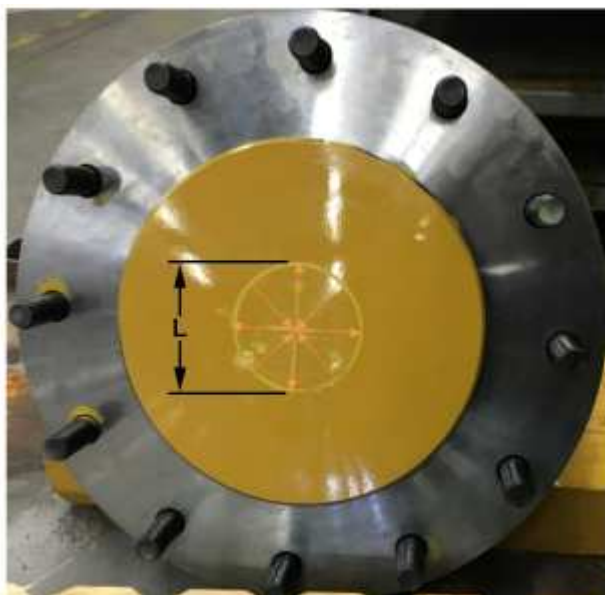
Illustration 13

After marking the inspection area outline and correctly calibrating the UT instrument. Scan the entire area highlighted in Illustration 13. The nominal through spindle thickness is 365.0 mm (14.4 inch).

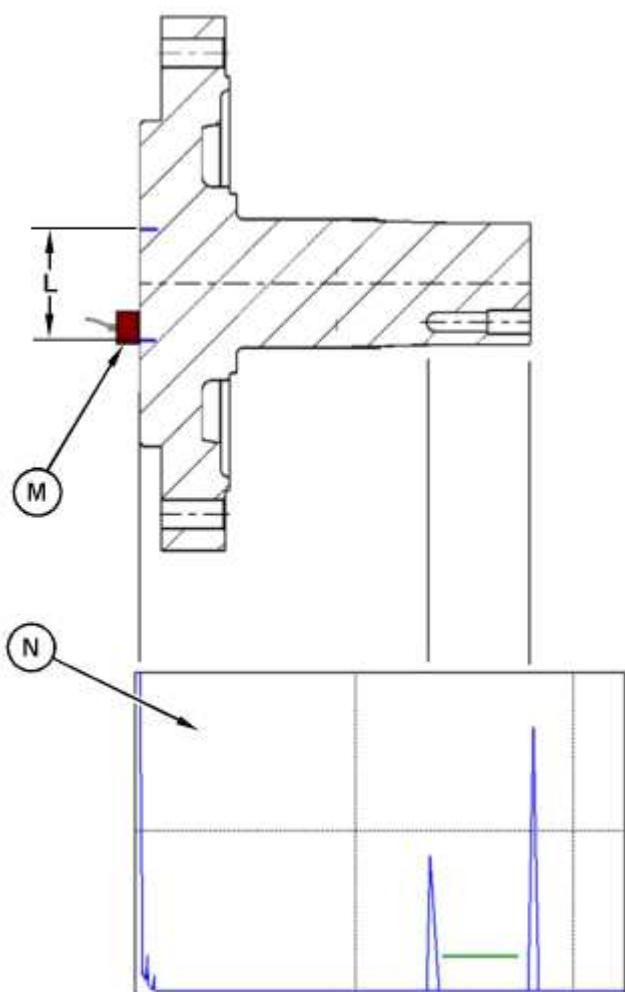
Illustration 14 g06118013  
Normal back wall and bolt hole UT indications.  
(L) Diameter of scan area 100.0 mm (4.0 in)  
(M) UT transducer  
(N) UT scan indication graph

Illustration 14 shows a large indication at the back wall thickness of the spindle. This back wall indication will be present and consistent throughout the inspection area on acceptable spindles. The transducer position is within the inspection area highlighted. Generally no indications, or low/mid amplitude indications will be present from the drilled and tapped holes on the spindle end because of the drill radius.

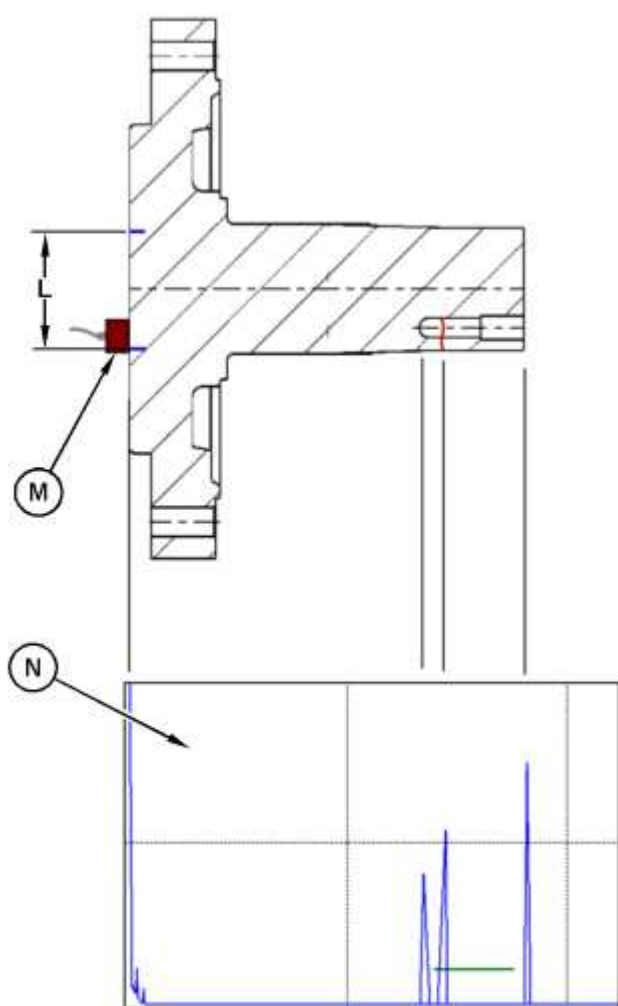
Illustration 15 g06118024  
UT indication from crack in spindle.  
(L) Diameter of scan area 100.0 mm (4.0 in)  
(M) UT transducer  
(N) UT scan indication graph

Illustration 15 shows that an indication is found in Gate A between the back wall indication and the bolt hole end indication. The transducer position is within the inspection area highlighted and the indication location is within the area of interest. This spindle is rejectable.

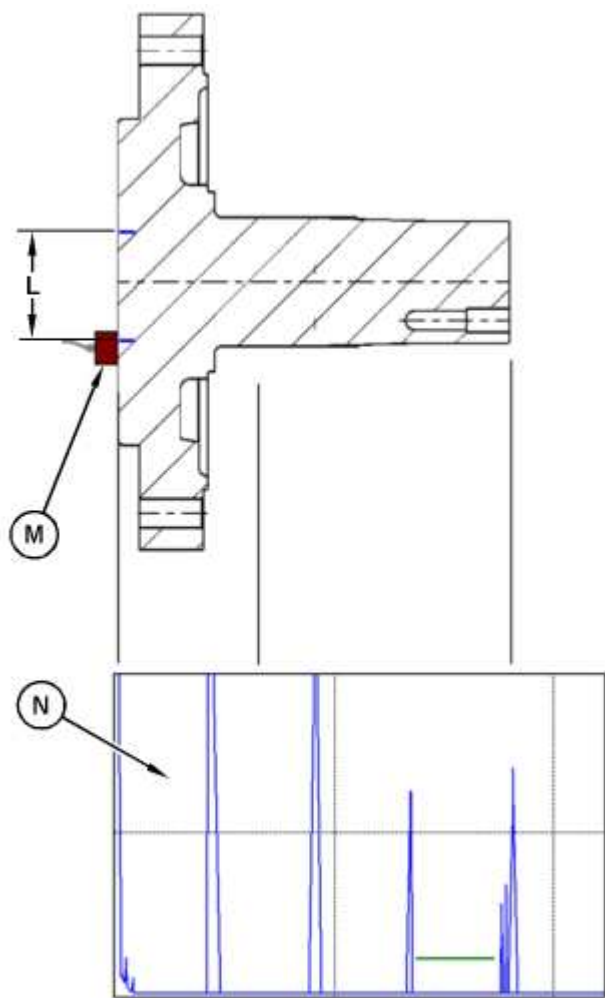
Illustration 16 g06118031  
False UT indications from geometry scanning outside of inspection area.  
(L) Diameter of scan area 100.0 mm (4.0 in)  
(M) UT transducer  
(N) UT scan indication graph

Illustration 16 shows false indications from geometry indications that are present outside the scanning inspection area of interest. These indications may show indications over the reject threshold but should be disregarded because the transducer position is outside the highlighted area.

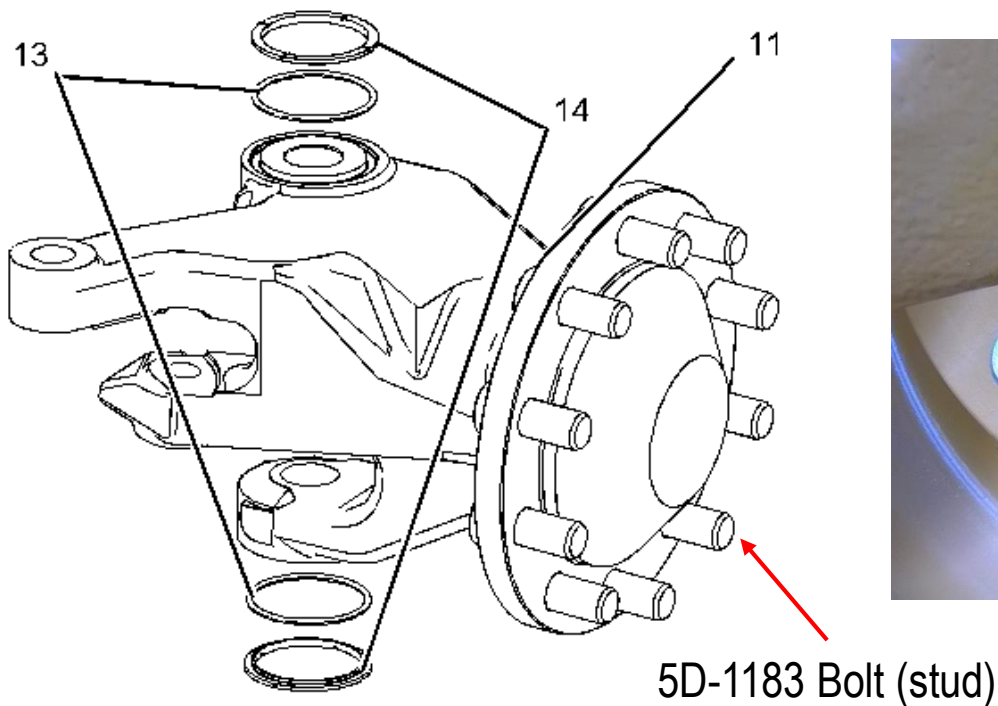
- 147-3402 Part Number
- Press in 5D-1183 Bolt (stud), 5D-0765 Nut-Full and 5D-0764 Washer
- Retaining Bolt PCD of 63.51mm.

Location of spindle part number

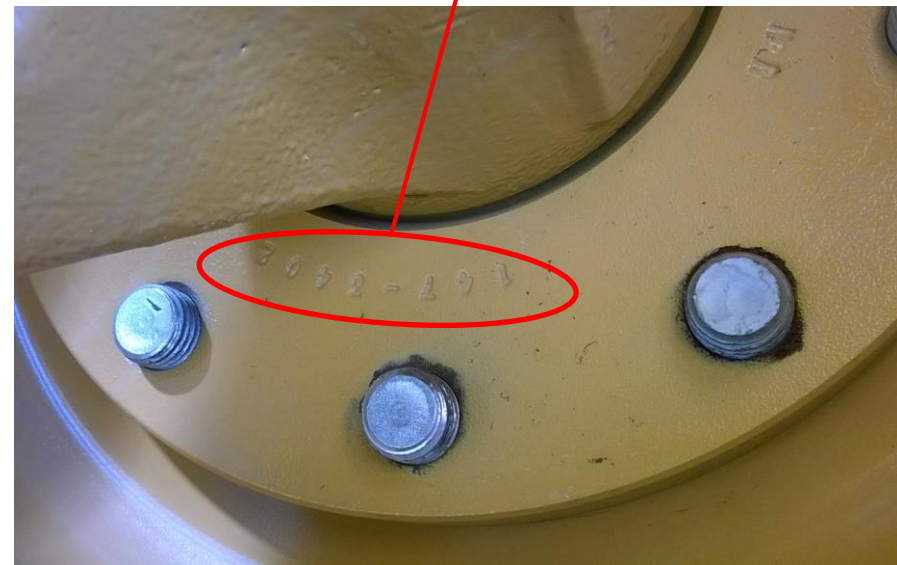
# 264-1161 Spindle Identification

The 264-1161 Spindle replaced the previous 147-3402 Spindle and was made effective in production from B9H1-UP and R9H1-892 as per SEPD1701. The 264-1161 Spindle can be identified by the following features:

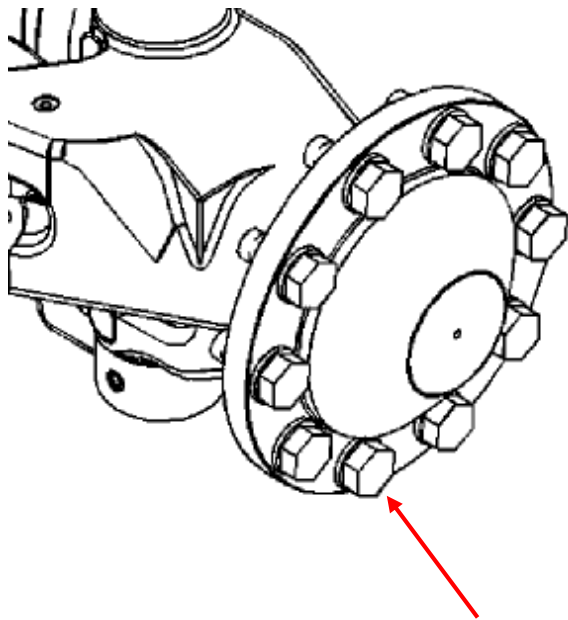
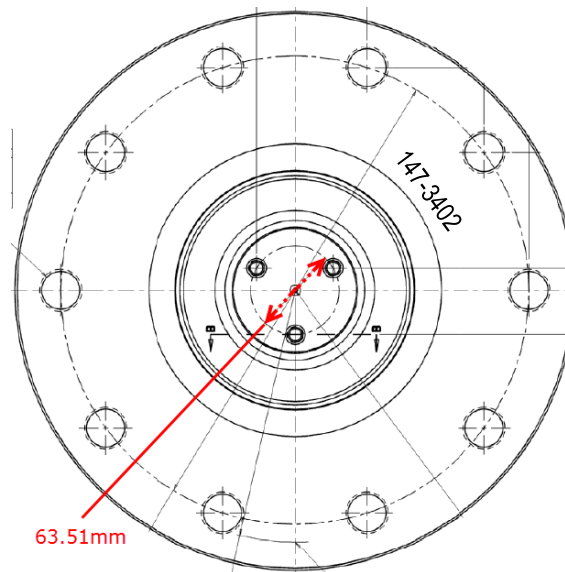
- 147-3402 Part Number
- 7Y-5232 Bolt and 9X-8258 Washer.
- Retaining Bolt PCD of 63.51mm.

Location of spindle part number

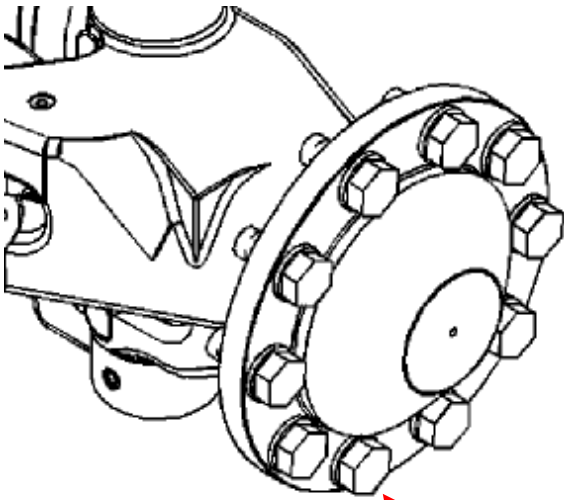
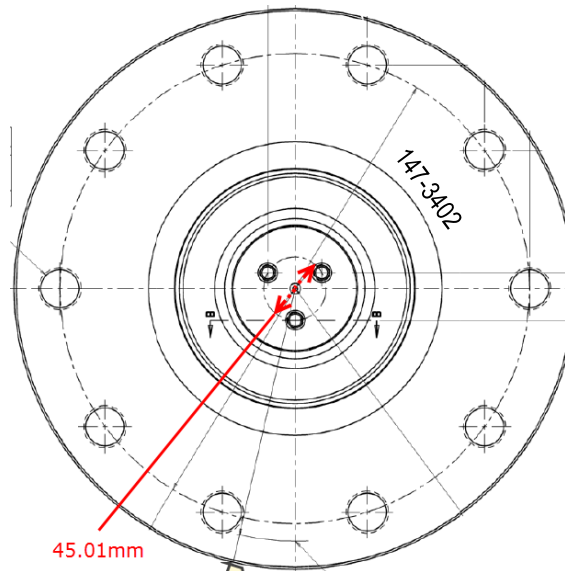
- 147-3402 Part Number
- 7Y-5232 Bolt and 9X-8258 Washer.
- Retaining Bolt PCD of 45.01mm.

Location of spindle part number
