Reference Number	Bulletin 02 2021 Revision 01
Affected Product	Caterpillar Link Brackets – part numbers listed below
Risks Identified	Potential risk of personal injury and/or property damage due to a failure of affected link brackets.
Release Date	08 April 2021, Revised 14 May 2021

Problem Overview

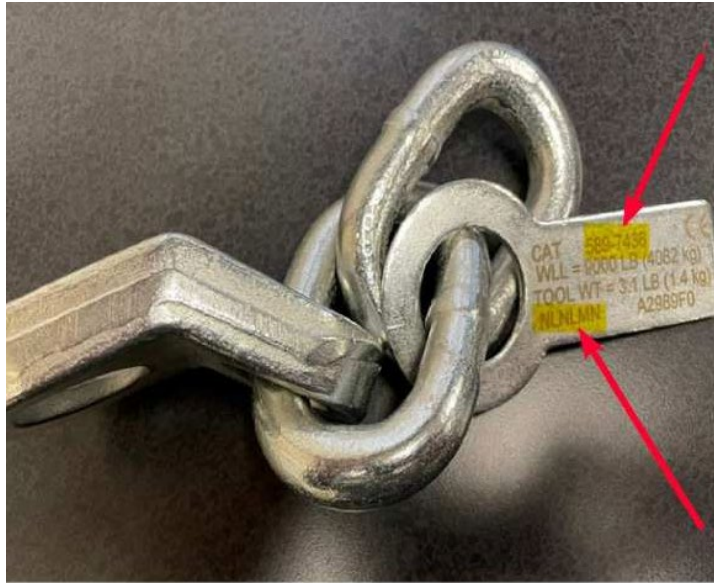
The Caterpillar part number and supplier batch codes are marked on the safety tag that is attached to the link bracket. See illustration 1 below for an example of the Cat part number identification and supplier batch code on 589-7436.

Illustration 1 589-7436 - Batch Code NLNLMN

Users should inspect and remove all new and used 589-7436 and 589-7437 link brackets with supplier batch codes of NLNLMN and NENLMN from parts inventory and service facilities.

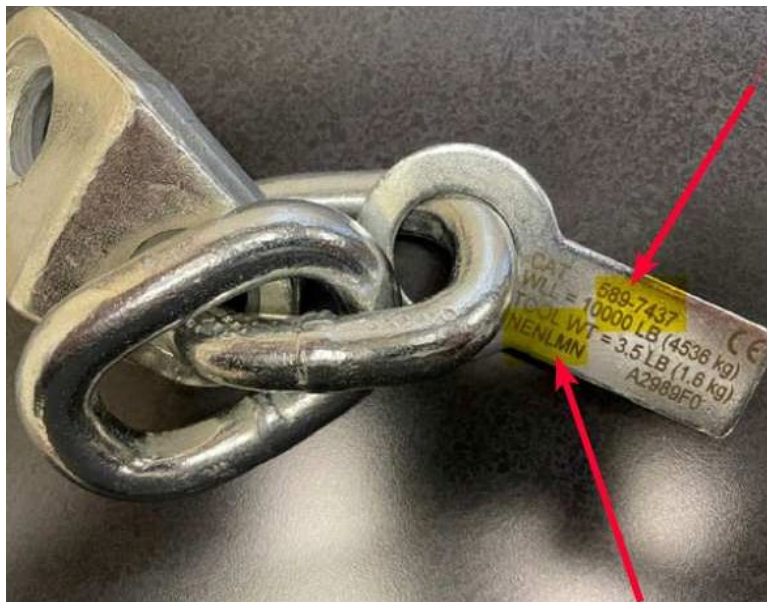
See Illustration 2 below for an example of the Caterpillar part number and the supplier batch code identification on 589-7437.

Illustration 2 589-7437 - Batch Code NENLMN

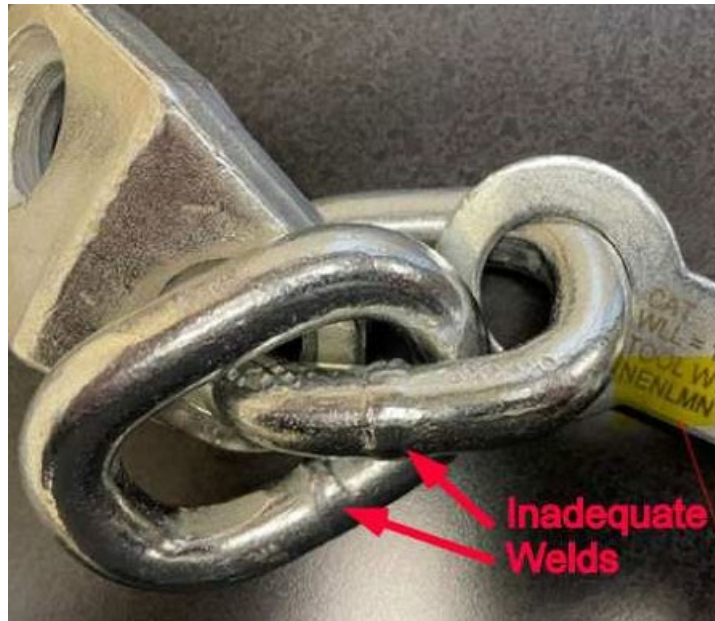
Certain Caterpillar link brackets with part numbers **589-7433, 589-7434, 589-7435, 589-7436, 589-7437** and **589-7438** may have defective butt welds in the chain link portion of the component. Other part numbers are not affected.

Link brackets are lifting appliances when attached to components to lift or support components during service operations. Most link brackets have two chain links, the smaller sizes only have one link, but the welds on both links need to be inspected. Any link brackets with the appearance of poor-quality welds should be removed from service until further advised.

Illustration 3 showing inadequate welds on links

All other affected part number link brackets [with any batch code] should be withdrawn from use, unless the link bracket has been inspected by a competent person in accordance with AS-4991:2004 section 15 and found satisfactory.

Quarantine all affected inventory and remove affected link brackets from service until further advised.
