**Section 106 Assessment and Texas Historic Commission  
(THC) State Historic Preservation Officer (SHPO)  
Coordination  
for the  
Runway 18L/36R Rehabilitation Project  
at  
Dallas Fort Worth International Airport**

RE: Initiation of Section 106 Consultation for DFW Airport Runway 18L/36R Rehabilitation

RE: Cultural Resources Desktop Analysis for the Dallas-Fort Worth International Airport Runway 18L/36R Rehabilitation Project, DFW International Airport, Tarrant County, Texas

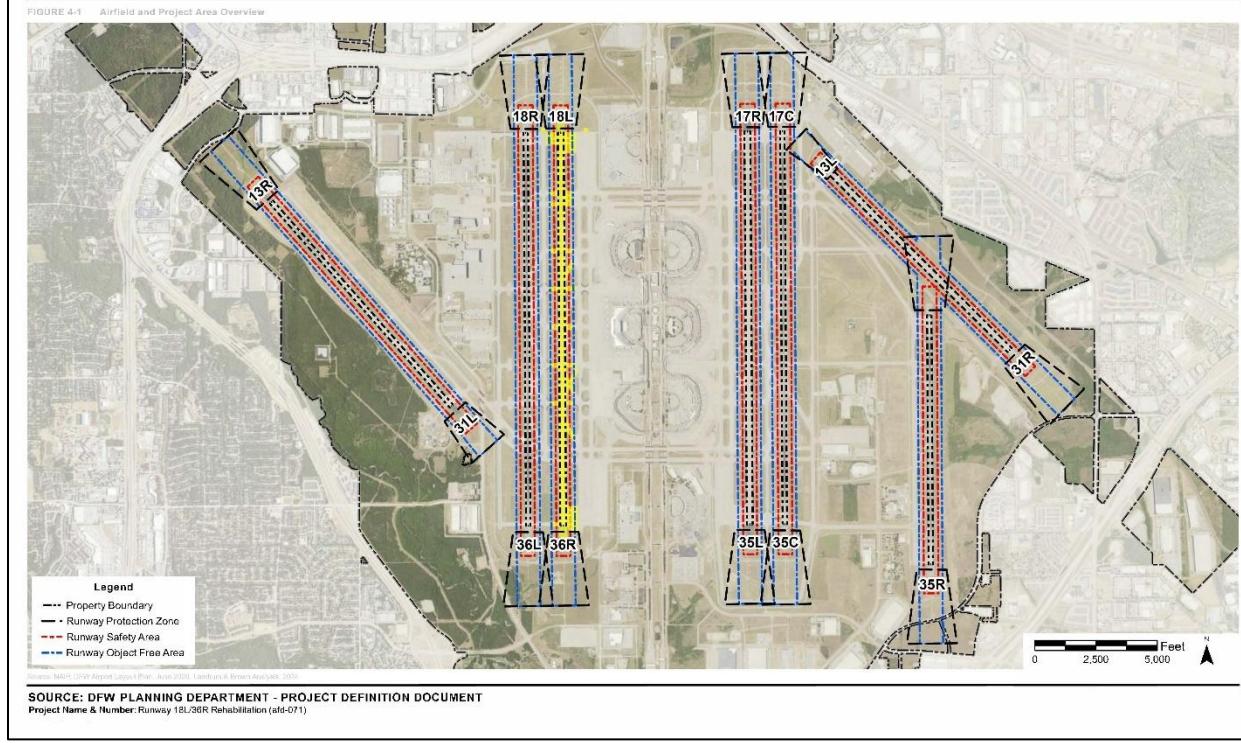
*Image 1. Airfield and Project Area Overview*

The Runway 18L/36R Rehabilitation project is located directly west of Terminals B and D buildings, and the North and South Express parking lot. Refer to Image 1 for a location map of the project site.

Runway 18L/36R was originally constructed in 1974 and was 11,386 feet in total length. In 2002, the runway was extended to the north by 2,015 feet to reach its current length of 13,401 feet. The Runway is 200 feet wide with 25-foot-wide asphalt shoulders.

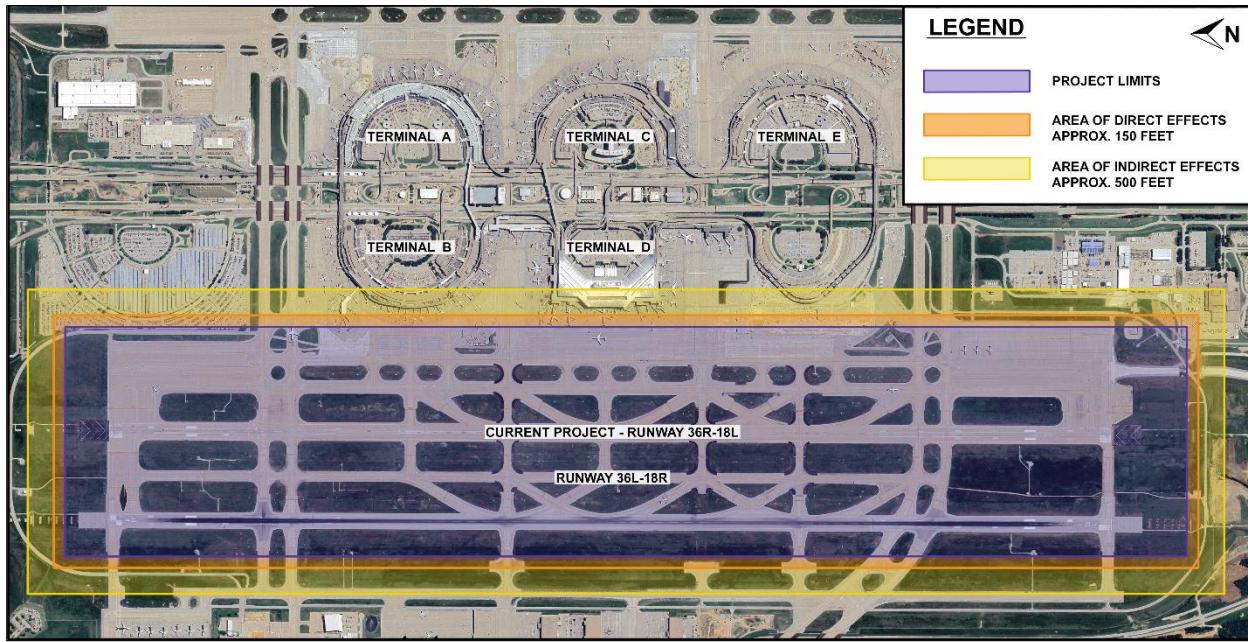
*Image 2. Area of Potential Effects Map*

The Area of Potential Effects (APE) has been defined by Komatsu Architecture in the map found in Image 2 on the following page. An enlarged version of the map is provided in **Attachment A** and **Attachment B** for the archaeological resources desktop evaluation. The Direct APE is applied to the proposed project area boundary and approximately 150 feet outside of the immediate project footprint (see **Attachment C** for select Design Drawing Sheets). The Indirect APE is applied to approximately 500 feet surrounding the project areas to include all visual and physical elements within the proximity of the project.

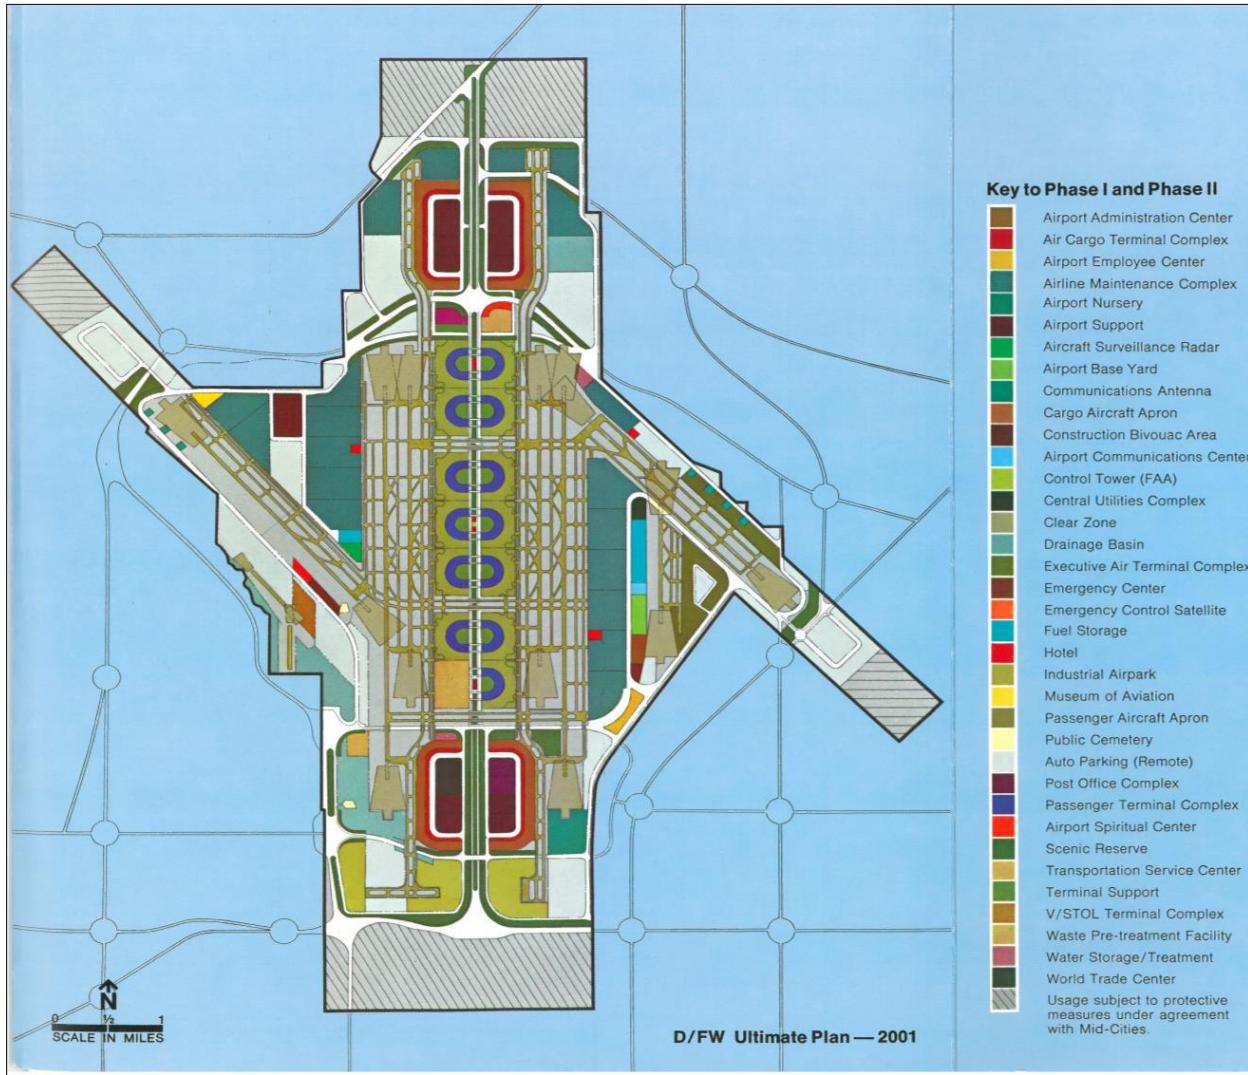
Image 3. DFW 1975 Ultimate Plan for 2001 by Tibbits Abbott McCarthy Stratton (TAMS) Terminal B and D

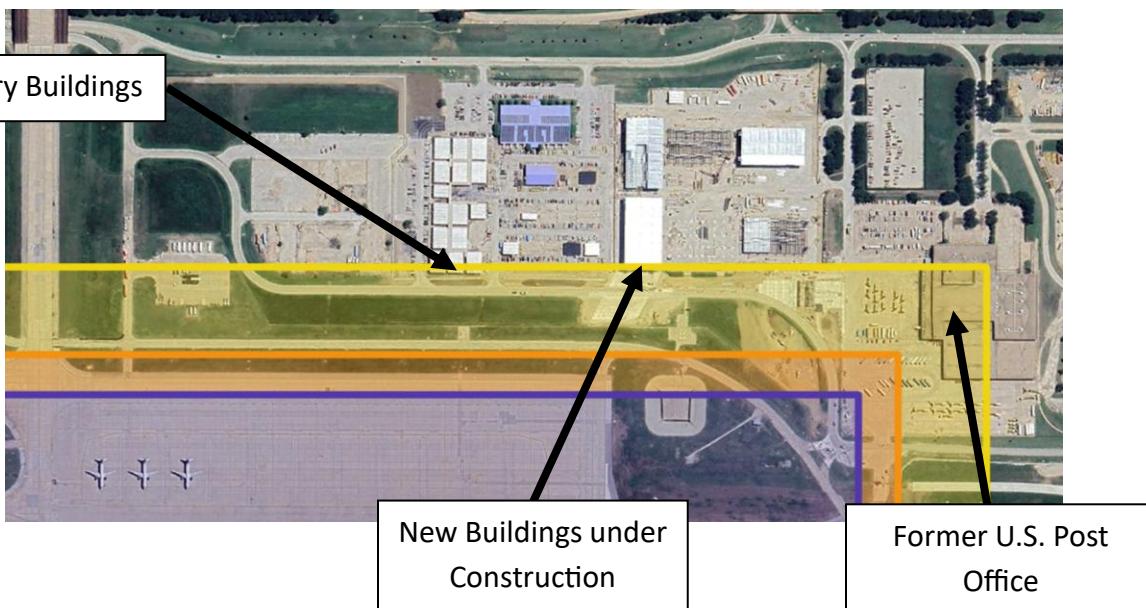
Image 11. Close up of above ground resources in south campus area within the Indirect APE.

The southern edge of the Indirect APE boundary touches several above ground structures at the southern portion of the airport. These structures from left to right include temporary buildings in the Environmental Affairs Division parking lot, new facilities under construction, and the former U.S. Post Office building. Of these, only the Post Office building is of historic age, as it was constructed in 1973.

The first portion of the Post Office facility was completed in 1973 as one of the early support facilities to serve the US Mail Air Service and Airport Ground operation needs. A straightforward processing building using the Airport's precast construction vocabulary, the building is unremarkable in its design. Over the years, several additions were made to the building. Today,

the building no longer functions as a Post Office. It is currently used for various storage needs as the new facilities were placed with other air cargo operations. The recommendation is that this historic-age facility does not meet significance in architectural design or construction methods criteria and is deemed “Not Eligible” for listing on the NRHP.

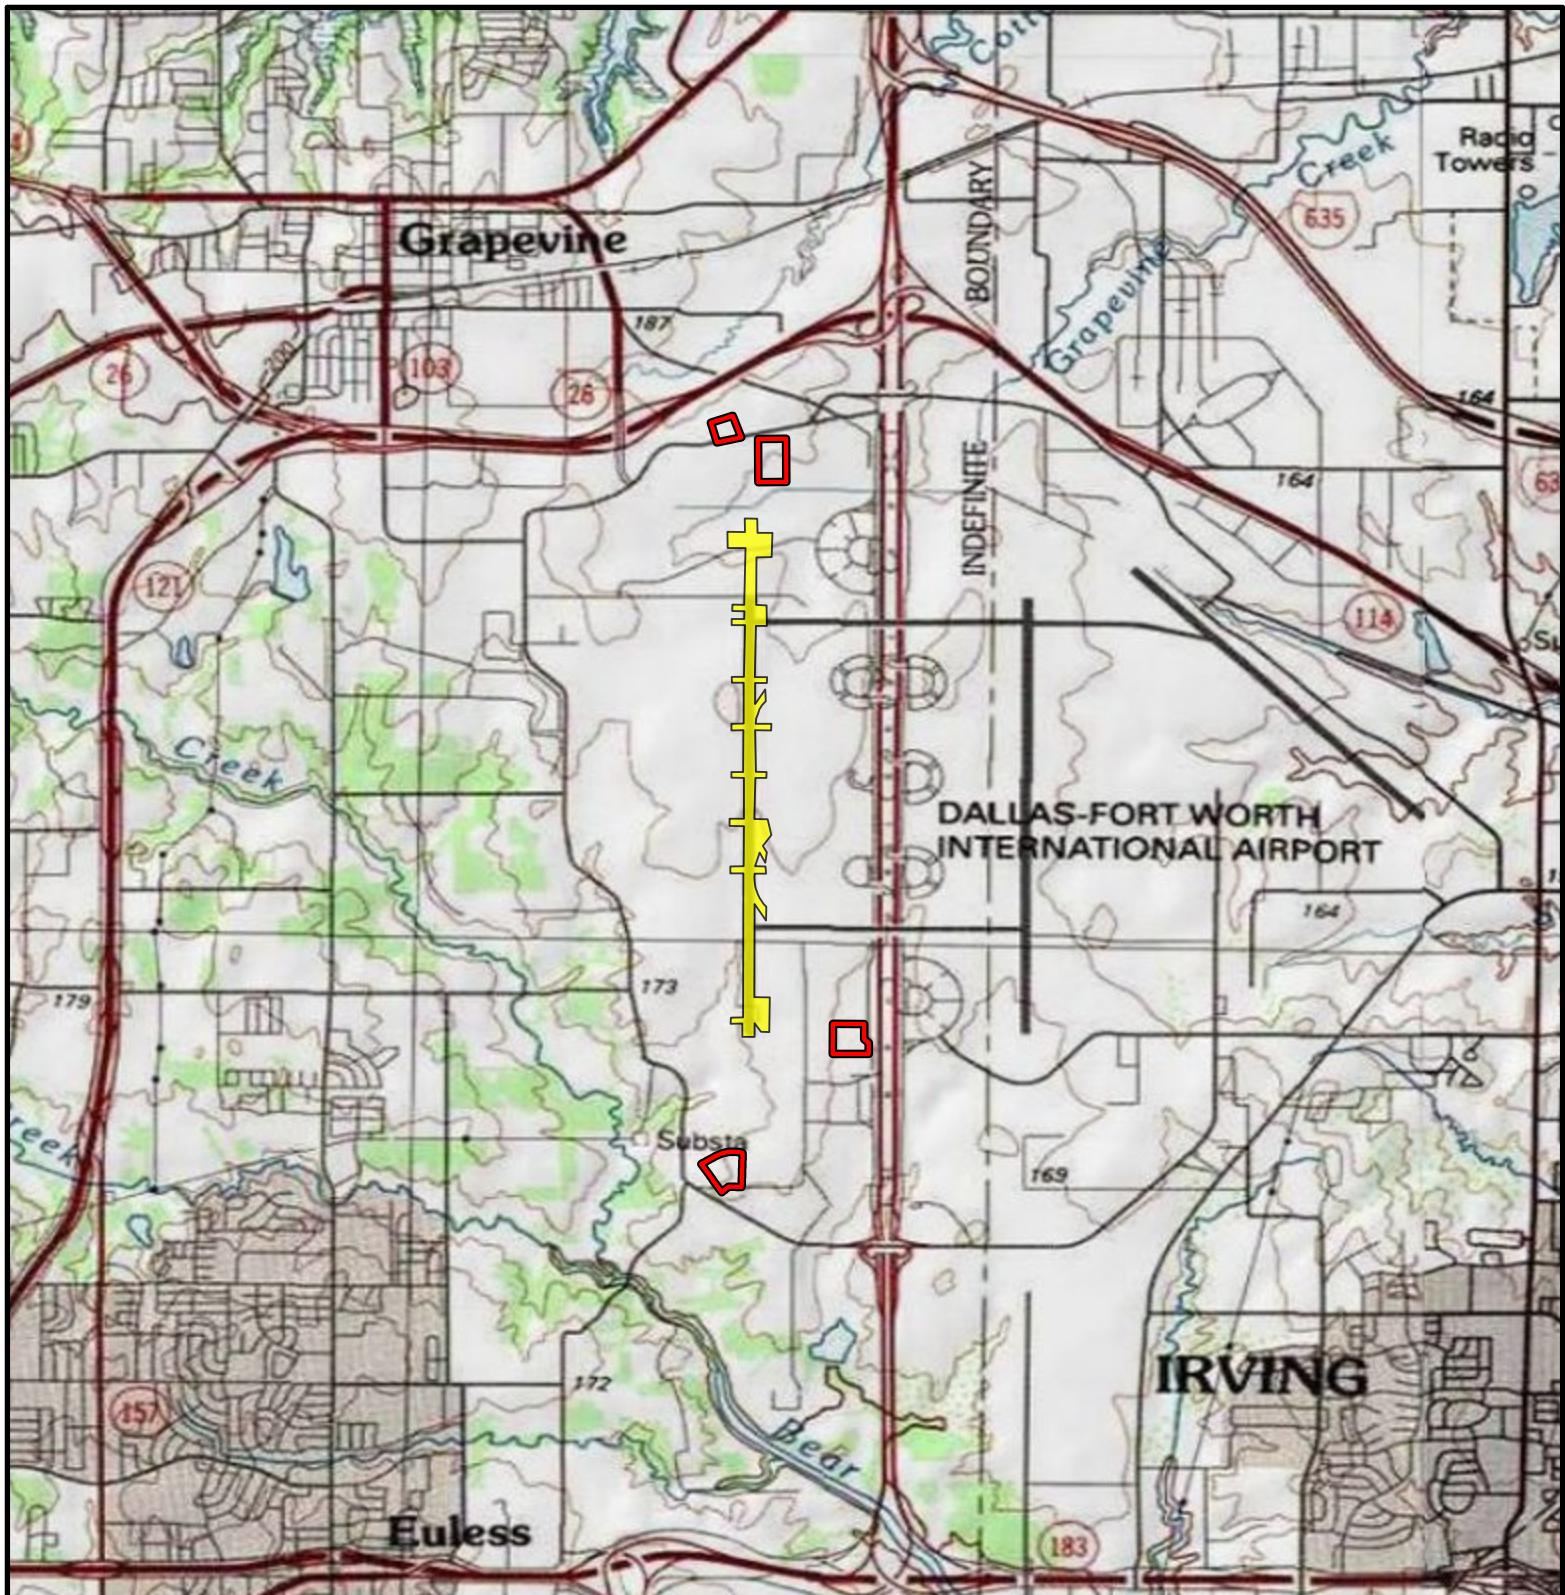
Figure 2  
Topographic Setting

The Grapevine 7.5-minute USGS topographic quadrangle map illustrates that the APE is situated on a north-south-oriented upland ridge (**Attachment A, Figure 2**). Elevations within the APE range from 547 to 611 feet (ft; 167 to 186 meters [m]) above modern sea level (amsl).

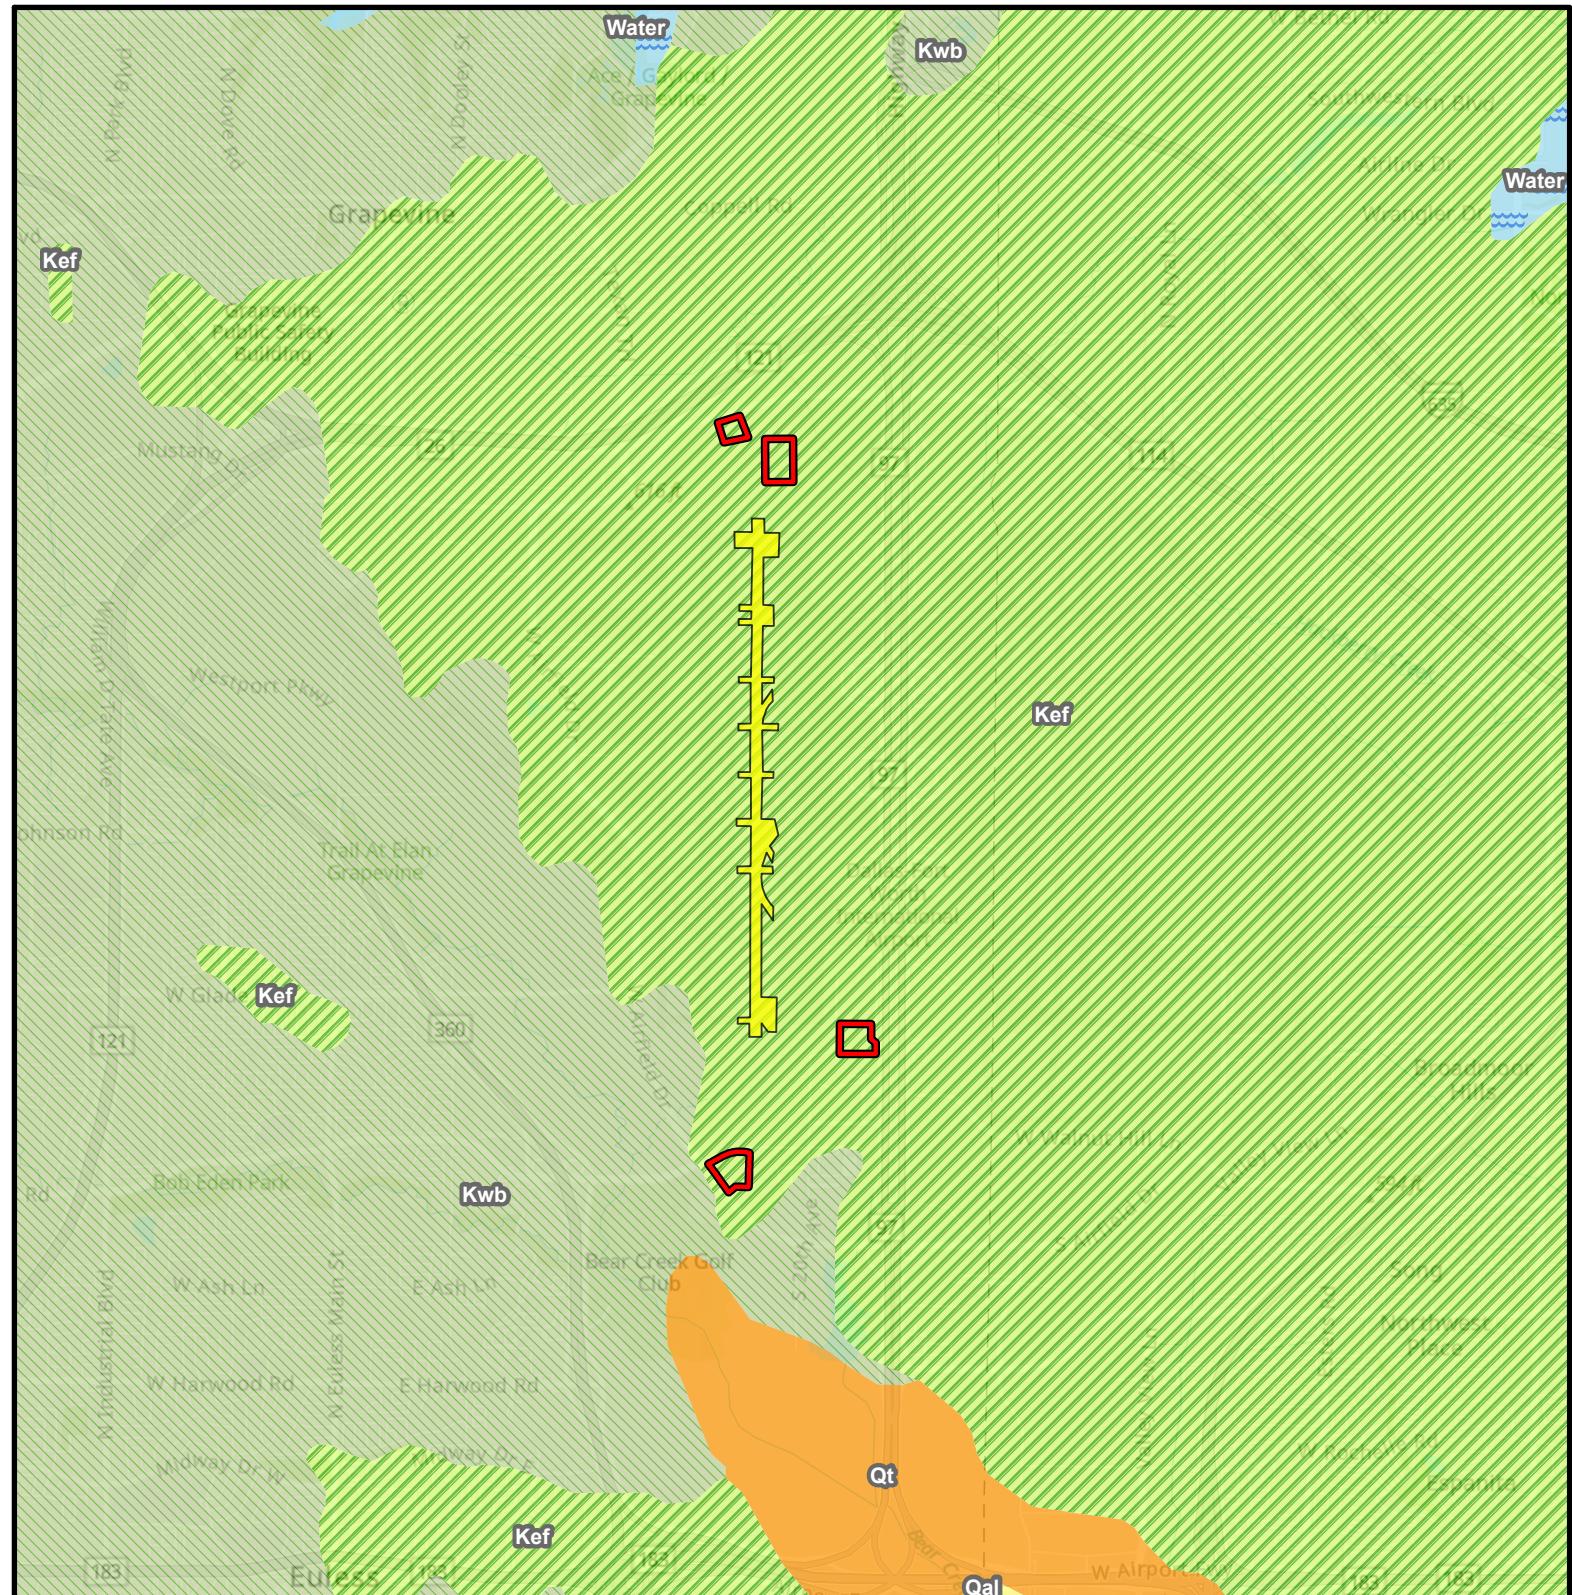
**Figure 3**  
**Geologic Setting**

The APE lies within the environmental interface, known as an ecotone, between the Northern Blackland Prairie and Eastern Cross Timbers ecoregions (McGowen et al. 1987). Variation among each ecoregion is a direct result of the underlying geology and overlying soils and sediments (Diggs et al. 1999). The natural divide between these two ecoregions is east of Big Bear Creek, which extends from the northwest to the southeast through the western portion of the DFW property. The Northern Blackland Prairie is distinguished from surrounding regions by gently rolling hills and fine-textured, black clayey soils and prairie vegetation (Griffith et al. 2007). Vertisols dominate the Blackland Prairie ecoregion and consist of high clay content soils with significant shrink and swell potential (Ressel 1981). Historical vegetation included little bluestem, big bluestem, yellow Indiangrass, and tall dropseed. The Eastern Cross Timbers region contains numerous hills that were once heavily wooded with oak, walnut, blackjack, and hickory trees that grow in deep sandy soil (Hill 1901). However, due to urban expansion, agricultural development, and other modern activities, the natural vegetation has become highly fragmented (Griffith et al. 2007). The APE is underlain by the Cretaceous-age Eagle Ford Formation (Kef), which is comprised of shale, sandstone, and limestone (McGowen et al. 1987; USGS 2025; **Attachment A, Figure 3**).

- Area of Potential Effects
- Runway 18L/36R
- Geologic Unit**
- Kef - Eagle Ford Formation
- Kwb - Woodbine Formation
- Qal - Alluvium
- Qt - Terrace deposits
- Wa - water

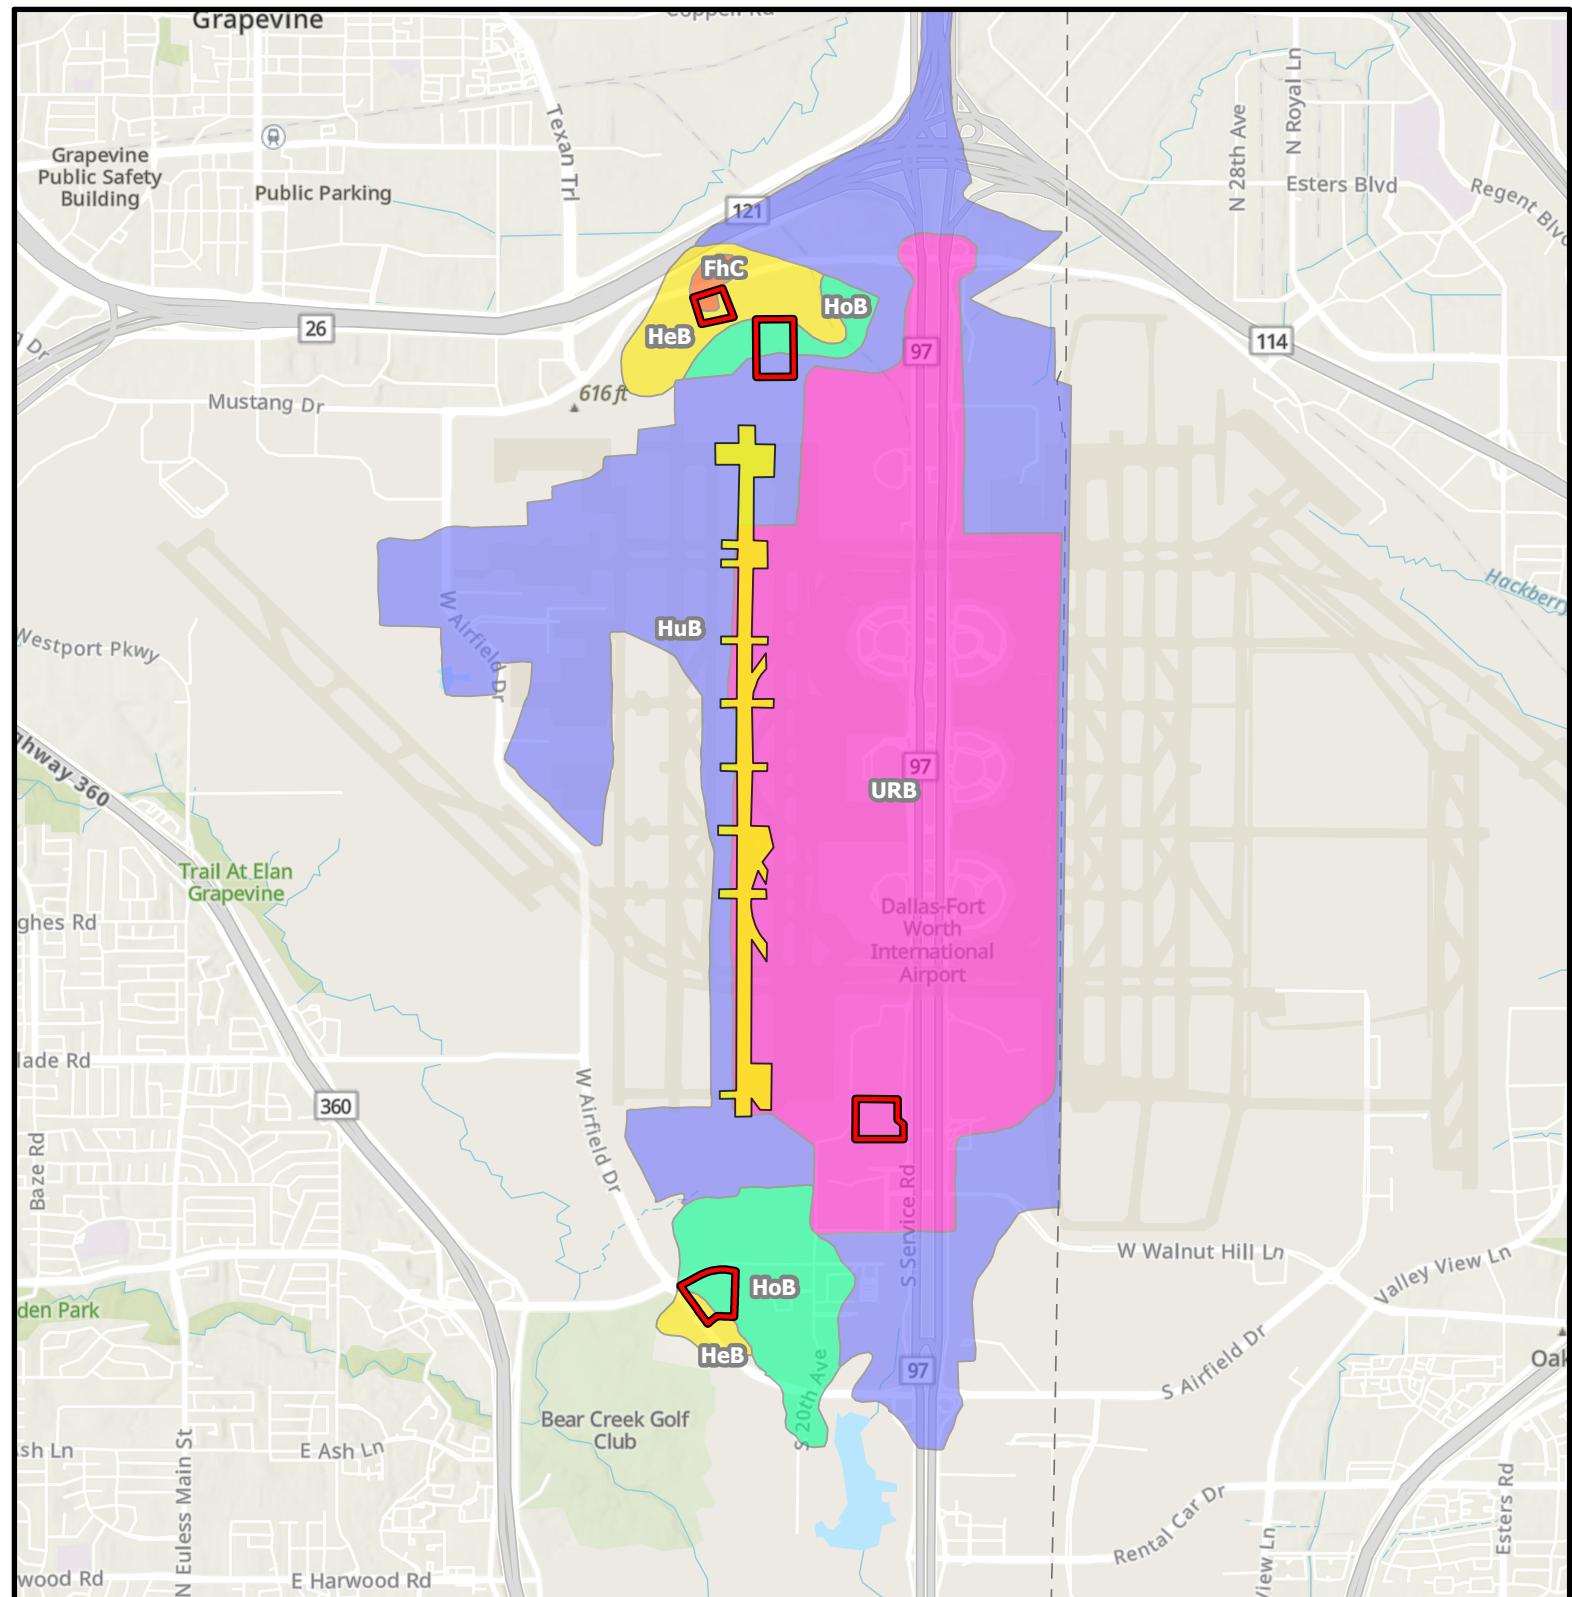
**Figure 4**  
**Soils within and Adjacent**  
**to the APE**

As shown by the *Soil Survey of Tarrant County, Texas*, there are five soil map units within the APE (Ressel 1981; **Table 1; Attachment A, Figure 4**). The entire APE contains soils typically found within an upland setting in the Northern Blackland Prairie. Soil data was viewed from the USDA NRCS Web Soil Survey (USDA 2025).

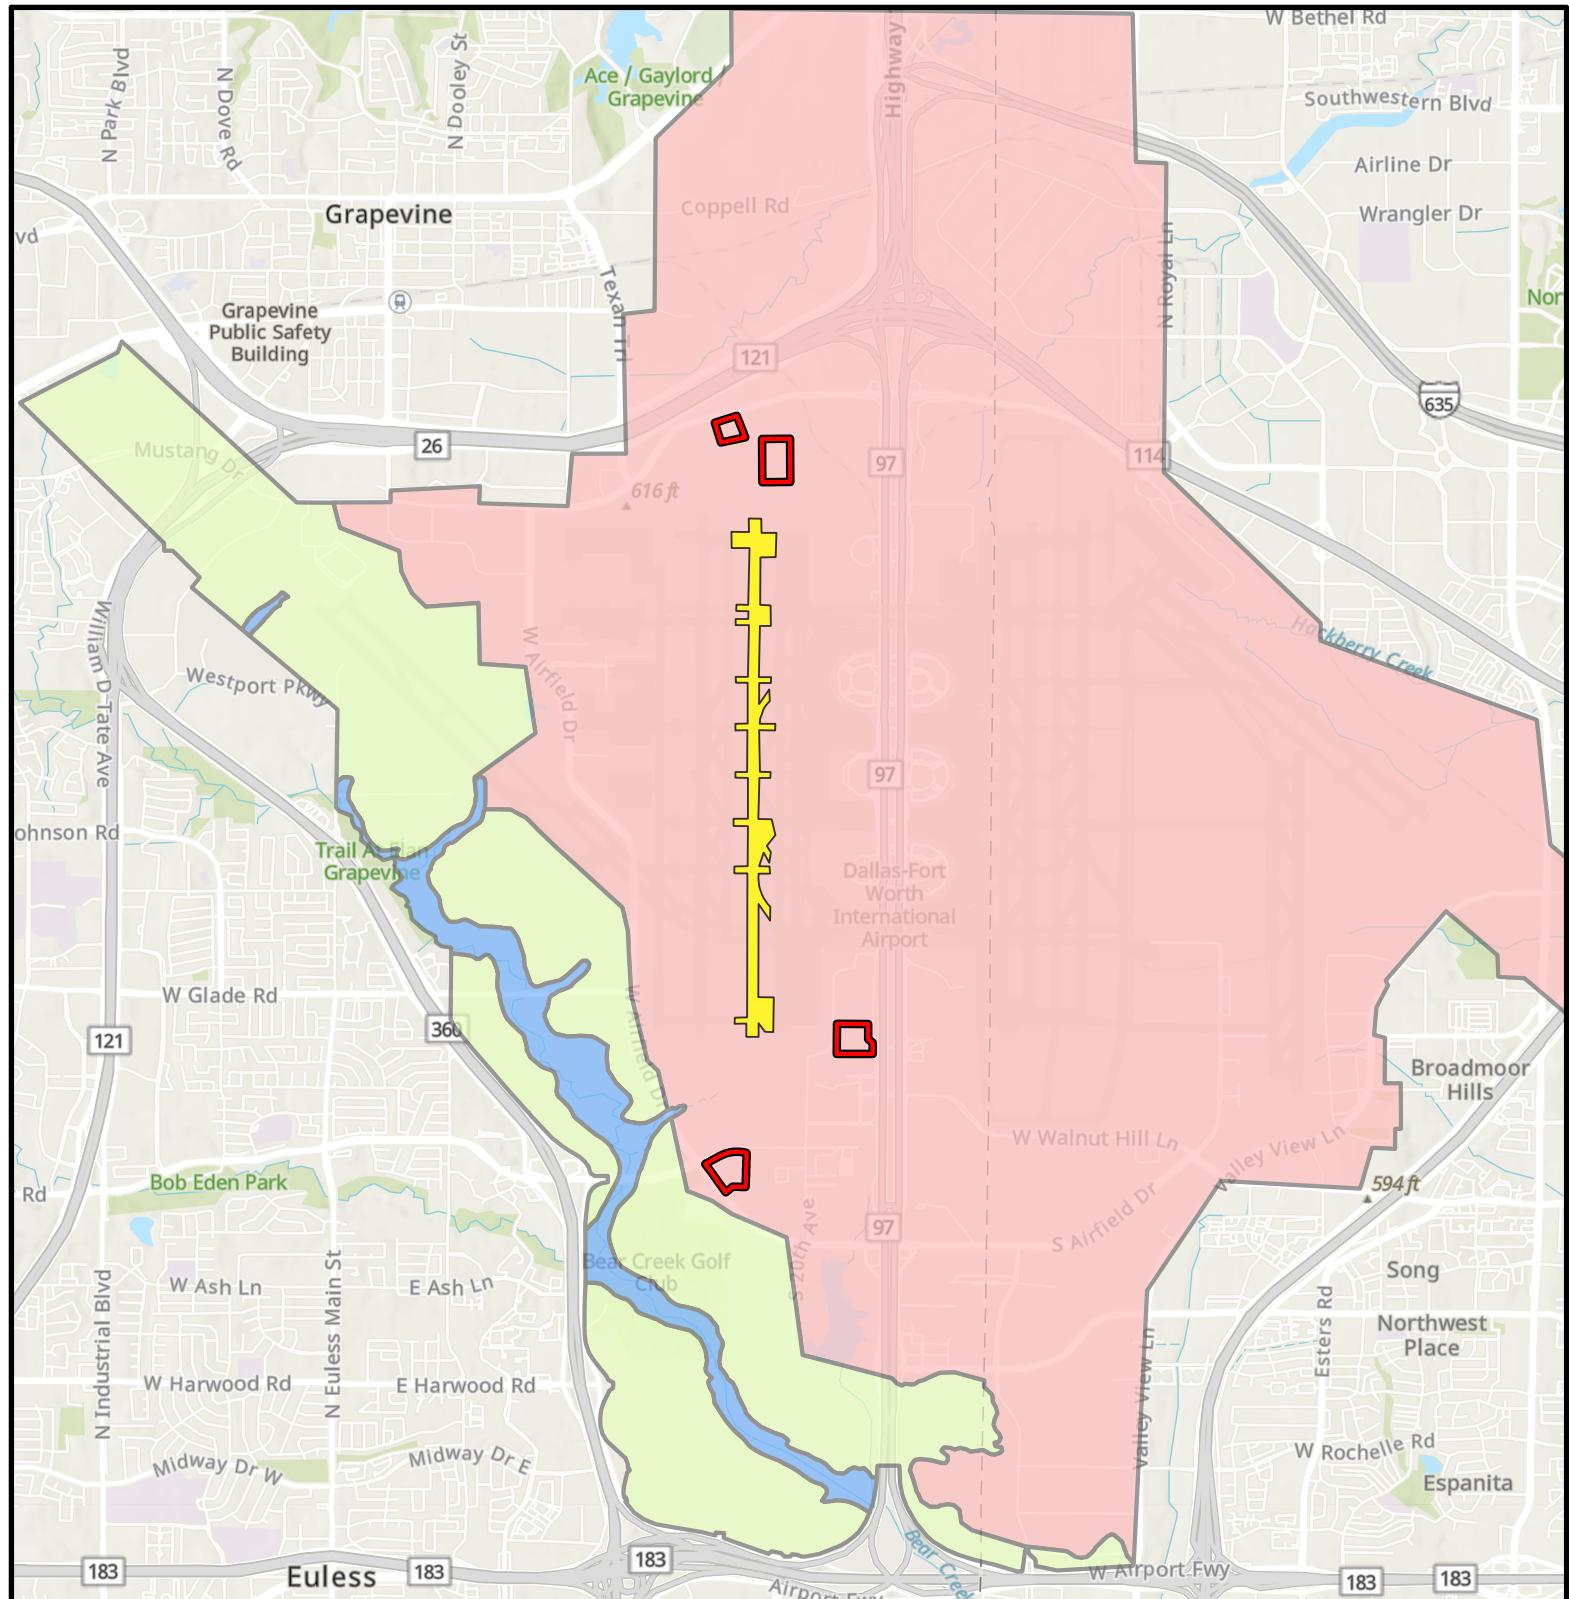
**Figure 7**  
Archeological Environmental  
Zones Map

Data presented within the PALM for Tarrant County indicates the APE features a low to negligible potential for shallow or deeply buried archeological materials within areas that have retained a reasonable contextual setting. Similar conclusions were reported by AR Consultants, Inc. (ARC) in 2007 and 2008. ARC conducted intensive pedestrian surveys of 1,210 ac on the DFW property under Texas Antiquities Permit Number 4491 and published their results in the report *An Archaeological Survey for Chesapeake Energy Corporation at DFW International Airport, Dallas and Tarrant Counties, Texas* (Shelton et al. 2008). Through this study, three environmental zones were identified within DFW property that contain varying amounts of cultural resources probability (**Figure 6**). The current APE will have ground disturbances within Zone 1.

Zone 1 comprises the Blackland Prairie Uplands ecoregion, which consists of mostly level clay or clay loam soils over limestone bedrock. Water permeates very slowly to the water table, causing surface run-off and high shrink and swell potential. This setting has a low biotic diversity and is dominated by short grasses. Due to the limited resources available within the area, it has a low probability of containing prehistoric sites (Shelton et al. 2008).
