201904329

West Cargo Demolition Project

RE: Cultural Resources Desktop Analysis for the West Cargo Demolition Project #1, City of Grapevine, Dallas County, Texas

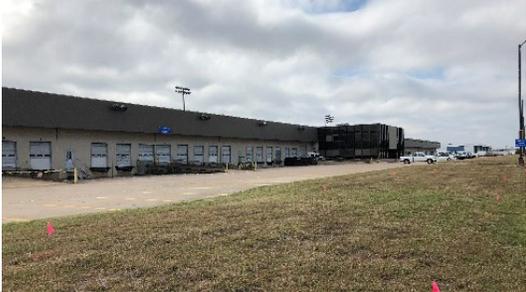
Property Name	Property Location/Address	Construction Date/ Architectural Elements	Photograph of Resource
Evergreen Facility	1530 W. 19 th Street	1972 Modern style, two-story building constructed of steel beam framing with concrete block and concrete slab walls. The front entrance features a series of large glass windows. The building contains numerous cargo-holds and loading docks.

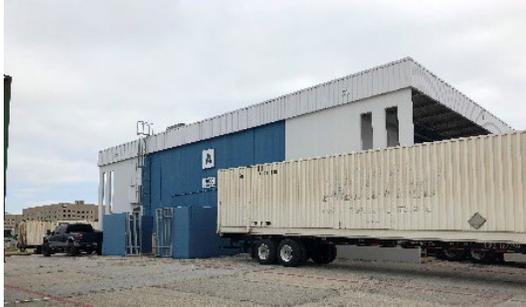
Building A	1900 W. Airfield Drive	1972 Modern style, two-story building constructed of steel beam framing with concrete block and concrete slab walls. The building features offices, storage, maintenance areas, and loading docks.

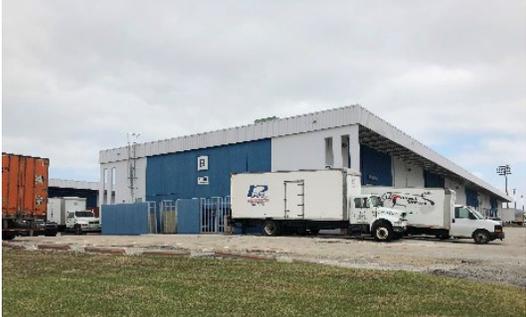
Building B	1910 W. Airfield Drive	1972 Modern style, two-story building constructed of steel beam framing with concrete block and concrete slab walls. The building features offices, storage or maintenance areas, and loading docks.

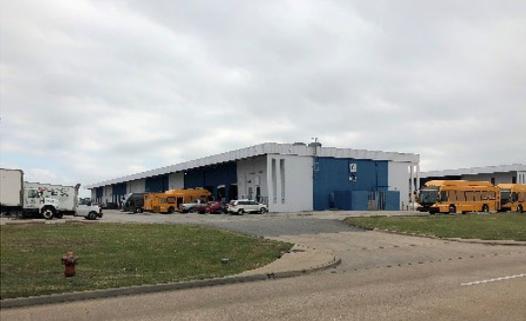
Building C	1920 W. Airfield Drive	1972 Modern style, two-story building constructed of steel beam framing with concrete block and concrete slab walls. The building features offices, storage or maintenance areas, and loading docks.

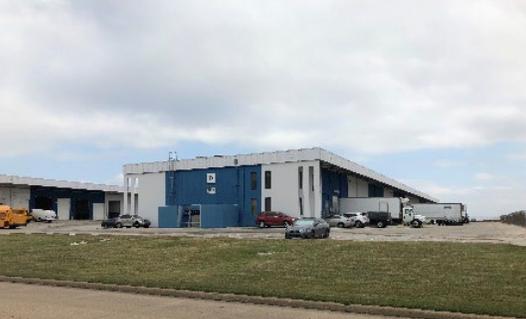
Building D	1930 W. Airfield Drive	1972 Modern style, two-story building constructed of steel beam framing with concrete block and concrete slab walls. The building features offices, storage or maintenance areas, and loading docks.

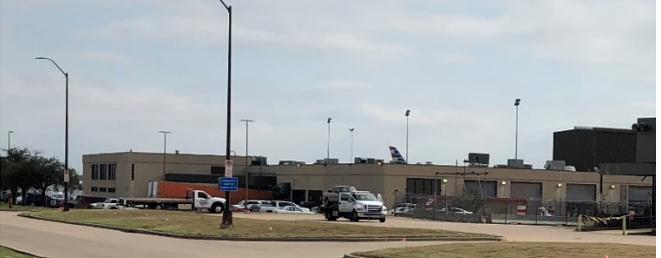
Property Name	Property Location/Address	Construction Date/ Architectural Elements	Photograph of Resource
American Airlines West Supply Warehouse	1630 W. 19 th Street	1972 Modern style, two-story building constructed of steel beam framing with concrete slab walls. The building features offices, storage, and loading docks.

The American Airlines West Supply Warehouse was built in 1972 or 1973 as part of the original development of the airport. The Modern style two-story building features administrative offices, warehouse storage space, and numerous loading docks (**Attachment B, Photograph 70**). According to current and historic aerial photographs, the building appears to have been minimally altered since its initial construction. Because the building is not historic-period and lacks historical significance, the American Airlines West Supply Warehouse is ineligible for NRHP listing under Criteria Consideration G.

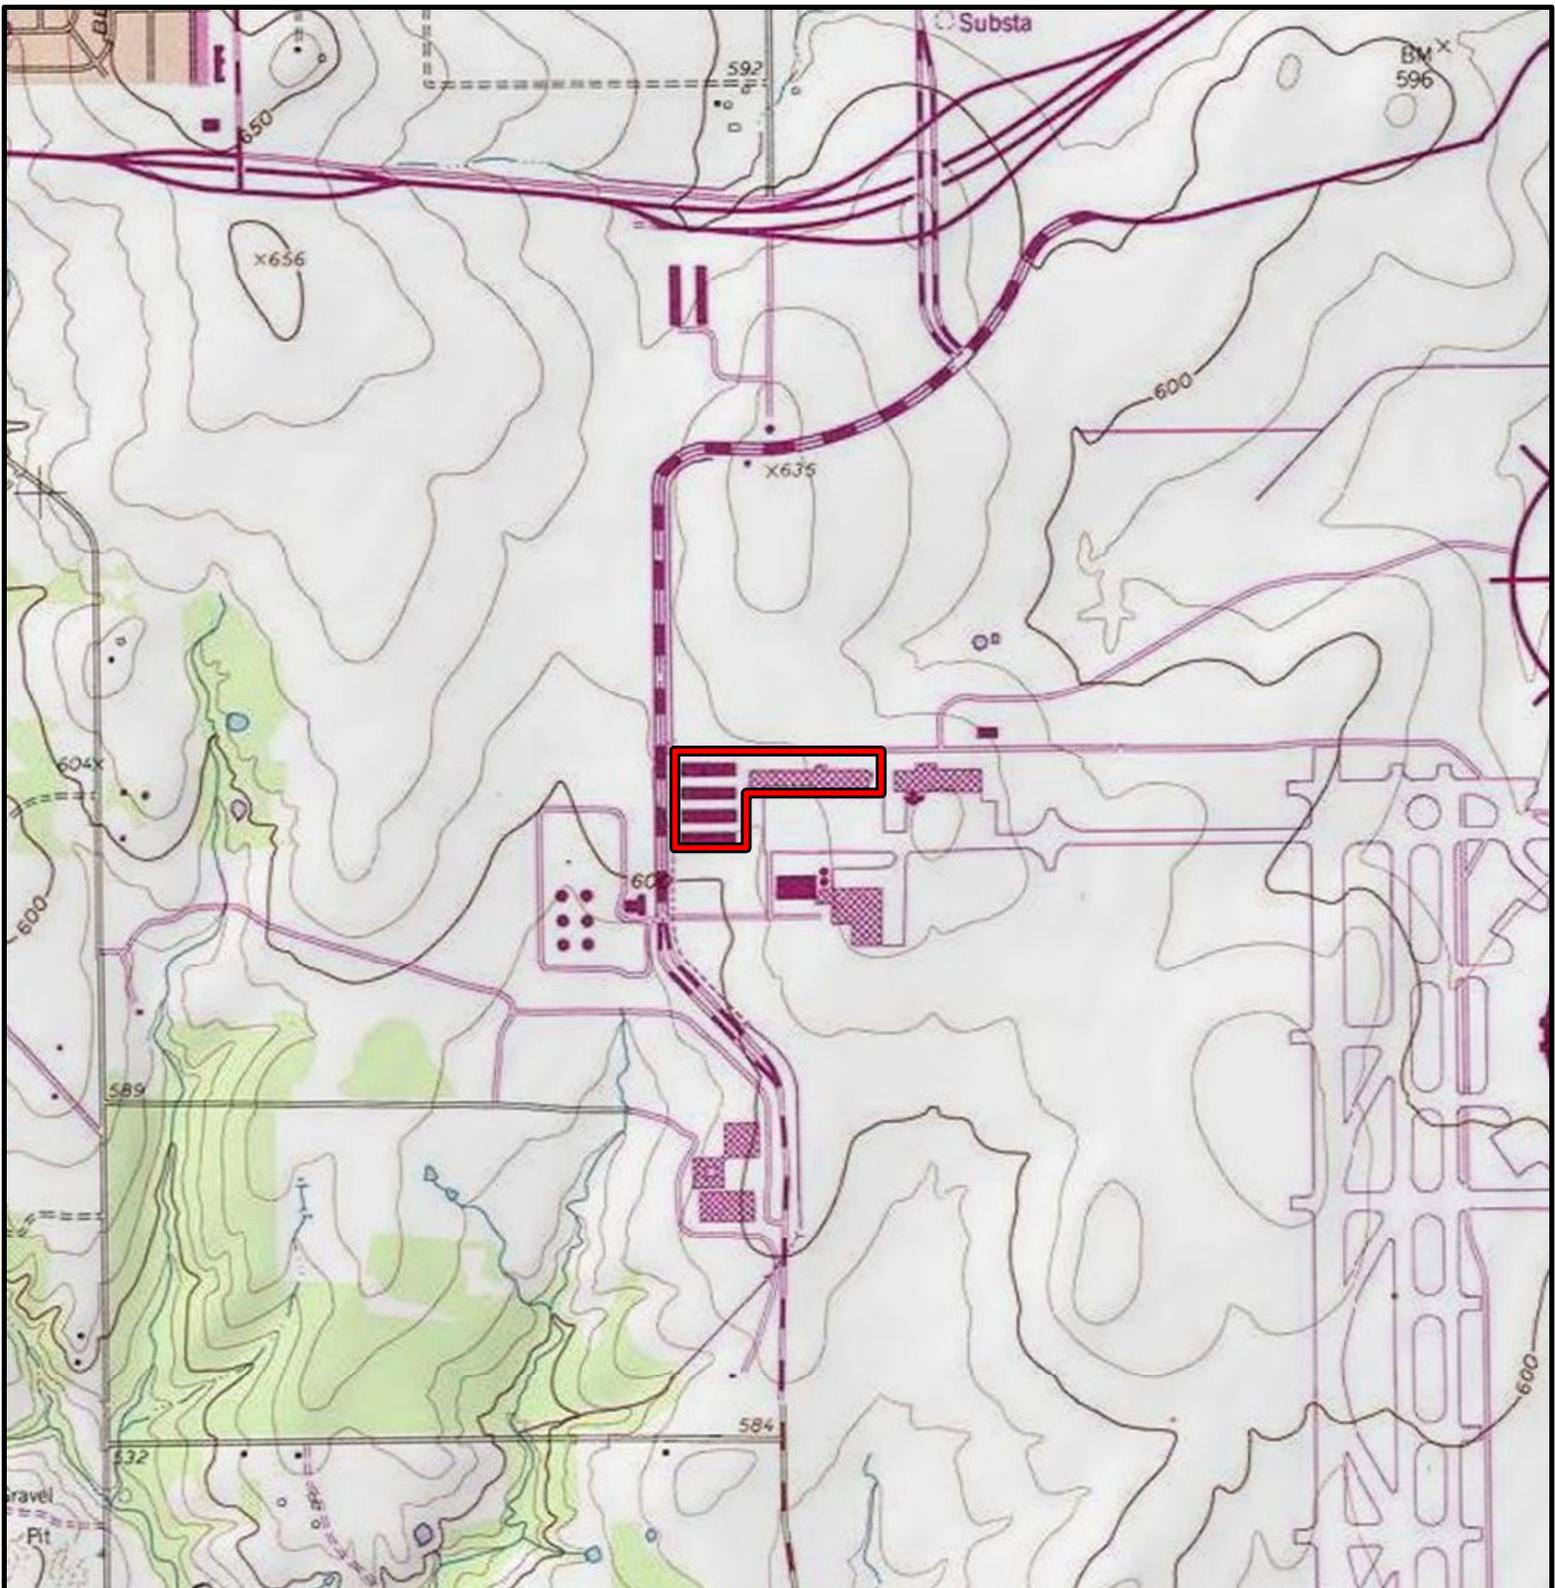
Figure 2
Topographic Setting

The USGS Grapevine 7.5' Quadrangle map illustrates the APE is located within a gently sloping upland setting (**Attachment A, Figure 2**). The APE is situated approximately 0.6-mile northeast of the watershed of Big Bear Creek. The project area occupies an elevation range of 610 to 620 feet (ft; 186 to 189 meters [m]) above modern sea level (amsl).

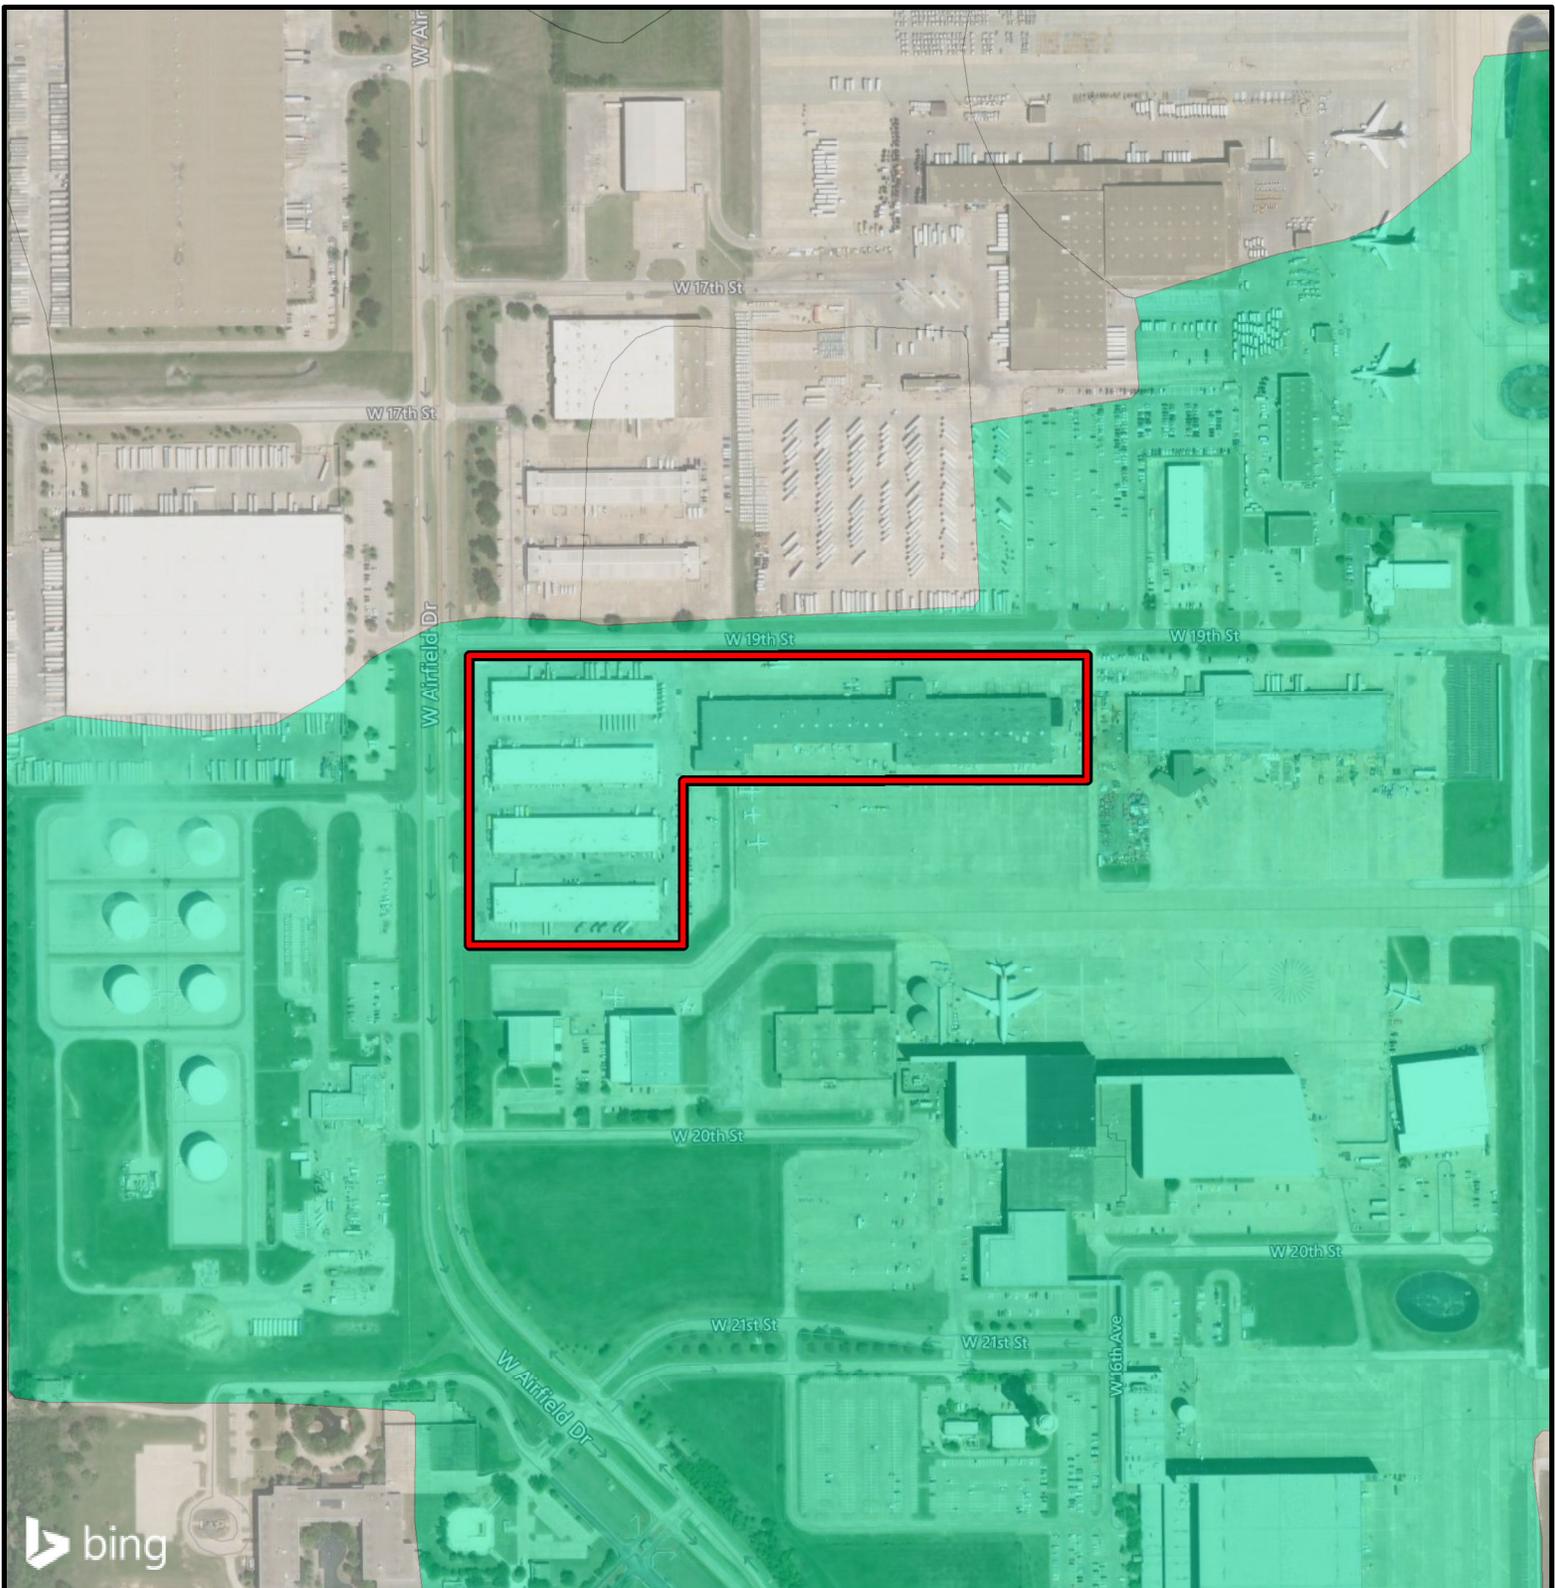
Figure 3
Soil Map Units Located Within and
Adjacent to the APE

As shown by the *Soil Survey of Tarrant County, Texas*, there is only a single soil unit within the APE (Ressel 1981). The entire APE contains Houston Black-Urban land complex, 1 to 4 percent slopes, which consists of clay weathered from calcareous shale of the Taylor Marl and Eagleford Shale formations. These soils are typically located in upland settings within the Northern Blackland Prairie and are moderately well drained. Soil data was viewed from the USDA NRCS Web Soil Survey (Web Soil Survey 2018; **Attachment A, Figure 3**).

35 - Houston Black-Urban land complex, 1 to 4 percent slopes

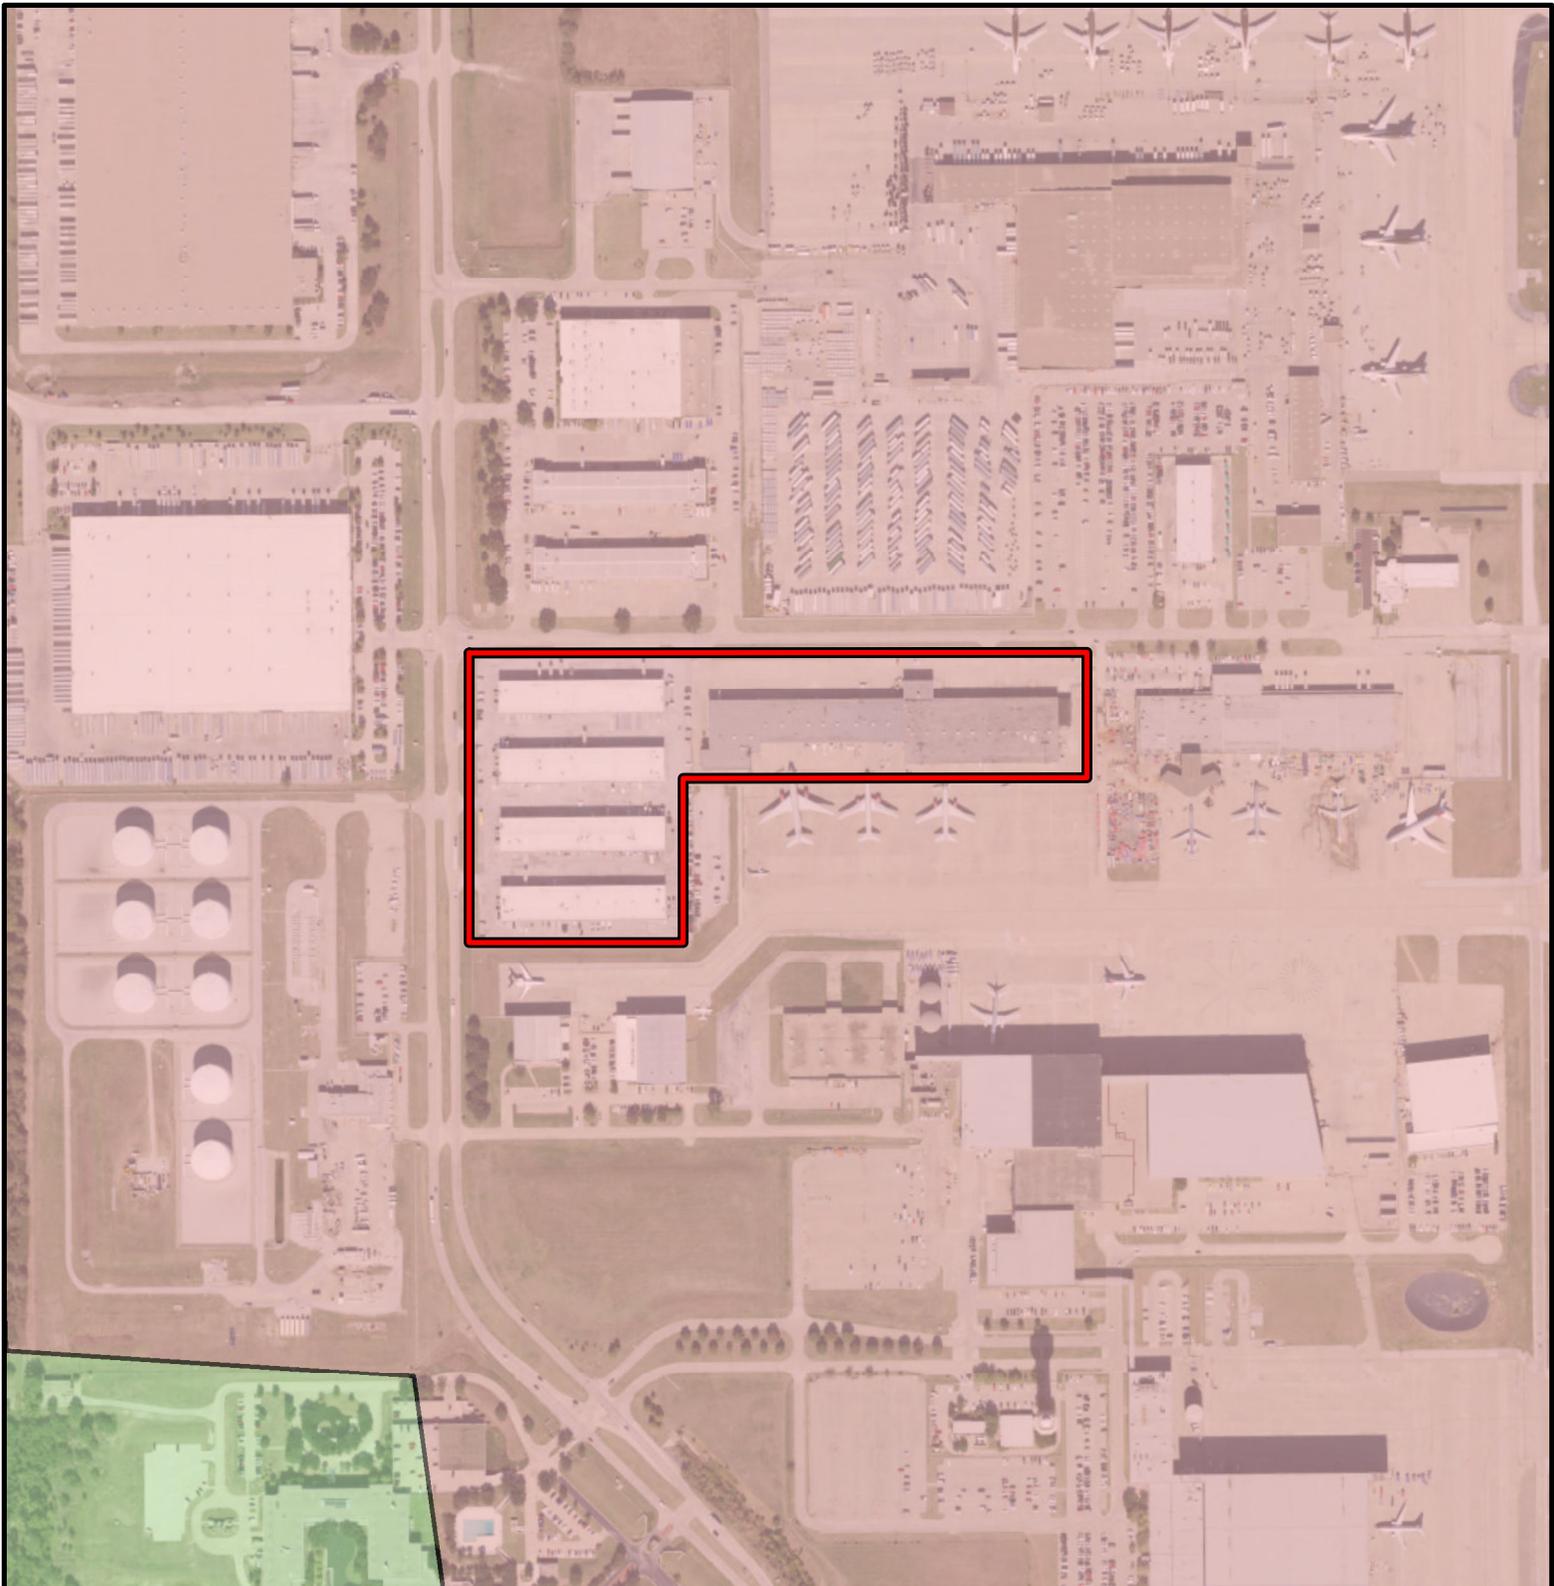
Figure 5
Archeological Environmental
Zone Map

Data presented within the PALM for Tarrant County indicates that the entire APE featured a negligible potential for both shallow and deeply-buried cultural deposits with reasonable contextual integrity. Similar conclusions were reported in 2007 and 2008 by AR Consultants, Inc. (ARC), who conducted intensive pedestrian surveys of 1,210 acres on the DFW property under Texas Antiquities Permit Number 4491. These results were published in the report *An Archaeological Survey for Chesapeake Energy Corporation at DFW International Airport Dallas and Tarrant Counties, Texas*. Through this study, three environmental zones were identified within the DFW that contain varying amounts of cultural resources probability. The current APE will have ground disturbances within Zone 1 (**Attachment A, Figure 5**).

Zone 1 is comprised of the Blackland Prairie Uplands ecoregion, which consists of mostly level clay or clay loam soils over a thin layer of limestone bedrock. Water permeates very slowly to the water table causing slow surface runoff and high shrink and swell potential. This setting has a low biotic diversity and is dominated by short grasses. Due to the limited resources available within the area, it has a low probability for containing prehistoric sites (Shelton et al. 2008). The THC reviewed and concurred with these conclusions.

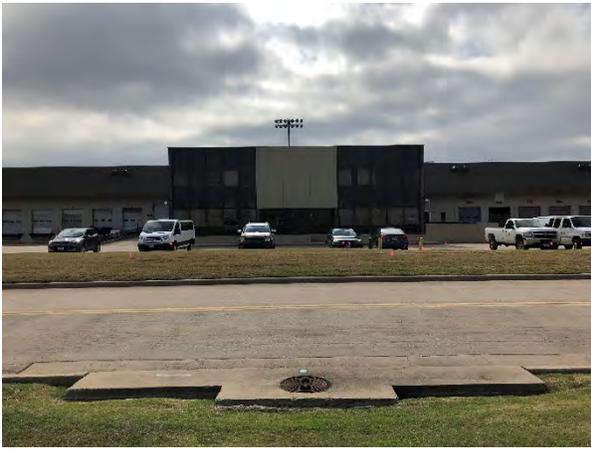
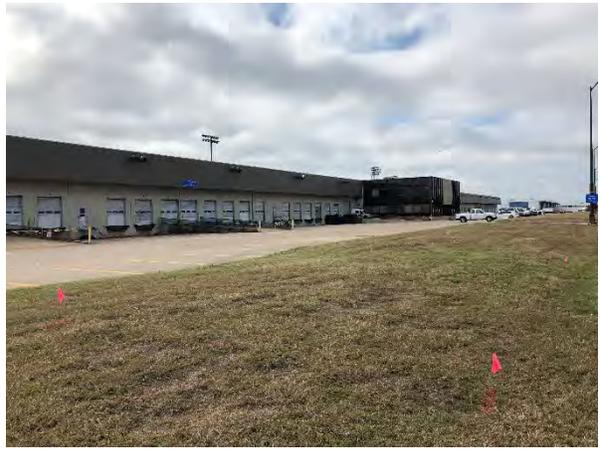
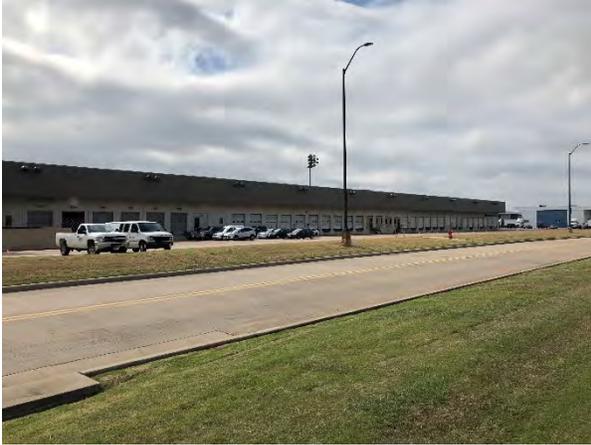
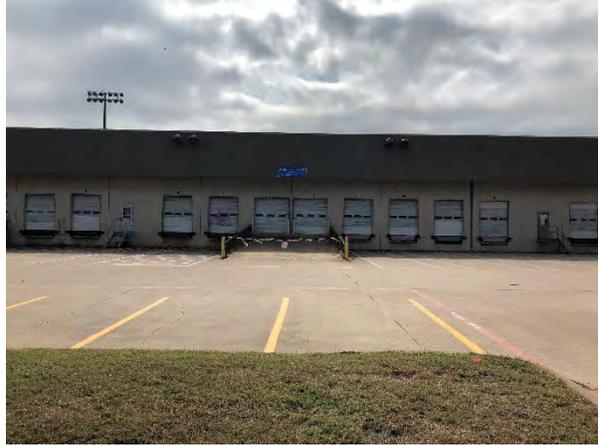
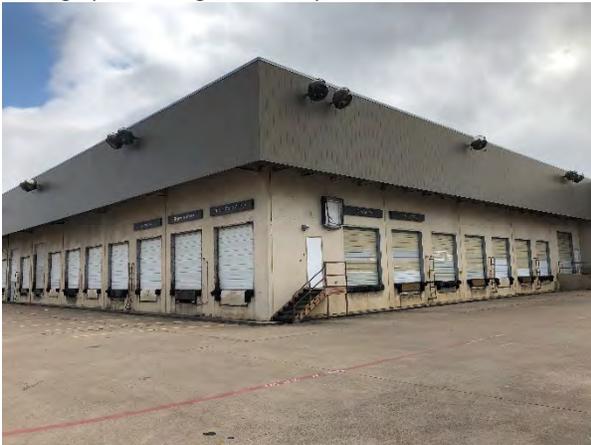
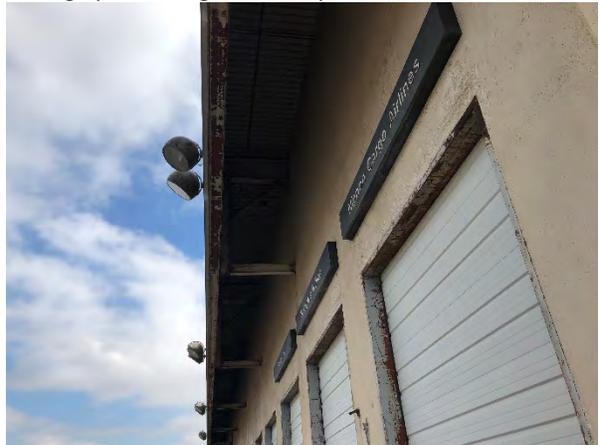
The largest of these recorded buildings was the Evergreen facility, which is located in the eastern part of the APE at 1530 W. 19th Street (**Attachment B, Photographs 1 through 22**). The Evergreen facility features offices, warehouse storage, and loading docks used by various air freight companies for cargo transportation. The building was constructed in the Modern style, which emphasized function over aesthetic embellishment. The facility is comprised of a flat roof, reinforced concrete slab exterior walls supported by steel beam framing, and a concrete foundation. The main entrance on the north wall of the building features three walls of glass paneling. The interior contains exposed metal beam roof supports and columns in the storage areas, second story cat walks, concrete block dividing walls, and insulated rooms (ceiling tiles, sheet rock walls, glass windows, wooden doors) for offices and common areas. Based on research, it was determined that the Evergreen facility is not of historic age, nor has it achieved exceptional importance since its construction and does not qualify for NHRP listing under Criteria Consideration G.

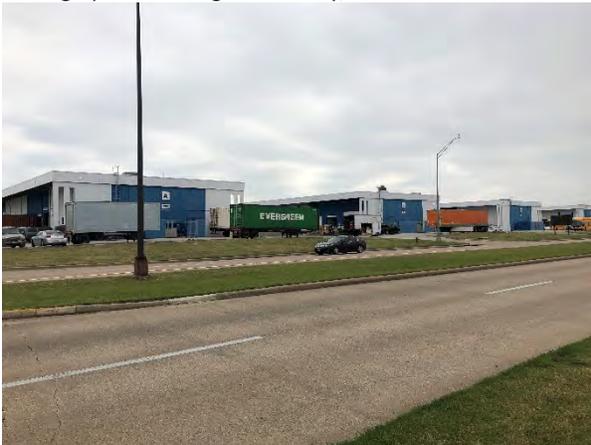
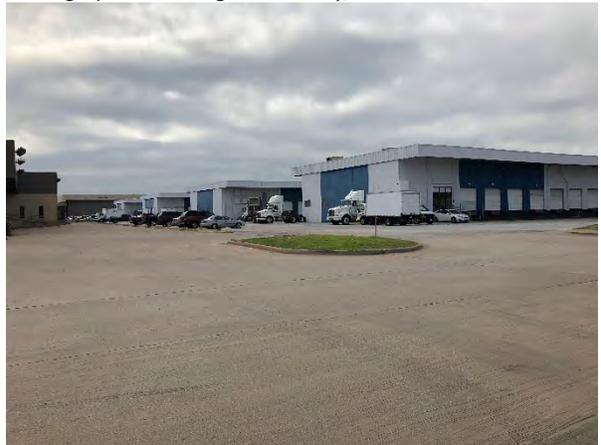
Photograph 23 – Building A, B, C, & D, View to Southeast

The west half of the APE features a row of four identical warehouses (**Attachment B, Photographs 23 and 24**), known as Building A (**Attachment A, Photographs 25 through 31**), Building B (**Attachment B, Photographs 32 through 46**), Building C (**Attachment B, Photographs 47 through 61**), and Building D (**Attachment B, Photographs 62 through 69**). The Modern style buildings feature flat roofs, reinforced concrete exterior walls, concrete block or sheet rock interior walls, steel beam framing, and concrete flooring. Each building contains warehouse and enclosed office space. A portion of Building C is currently being leased by an airport limousine service provider for maintenance and office space. In Building D, a portion of the space is used by a bussing contractor for DFW. Based the age of the buildings and general lack of significance in the history of DFW, Buildings A, B, C, and D are not eligible for NRHP listing under Criteria Consideration G.
