Addendum (01) – Alliance Remediation Action Plan (RAP)

Westlink Stage 1 – 90-308 Aldington Road and 59-63 Abbots Road, Kemps
Creek, NSW, 2178

EP3244.004_v1 | 12 September 2023

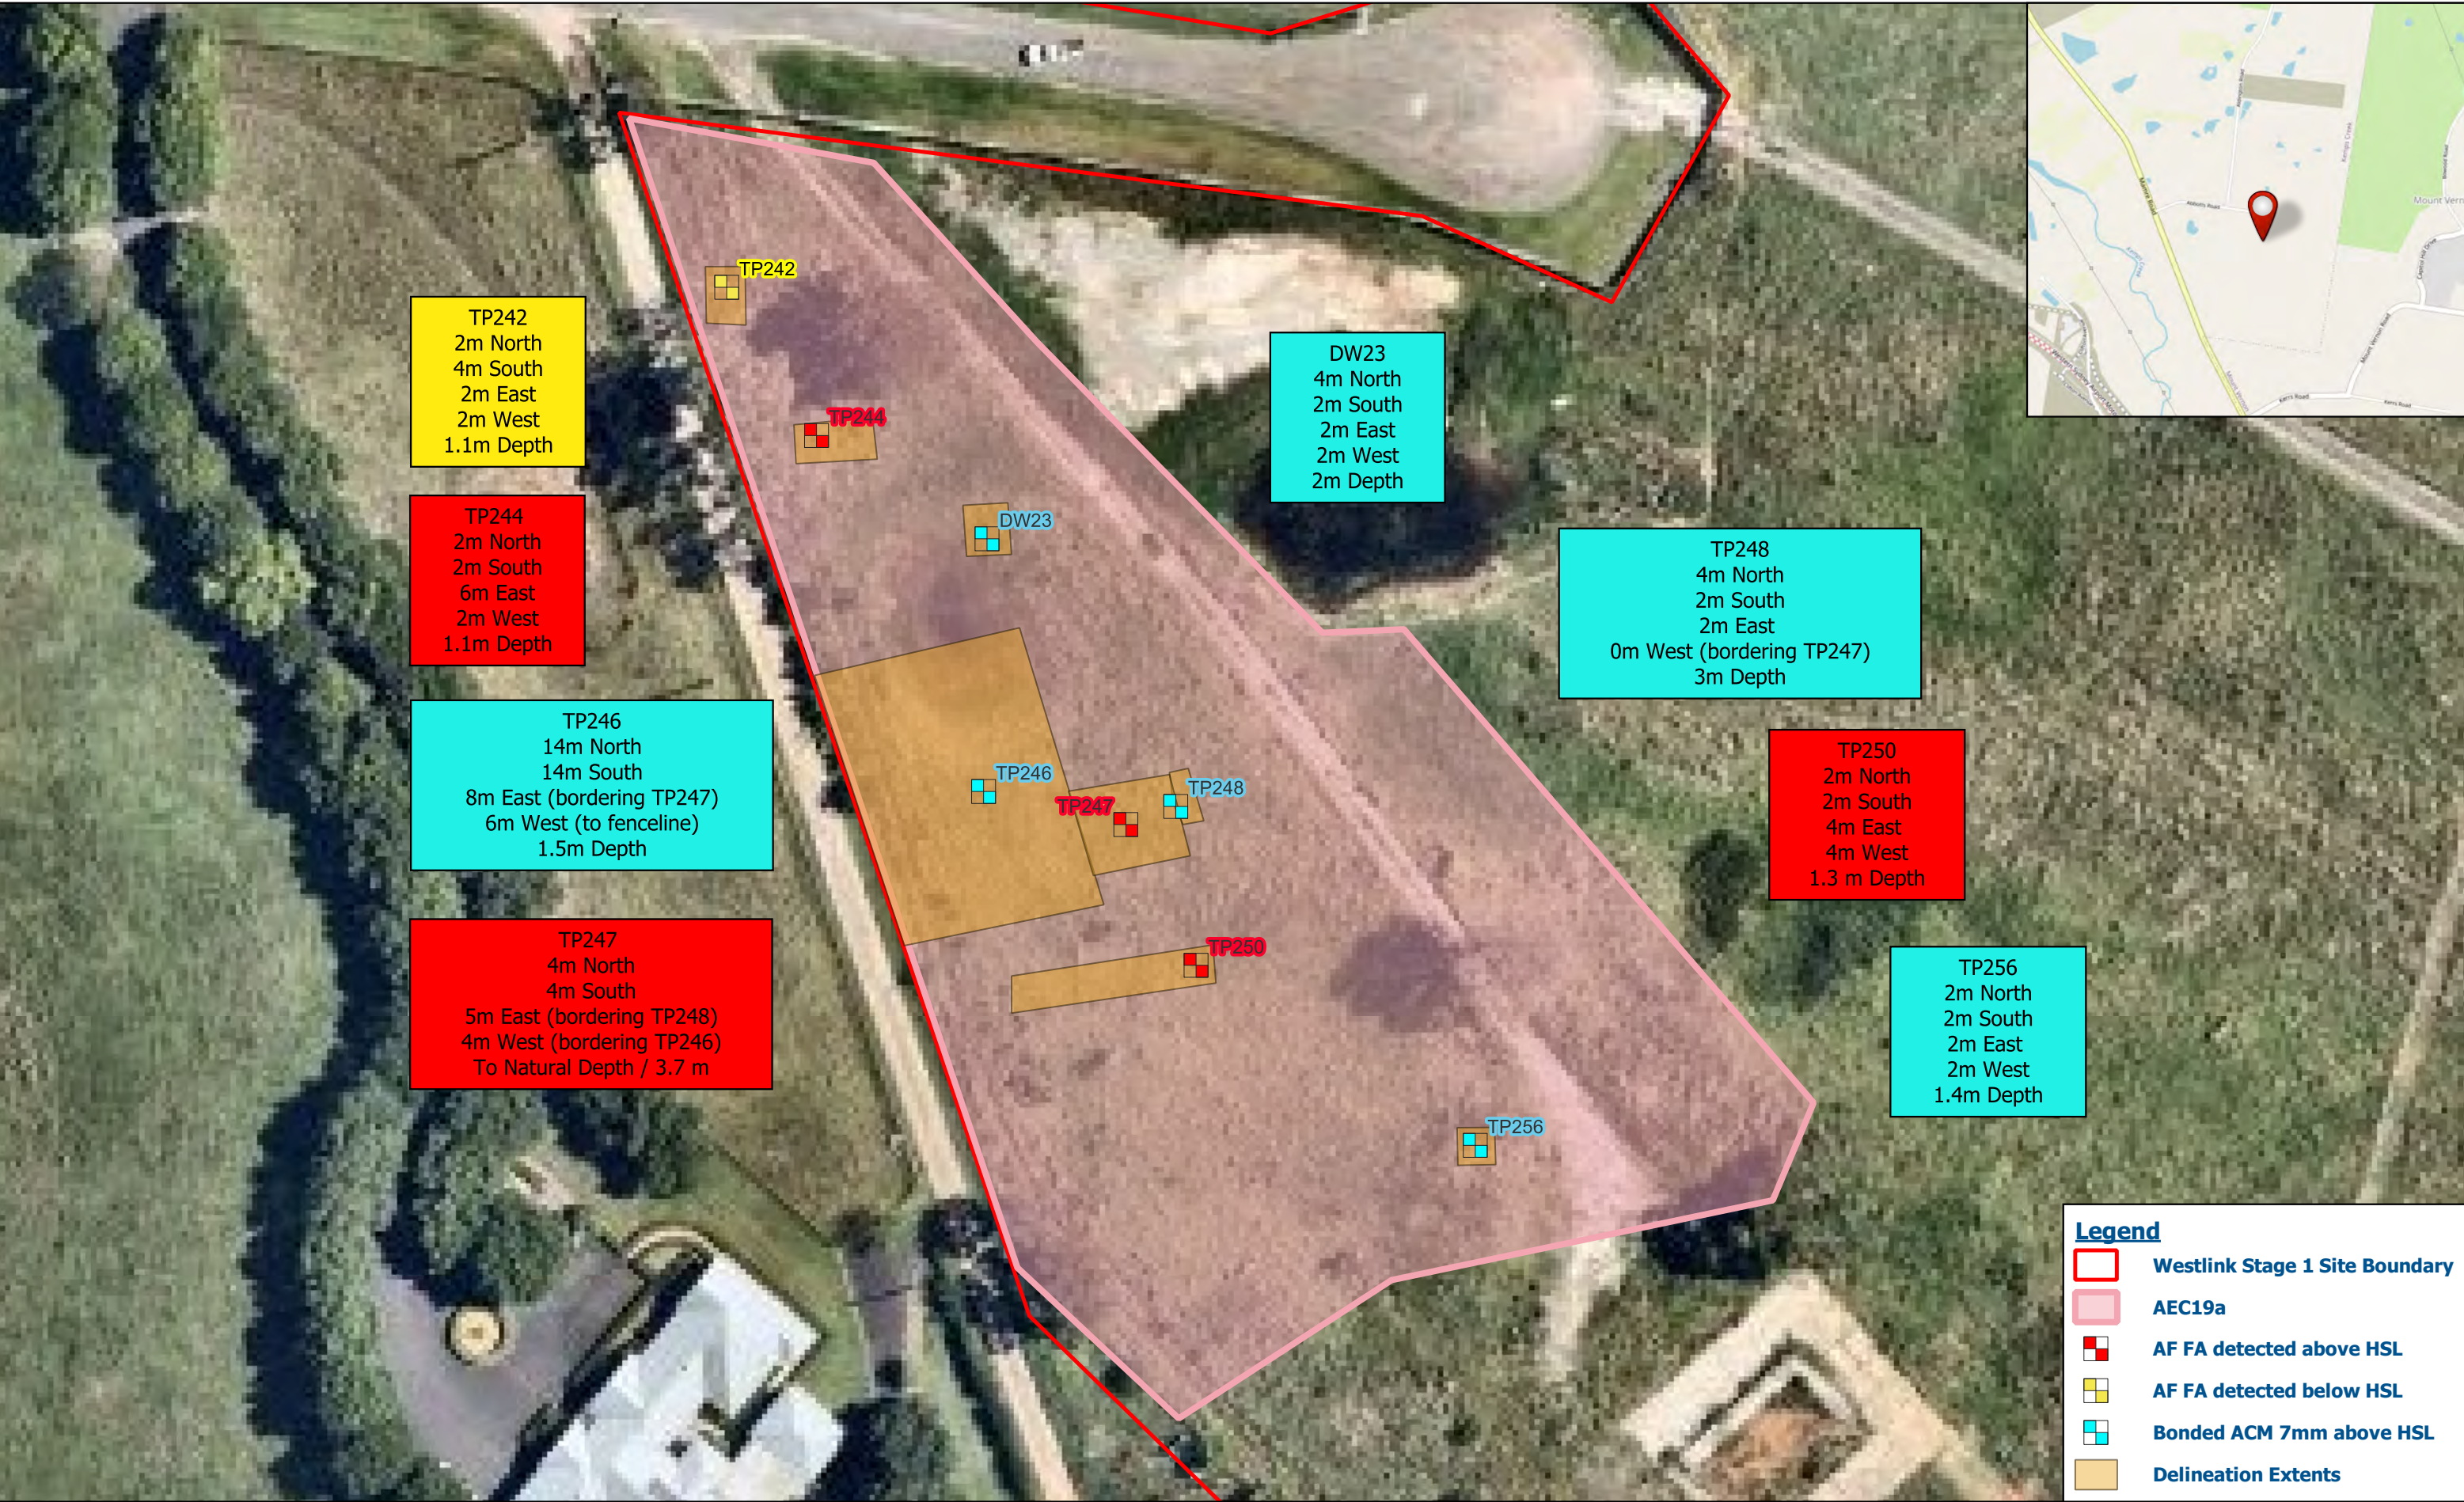
Attachment 2 – AEC19a Delineation Extent Map

The findings of the delineation sampling for AEC19a have been summarised in **Table 2** below and within **Attachment 2 – AEC19a Delineation Extent Map**. Associated laboratory reports will be provided in the final Validation Report for the Site.

Table 2 - AEC19a Delineation Extents							
Test Pit	Lateral				Vertical	Approximate Surface Area	Approximate Volume
	N	S	E	W	Depth		
AF/FA – At or above the HSL							
TP247	4 m	4 m	5 m	4 m	To Natural / 3.7 m	8 m x 9 m 72 m ²	266.4 m ³
TP244 ¹	2 m	2 m	6 m	2 m	1.1 m	4 m x 8 m 32 m ²	35.2 m ³
TP250 ¹	2 m	2m	4 m	17 m *	1.3 m	4 m x 21 m 84 m ²	109.2 m ³
SUB TOTAL						188 m ²	410.8 m ³
AF/FA – Below the HSL							
TP242	2 m	4 m	2 m	2 m	1.1 m	6 m x 4 m 24 m ²	26.4 m ³
SUB TOTAL						24 m ²	26.4 m ³
Bonded ACM > 7mm – At or above the HSL							
DW23	4 m	2 m	2 m	2 m	2 m	6 m x 4 m 24m ²	48 m ³
TP246	14 m	14 m	8 m	6 m	1.5 m	28 m x 14 m 392 m ²	588 m ³
TP248	4 m	2 m	2 m	0 m	3 m	6m x 2m 12 m ²	36 m ³
TP256	2 m	2m	2 m	2 m	1.4 m	4 m x 4 m 16 m ²	22.4 m ³
SUB TOTAL						444 m ²	694.4 m ³
TOTAL						656 m ²	1,131.6 m ³

¹TP244 and TP250 were originally classified as AF/FA below the HSL, however are now classified as AF/FA at or above the HSL based on the results of delineation sampling.

²At the request of ESR, the western extent of TP250 was delineated to the closest clean test pit (TP249) in lieu of additional step out samples due to time constraints associated with analytical testing.
