Geotechnical Investigation Report

Proposed Industrial Subdivision

290-308 Aldington Road, Kemp's Creek NSW 2178

Report No: 9687-GR-1-1

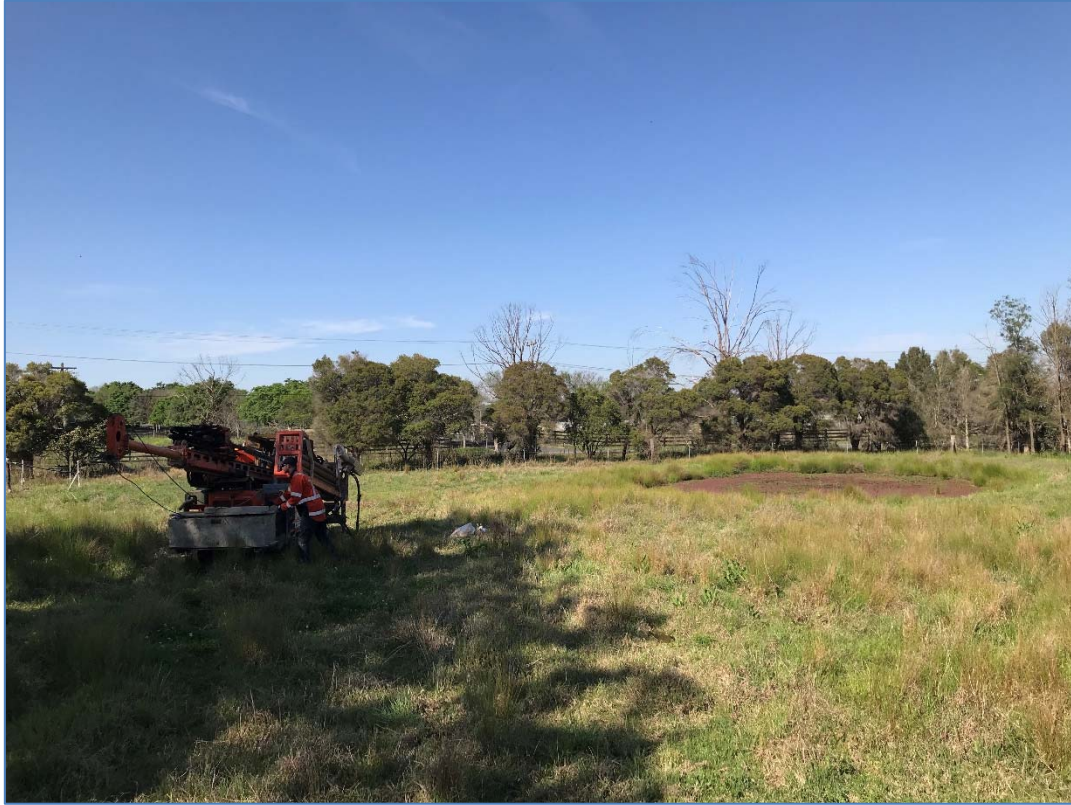
Figure 1 – General overview of the site

The general overview of the site is provided in photographs in Appendix A. The site locality is presented in a satellite image in Figure 1.

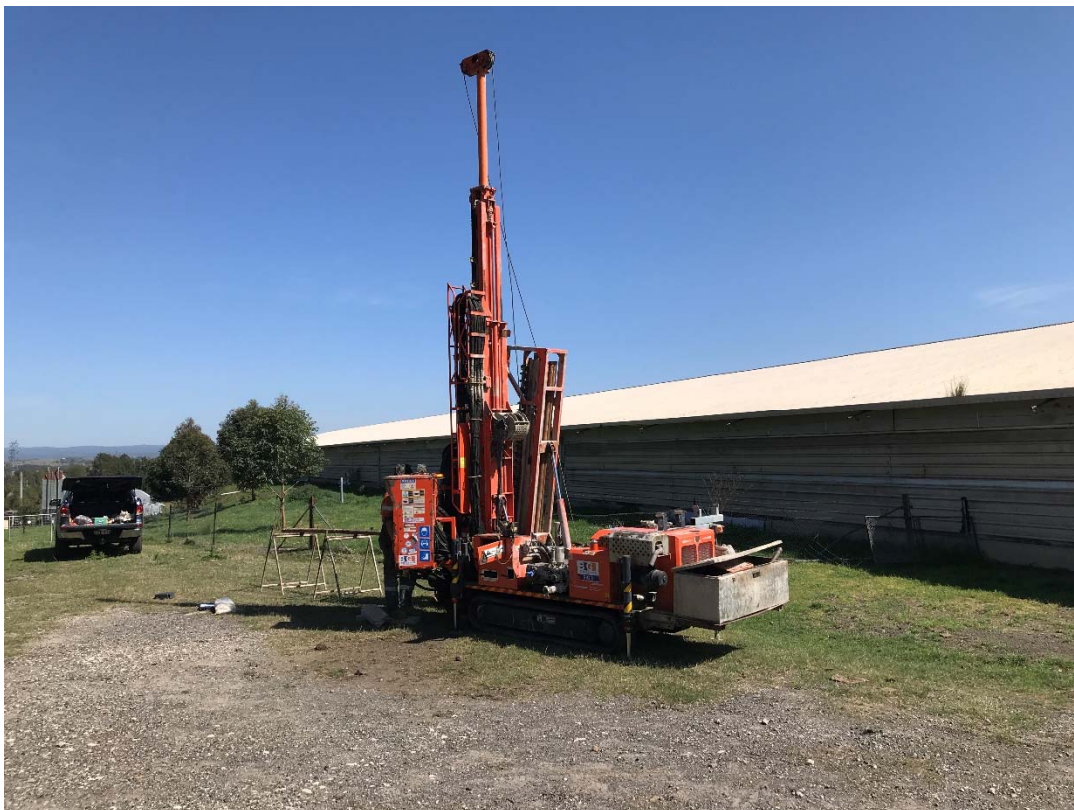
Figure 2 – Drilling rig setup in the location of BH4

An engineering geologist from AG was present at the site to witness the drilling and log the subsoil based on the retrieved drill cuttings, in-situ tests and observed performance of TC bit. Soil samples were collected from selected locations and depths for the required laboratory tests.

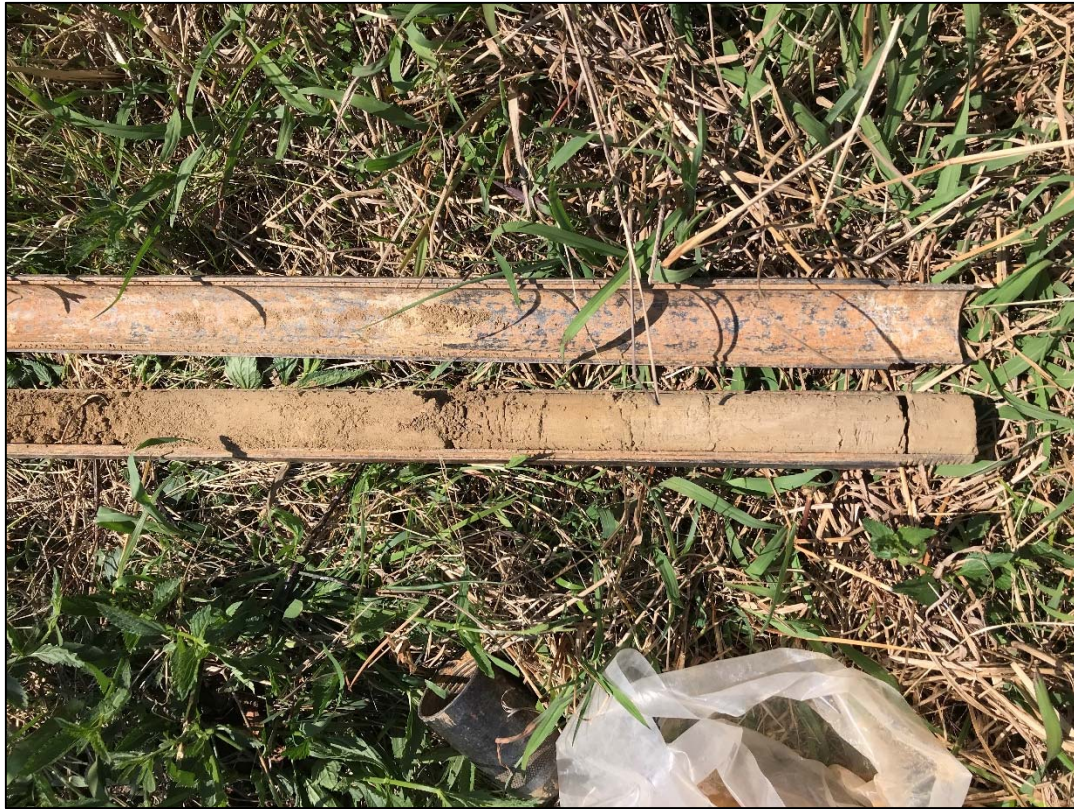
Figure 3 – SPT sample retrieved from residual soil after the test

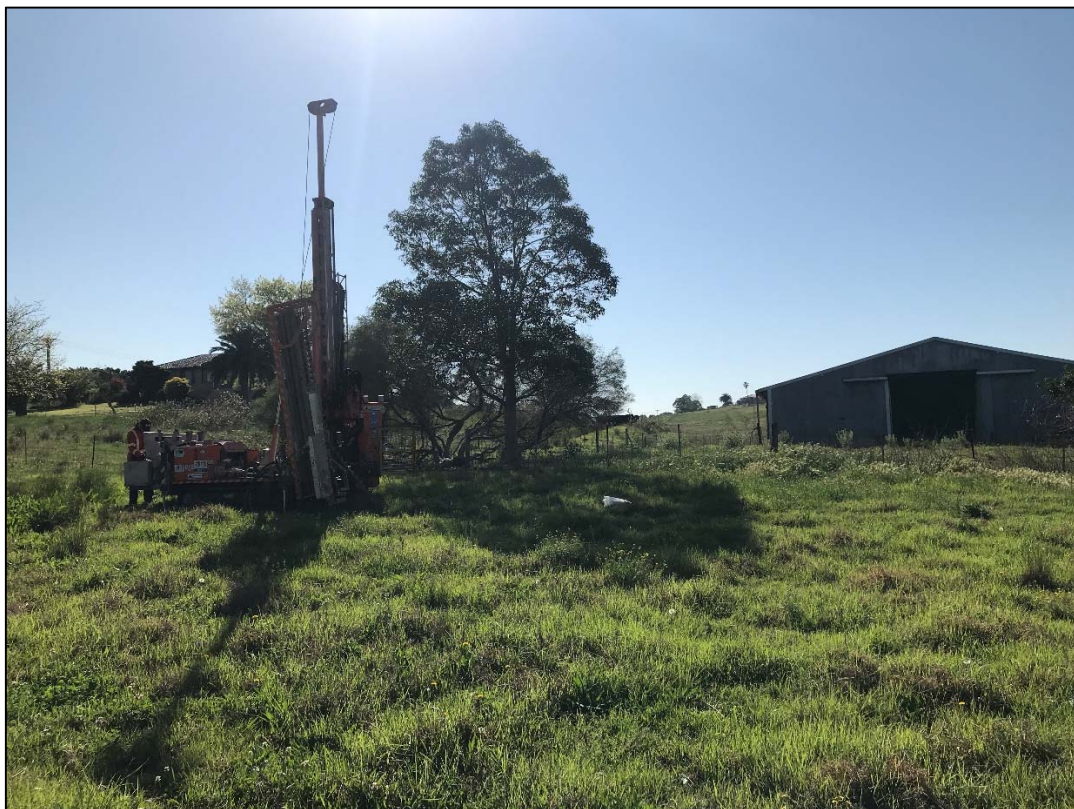
Figure 4 – General site overview and drilling rig setup in the location of BH1
