3rd November 2023

Rev 1

Asbestos Clearance Certificate

Site Identifier	Site Details
Site Location	290-380 Aldington Rd & 59-63 Abbots Rd, Kemps Creek NSW 2178
Local Government Area (LGA)	Penrith
Current Site Use/Status	Vacant/ Construction Zone
Surrounding Land Uses	Residential/ Rural Residential
Previous Land Use	Residential/ Rural Residential

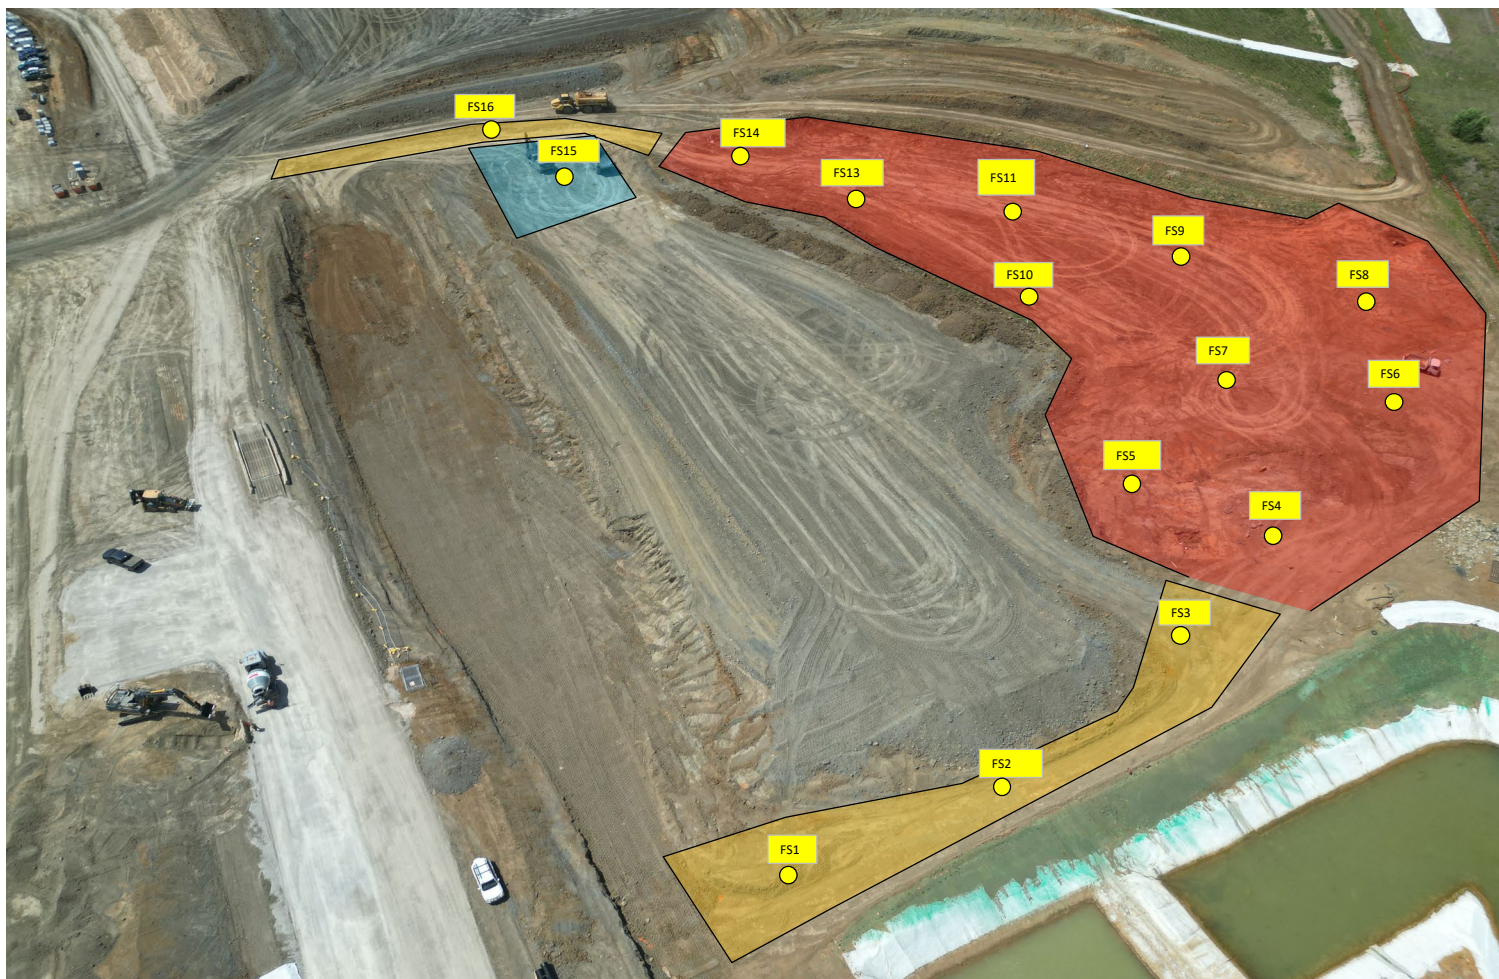
DRAWN DG	Site Plan
		Figure 1	Asbestos Clearance Certificate
		Job # E3116-2	290-380 Aldington Rd & 59-63 Abbots Rd, Kemps Creek NSW 2178

Key Site Boundary & Location Testing Locations Asbestos Removal Zone Waste and Transit Routes Machinery Cleaning Zone
