**Addendum (01) –
Douglas Partners (2022) Remediation Action Plan (RAP)**
Westlink Stage 2 – 1030 – 1064 Mamre Road, Kemps Creek, NSW, 2178

Prepared for: ESR Australia
EP4132.001_v1 | 3 April 2025

Addendum (01) – Douglas Partners (DP) Remediation Action Plan (RAP) Westlink Stage 2 –1030 – 1064 Mamre Road, Kemps Creek, NSW, 2178

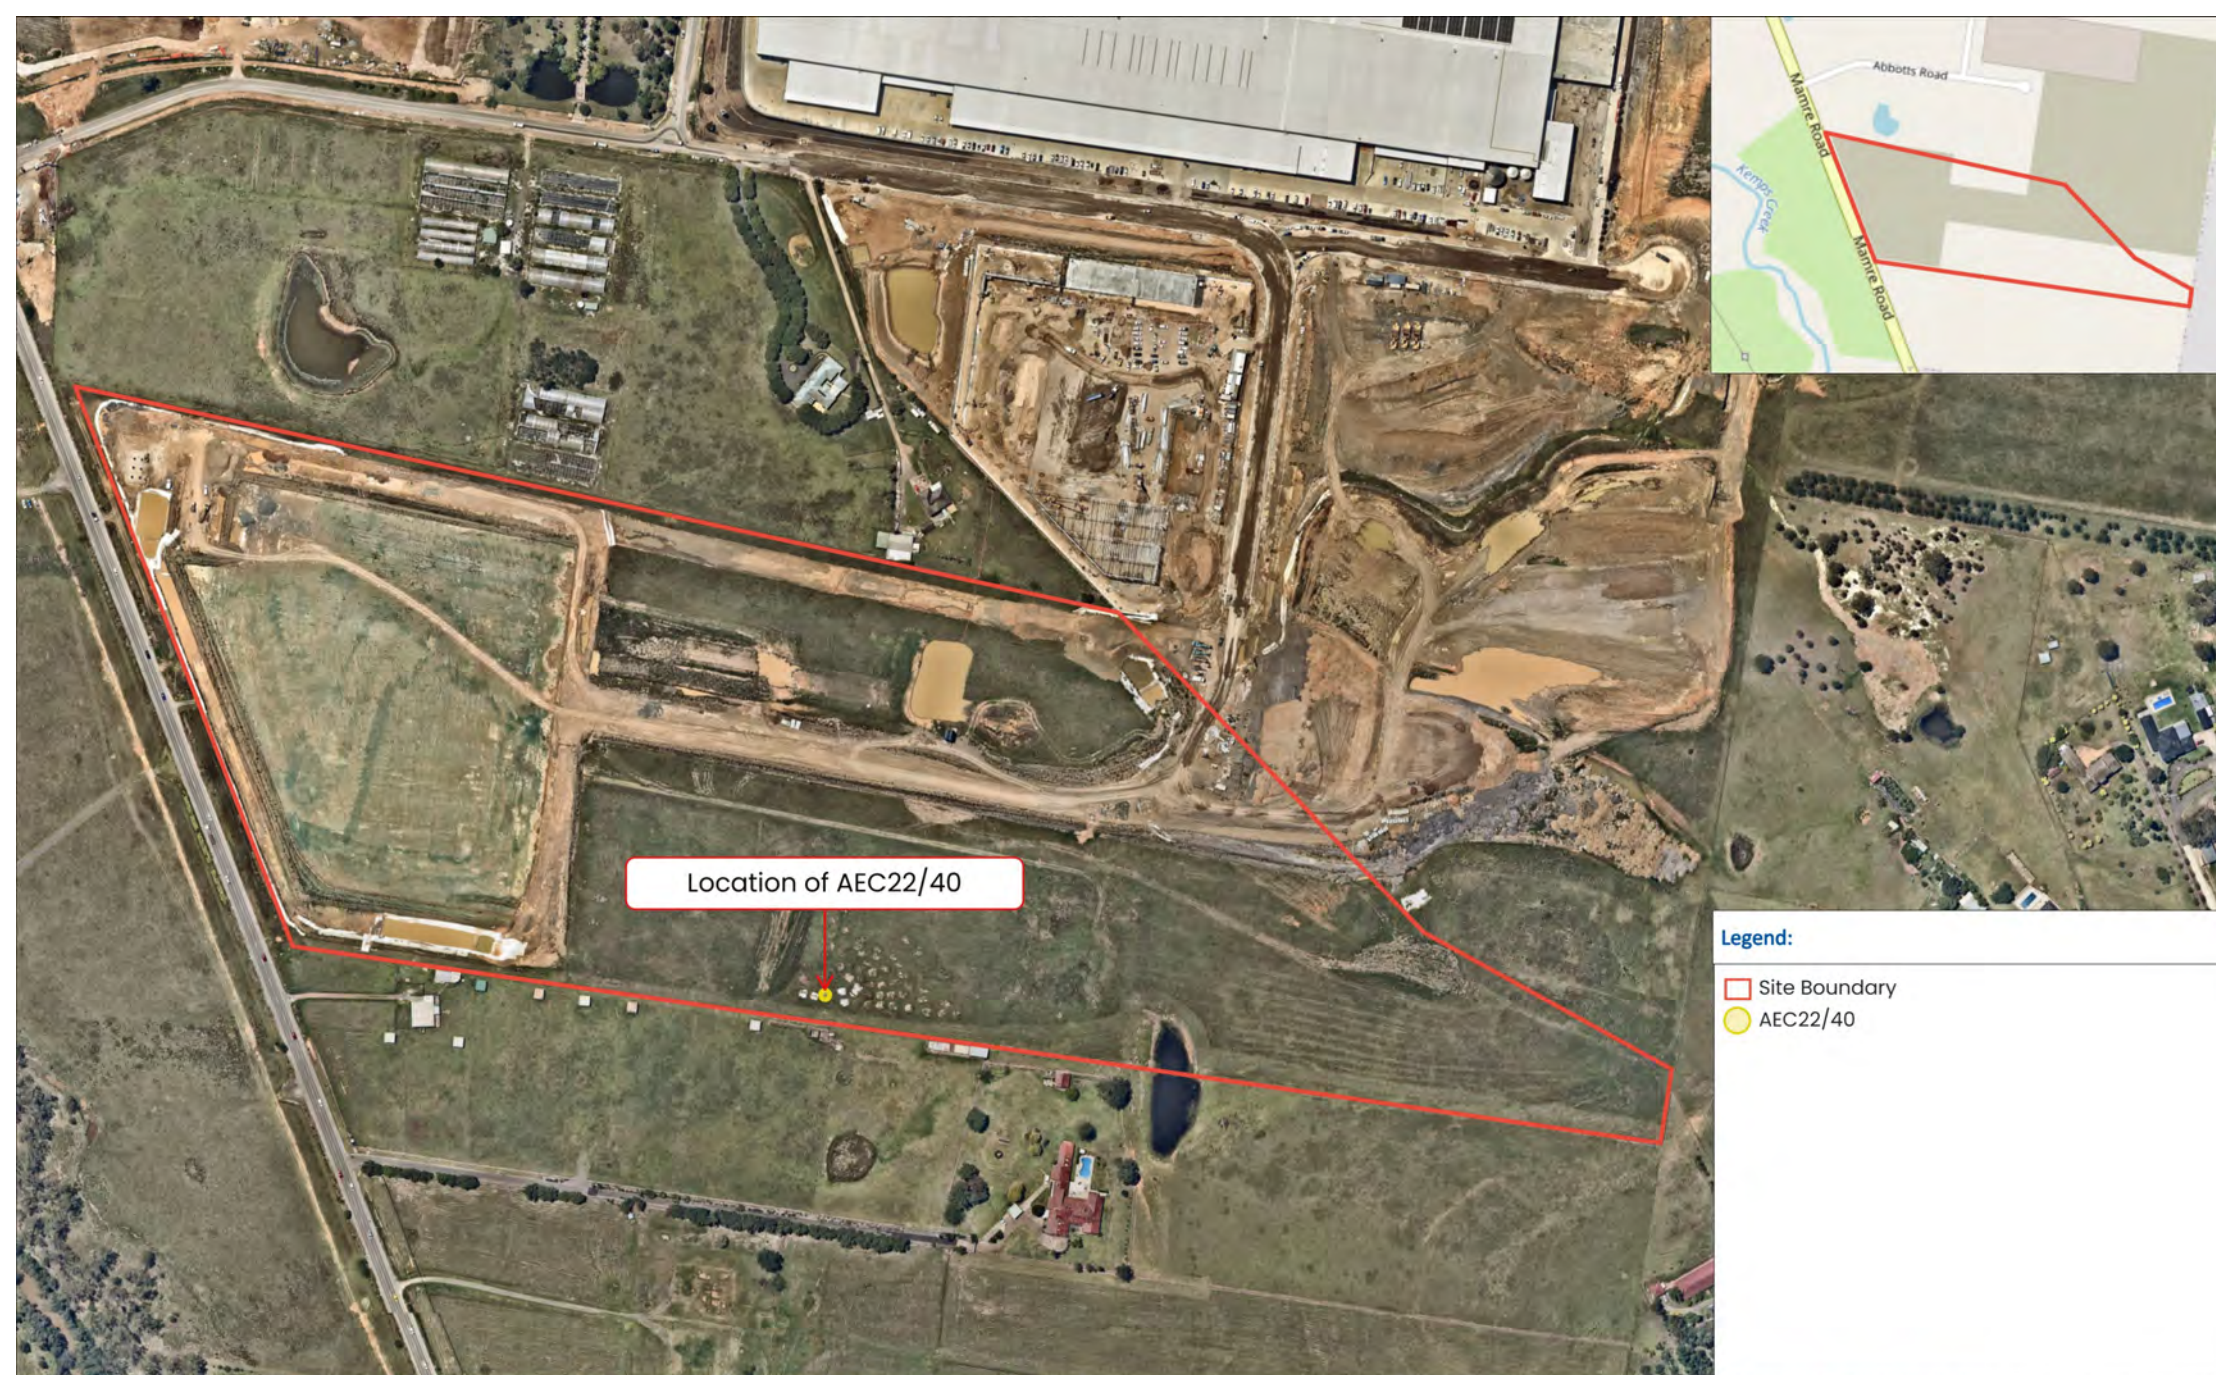
Figure 2 - Location of AEC22/40

2. The location of AEC22/40, is presented in **Figure 2** and **Figure 3**. It is understood AEC22/40 has not been placed on geofabric or plastic sheeting.
