Report on
Preliminary Geotechnical Investigation

Proposed Industrial Subdivision
59 - 63 Abbots Road, Kemps Creek

Prepared for
ESR Australia

Project 92352.00
August 2019

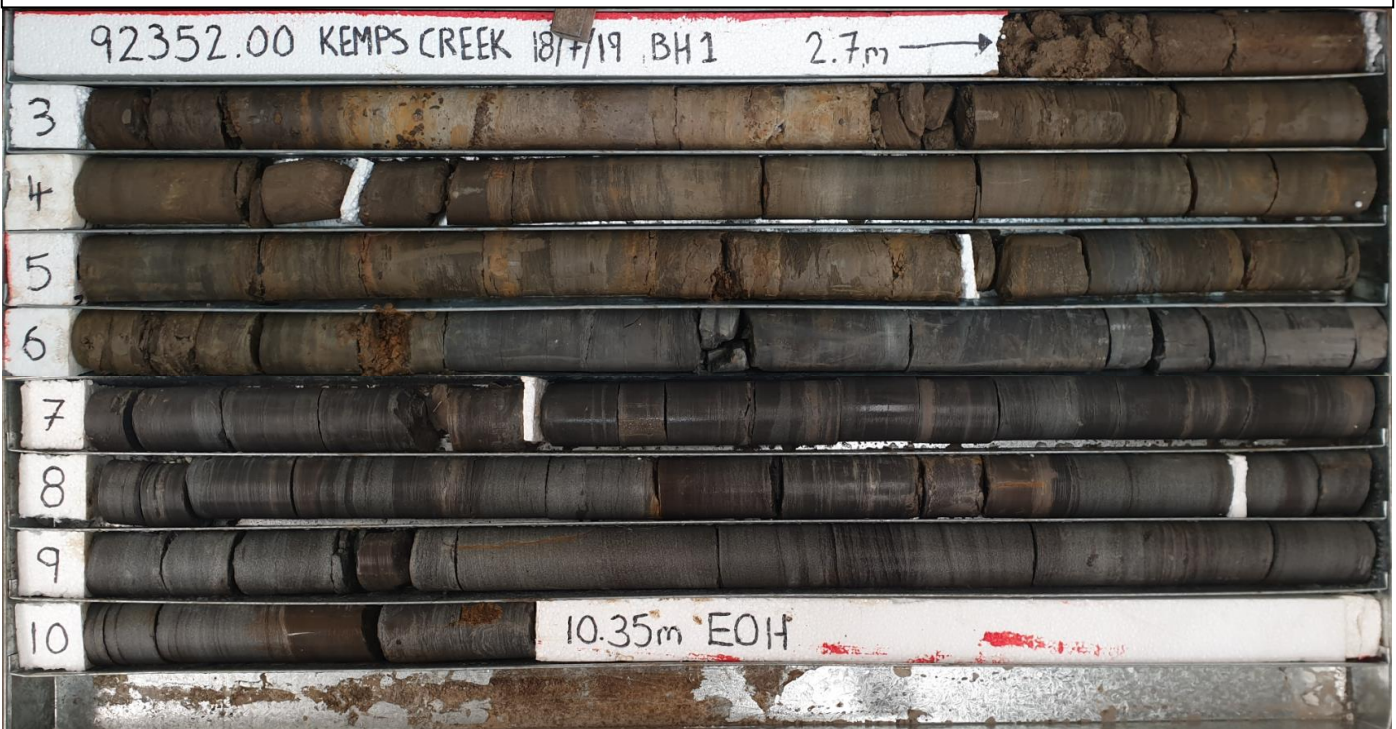
BORE: 1 DEPTH: 2.70 – 10.35m PROJECT: 92352.00 July 2019

End of Bore at 10.35 m

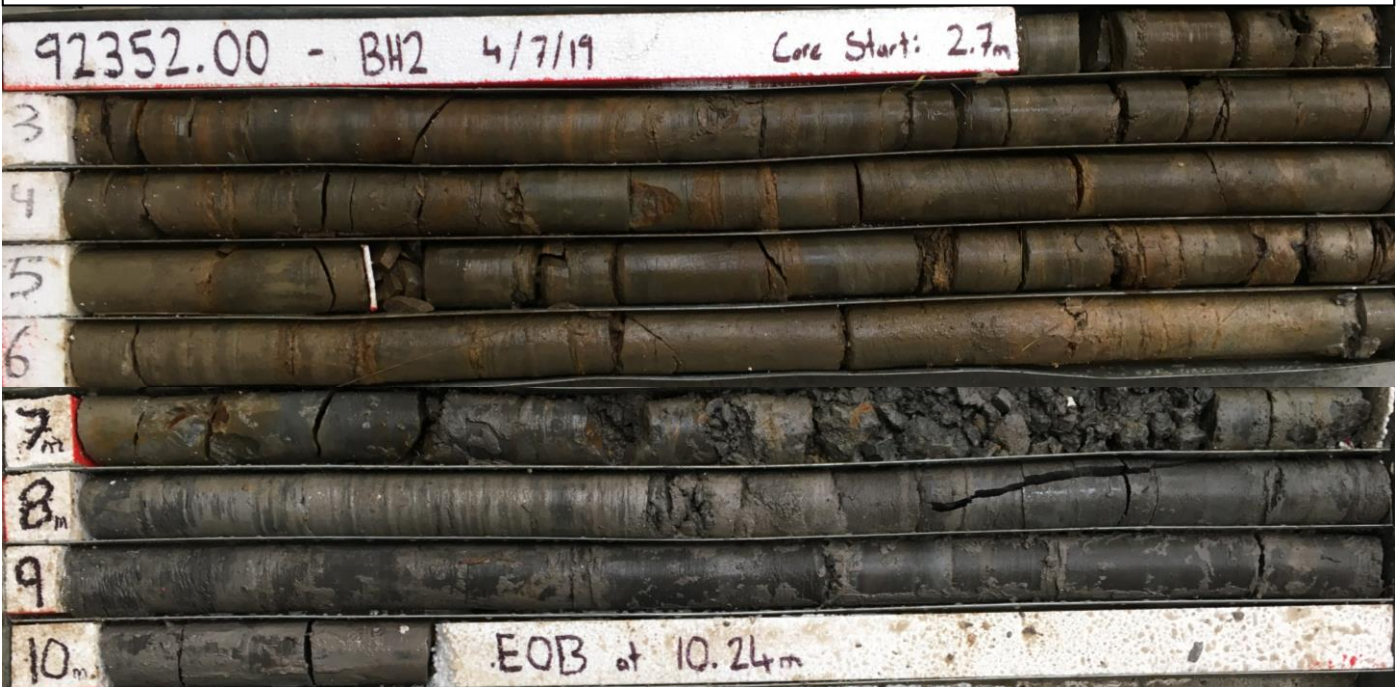
BORE: 2 DEPTH: 2.70 – 10.24m PROJECT: 92352.00 July 2019

End of Bore at 10.24 m

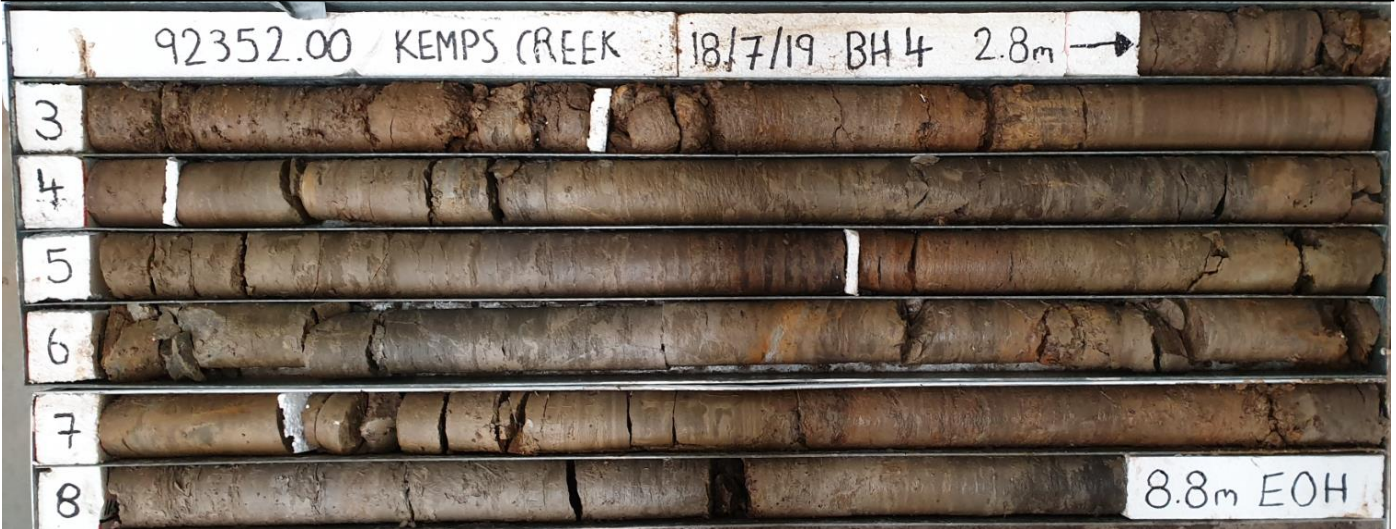
BORE: 4 DEPTH: 2.80 – 8.80m PROJECT: 92352.00 July 2019

End of Bore at 8.80 m

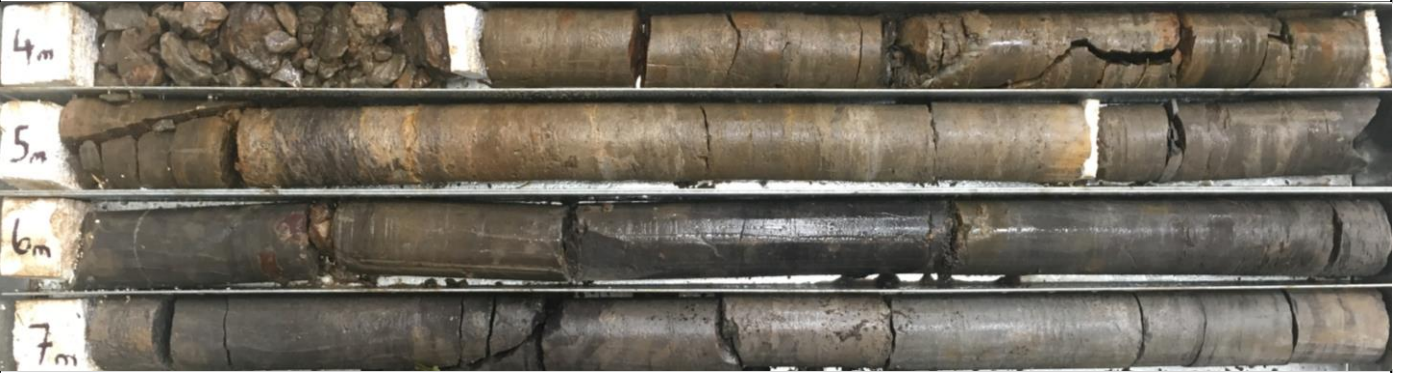
BORE: 5 DEPTH: 4.30 – 8.00m PROJECT: 92352.00 July 2019

End of Bore at 8.00 m
