# 1030-1048 and 1050-1064 Mamre Road Riparian Assessment Report

DRAFT REPORT

Prepared for ESR Australia

27 October 2022

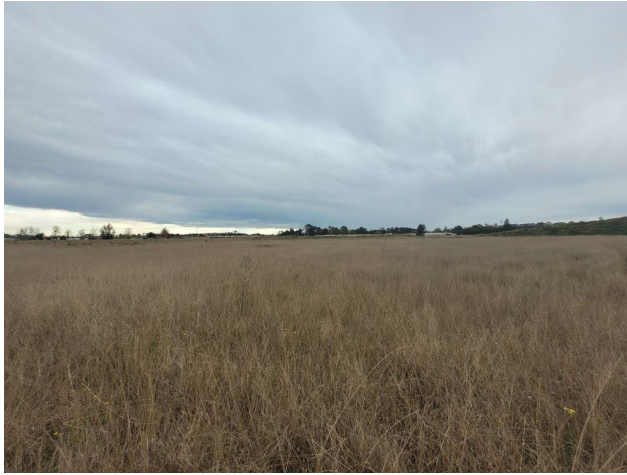
The flow of the mapped second order stream to the northwest of the study area was observed to be disconnected due to the presence of a man-made dam in the adjacent property. Subsequently, there was no indication of surface or sub-surface flow, aquatic vegetation, or a defined bed or bank (Photo 1, Photo 2, Photo 3 and Photo 4). As such, this waterway would not be considered to meet the definition of a 'river' under the WM act. Surrounding vegetation comprised solely of urban native/exotic grasslands with no remnant vegetation. While there is some suggestion that the surrounding soils may occasionally become waterlogged during periods of wet weather there is no indication that the mapped waterway would provide any sort of flow path for waterlogged soils within the area.

**Photo 1 Mapped second order stream  
(photo point 1)**

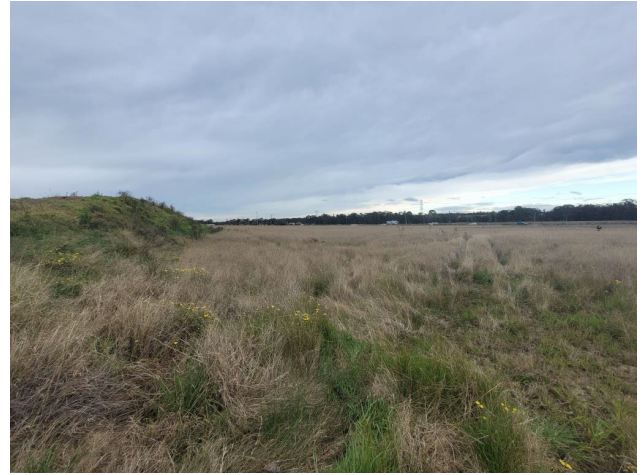
**Photo 2 Mapped second order stream  
(photo point 2)**

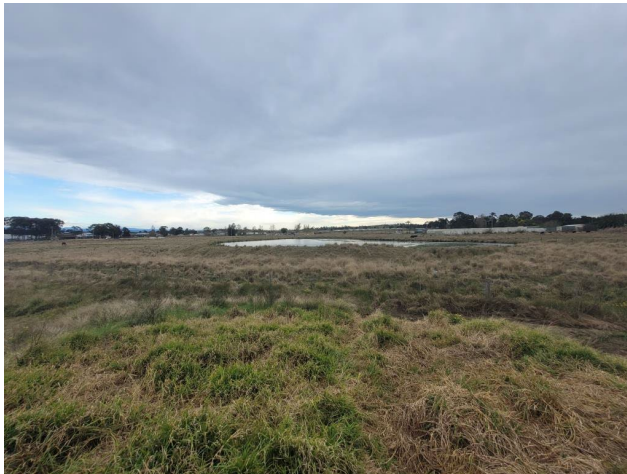
**Photo 3 Mapped second order stream  
(photo point 3)**

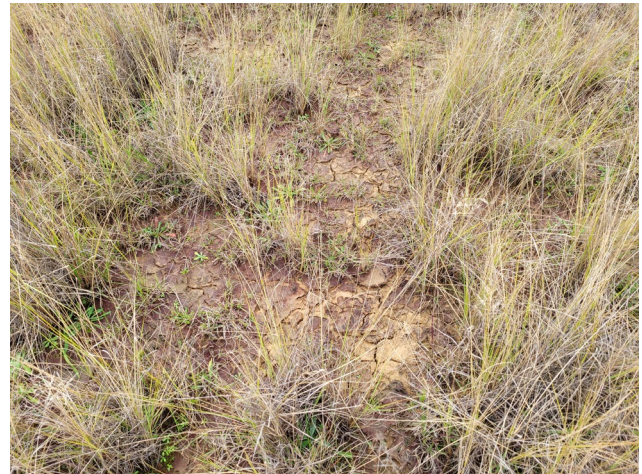
**Photo 4 Mapped second order stream  
(vegetation and soil composition)**

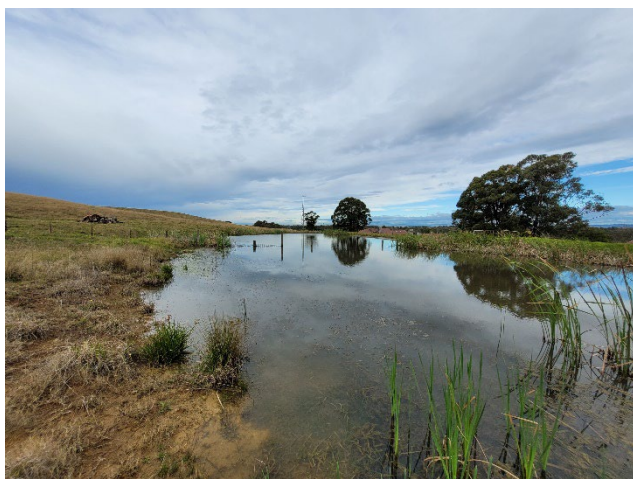
The two man-made dams within the study area provide poor habitat for aquatic and semi-aquatic fauna, due to the limited amount of riparian vegetation surrounding each dam, which is mostly dominated by urban native/exotic grasses. Dam 1 (Photo 5) is located to the southeast of the study area and occurs half in the study area and half in the adjoining property to the south (Figure 3). Dam 2 (Photo 6) is located in the northwest portion of the study area (Figure 3). Both dams observed within the study area are man-made.

Although the two dams provide limited habitat for aquatic fauna, the overall condition of the two man-made dams within the study was relatively good, with each exhibiting reasonably clear water and a variety of macrophytes including; Broad-leaved Cumbungi *Typha orientalis*, *Juncus usitatus*, Water Primrose *Ludwigia peploides*, Water Couch *Paspalum distichum* and Eelweed *Vallisneria australis*. Macrophytes and fringing vegetation have the potential to provide dispersal, sheltering and foraging habitat for common aquatic fauna such as; Longfin Eel *Anguilla reinhardtii*, Eastern Long-necked Turtle *Chelodina longicollis* and Common Eastern Froglet *Crinia signifera*. Both dams are artificial and are therefore not representative of natural waterways in the locality.

**Photo 6 Dam 1**

- Appropriate erosion and sediment control measures should be installed to avoid impacts to nearby waterways via stormwater collection systems.
- As dams within the study area will be decommissioned and backfilled as part of the project. Biosis recommends that a dam dewatering plan be implemented.

- Dam dewatering is to be undertaken under supervision of a suitably qualified ecologist to ensure that dewatering activities are undertaken appropriately and any fauna within the dams is salvaged and relocated (an ecologist would only be required on site when dam water levels are below 1/3 capacity).

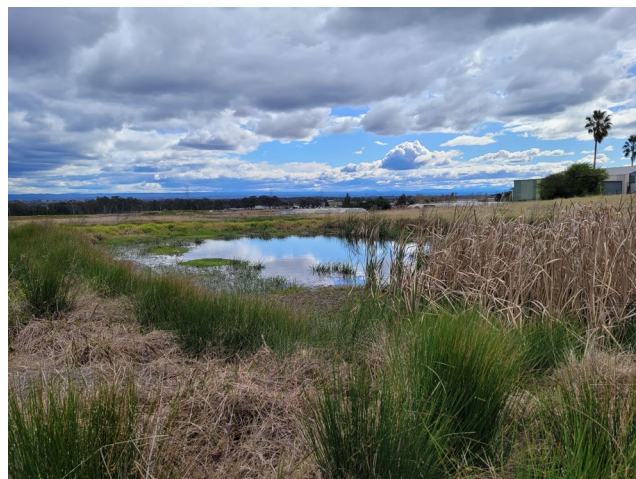
**Photo 5 Dam 2**

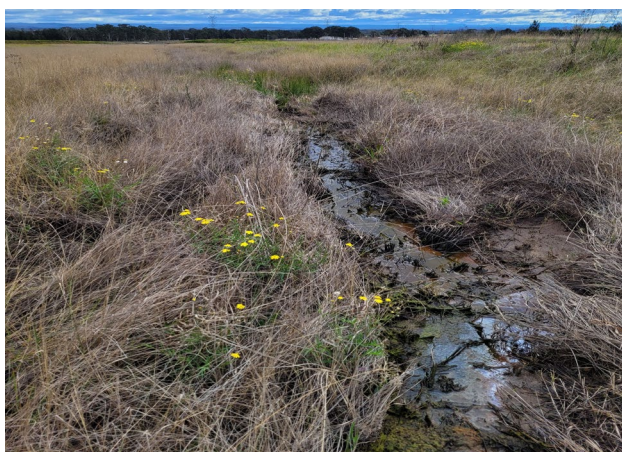
Soils along the bed and bank of the drainage line were observed to be highly unstable, comprising of predominantly clay based loams (Photo 8). The lack of bank stabilising vegetation and the presence of highly unstable clay soils make this drainage line highly susceptible to erosion in the event of flooding.

**Photo 8 Trunk drainage**

- Consultation with Sydney Water and NRAR should be undertaken to assess the capability of the development to incorporate a realignment of the trunk drainage within the study area.

- The increased coverage of impervious surfaces post construction will likely increase flow speed post conduction. As such, if a realignment of the trunk drainage does occur, consideration should be given to utilising substrates designed to lower flow spreads and minimise erosion.

- A Vegetation Management Plan should be implemented either side of naturalised trunk drainage in order to adhere to NRAR requirements and the Aerotropolis DCP.

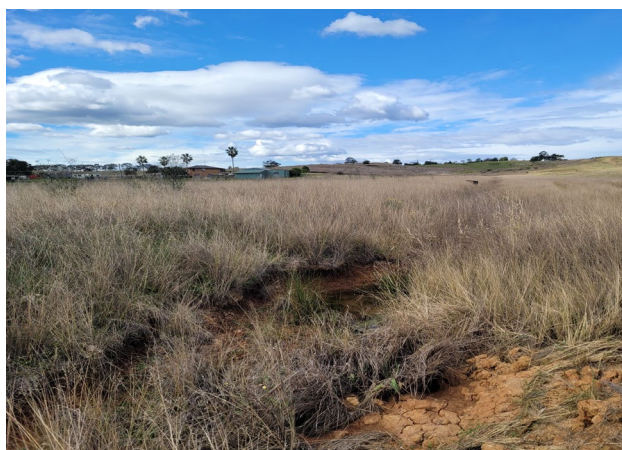
A drainage line, as mapped within the Mamre Road DCP (Figure 3),, transverses the centre of the study area from east to west. Field investigations of this drainage line indicated that the current flow pathways have likely been historically altered. This alteration was likely undertaken to assist the effective drainage of the study area and prevent soils throughout the area becoming waterlogged. While altered, it is likely that this drainage line occurs within close proximity to the natural flow path of the original drainage line, based on an assessment of local topography (Photo 7).

**Photo 7 Trunk drainage erosion**

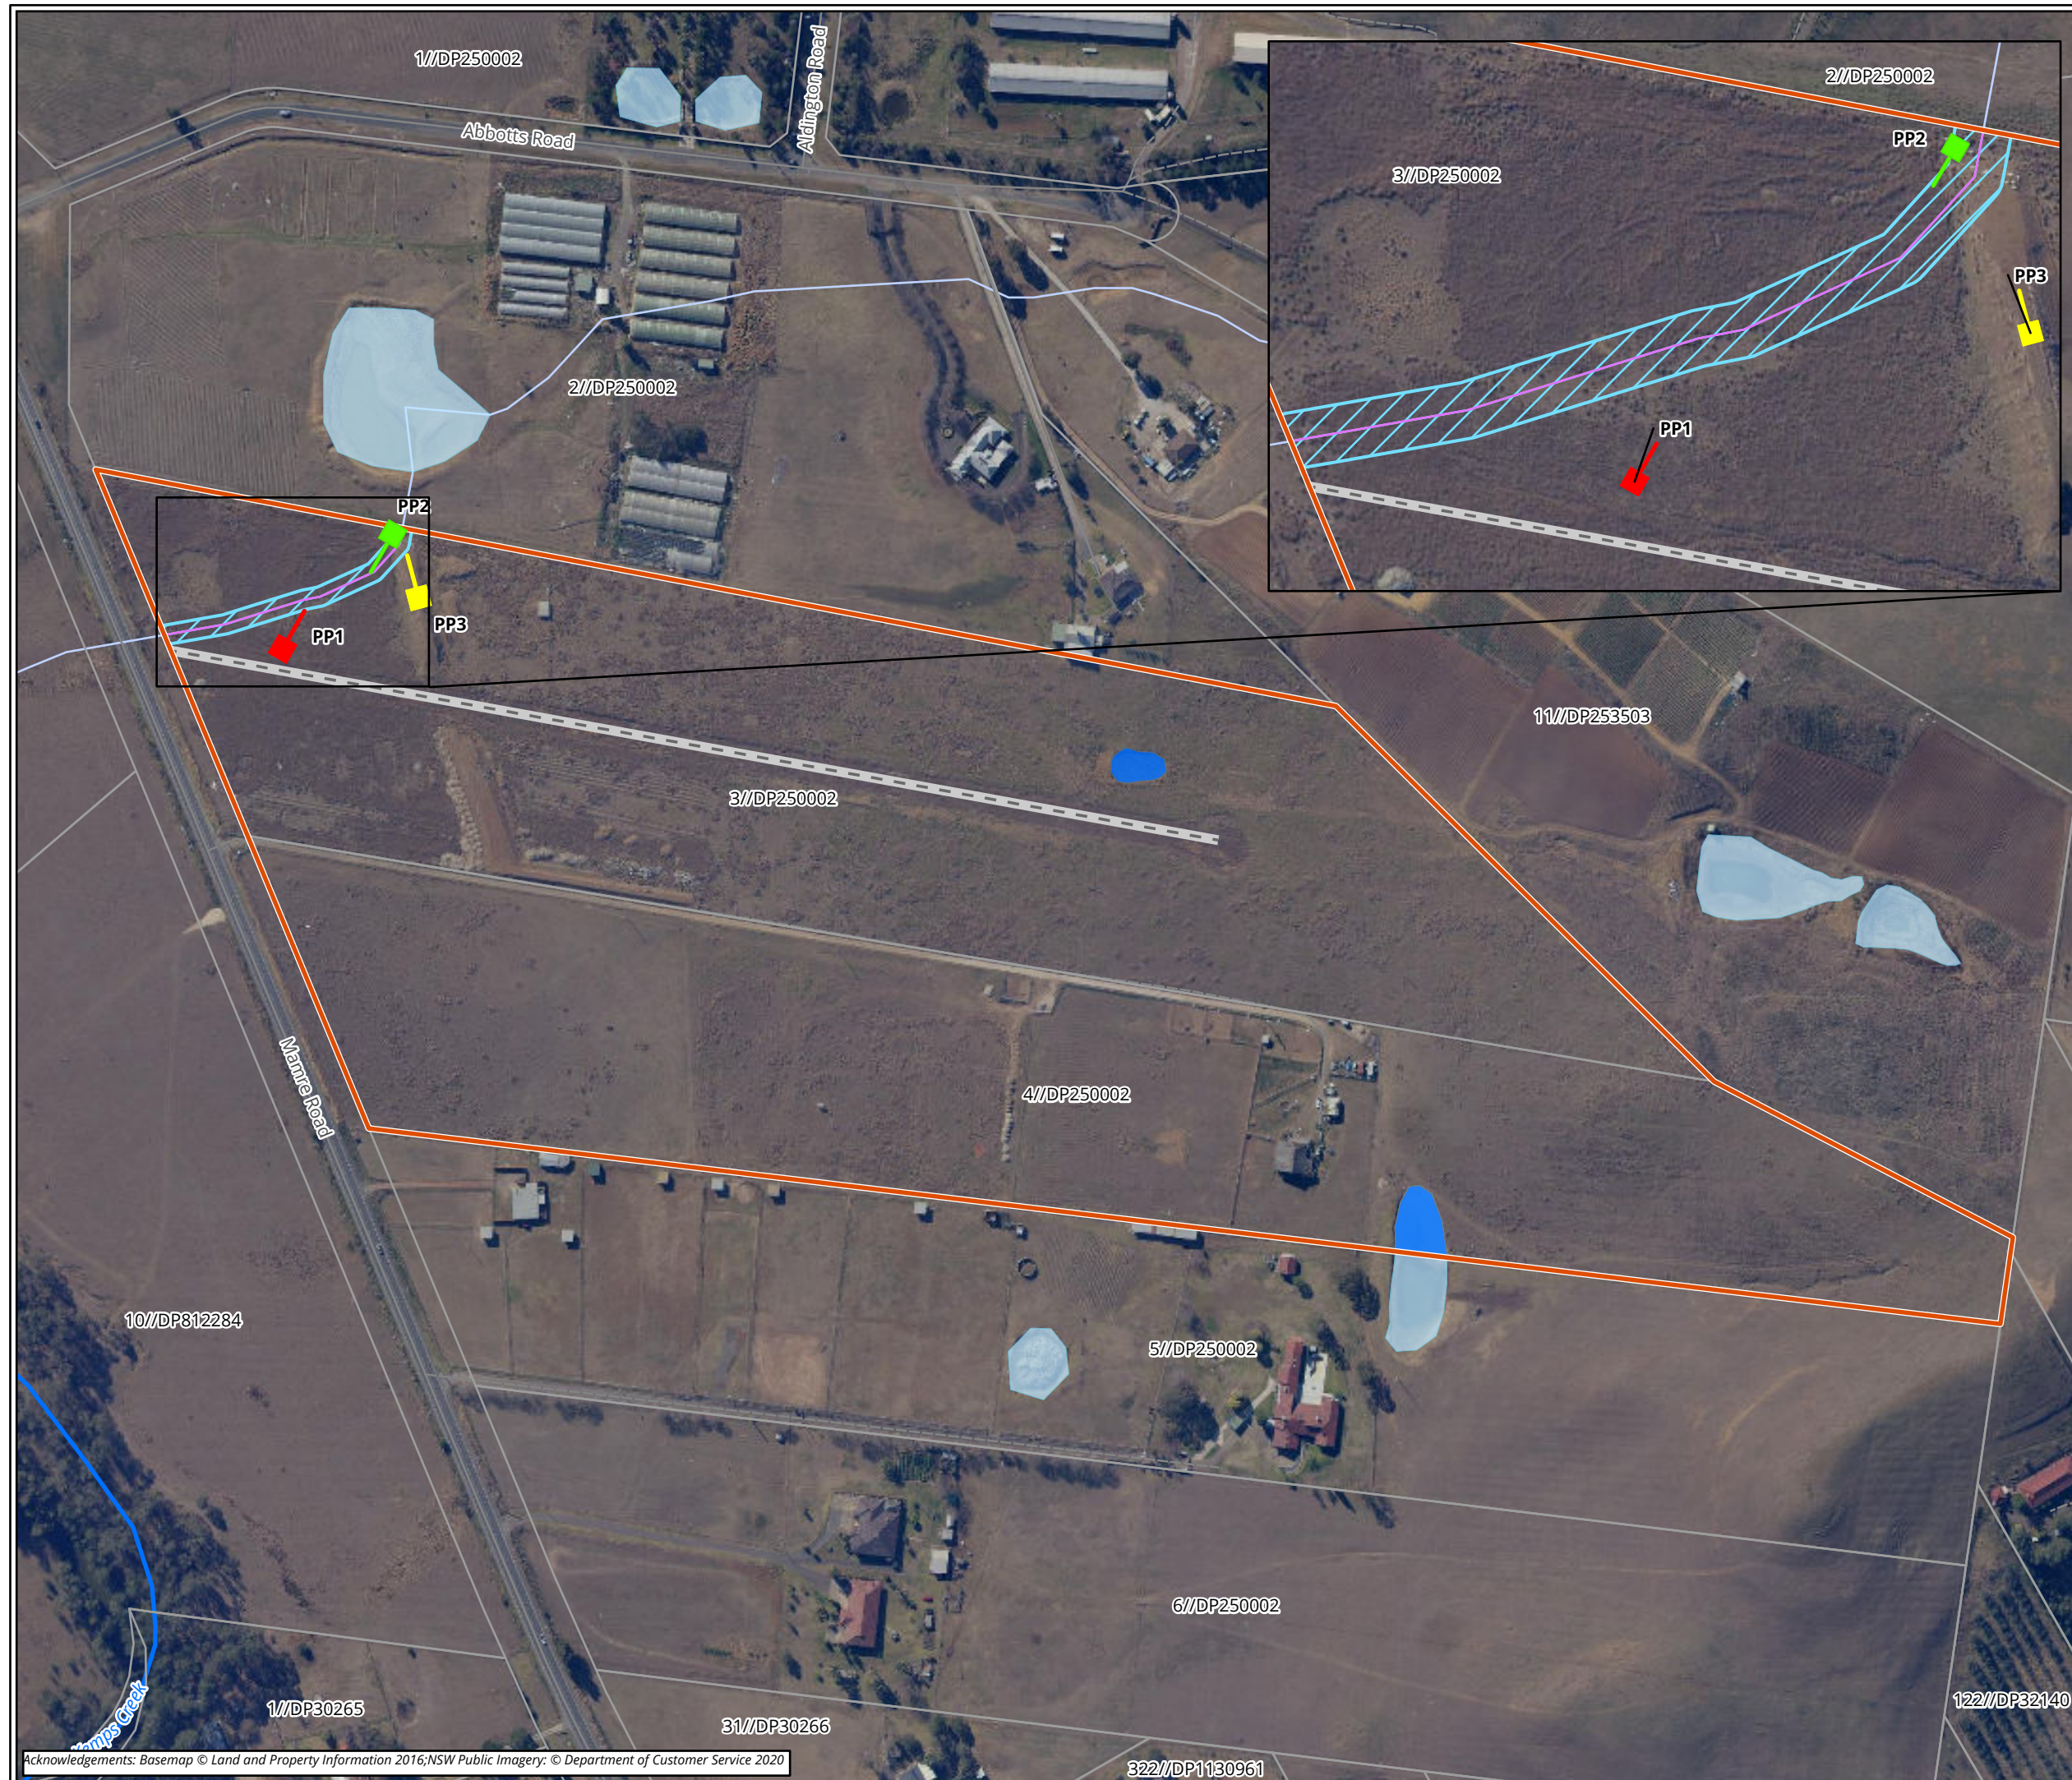
**Figure 2 Riparian assessment**

The study area contains one mapped (DPI 2022) un-named second order (strahler) stream (in the northwest corner), two man-made dams and one drainage line; mapped as 'Trunk Drainage' under the Mamre Road DCP (DPIE 2021a) (Figure 3). A second trunk drainage is mapped as occurring directly to the south of the study area in the adjoining property to the south, however no impact to this trunk drainage is expected to occur as a result of the works. Further, this second trunk drainage line falls outside of the study area, hence is not shown on Figure 2, nor discussed further in this report.
