RE: INTERIM AUDIT ADVICE LETTER NO. 1 - REVIEW OF REMEDIATION ACTION PLAN, 28-30 BURROWS ROAD, ST PETERS

Audit Number: LW-031

Attachments: 1 Site Location
2 Site Features
3 Sample Location Plan

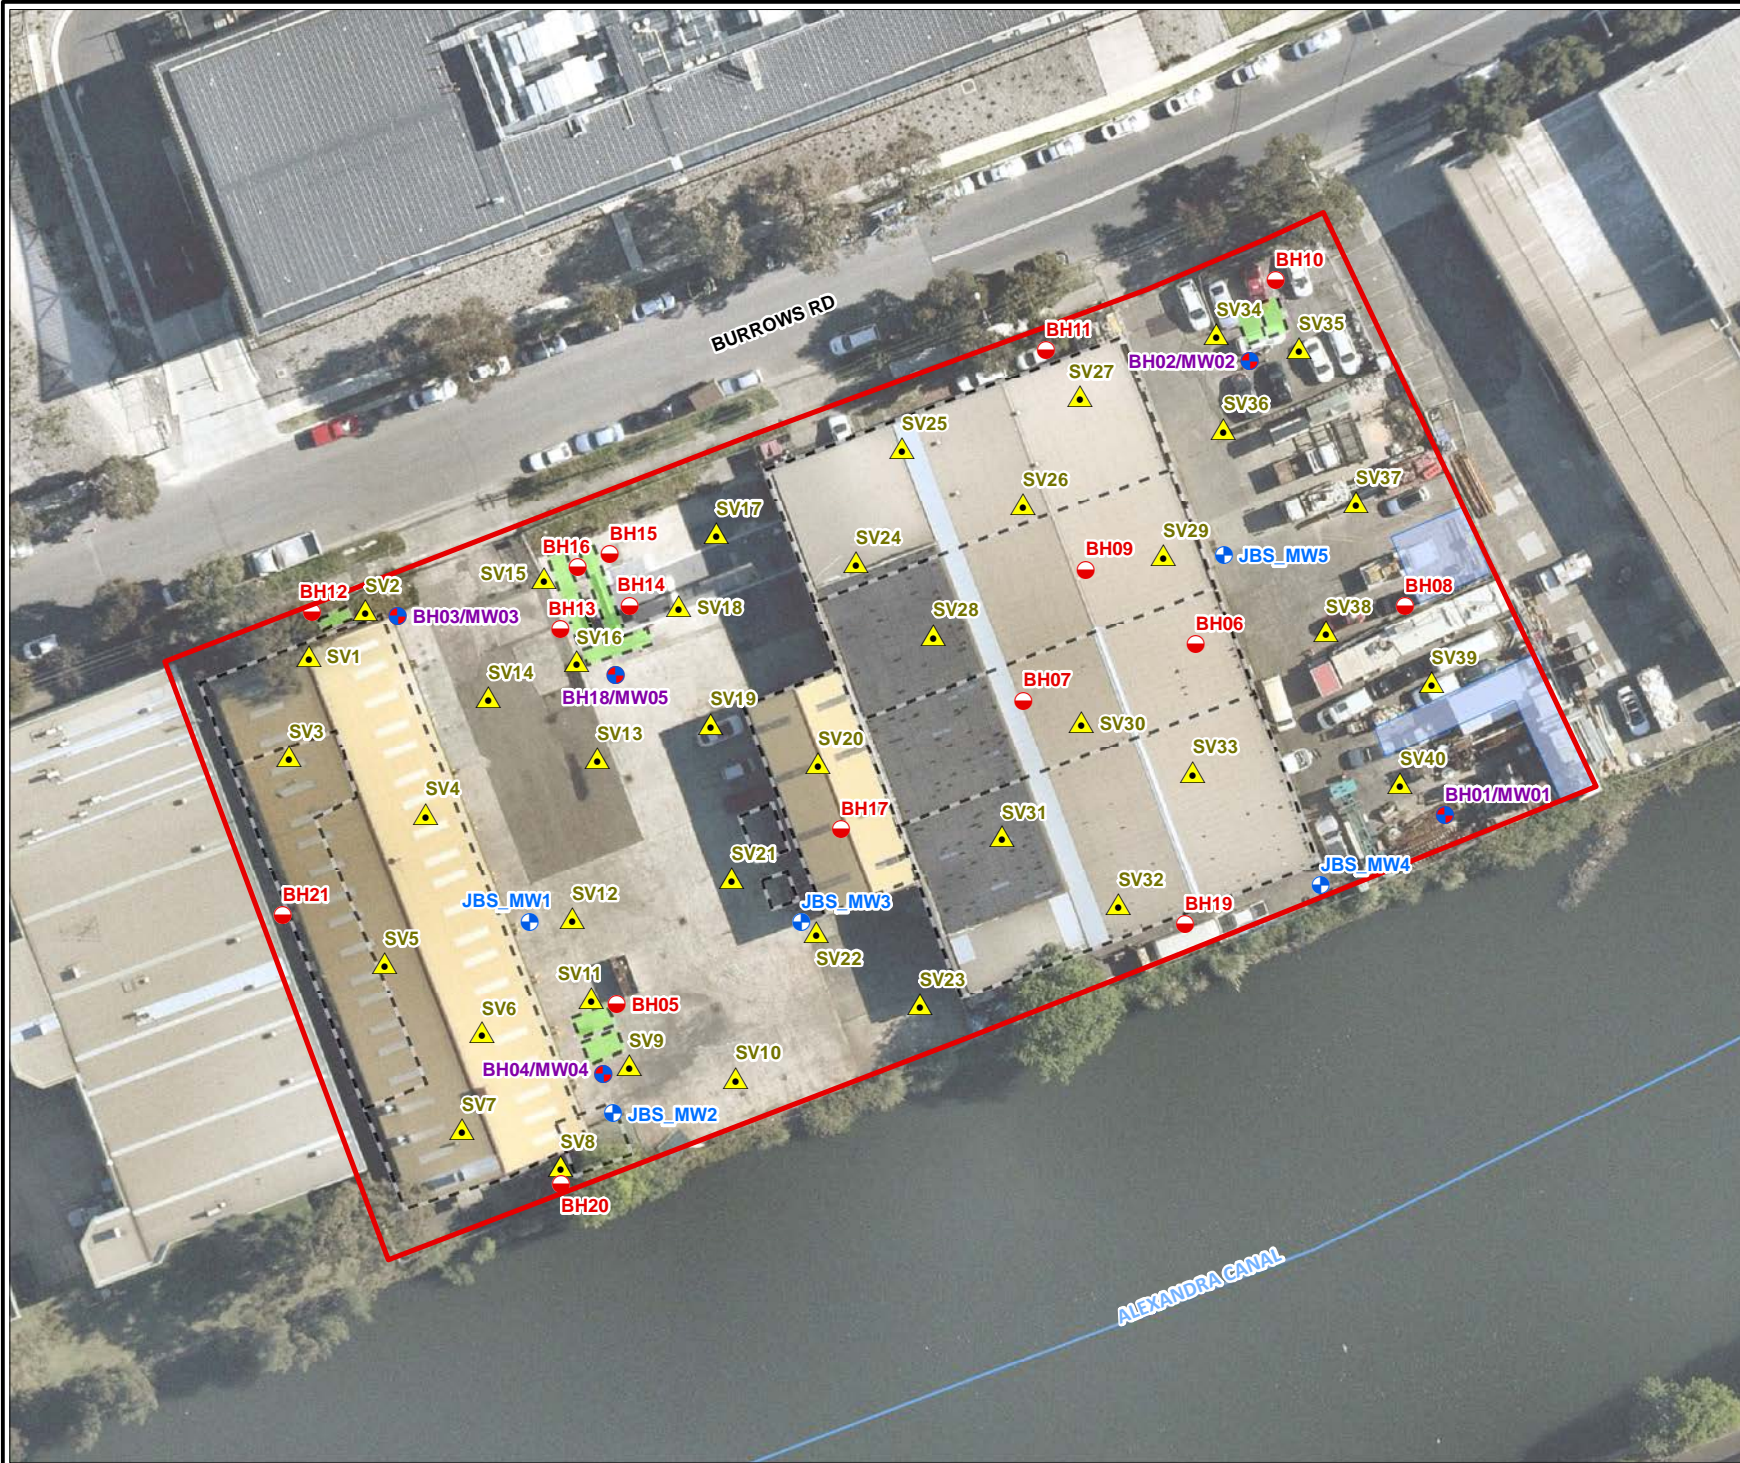
SES (2020) completed a due diligence contamination assessment. The scope of works included a desktop review of available background information, sampling of soil from 21 soil bores (BH1-BH21) and installation of five groundwater monitoring wells (MW01-MW05) and sampling of groundwater (Attachment 3). The sampling strategy was based on a combination of targeted and systematic sampling. Sampling could not be completed in some inaccessible areas of the site including the warehouse footprint on 28 Burrows Road (including the spray booth), and within the mechanics workshops on 30 Burrows Road. Locations were also not completed near the interceptor or sump in the southern portion of 28 Burrows Road. Groundwater wells targeted areas adjacent to the USTs and in the south-eastern corner of the site where staining was observed.

In addition, JBS&G installed 42 sub-slab vapour pins on a grid-based sampling plan across the site (Attachment 3). A GFM 435 gas detector was used to purge each probe for a period of approximately 30 seconds until gas readings for methane, oxygen and carbon dioxide and photo-ionisation detector (PID) readings had stabilized. Samples were then collected onto carbon tubes for analysis by the laboratory. Leak testing was completed at each sample location using a shroud and isopropyl alcohol (IPA). At each sampling location, a 6.0 L volume was collected using a calibrated pump at a flow rate of 200 mL/min (30 min sample time) onto a carbon tube. Vapour samples were analysed for VOCs and IPA (40 samples).
