Figure 42: Viewpoint 11 - Jacfin Lands, Aldington Road, Kemps Creek - Position 2 - Looking North (Photomontage)

9.0 CONCLUSIONS AND NON-TECHNICAL SUMMARY

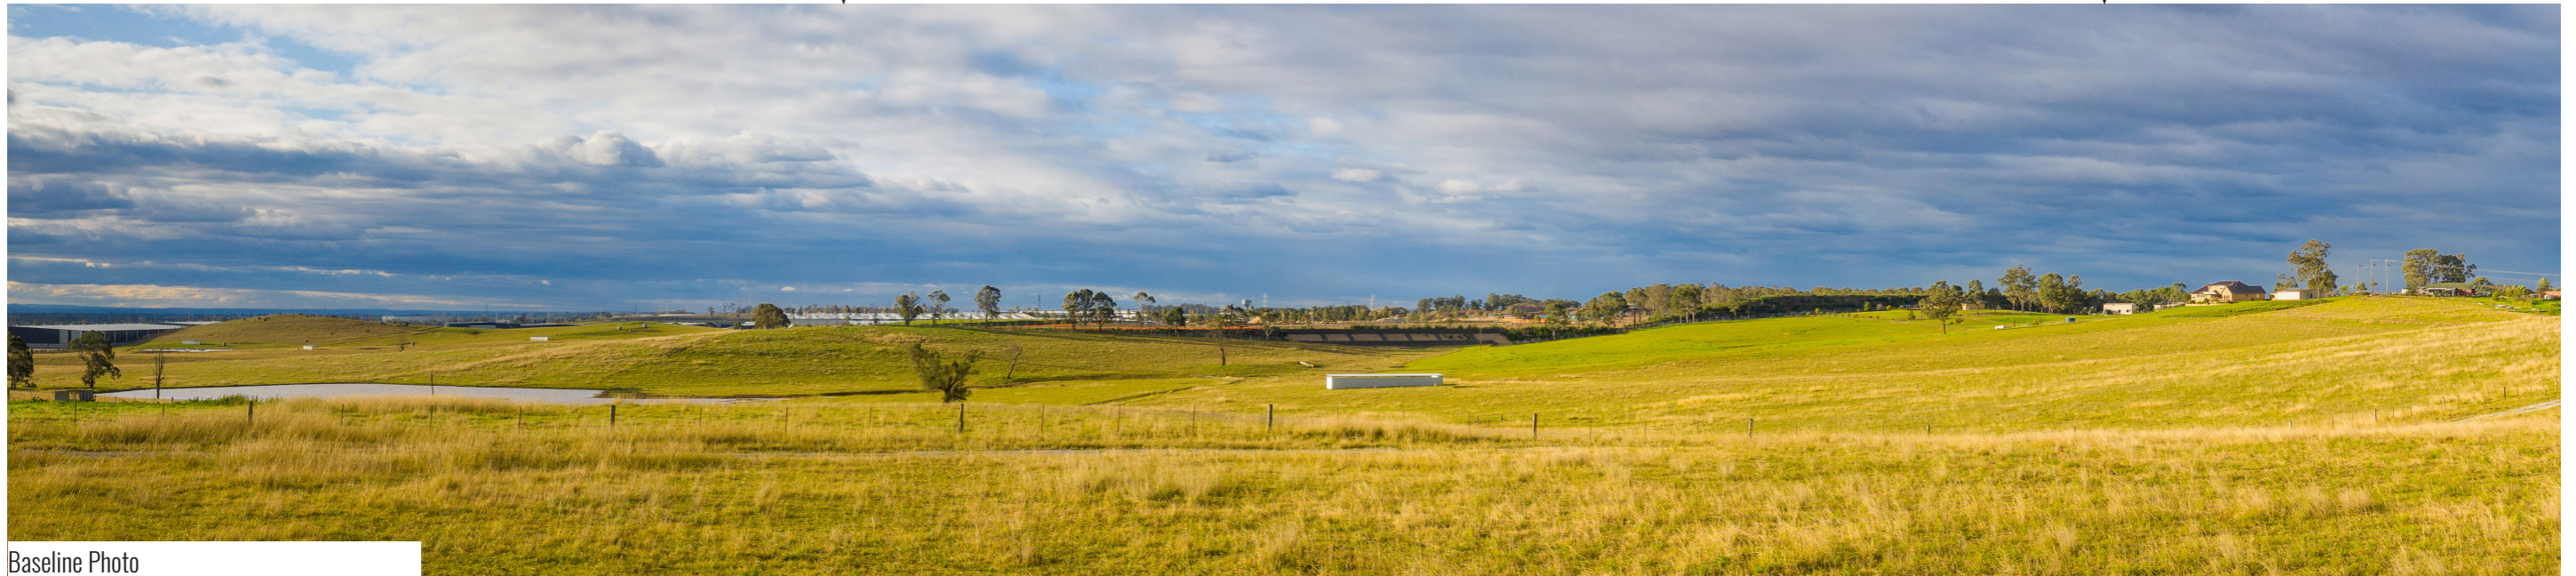
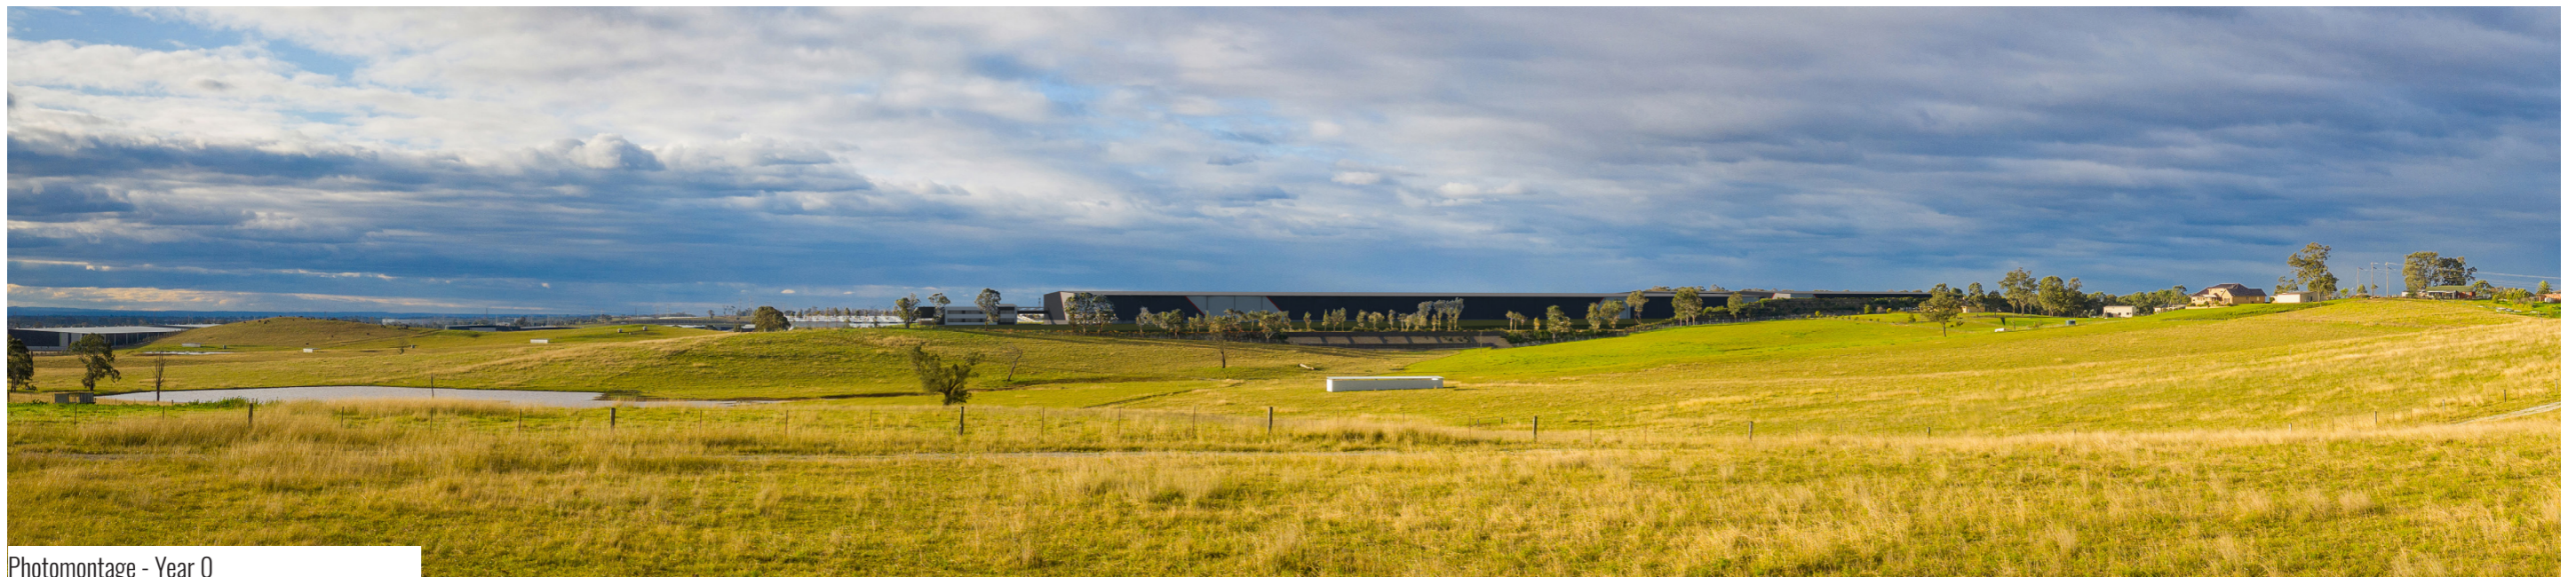
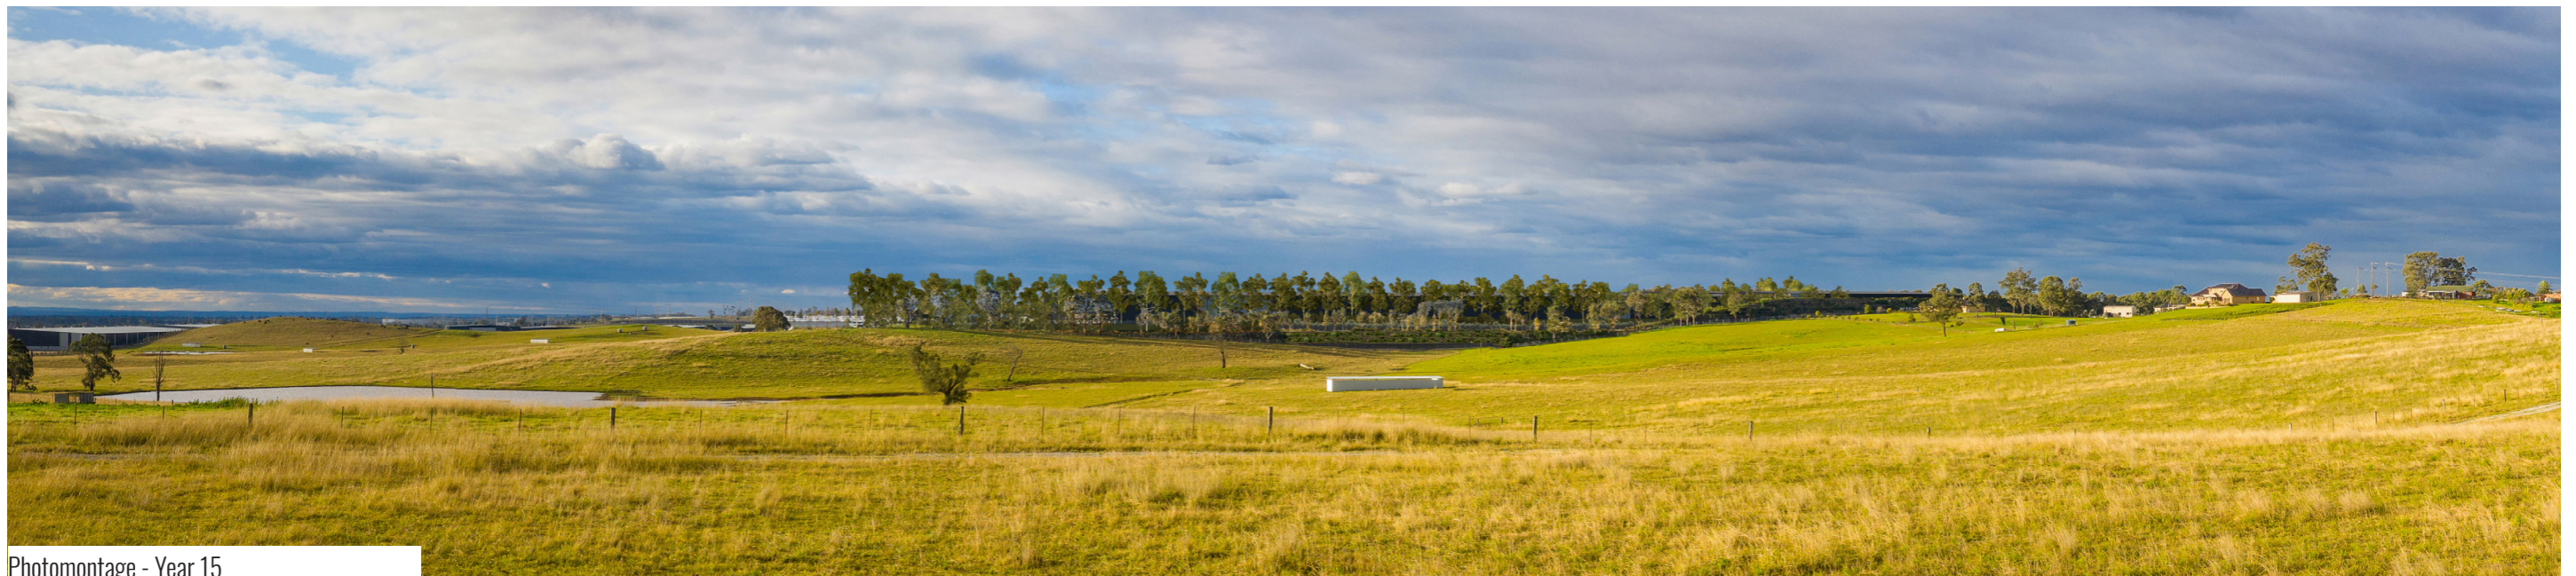
Baseline Photo

Photomontage - Year 0

Photomontage - Year 15

Approx Panoramic Angle of View - 67°

- Opposite 396-398 Horsley Road, Horsley Park (VP1)
- 32 Aldington Road, Kemps Creek (VP8)
- Bowood Park, Bowood Road, Mount Vernon (VP9)
- Jacafin Lands, Aldington Road, Kemps Creek - Position 2 (VP11)
