Ground King Civil Pty Ltd
1/15-17 Hallstrom Pl,
Wetherill Park NSW

Stockpiles - Asbestos Clearance Certificate

Site Identifier	Site Details
Site Location	290-308 Aldington Road and 59-63 Abbots Road, Kemps Creek NSW
Local Government Area (LGA)	Liverpool
Current Site Use/Status	Vacant under construction
Surrounding Land Uses	Rural Residential
Previous Land Use	Rural/Residential

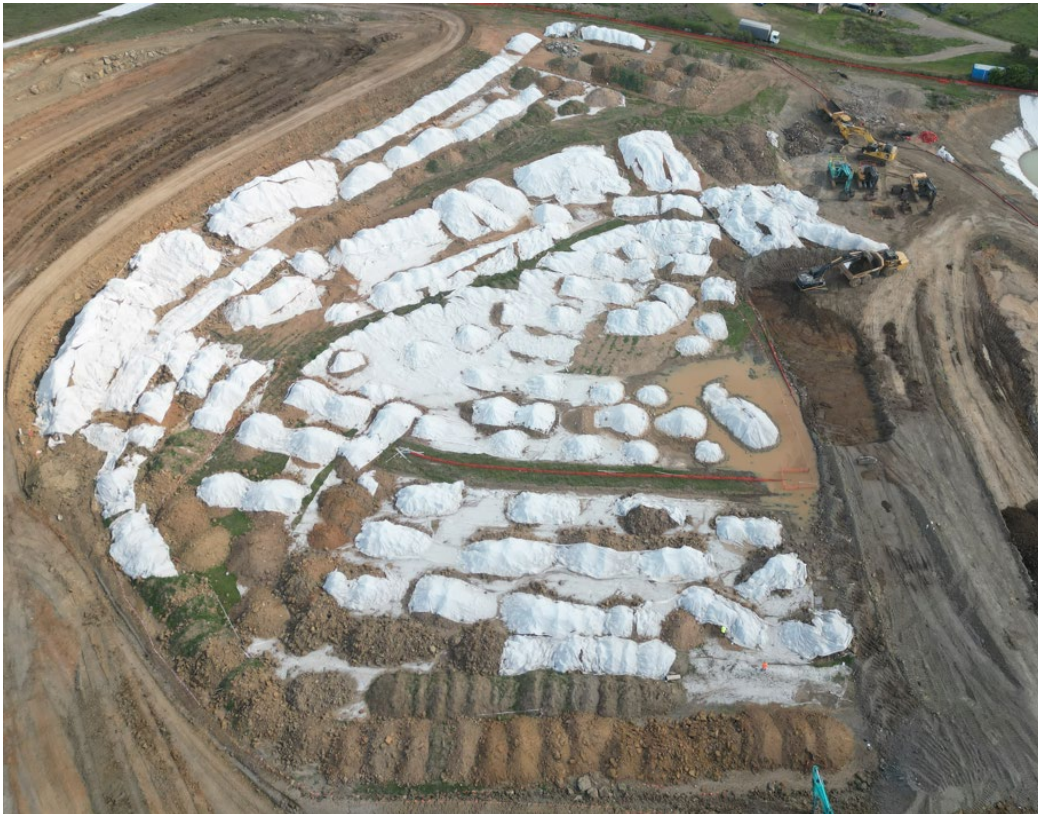
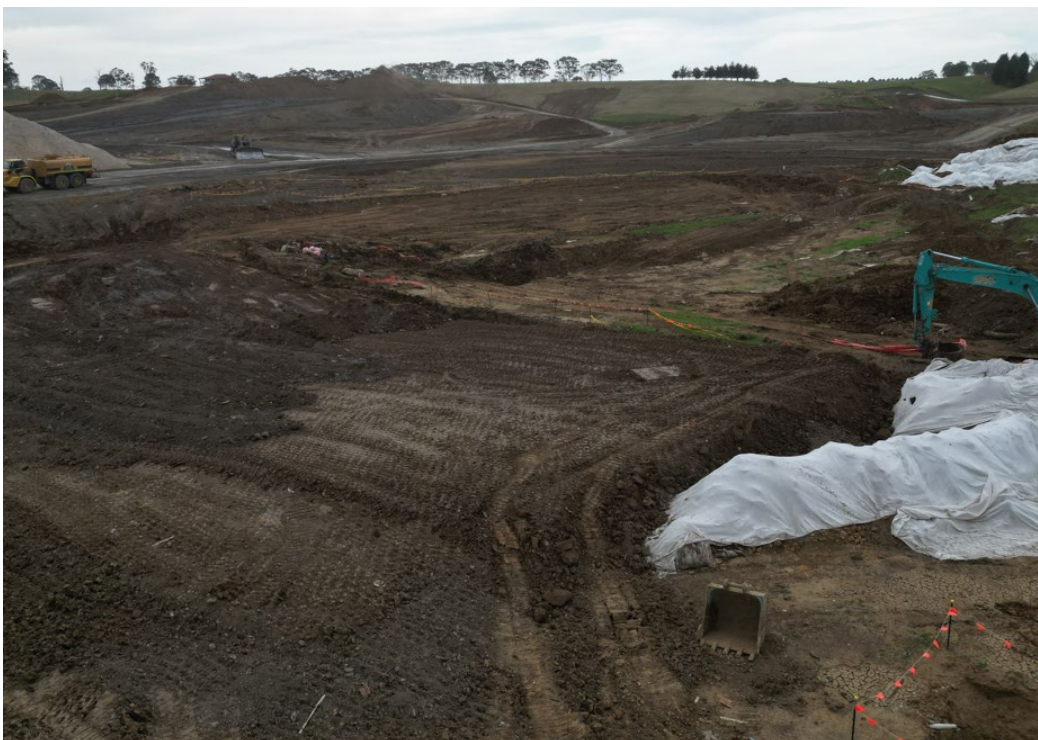
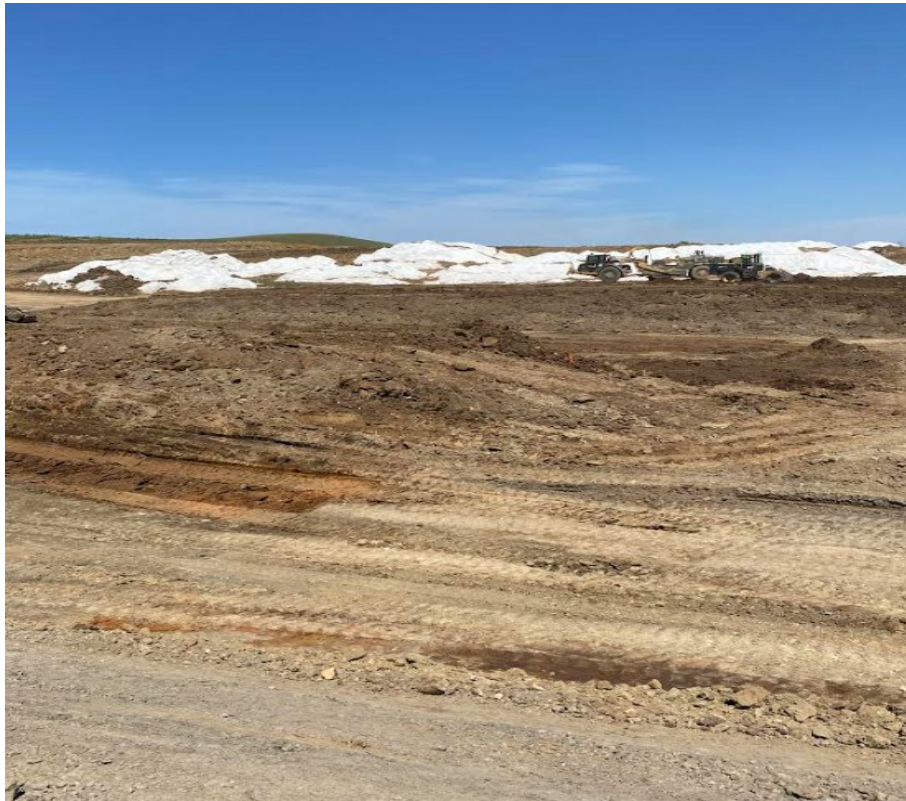
13.0 Site photos

Area after Removal

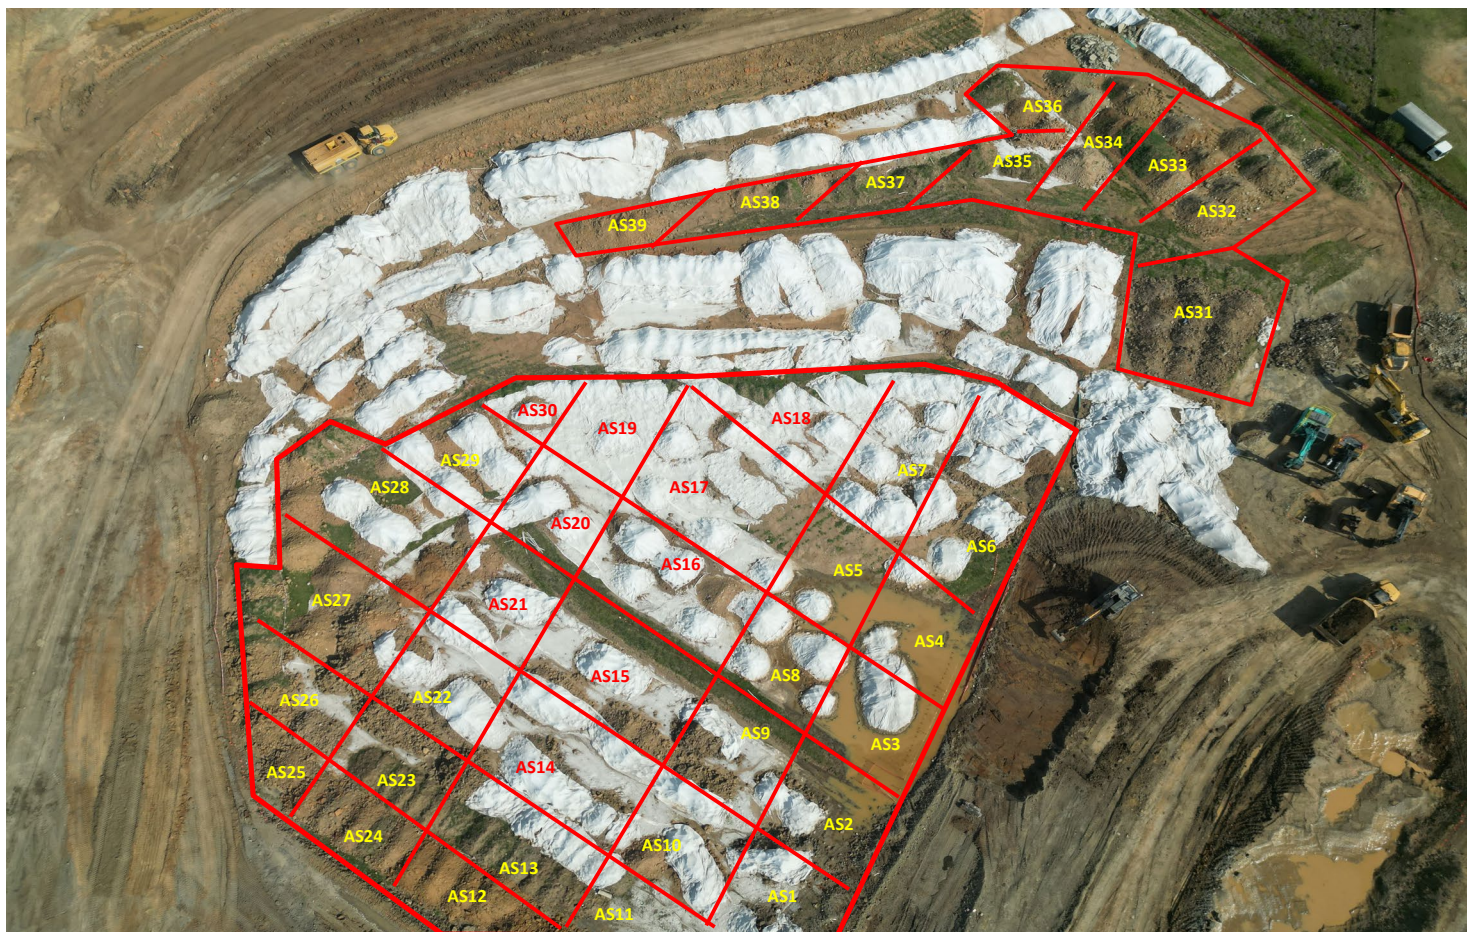
FOUNDATION EARTH SCIENCES	DRAWN	Site Features and Borehole Location Plan	
Area A Site Location ———			DG		
Area B Site Location ———			Figure		Jk Williams/ Ground King Civil
			1		
		Job #	Aldington Road, Kemps Creek		
		E3116

*Approximate areas only (some locations may have changed due to stockpiling)

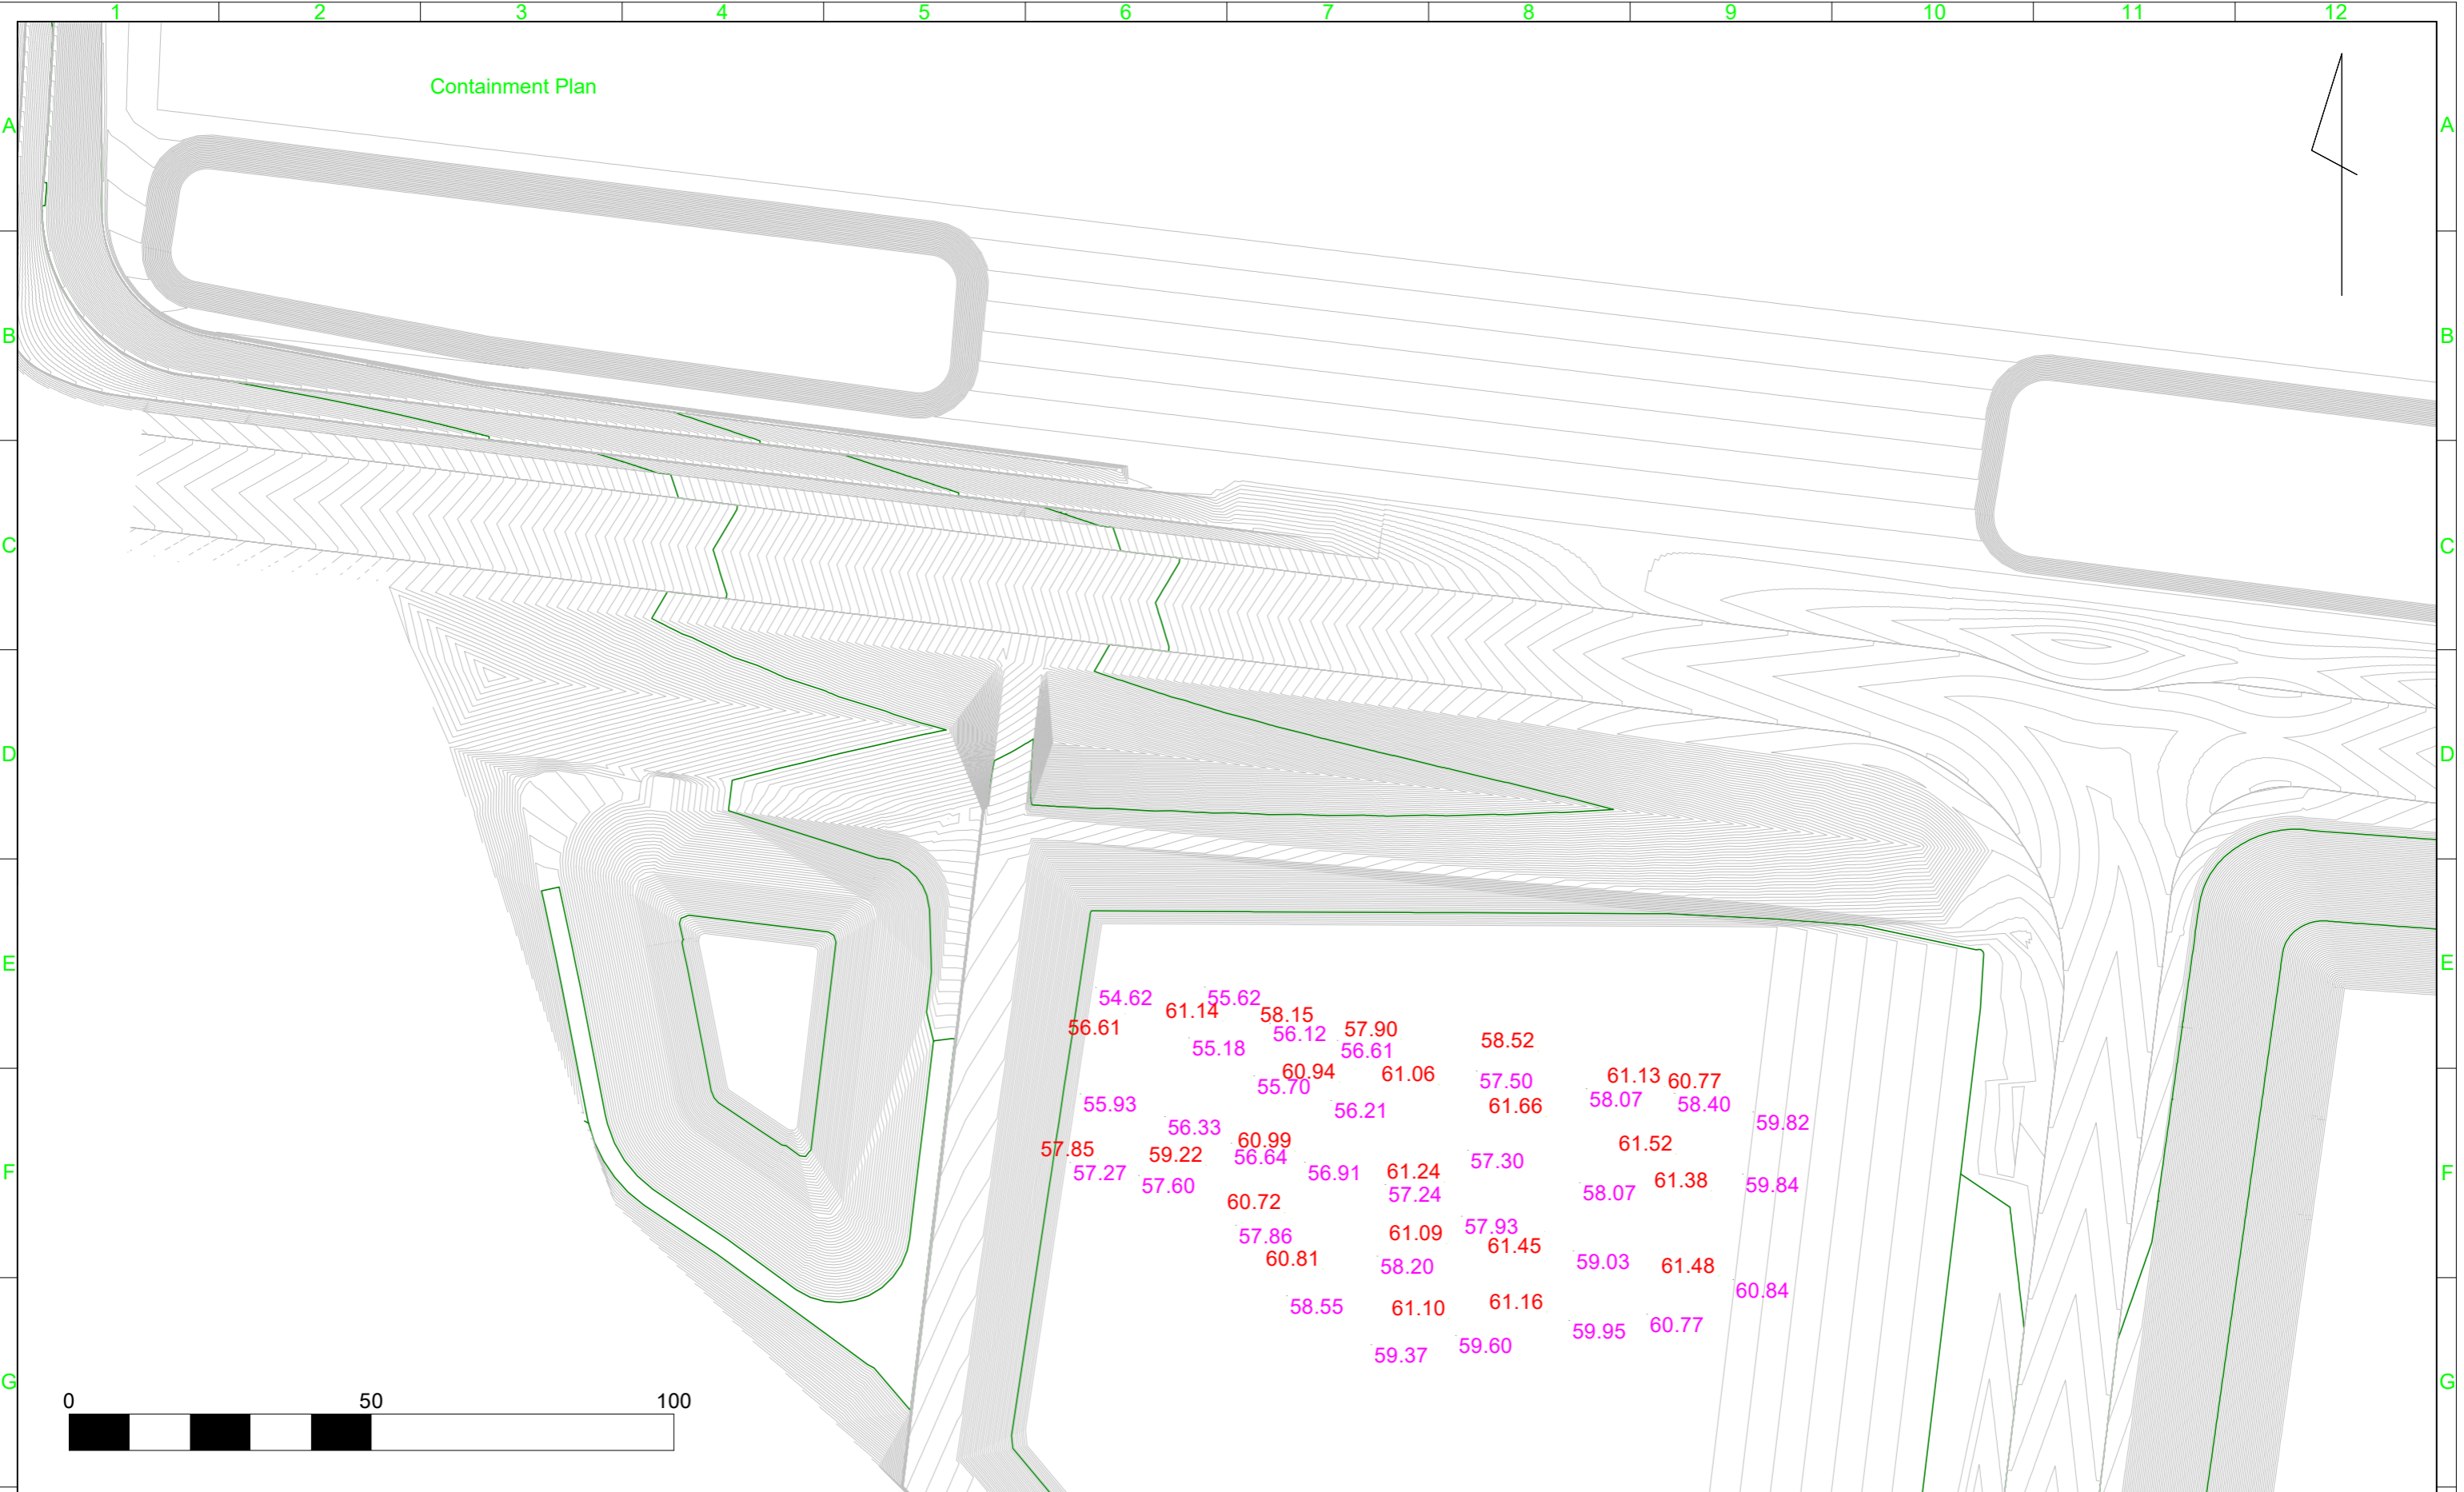
39-53 Jack Williams Drive, Penrith, NSW 2750 Phone: 02 4725 3400 Email: jkw@jkw.com.au	Client:	Project:		Description: Purple = Strip RL Red = Top B2 Lot 3	Rev	Date	Revision Details	Contour Interval Major:		
		Horizontal Datum:			Level Datum:	A			Minor:	
		Surveyed:			Checked:	B			Scale:	
		Drawn:			Ref No.:	C			Sheet Size: A3	
		Local Authority:				D			Drawing Number:	
						E				
					F			DATE OF SURVEY:		
								Sheet No.	of	Rev. A

An inspection was undertaken on the 13th October 2023 in order to visually inspect the surface after the remediated soils had been removed from the area and buried in an area designated by JK Williams. The burial location of the soils can be seen in the attached plan "Containment Plan".
